NRC PERD 079 Project - Task 1 - Findings from the Carmacks Yukon survey

**Findings from the Carmacks Yukon Survey
prepared by
Madeleine Rousseau, Marianne Manning,
Nady Said, Mike Swinton and Steve Cornick
Feb. 2007**

Carmacks Survey

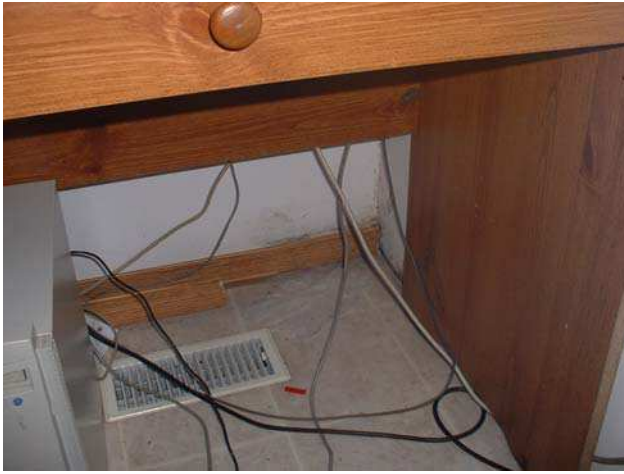
Mould growth in exterior walls, particularly behind furniture and at lower portion of floor. Mould noted in bathroom

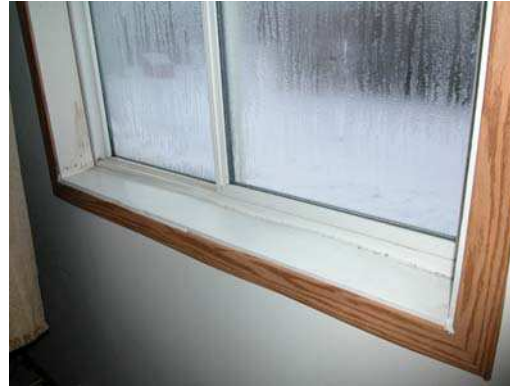
Windows have frost on them and are frozen open

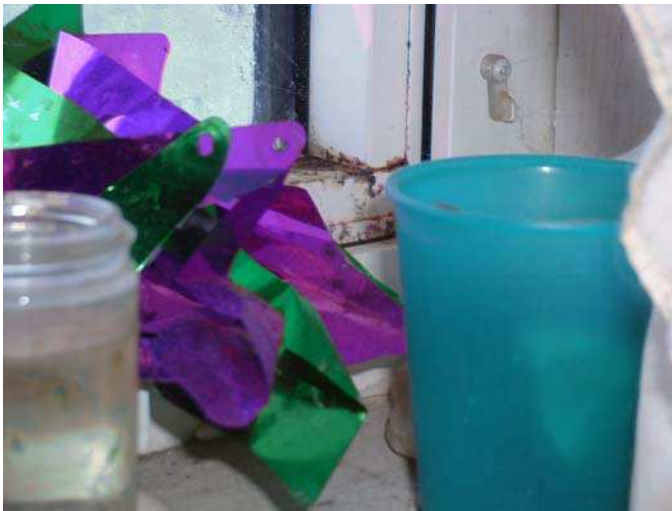
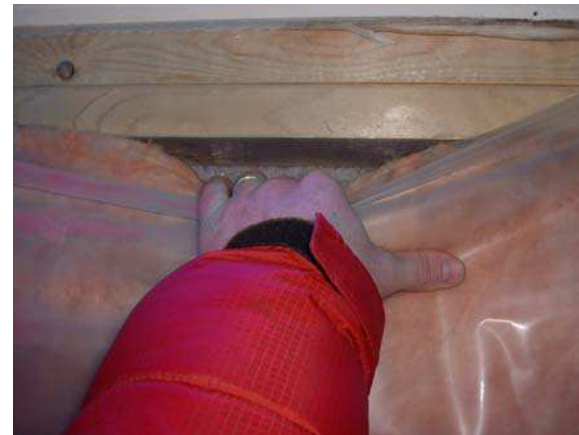
Stained drywall removed at time of site visit. It was noted that the air barrier was incomplete around penetrations. There was approximately 1cm thick of ice on the inside face of the exterior sheathing at these locations

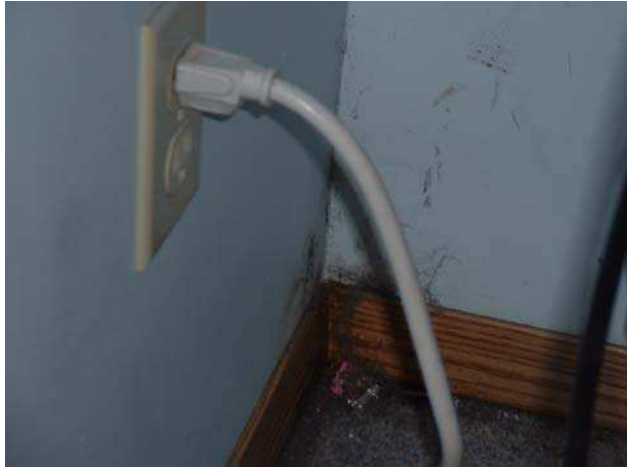
Mould on walls, at corners of floor and ceilings
