Building Research Note

EXPOSURE OF SOME ROOFING SYSTEMS

B. F. Stafford

March 1970

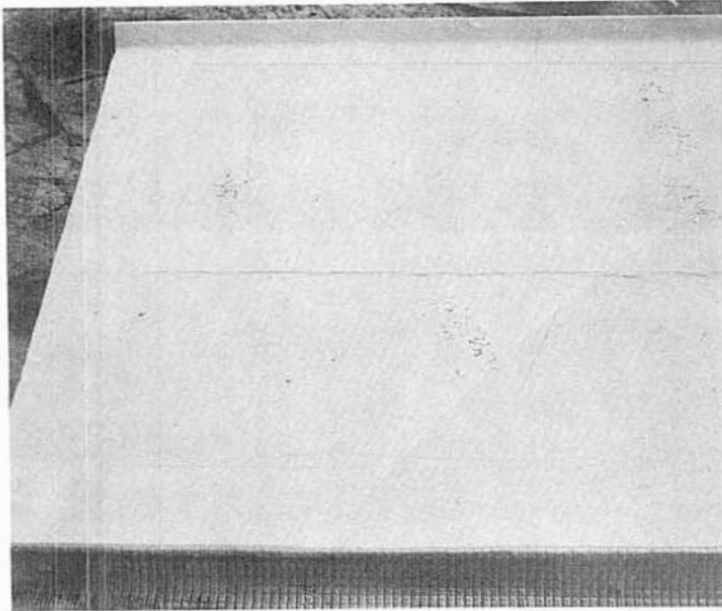
After 6 to 8 months exposure, small hairline cracks appeared over the entire surface about 2 in. apart. This random surface cracking

was very pronounced after 2 years and there was slight damage along the front edge. After 5 year's exposure, this effect had increased so that the distance between each hairline crack was reduced from $\frac{1}{2}$ in. to $\frac{1}{4}$ in.; this cracking did not, however, appear to affect the polyisobutylene sheet. Some small portions of the topcoat were beginning to peel and the adhesive at the centre overlap had failed for a distance of approximately 10 in. to a width of $\frac{1}{4}$ in. Some blistering along the cant strip, and some slight chalking was observed, but there appeared to be only slight dirt retention.

ROOF NO. 1 - 5 years exposure:
severe hairline cracking.

Some degradation of the surface of the materials, such as that noted in the white butyl sample, could be tolerated if the wash-off were not allowed to disfigure the building's facade. The polyisobutylene system suffered marked cracking of its reflective, acrylic topcoat, but the sheet material itself appeared to be in excellent condition. If this system, then, were installed in an easily accessible area, periodic recoating would probably ensure satisfactory performance for many years.

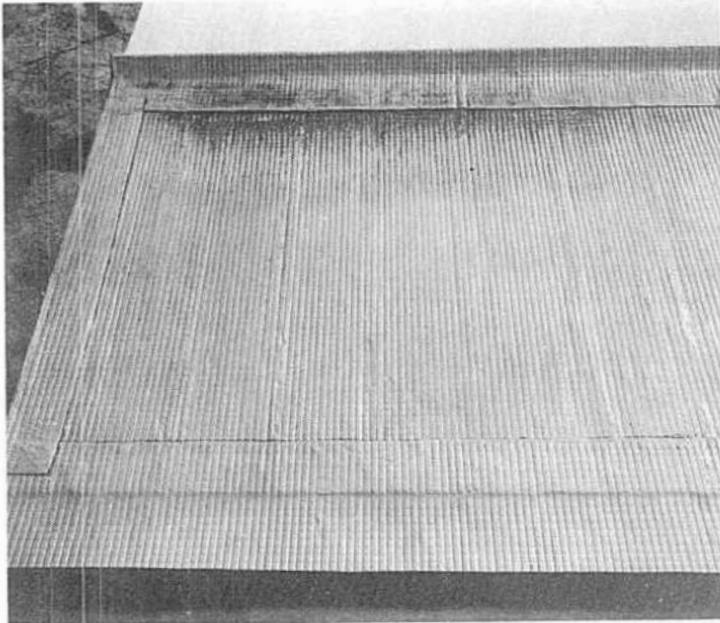
Slight dulling of the aluminum-foil surface had taken place by the end of the first 12 months of exposure. After 2 years, the glass reinforcement at the lap was beginning to show; 3 months later there was a slight loss of bond in two locations on the lap joints, 4 ft apart. The final observation after 5 years of exposure showed some loss of adhesion $\frac{1}{2}$ in. inward on the overlap section covering the cant strip, in addition to 3 large ridges running perpendicular to the length of the deck. There were also 8 ridges 1-in. wide running across the width. Surface dulling was moderate and dirt retention moderately high in an area where water ponding took place.

ROOF NO. 2 - 5 years exposure:
slight dulling and some ridging.

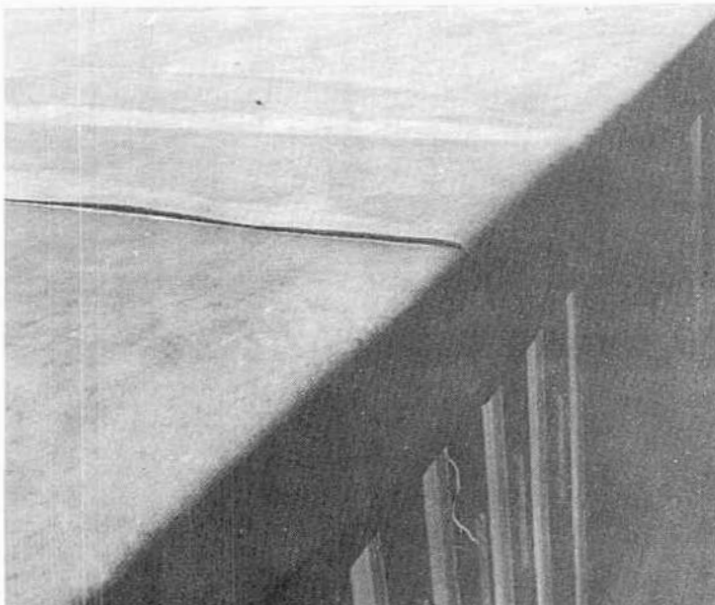
After 10 months, the centre-lap joint began to lift slightly. This loss of bond was more noticeable after 2 years when the lap had lifted approximately $1/8$ in. along the length of the lap. By then, there was also a lightening of colour and a small crack at the front of the cant. After 5 years, the loss of bond along the lap joint had increased to a maximum depth of 1 in., chalking was of medium intensity, water staining along the low edge was severe, two nails from the deck had lifted but had not penetrated the butyl sheet, and the overlap at one of the corners of the cant strip had lost its adhesion.

ROOF NO. 3 - 5 years exposure:
colour change, chalking and
adhesive failure.

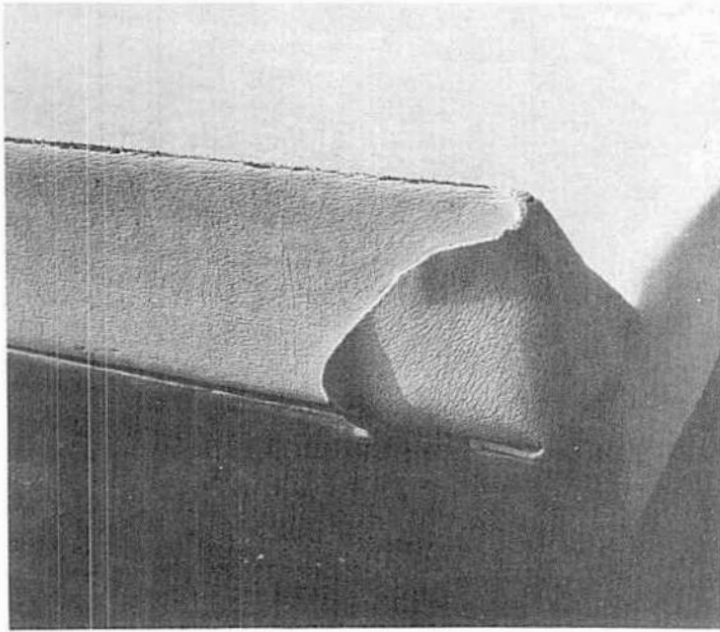
After 2 months, slight surface chalking was noticeable. At the end of 4 months, this effect was considered pronounced, and with 2 month's additional exposure, the chalking was washing over the edge of the roofing. After 2 years there was a loss of bond at the centre overlap and defects in the membrane were quite noticeable; chalking continued to be severe with large amounts of wash-off taking place, and a pattern of surface cracks had appeared. After

5 years, adhesive failure had begun along the centre overlap to a depth of approximately $\frac{1}{2}$ in., and surface defects in the form of $\frac{1}{2}$ -in. long, oblong craters were spread over the whole surface although not penetrating the butyl sheet. A long crack along the front edge had resulted in the separation of the deck and edge covering. A deep crack had also developed along the top edge of the cant strip.

As noted, it became evident in the early stages of this exposure program that a major problem with the material was its severe chalking characteristics. The manufacturers submitted a second sample that had been chemically modified in an attempt to improve the material's resistance to chalking; in a few months, however, it too had chalked heavily.

ROOF NO. 4 - 5 years exposure:
severe chalking, splitting and
checking.

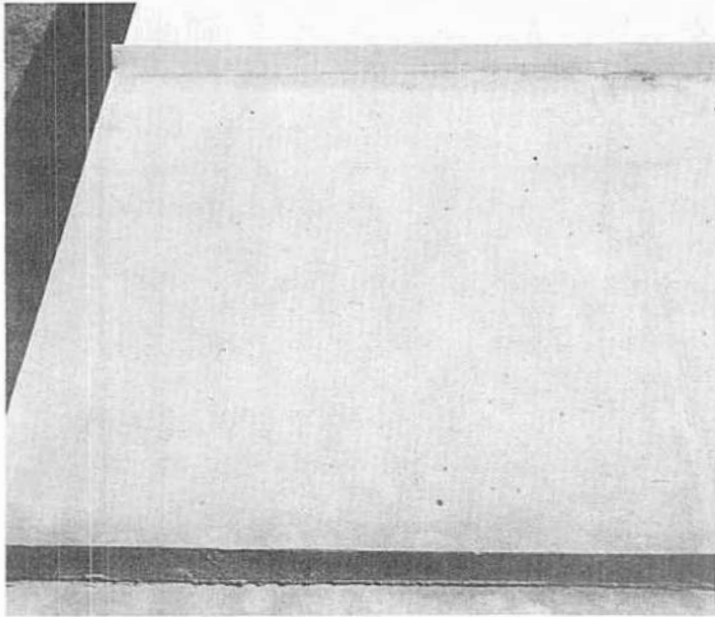
Some minor cracking had developed in this coating immediately following its application and before exposure, but it had become no worse after 1 year's exposure. After 2 years, the flashing tape split in two places and other small splits appeared on the cant strip, the surface was dirty, chalking had begun and a few of the nail heads under the roof material were showing through. Six months later, the splitting which ran along the long dimension of the deck, had become pronounced and the membrane had opened at an edge (due to splitting) which allowed water to enter the deck. After 5 years, several cracks had developed along the cant strip 1 to 2 in. in length. These cracks allowed water entry, and caused loss of adhesion along the length of the cant strip. Several nails pushed through the membrane with resulting rust stains accentuating the dirt accumulation on the low side. The topcoat had cracked to moderate severity.

ROOF NO. 5 - 5 years exposure:
cracking and splitting.

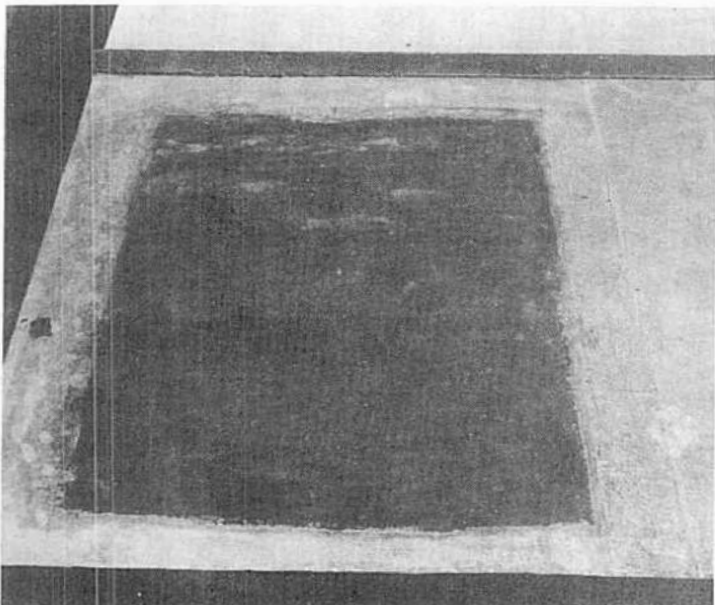
After 2 months, the sheet-applied system showed high dirt retention and a few small blisters whereas the liquid-applied material did not appear to have changed, but after an additional 6 months exposure, both systems were high in dirt retention. In 12 months time this effect was rated as severe. After 2 years, some loss of adhesion was found at the areas adjacent to the portions that had suffered mechanical ruptures. After 5 years, the sheet-applied portion of this roof showed signs of heavy erosion. The entire roof was very dirty and adhesion was poor near the damaged areas.

ROOF NO. 6 - 5 years exposure:
heavy dirt deposition and surface
erosion.

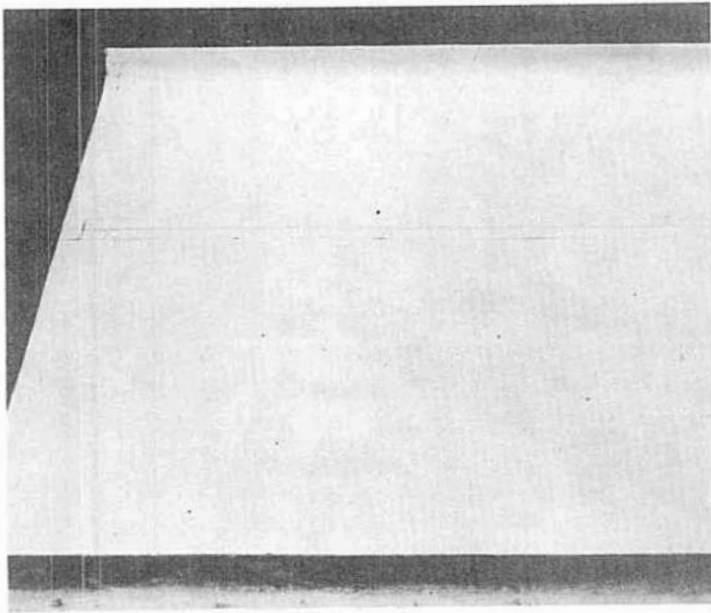
After 2 months, there was slight shrinkage of the tape at the joint. Except for the above-mentioned effect there was no change after $2\frac{1}{2}$ years of exposure. After 5 years, there was a slight loss of gloss, a few punctures in the topcoat (which appeared to have been the result of mechanical damage) and a moderate loss of adhesion at the edges of the centre tape.

ROOF NO. 8 - 5 years exposure:
loss of adhesion at taped joint.

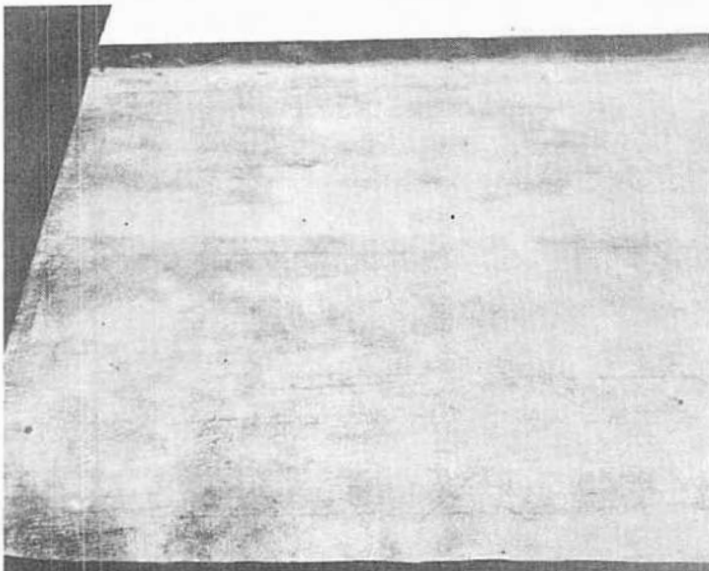
After 2 months, that portion not covered with hypalon showed slight dirt retention. After 4 months, this dirt staining on the butyl-latex portion had become quite severe, and the glass scrim on the cant strip had pulled away from the cant. There was also some fracture of the butyl-latex glass-scrim membrane at the edge where it had received wear from traffic. After 2 years, cracks had developed on the cant strip. Three months later, a crack appeared over the joint in the substrate. The uncoated, butyl-latex portion of this test sample appeared quite porous, and a large number of holes were evident. After $2\frac{1}{2}$ years, it was observed that this porous uncoated area was allowing water penetration. After 5 years, water was getting into the deck through the cracked joint, several small crater-like depressions had appeared over most of the hypalon-coated area, and there was severe erosion of the uncoated butyl-latex portion.

ROOF NO. 9 - 5 years exposure:
membrane cracked, severe
surface erosion, and heavy dirt
retention.
