## **Shrinkage of EPDM roof membranes: phenomenon, causes, prevention and remediation**

**Paroli, R.M.; Delgado, A.H.; Dutt, O.M.; Smith, T.L.;  
Simmons, T.**

**NRCC-40627-6**

**Building Better Roofs: IRC Technical Seminar, 11 Cities Across Canada,  
September 1996-February 1997, pp. 90-110**

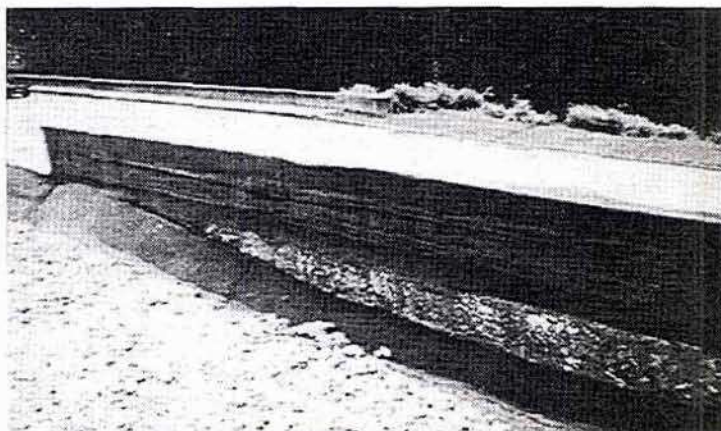
Photo 1. After the field sheet was torn at the metal batten, the originally uncured flashing over the batten stretched and tore. (Georgia)

Fortunately, this type of problem is typically not catastrophic. (An exception would be a long tear extending from an equipment curb into a ponded area, which happened in another area of the roof shown in Photo 1). In many instances, if flashings have become damaged, the roof life can be extended by their replacement/repair.<sup>21</sup>

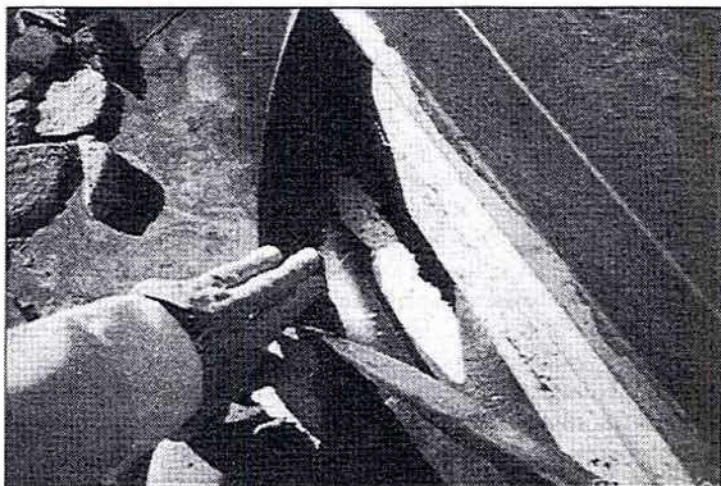
*Photo 2. Roof S5: The field sheet was attached to a CMU wall with wood battens that were fastened with plastic sleeves/drive pins, spaced at 12 in., 11½ in. and 9½ in. (305, 290 and 240 mm). The field sheet tore and pulled out from under the batten at the fastener locations. The originally uncured flashing over the batten was then stretched and torn. At other locations, the fasteners pulled out of the wall and the batten moved inward approximately 6 in. (150 mm).*

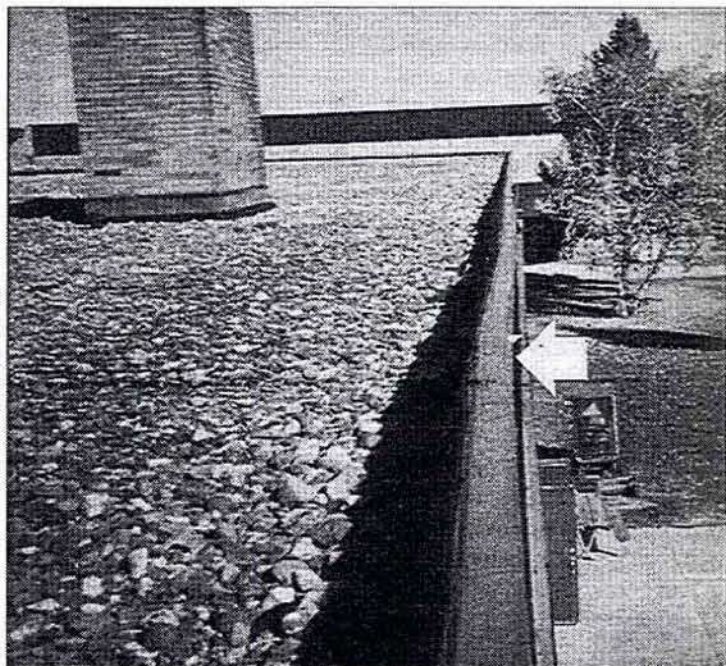
*Photo 3. Roof S7: Membrane contraction caused the top of this weak metal parapet to move to the left. The parapet rested on the field sheet and the sheet was attached with roofing nails spaced at 18 in. (455 mm). It may have also had other securement. Water can now enter the top of the parapet (see arrow).*

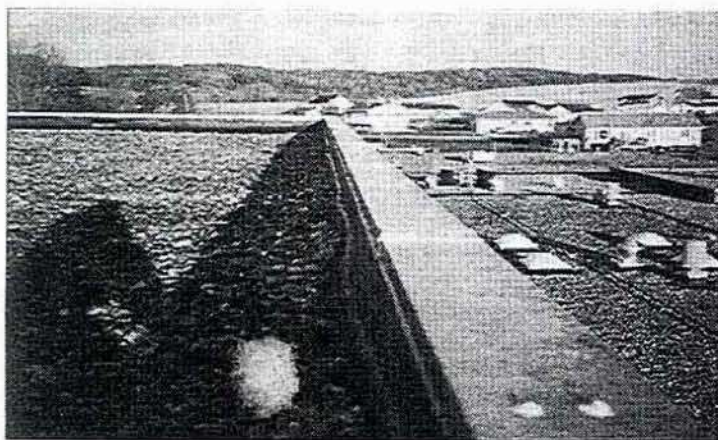
*Photo 4. Roof S9: Along most of this parapet, the wood batten fasteners pulled out of the brick. In some locations, patches had been placed where the ends of the battens had punctured the flashing.*

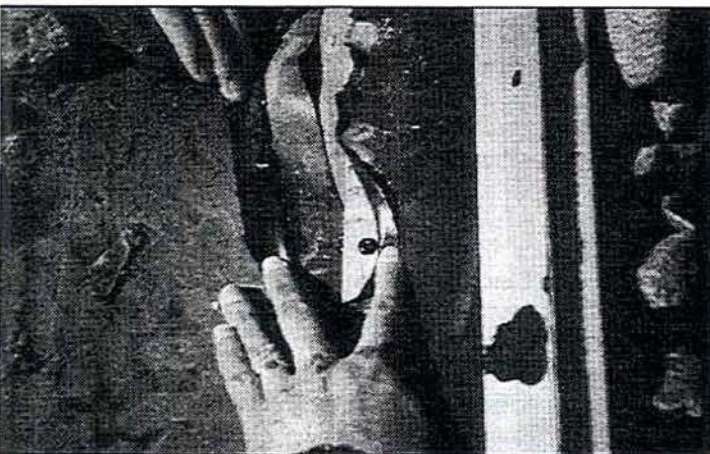
*Photo 5. Roof S10: Looking down at a vertical transition between a new and old roof. The field sheet on the left was attached with a 1 in. (25 mm) wide aluminum batten that was fastened with screws at 12 in. (305 mm) on center. The field sheet tore at the fasteners and the originally uncured flashing over the batten was stretched until it tore.*

- Membrane shrinkage does not appear to be the cause of the flashing problems on Roof S10 (Photo 5). The damage may be related to temperature-induced loads, however, since it was installed directly over an unreinforced PVC membrane that had shattered, perhaps the flashing damage was related to EPDM movement associated with subsequent shrinkage of the unreinforced PVC membrane. To avoid this later possibility, rather than recovering a membrane that may be susceptible to further shrinkage, the existing membrane could be removed. However, with conservative base securement details (which was not the case with this roof), flashing problems will probably not be experienced even if the old membrane remains.

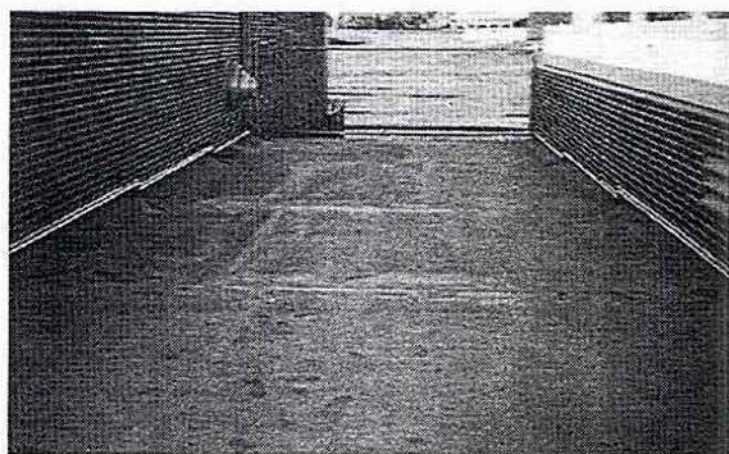
*Photo 6. Roof S11: This mechanically attached roof is taut near the metal termination bars. The membrane is susceptible to puncture and tearing at the sharp ends of some of the bars.*

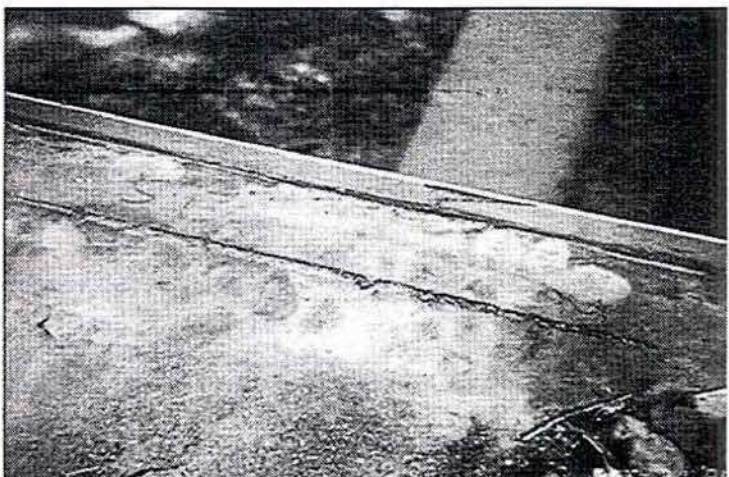
*Photo 7. Roof S13: The field sheet is fastened with roofing nails that were also used to attach the metal edge flashing. The nails were spaced at 5 in., 5 in. and 4 in. (125, 125 and 100 mm). The field sheet turned down at the wall and was fastened by the continuous cleat fasteners. As the field sheet moved inward, the originally uncured flashing was stretched and torn.*

(1985 and 1989) of *The NRCA Roofing and Waterproofing Manual* show batten strips near the base of parapets and curbs, and most of the details indicate a fastener spacing of 12 in. (300 mm), but the type of fastener is not indicated. The *Manual* also has a metal edge flashing detail that is similar to that shown in Photo 7.

For metal edge flashings, securement of non-reinforced sheets may be successful if the sheet is turned down at the outside face of the wall and fastened with capped-head nails which are closely spaced (e.g., 4 in. [100 mm] on center), and the membrane is additionally secured with a continuous metal cleat. The 90° angle change reduces the tearing stresses at the holes around these fasteners. However, some tearing/elongation of holes around the fasteners securing the horizontal flange of the edge flashing may still occur. Periodic observation and repair of the flashing may be required (Photo 7), as is commonly the case with similar details in built-up roofs.

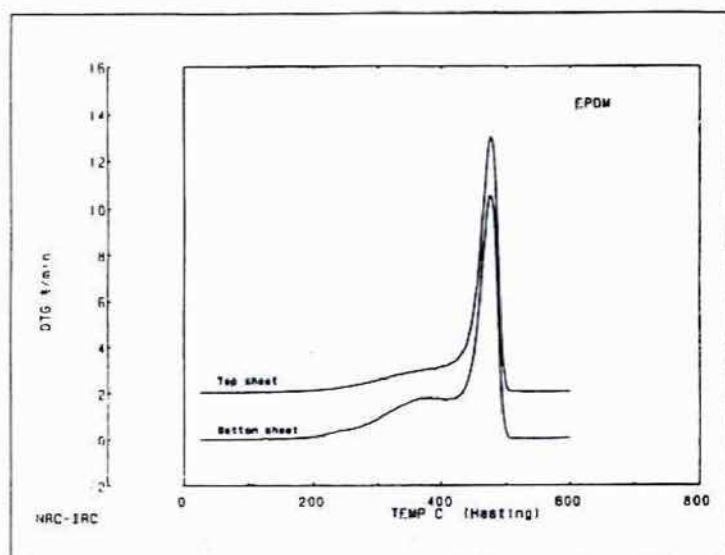
Typical derivative thermogravimetry (DTG) plots for exposed (top) and unexposed (bottom) EPDM membranes are shown in Figure 1. As can be seen, there are two degradation steps. The shoulder observed between 410°F (210°C) and 780°F (415°C) may be attributed to the partial volatilization of oil. While the weight loss region between 780°F (415°C) and 930°F (500°C) corresponds to further volatilization of oil and the decomposition of the polymer. It is evident that the region where the oil is lost overlaps with the region where the polymer degrades. As a result, the weight loss observed is a combination of oil and polymer loss. The total oil content for each EPDM sheet being tested is thus difficult to measure by conventional TG. However, the EPDM rubber polymer is relatively stable and is not expected to decompose when exposed to natural weathering. Hence, it is possible to compare the

Figure 1. DTG plot for the SG1 EPDM roof membrane.

The amount of oil loss for the top sheets for S3A, S5-A, S7, S5-B, S13-B and SG1 is at least 3 percent (Appendix 5). For instance, the total weight loss below 930°F (500°C) for the top sheet of sample SG1 was 52.9 percent while for the bottom sheet, the weight loss was 60.9 percent. This indicates that the top sheet has lost some oil (~8 percent) during exposure to natural weather conditions. Results obtained for sample S13-B could indicate that the two bottom layers that have been naturally aged, but protected by the top layer, are losing oil at a slower rate. As can be seen from the results, the total weight loss for the oil and polymer region of the middle sheet is 2.6 percent higher than the top sheet, but 2 percent lower than the bottom sheet (i.e., the retained oil content is greatest for the bottom sheet).

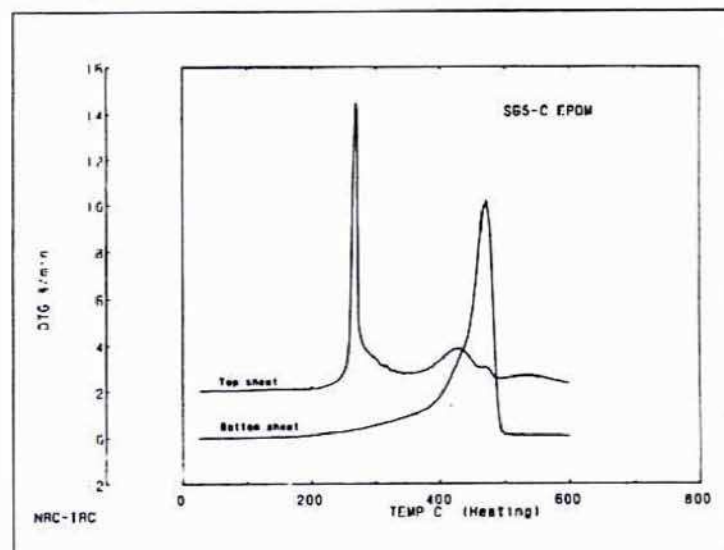
One sheet from SG5-C exhibits a weight loss between 480°F (250°C) and 700°F (370°C) which is not observed in a typical EPDM membrane (Figure 2). This sample, which was taken near a flashing, is an originally uncured sheet. It is interesting to note how the TG and DMA techniques can easily be used to differentiate between the various membranes on this roof. Using other chemical techniques such as Fourier-transform infrared (FTIR) spectroscopy, one can determine if the originally uncured flashing is either butyl- or neoprene-based. In this case, it is neoprene-based.

Figure 2. DTG plot for the SG5-C flashing.

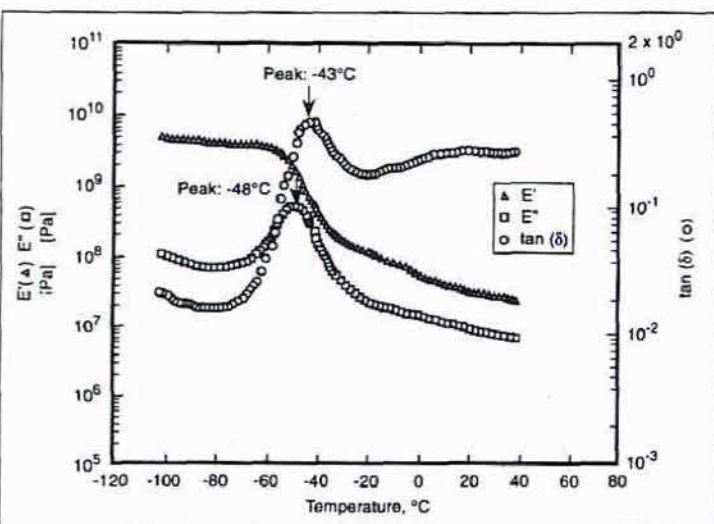
A typical DMA plot showing the storage modulus ( $E'$ ), loss modulus ( $E''$ ) and damping factor ( $\tan\delta$ ) is shown in Figure 3. The data are summarized in Appendix 5. In general, the  $T_g$  values did not change substantially. The  $\Delta T_g$  ( $T_g$  [top sheet or "exposed"] -  $T_g$  [bottom sheet or "unexposed"]) was as low as 0°F (0°C) to a high of 16°F (+9°C). A change in  $T_g$  to warmer temperatures can be attributed to various factors such as crosslinking, loss of oils (or plasticizers) or other molecular rearrangements. The only EPDM samples to show a change in  $T_g$  greater than 5°F (3°C) were S5-A, S13-B and SG1. This implies that although oil loss was detected in other samples, the amount was not sufficient to affect the  $T_g$ . On average, the  $T_g$  values ranged from -54°F (-48°C) to -72°F (-58°C). Only one sample, the originally uncured neoprene-based flashing in SG5-C, had a  $T_g$  value as high as -36°F (-33°C).

Figure 3. DMA plot for the S3-B EPDM roof membrane. (Note:  $E'$  is the storage modulus,  $E''$  is the loss modulus and  $\tan \delta$  is the damping factor.)

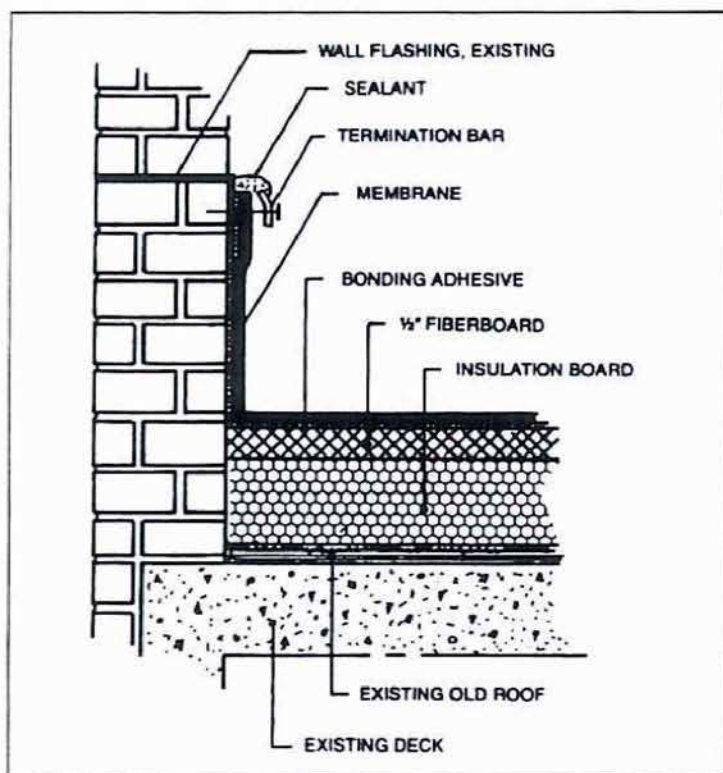
Since the introduction of EPDM roofing sheets, the various manufacturers/suppliers have recommended a variety of base securement details, and individual manufacturers have typically changed their requirements over the years. Some manufacturers did not recommend mechanical attachment near the base of parapets or curbs (Figure 4), but rather relied upon the bonding adhesive to resist the contraction load. However, because of the adhesive's low peel-strength, the membrane could be pulled off the parapet or curb with very little force.

Figure 4. A 1980 detail from a manufacturer that did not recommend mechanical attachment near the base of the parapet. (This manufacturer no longer supplies EPDM sheets in North America.)

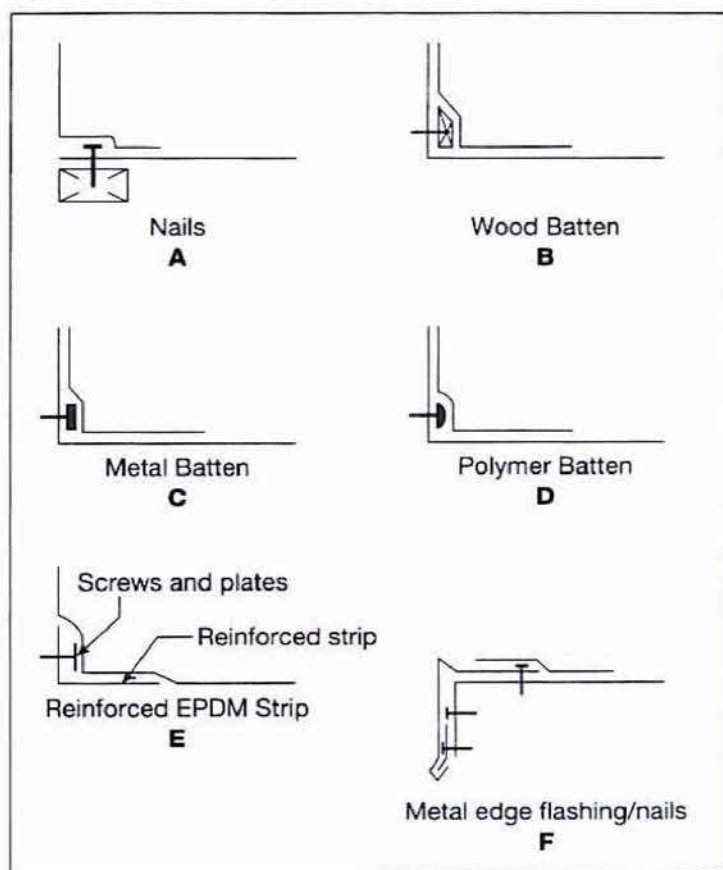
Early base securement details relied on roofing nails, which typically proved to be ineffective. A variety of base securement devices followed, including wood, metal and polymer battens (see Figure 5). Metal and polymer edge flashings of various designs have also been used. The latest base securement detail uses a strip of reinforced EPDM, which is fastened with screws and plates (see Figure 5-E). The Second and Third Editions

Figure 5. Common base securement details that have been or are still being used. (Typically, fastening strips may be installed on the vertical or horizontal plane.)
