**FIELD STUDIES OF A SULPHUR/ASPHALT COMPOSITE
POTHOLE REPAIR SYSTEM**

by J.J. Beaudoin and P.J. Sereda

DBR Paper No. 1156
Division of Building Research

The results of two field studies on the performance of a novel sulphur/asphalt composite pothole repair system are described, as well as the material properties and equipment development. More than 100 potholes at each location (Ville St-Laurent, Quebec, and Winnipeg, Manitoba) were repaired under both summer and winter conditions. Control patches using conventional cold patch material were made whenever possible. Road types repaired included concrete pavement with and without asphalt overlays and asphalt pavement on a granular base. The potholes were prepared using various methods of cleaning and preheating, tack coat, wire mesh reinforcement, crushed stone filler and edge cutting. The composite system performed better, by far, than the conventional cold patch material.

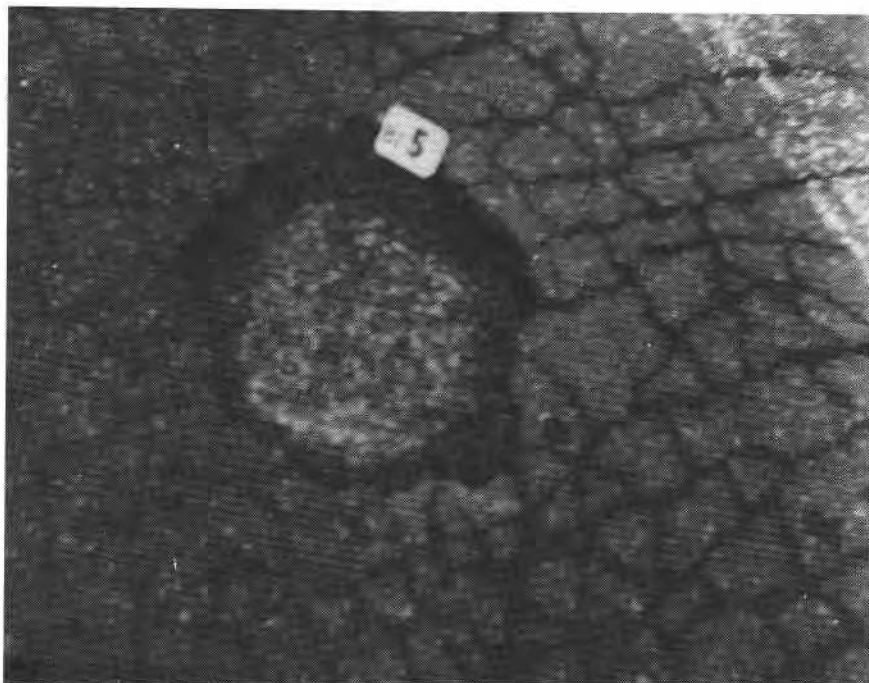
A pothole can be considered as a pavement defect, involving the surface or surface and base, potentially hazardous to motor vehicle transport. Potholes are usually the after-effects of differential heaving and settlement which are often attributed to poor design, poor drainage and poor maintenance aggravated by freeze-thaw effects. One such example is shown in Fig. 1.

Fig. 1. Typical pothole formed when surrounding pavement has badly deteriorated. Pavement type is concrete base with asphalt overlay. Pothole is approximately 40 cm in diameter.

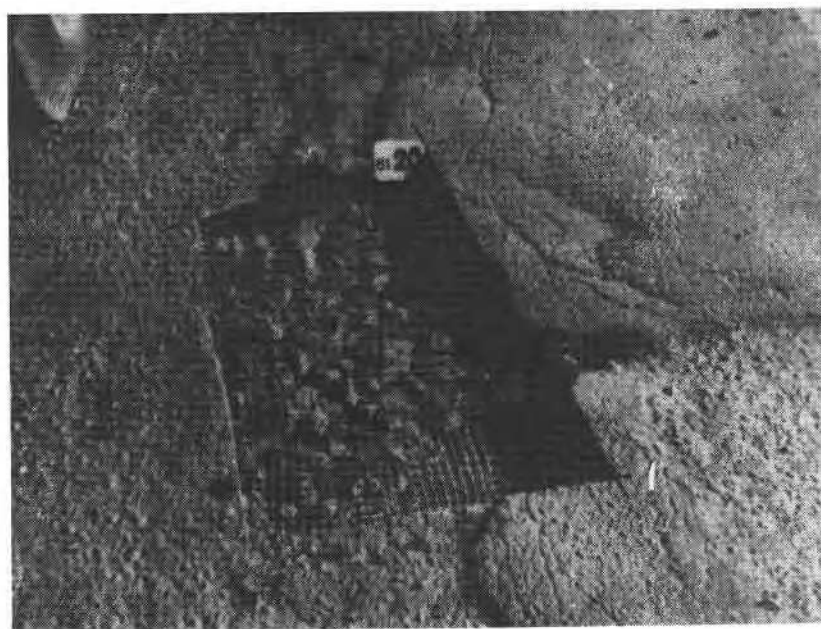
Fig. 2. Pothole shown contains wire screening to reduce cracking. Edges have been saw-cut and crushed stone has been utilized to economize on repair material.

To prepare the pothole properly before repair, the following techniques should be considered. Debris and water can be removed from the cavity using steam, compressed air or mechanical implements. Preheating the surfaces of the hole and applying a *tack coat* improve adhesion with the repair material. Filling deep holes with a crushed stone layer prior to applying the repair material lowers cost. Reducing and modifying cracking by placing wire screening in the pothole before adding the repair material is another possibility (Fig. 2).

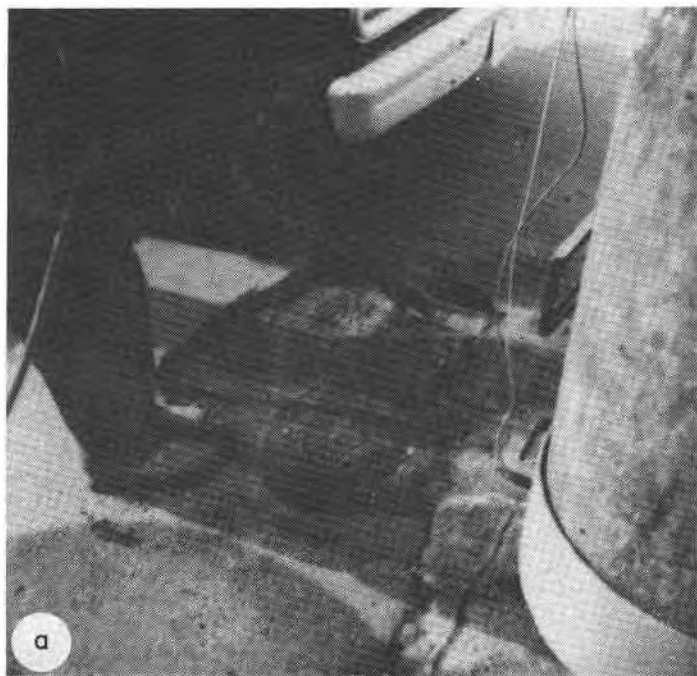
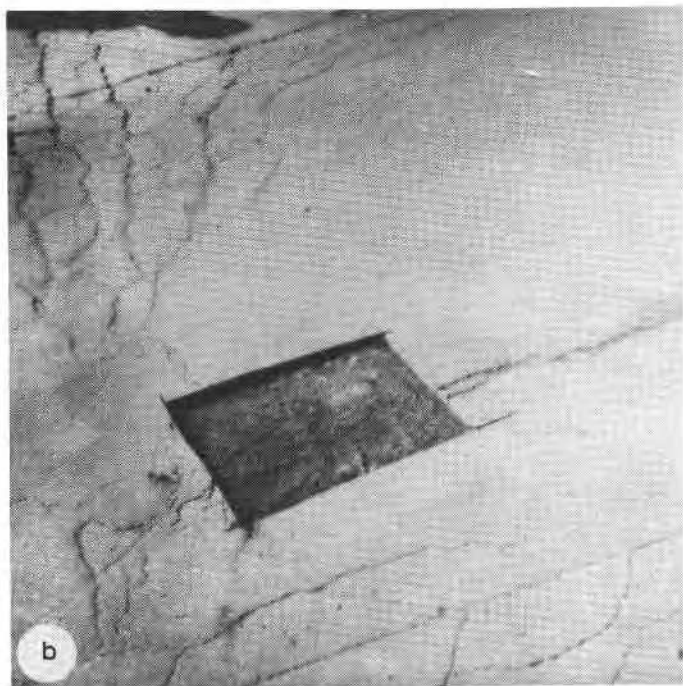
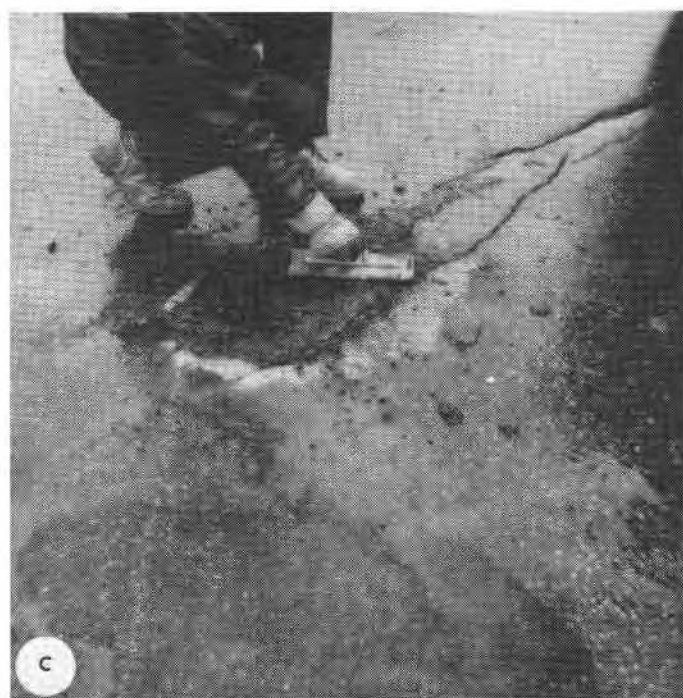
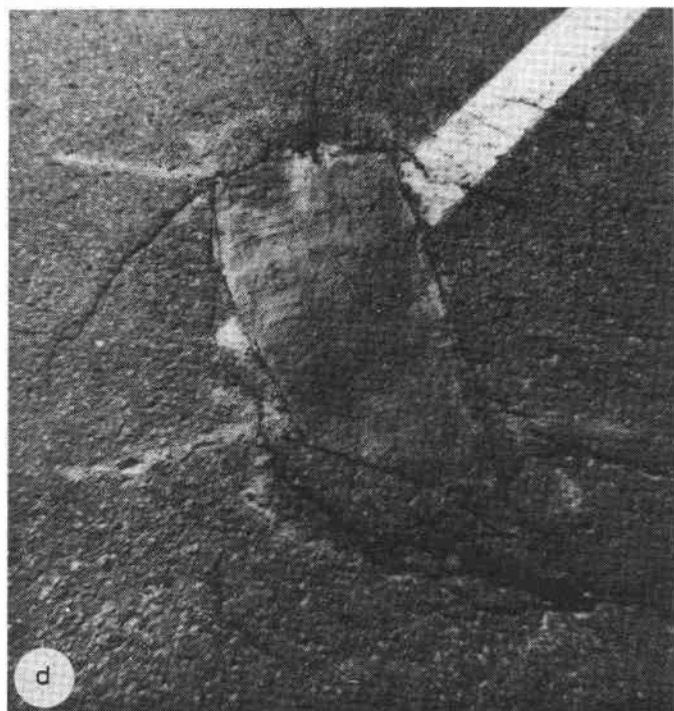
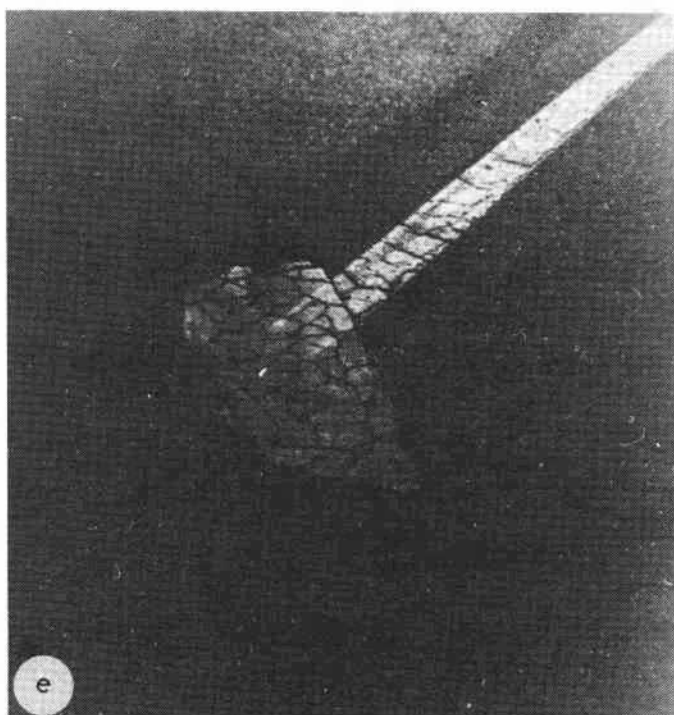
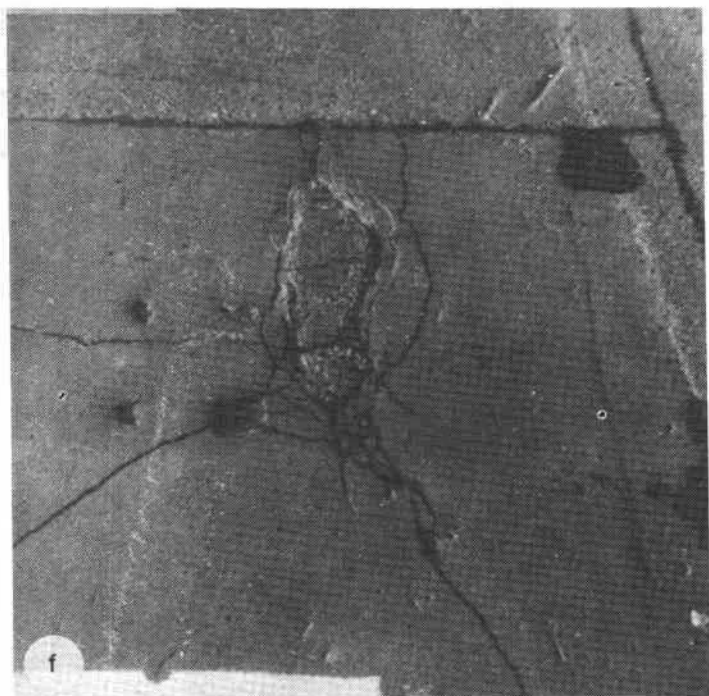
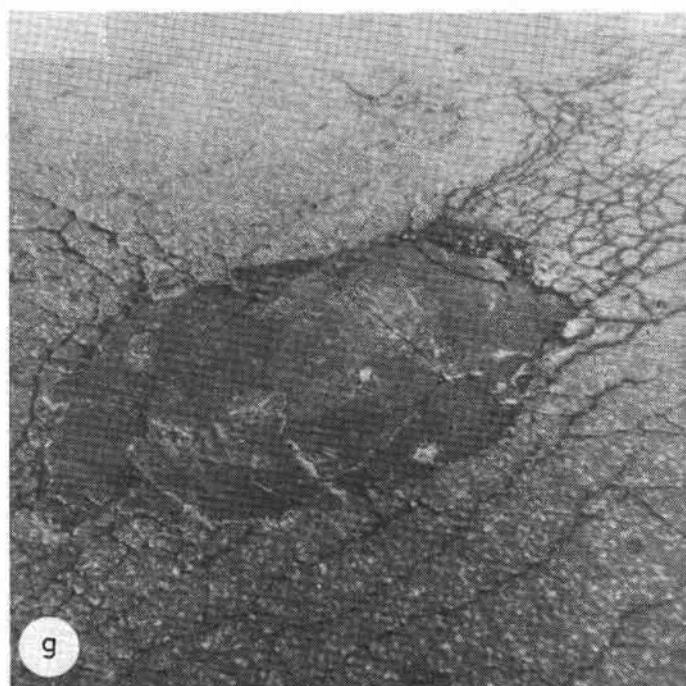
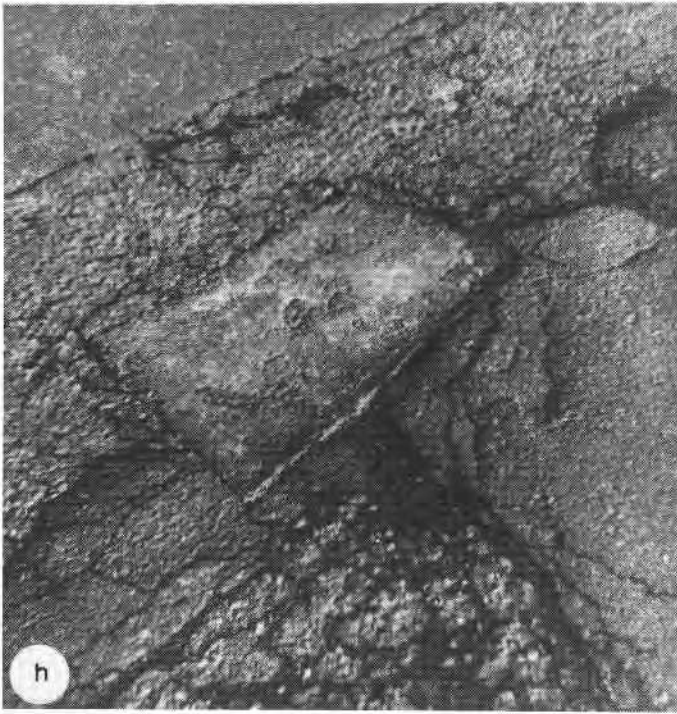
Some methods of pothole preparation and differences in performance of various repairs are illustrated in Figs. 6(a) — (h). The captions give specific details about each repair. Some general observations are as follows: the smaller patches cracked less than the larger ones; the weaker the road base, the sooner the patch cracked; the patches that were saw-cut appeared to undergo less deterioration and cracking than those that were not; repairs made in spring performed as well as those made during summer; cracking of patches in potholes less than 0.2 m^2 in area can be eliminated by using wire mesh reinforcing; potholes more than 15 cm deep can be partially filled with granular material to reduce the quantity of the repair material needed without adversely affecting performance. Using a minimum thickness of 7.5 cm of the patching material produced no adverse effects.

Fig. 6. Pothole repair at Ville St-Laurent, Quebec: (a) Preheat treatment is applied to cleaned pothole using propane torch; (b) Pothole is prepared by saw-cutting boundaries; (c) Surface of pothole repair is troweled; (d) Pothole repair with saw-cutting boundaries is shown shortly after completion; (e) Same pothole as in (d) is shown after 2½ years service. Although extensive alligator cracking has occurred, adhesion and serviceability remain good; (f) Repair installed in March 1980 is shown 1½ years later; (g) Repair containing wire mesh is shown 10 months after installation. Note poor condition of surrounding material and minor cracking of patch; (h) Repair similar to (g) except for saw-cut boundaries is shown.

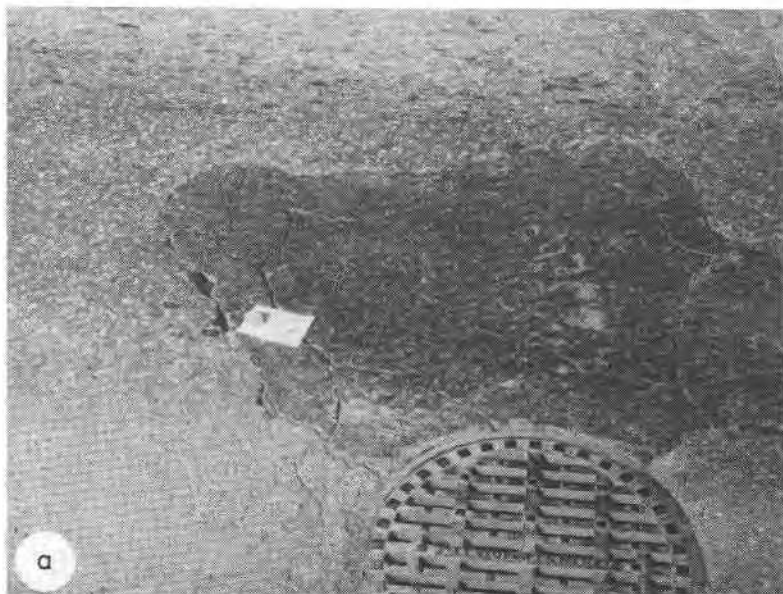
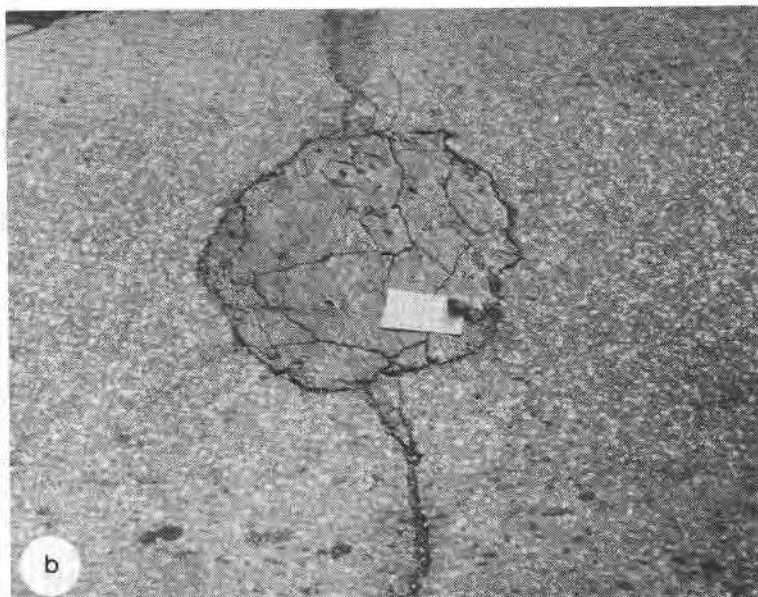
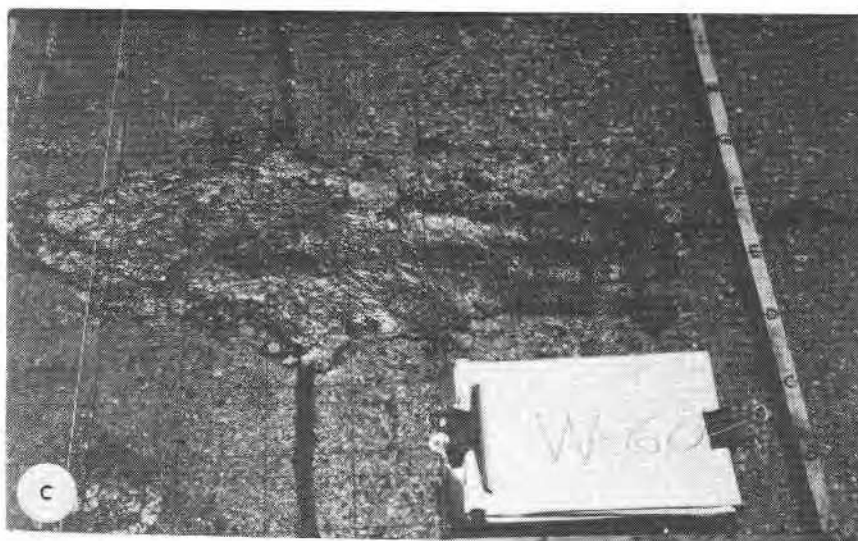
service (at last inspection) and the effect of freeze-thaw cycles, salt, traffic and maintenance operations. Despite the great demands placed on material used to repair joints as a result of continual movement and stress reversal at the joint, many of the repairs were still serviceable. Reinforcing was not evaluated at the Winnipeg site. In contrast with the NRCC SAC patches, many of the control *cold mix* patches were replaced 4 or more times. Figure 7 shows some typical repairs at the Winnipeg site.

Fig. 7. Some repairs at Winnipeg site: (a) Typical patch at periphery of catch basin shows deterioration after 6 months; (b) Typical pothole repair shows some reflection cracking after 6 months; (c) Example of joint repair is illustrated.
