FAILURE OF WHITE COAT PLASTERS - CAUSE AND REMEDY

V. S. Ramachandran and P. J. Sereda

No 95

September 1974

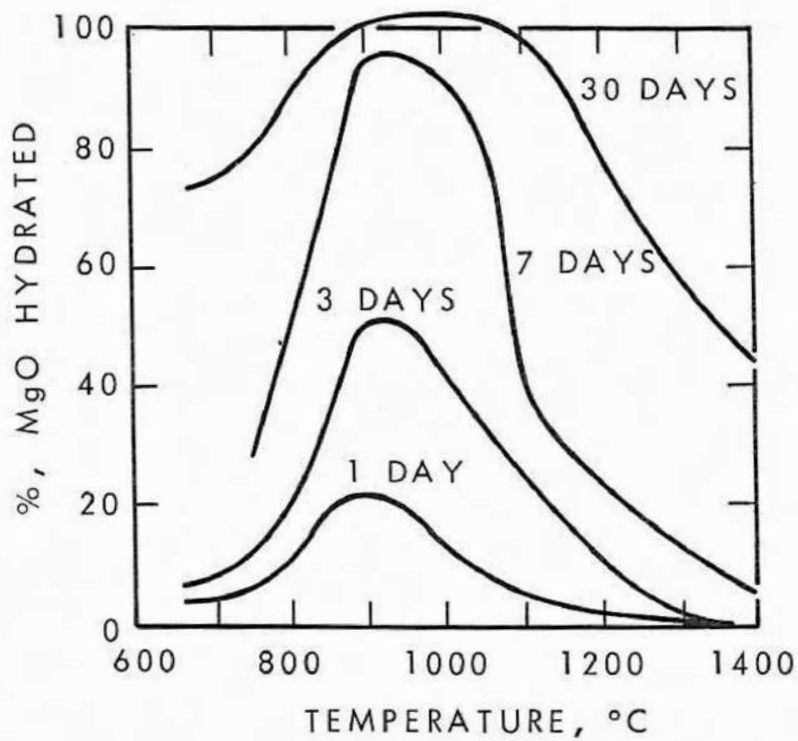
FIGURE 1 HYDRATION OF MAGNESIA IN
CALCINED DOLOMITE

Some of the causes leading to failure are defects in the materials, which may originate in their physical or chemical nature, exposure conditions and/or mistakes in the execution of the job. A common cause of failure is the presence of particles of hard-burned quick-lime or magnesium oxide in the lime used in the plaster mix. These oxides are resistant to easy hydration and hydrate gradually over the years by the moisture provided by high humidity conditions. Water for hydration is also provided by the reaction of atmospheric carbon dioxide with lime in plaster mix. The rate of hydration of MgO or CaO depends, among other factors, upon the temperature at which the lime was originally burnt before it was mixed with the plaster. Figure 1 indicates the effect of calcination temperature on the rate of hydration of MgO in calcined dolomite (7). The hydration was carried out in water in this case but when the material is exposed to ambient conditions of temperature and humidity the rate of hydration of MgO is decreased severalfold.
