### **An investigation of the corrosion of domestic hot water tanks**

# AN INVESTIGATION OF THE CORROSION OF DOMESTIC HOT WATER TANKS

RESEARCH PAPER NO. 2

*Reprinted from Canadian Journal of Technology, 29: 435-446. October, 1951*

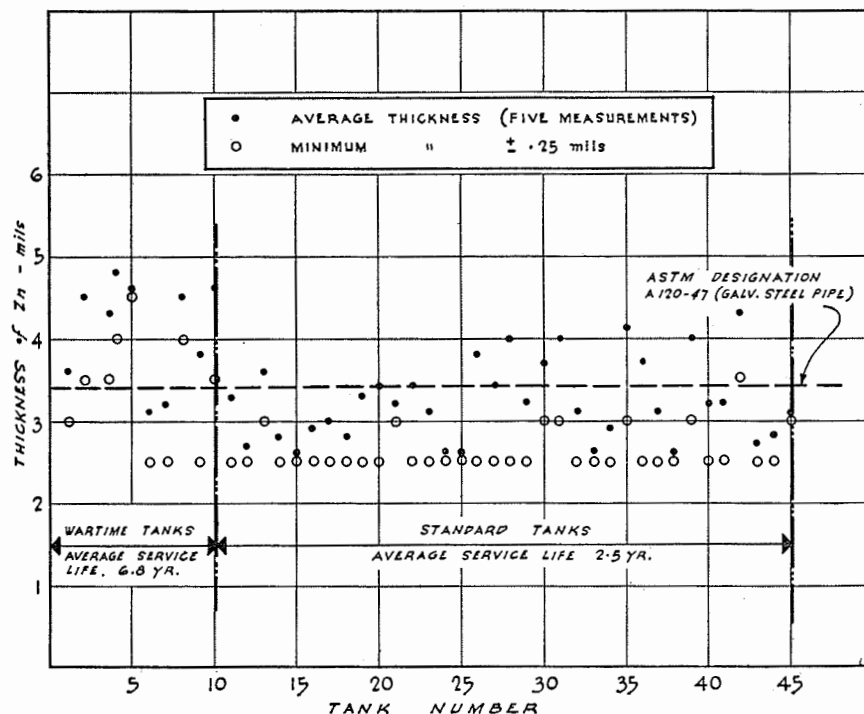
FIG. 3. Thickness of zinc coatings on individual sample tanks.

The thickness of the zinc coatings as measured on the outside surfaces of the tanks varied over the range 2 to 6 mils. Data presented in Fig. 3 show the

average and the minimum thickness of zinc coatings on the tanks examined. Deviation of the minimum thickness from the average on any one tank was found to be 0.5 to 1.5 mils. Similar variation in the thickness of the zinc coating could be found on an area of 1 sq. in. of some of the tanks.

The measured thickness of zinc on the tanks examined is shown in Fig. 3. It indicates the fact that most of the tanks which had a service life of less than three years had areas of zinc coating less than 3.4 mils which is the minimum thickness of zinc specified by A.S.T.M., Designation A 120-47, for zinc coatings on steel pipe. It may be noted that the groups of tanks which had a service life of over six years in most cases had a minimum thickness of zinc exceeding 3.4 mils.

As was discussed above, a thick uniform coating of zinc is desirable even under the best conditions and therefore all possible effort should be made to achieve this. If necessary, the design of the tank should be changed to allow for close inspection during manufacture and this should result in a better quality product.

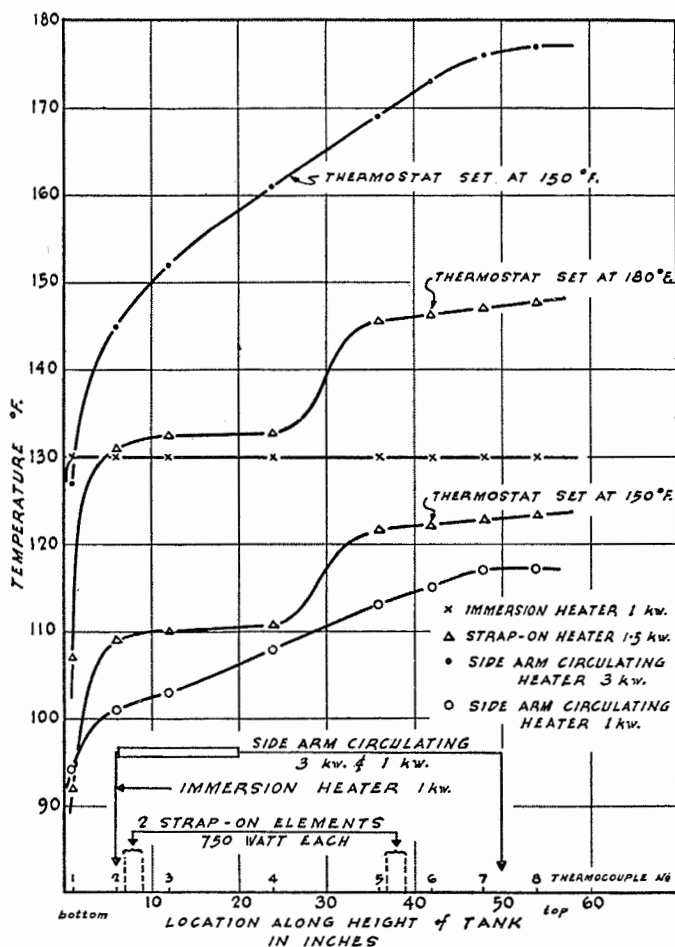
FIG. 4. Variation of the temperature of the water along the height of the tank heated by means of three types of electric heaters.

Generally, with an evenly corroding system, the rate of attack will be increased by increasing the temperature. This was observed in tanks where temperature gradients existed owing to the method of heating. Fig. 4 illus-

trates the temperature distribution found in a tank full of hot water when three different types of heaters were used. In the tanks examined the distribution and depth of pits along the height of the tank were related to the temperature variation. When no temperature gradient existed as in the case

when an immersion heater was used, the number and depth of pits were nearly constant. Sample tank, Fig. 7, is an example of this case. When a side arm circulating heater was used the depth and number of pits increased with height of tank from the bottom. The depth of the pits at the top was twice the depth of the pits at the bottom in tanks heated in this manner, (Fig. 6). Several tanks were examined which were heated by means of a strap-on heater element

placed around the tank at a location about two ft. from the bottom. In these cases there was no evidence of pitting in the tank below the heater location whereas serious pitting of the tank occurred above the heater location, resulting in failure. From Fig. 4 it is evident that water would be heated only above the location of the strap-on element and there would be no tendency for the water below the heater to circulate and mix with the hot water.

A survey of the performance of a large number of tanks in one locality revealed that tanks equipped with 3-kw. heaters (manually controlled) gave longer service than tanks equipped with 500-w. heaters (automatically controlled). Study of the method of operation of the two groups of units revealed one significant difference. The heaters of the first group were operated intermittently resulting in the storage of hot water for a relatively short period each day, the capacity of the heater being large enough to meet the demand after being on for two to three hours. The heaters of the second group being of low capacity were left on continuously resulting in the storage of hot water in the tanks for the greater part of each day. Thus it would appear that tanks using large heaters operated intermittently constitute the better system. The thermostat should be used only as a safety device.

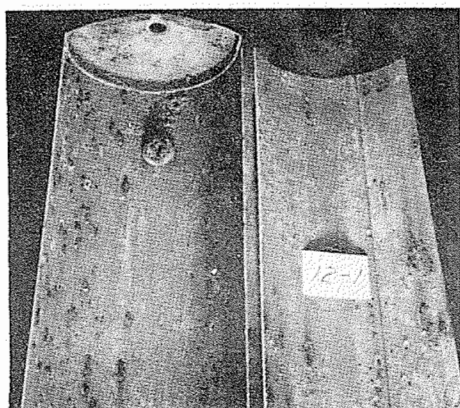
FIGURE 5

- FIG. 5. Sample of standard tank in service at Port Hope, Ont., for two years. Failed by pitting.
- FIG. 6. Sample of standard tank in service at Belleville, Ont., for two years. Failed by pitting. (Note dross inclusions and lack of corrosion products over pits.)
- FIG. 7. Sample of standard tank in service at Hamilton, Ont., for three and one-half years. Failed by pitting.
- FIG. 8. Sample of standard tank in service at Lindsay, Ont., for two and three-quarter years. Failed by pitting.
- FIG. 9. Sample of a tank and the magnesium anode (used to provide cathodic protection) in service at Lindsay, Ont., for two years. Failed by pitting.

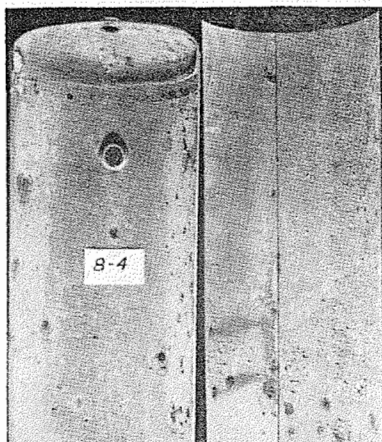
FIGURE 8

The size and number of pits per unit area were characteristic of the locality where the tanks were in service. Figs. 7 and 8 illustrate this point. Considering the area of 1 sq. ft. at the top of the tanks, the average number of pits per 10 sq. in. varied from 0.3 to 30. These data could not be correlated with service life. Similarly the average pit depth for the area in question varied from 0.025 to 0.060 in. at the time when several pits had produced holes in the wall of the tank. Pits on tanks from localities such as Hamilton, Lindsay, Port Hope, and Ottawa were covered with caplike nodules of corrosion products as shown in Figs. 5, 7, 8, and 9. In the case of the tanks from Belleville the pits exposed shiny metal (Fig. 6).

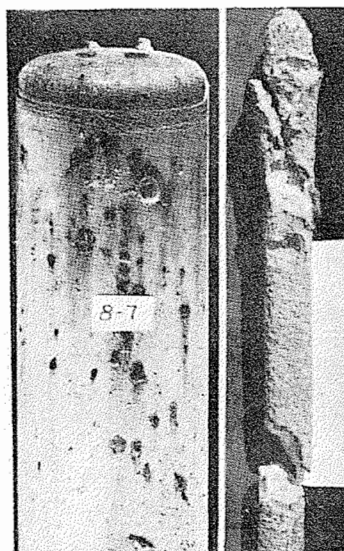
FIGURE 9

Four tanks from Lindsay had magnesium anodes for cathodic protection. The average service life of these tanks was one year and seven months. Fig. 9 illustrates the condition of a typical anode after use and the appearance of the tank in which it was installed. The appearance of the inside of this tank was similar to that of the standard tank not equipped with a magnesium anode (Fig. 8). The deterioration of the anode appears to be due to local action between the magnesium and the steel core upon which it was cast. It is evident that this type of magnesium anode does not protect the tank and hence does not improve the service life of a galvanized tank in service at Lindsay.

An improved design of magnesium anode might be more effective than those used in Lindsay, especially if it was used in areas where the water has a high conductivity and the ability to deposit a protective scale.

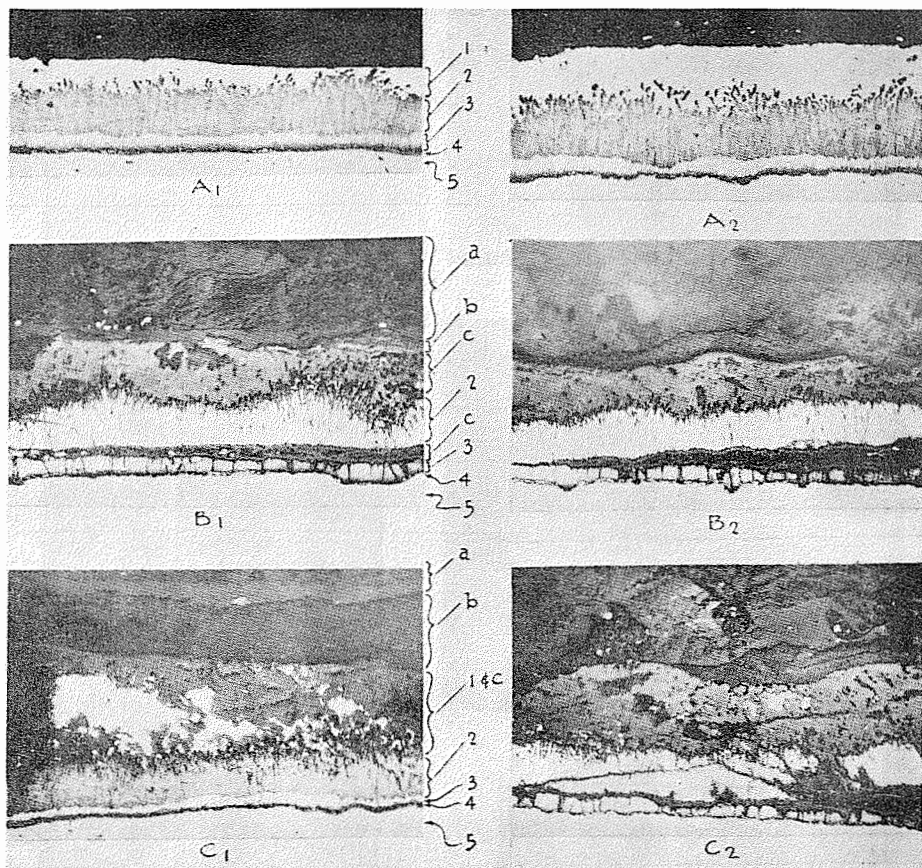
FIGURE 10 SAMPLES FROM HAMILTON

FIG. 10. Samples from Hamilton. ( $A_1$  and  $A_2$ ). Outside zinc coating—showing the zinc alloy layers and the steel base; 1, eta; 2, zeta; 3, delta<sub>1</sub>; 4, gamma; 5, steel. ( $B_1$  and  $B_2$ ). Inside top—showing the steel, the slightly attacked delta<sub>1</sub> layer, the blistered zeta layer, the complete replacement of the eta phase by corrosion products (c), and the scale (b) deposited by the water. ( $C_1$  and  $C_2$ ). Inside bottom—similar to ( $B_1$ ), except that the eta layer has been partially replaced by corrosion products and there is a thicker scale deposited from the water. The bakelite lacquer and the bakelite mount marked (a) are visible above the scale in  $C_1$ .

1. The indication of polarity reversal between the zeta layer and the delta<sub>1</sub> layer, as evidenced by the failure of the zeta layer to completely protect the delta<sub>1</sub> layer.
2. That there is a heavy scale formed from the hard water which is not too protective.

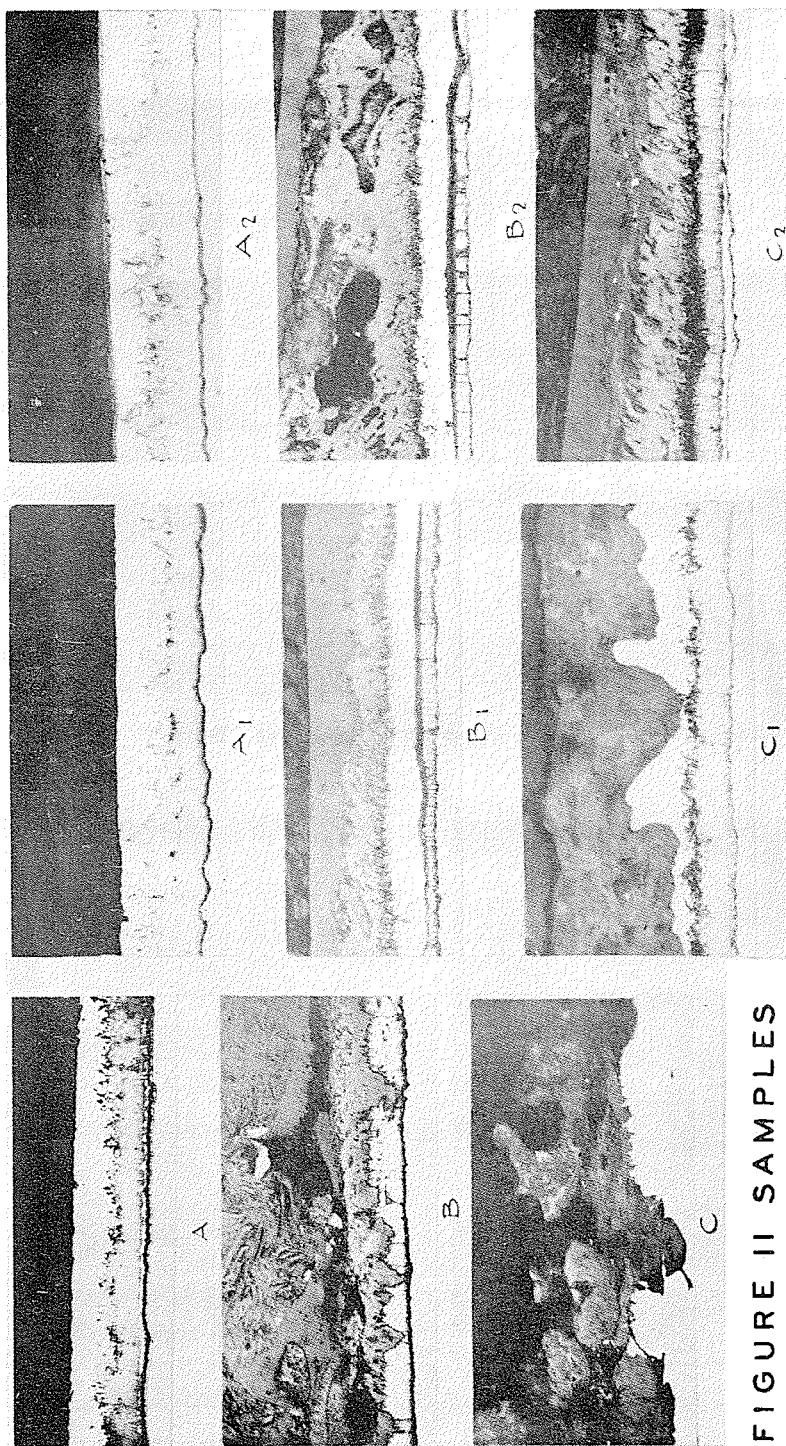
FIGURE II SAMPLES  
FROM OTTAWA

FIG. 11. Samples from Ottawa. (A). Outside zinc coating—showing the steel, the gamma, the delta<sub>1</sub>, the zeta, and the eta layers. (B). Inside top—showing the steel, the delta<sub>1</sub> layer, the pitted zeta layer, the complete replacement of eta by corrosion products, some scale, the lacquer, and the bakelite. (C). Inside bottom (unetched)—showing the pitted steel and the remainder of the zinc.

1. The indication of polarity reversal between the zinc and the steel as evidenced by the failure of the zinc to protect the steel.
2. That the scale was nonprotective.

FIG. 12. Samples from Lindsay. ( $A_1$  and  $A_2$ ). Outside zinc coating—showing the steel, and the alloy layers (Fig. 10). ( $B_1$  and  $B_2$ ). Inside top—showing the steel, some gamma, the delta<sub>1</sub>, the slightly blistered zeta layer, the complete replacement of the eta layer by corrosion products, the bakelite lacquer and the bakelite mount. Note that there is some evidence of a scale deposited from the water on  $B_2$ . ( $C_1$  and  $C_2$ ). Inside bottom—similar to ( $B_1$ ) except that the zeta layer shows no blistering and some of the eta layer remains. There is some evidence of scale deposited from the water on  $C_2$ .

1. That no reversal of polarity is indicated between the phases of the zinc coating.
2. That in spite of Lindsay's comparatively hard water there is no evidence of heavy scaling. The scale that does form is nonprotective.
3. That there would be a linear relationship between tank life and the thickness of the zinc coating (secondarily the thickness of the steel).

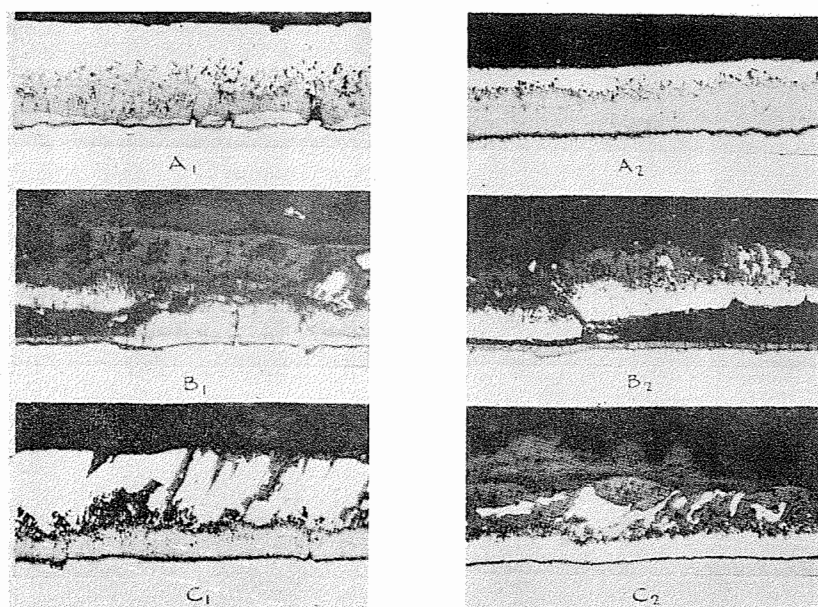
FIGURE 13 SAMPLES FROM PORT HOPE

FIG. 13. Samples from Port Hope. ( $A_1$  and  $A_2$ ). Outside zinc coating—showing the steel, the gamma, delta<sub>1</sub>, zeta, and eta layers. ( $B_1$  and  $B_2$ ). Inside top—showing the steel, some gamma, the attacked delta<sub>1</sub> layer, the blistered zeta layer, the complete replacement of the eta layer by corrosion

products, and some evidence of scale deposited from the water. ( $C_1$  and  $C_2$ ). Inside bottom—showing the steel, the gamma,  $\delta_{11}$ , and zeta layers fairly intact, the partial replacement of the eta layer by corrosion products, and some evidence of a scale deposited from the water.

1. That there is an indication of a reversal of polarity between the zeta and  $\delta_{11}$  layers of the zinc coating.

2. That the scale deposited from the water is only slightly protective.

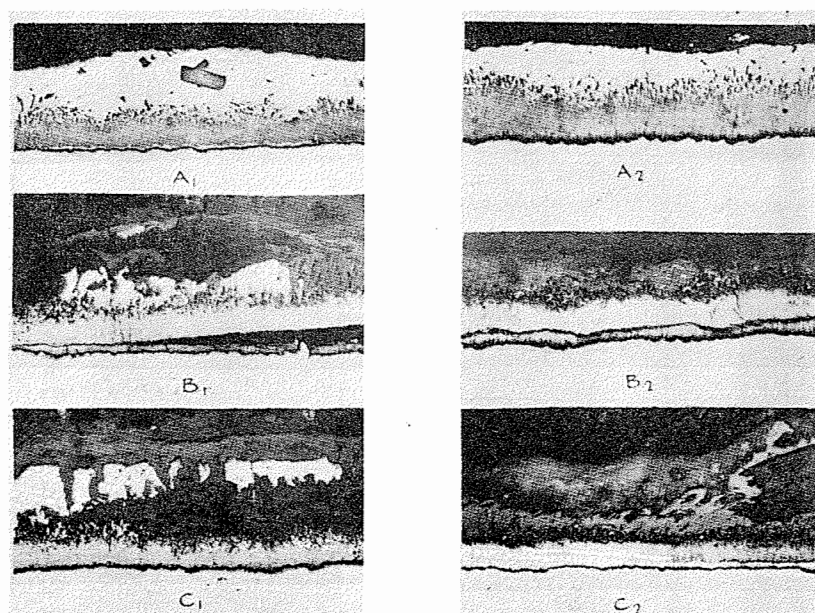
FIGURE 14 SAM FROM BELLEVILLE

FIG. 14. Samples from Belleville. ( $A_1$  and  $A_2$ ). Outside zinc coating—showing the steel, the gamma,  $\delta_{11}$ , zeta, and eta layers. ( $B_1$  and  $B_2$ ). Inside top—showing the steel, some gamma, the attacked  $\delta_{11}$  layer, the blistered zeta layer, the complete replacement of the eta layer by corrosion products, and some evidence of scale deposited from the water. ( $C_1$  and  $C_2$ ). Inside bottom—showing the steel, the gamma,  $\delta_{11}$ , and zeta layers fairly intact, the partial replacement of the eta layer by corrosion products and some evidence of a scale deposited from the water.

1. That there is an indication of a reversal of polarity between the zeta and  $\delta_{11}$  layers of the zinc coating.

2. That the scale deposited from the water is only slightly protective.
