Effect of train-induced vibrations on houses: a case study

Rainer, J. H.; Pernica, G.; Maurenbrecher, A. H. P.; Law, K. T.; Allen, D. E.

Proceedings, Symposium/Workshop on Serviceability of Buildings (Movements, Deformations, Vibrations): 16 May 1988, Ottawa, Ontario, Canada, 1, pp. 603-614, 1988

ABSTRACT: Train-induced vibrations of houses and mobile homes in Kamloops, British Columbia, were investigated to determine whether the vibrations could have resulted in damage to residences near the tracks. A detailed investigation showed that building resonance could result in architectural damage up to 250 m from the tracks and that vibration-induced settlement could occur for certain mobile home foundations located on loose wet fill. The criterion for possible architectural damage to stucco and brittle interior finishes was taken as 5 mm/s peak velocity, measured at the ceiling level of the one-storey houses. As a result of this study, general recommendations are presented regarding the methods employed in investigating similar train vibration problems.

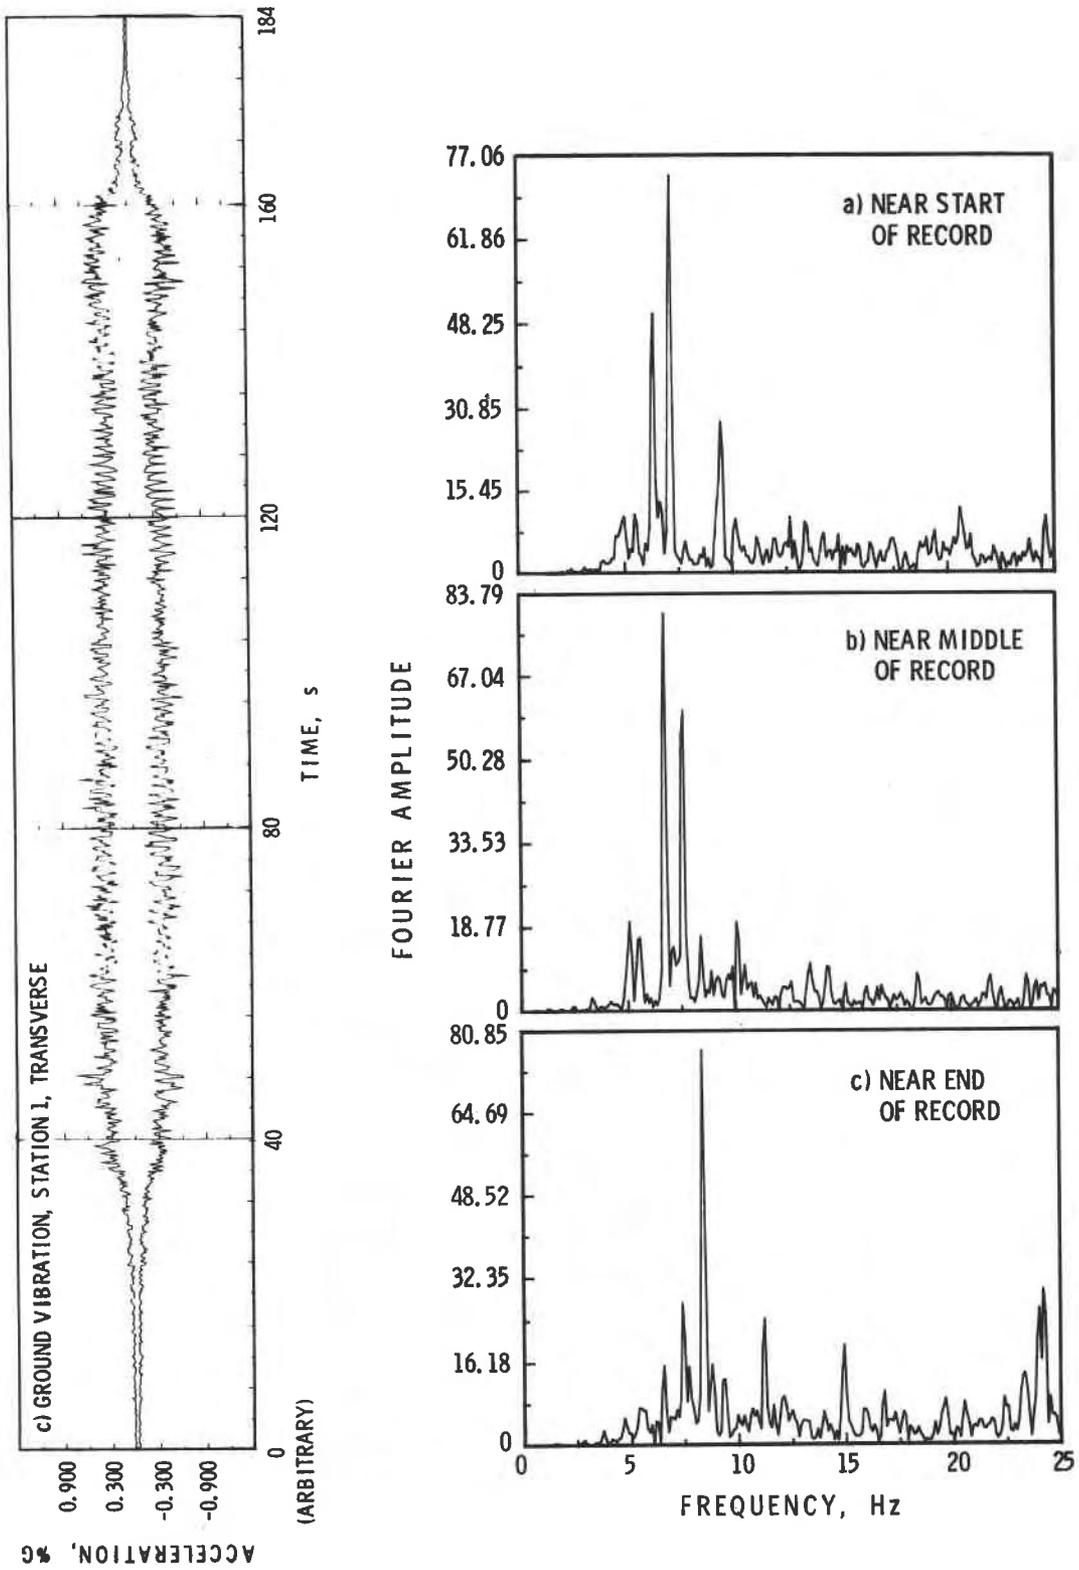
Figure 2: Transverse ground vibrations at Station 2, Line 1, from Train 5248.

- (a) The ground vibrations emanating from trains on the new track consisted of 1 or more predominant sinusoidal waves (Fig. 2).
- (b) The frequencies of the dominant ground vibration components generated from loaded freight trains travelling on the new track increased linearly with train speed, with a dominant frequency ranging from 6 Hz at 42 km/h train speed to 10 Hz at 70 km/h (Fig. 3).
- (c) The maximum ground vibration amplitudes varied along the track and with distance from the track, depending on train speed and train load (Fig. 4).
- (d) The vibration amplitudes produced by trains on the old track were approximately one-third those produced from the new track; this agrees with the results from previous investigations.

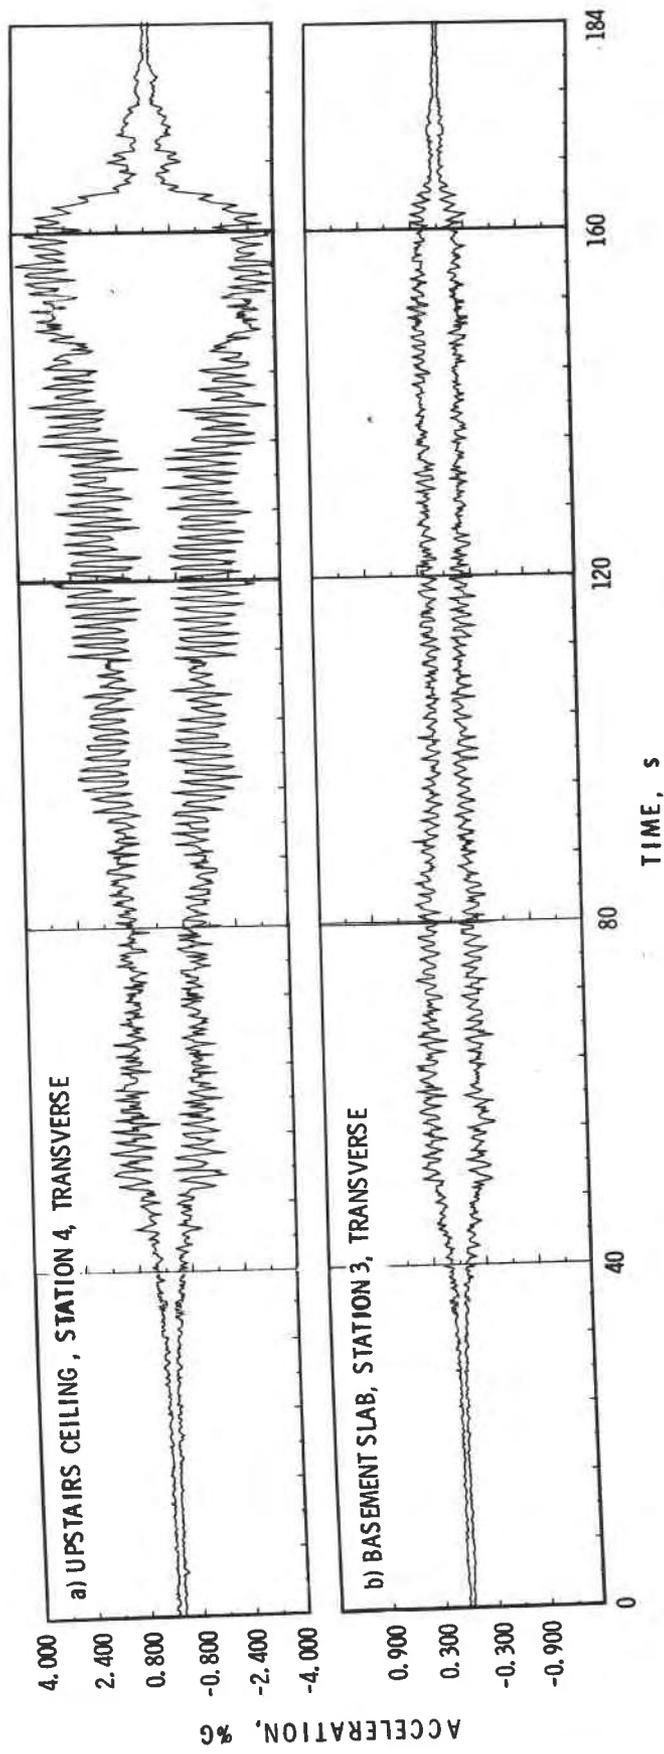
Figure 5: Envelopes of house response from train 5248.

2.3 House Response to Train-Induced Ground Vibrations: The horizontal vibration response of a single-storey house with basement, 1160 Bentley Place (Fig. 2), was monitored on the basement slab, at the first floor level, and at ceiling level at the same time as the ground vibrations were measured during train passage as described in 2.2. Typical results of the measurements are presented in Fig. 5 in the form of envelopes of peak accelerations.

The results demonstrated that large resonant response in a house as a result of trains travelling on the new track produced amplifications of 9 to 10 times between the ground and the first floor ceiling of the house under investigation. The maximum response recorded at the first floor ceiling level in the house tested was 4.0% g acceleration or 8.0 mm/s velocity.

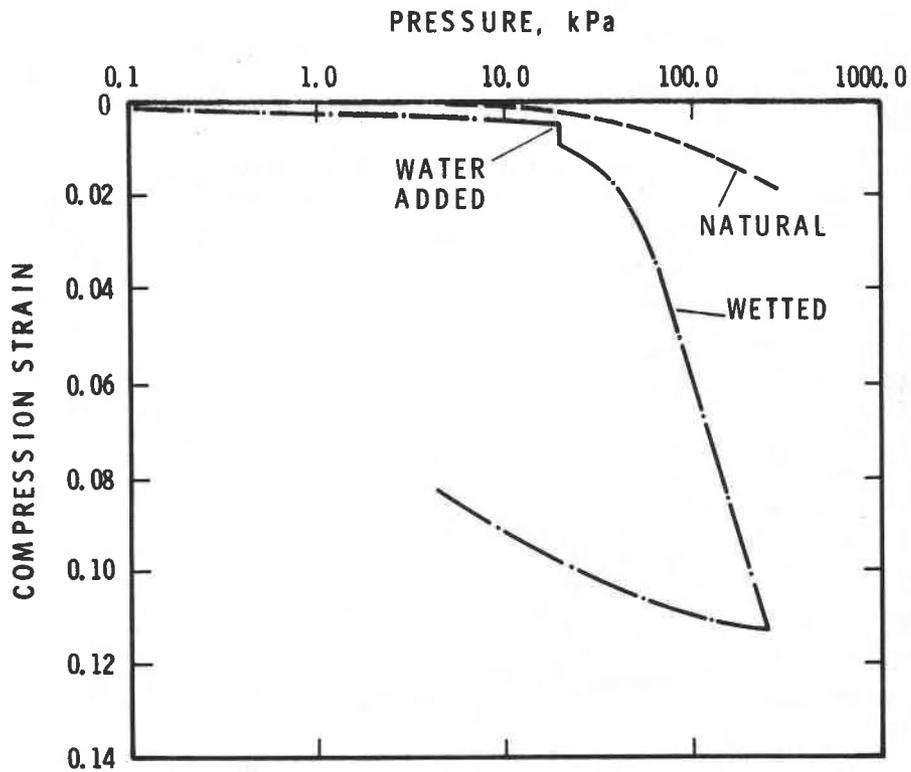
Figure 6: Static pressure-compression curves for soil sample from Bentley Place.

- (d) Tests on reconstituted soil samples showed that loosely compacted fill consisting of the silty material present in Brocklehurst will, when wetted, settle substantially more than the naturally-deposited wetted soil (Fig. 6). Vibrations of amplitudes as stated above will cause little additional settlement when the void ratio of the soil is less than 1.25.

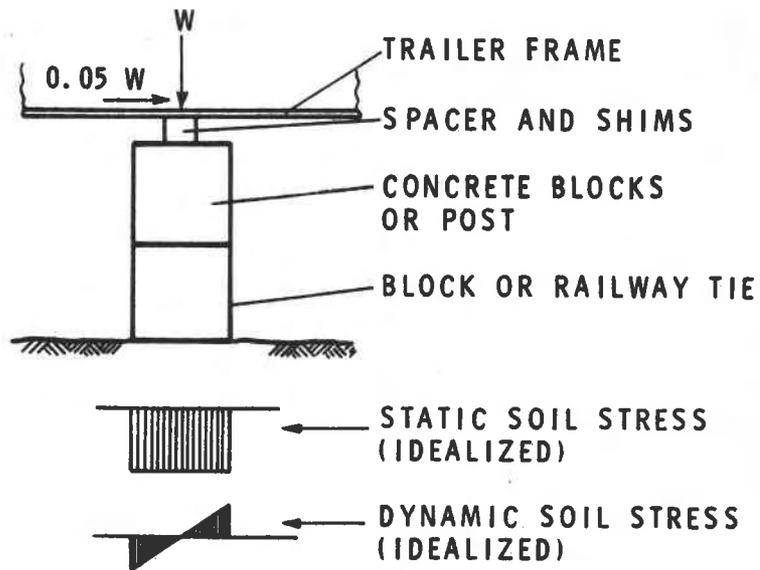
Figure 7: Static and dynamic soil pressure under mobile home footing.

- (e) Foundations supporting trailer homes may rock under train-induced ground vibrations (Fig. 7). This rocking motion can cause a high concentration of dynamic stresses under small footings. If such footings rest on loose and wetted fill, at a void ratio 1.25 or higher, some appreciable settlements may occur (Fig. 8).
