The Collapse of WTC7

**The Collapse of WT7 : a Canadian researcher who
studied the World Trade Center disaster reports on
the collapse of a building beside the twin towers**

Fire Resistance Issues in the Collapse of Building WTC 7

By V.K.R. Kodur, Ph.D., P.Eng

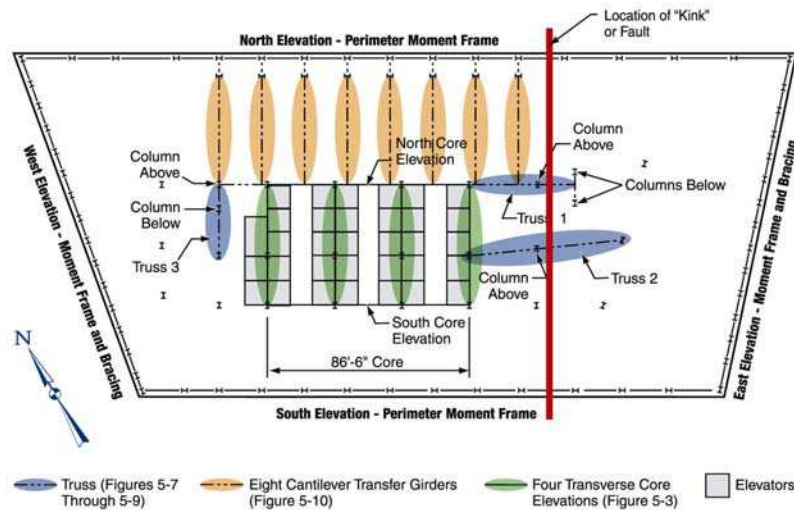
At about 5:20 p.m., the collapse sequence began. First, the east and west penthouses disappeared from view, followed by progressive collapse, apparently on a lower floor. Videotapes show the upper 30 to 35 stories appearing to descend intact, indicating the collapse was initiated on a lower floor. Just prior to the collapse, a crack or “kink” or fault line¹ developed along the north wall in the vicinity of the east penthouse located over transfer trusses 1 and 2 on the east side (Figure 2).

Figure 2 Area of potential transfer truss failure in WTC 7¹
