APPLICATIONS OF INFRARED THERMOGRAPHY IN LOCATING AND IDENTIFYING BUILDING FAULTS

by Kenneth N. Burn and G.D. Schuyler

Reprinted from
**Journal of the International Institute for
Conservation — Canadian Group**
Vol. 4, No. 2, Spring 1979
p. 3 - 14

DBR Paper No. 964
Division of Building Research

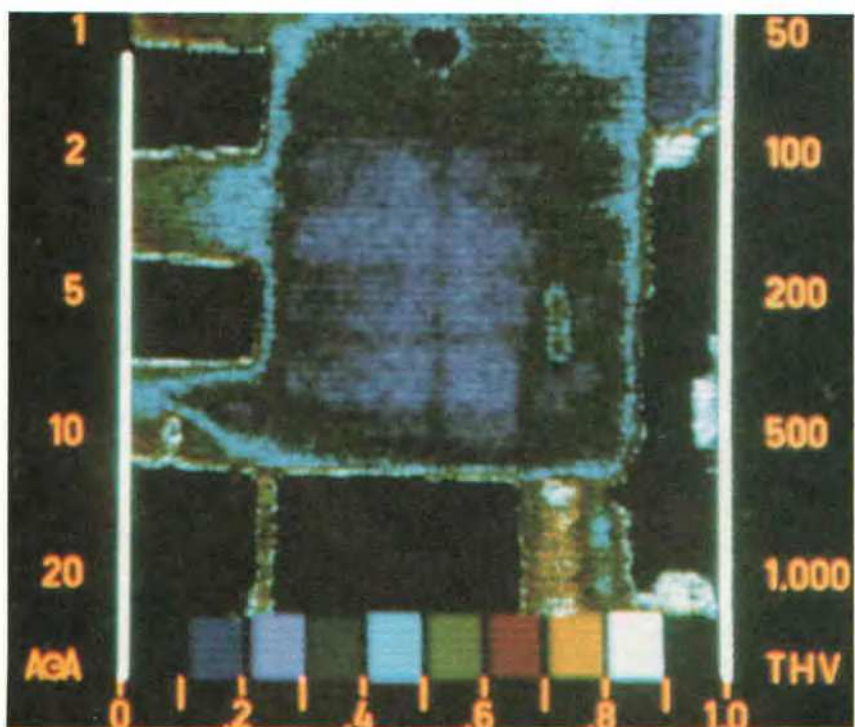
Plate 2: Thermogram of lower part of highrise building. This was taken at the same time as Plate 1; the change in colour arose from changing the setting of the sensitivity scale from 2 to 1 (shown to the left of the thermograms).

expressed by the thermogram should have shown some uniformity, inasmuch as the brackets at each column are all the same size and attached in the same manner. Examination of **Plate 2**, the lower part of the wall, shows no hot spots at the ends of the panels, permitting the conclusion that heat loss through the brackets by conduction was either too small to be detected or masked by something of greater consequence. In addition, the premise that heat transfer was entirely by conduction through the thermal bridges could in no way explain the presence of moisture on the face of the panels.

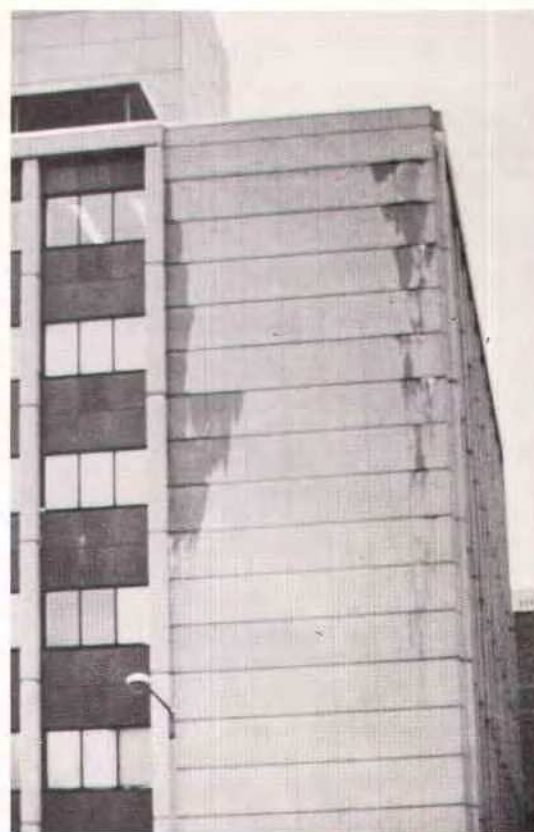
Plate 3: Photograph showing wetting pattern on wall of highrise building.

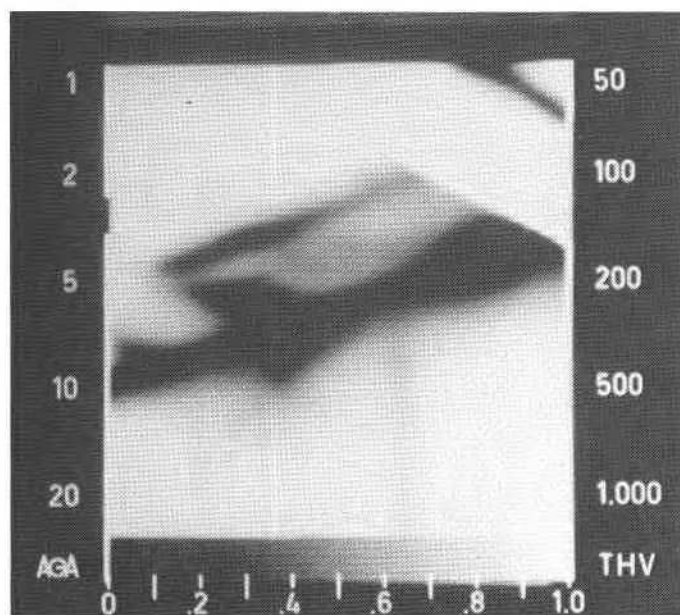
Figure 4. Thermogram of ceiling showing batt of insulation out of place.

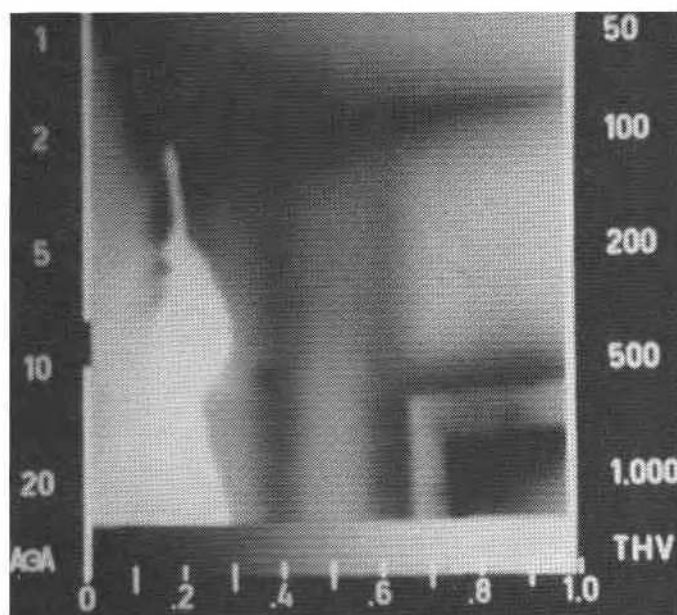
Figure 5. Thermogram of corner of room at ceiling.

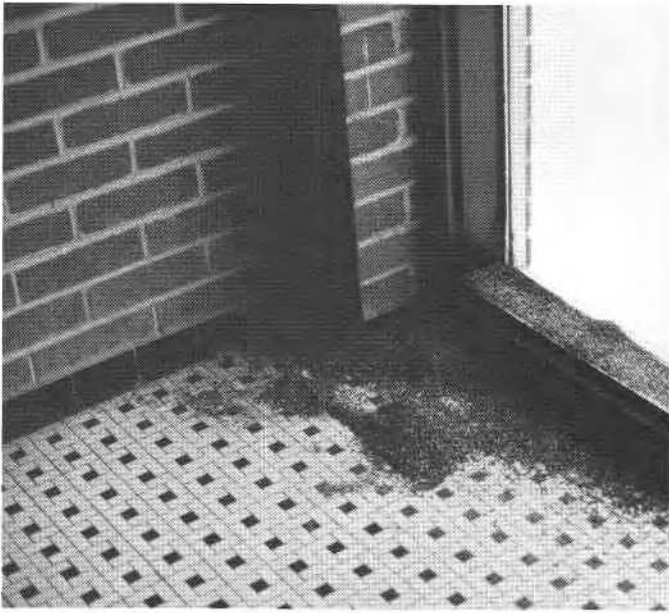
Figure 6. Vermiculite insulation at base of window in school building.

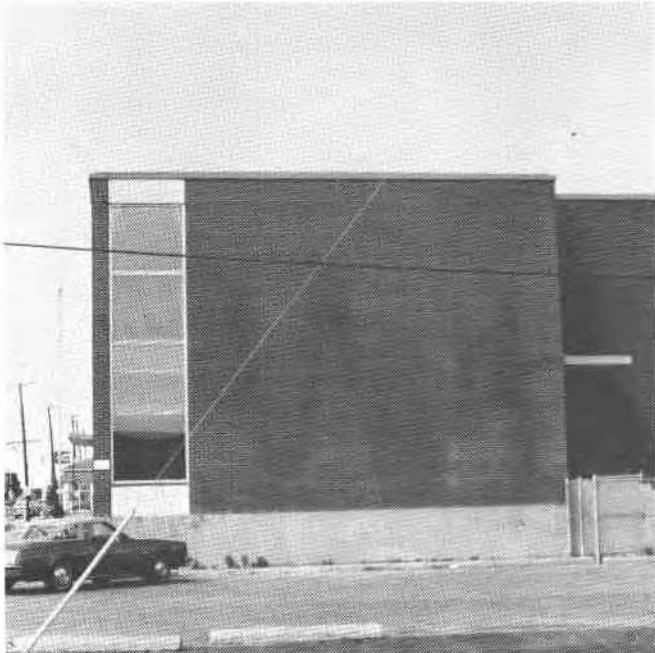
Figure 7. Photograph of east wall of main wing of school building.

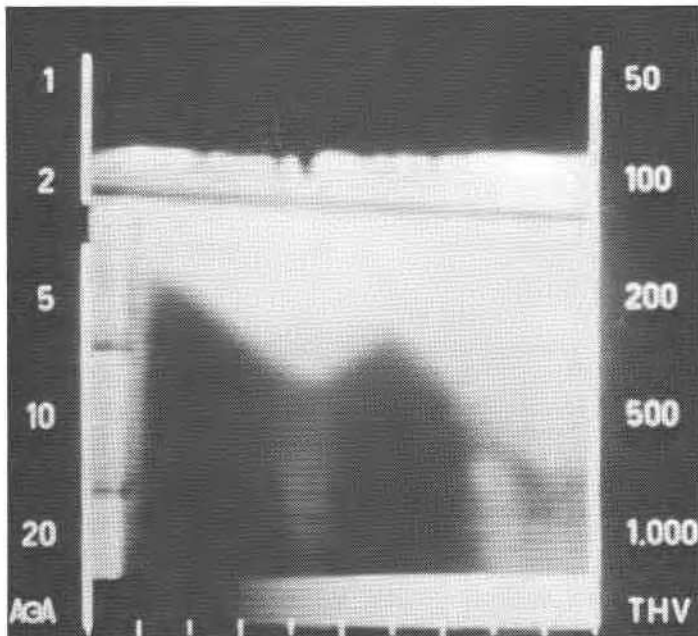
Figure 8. Thermogram of east wall of main wing of school building.

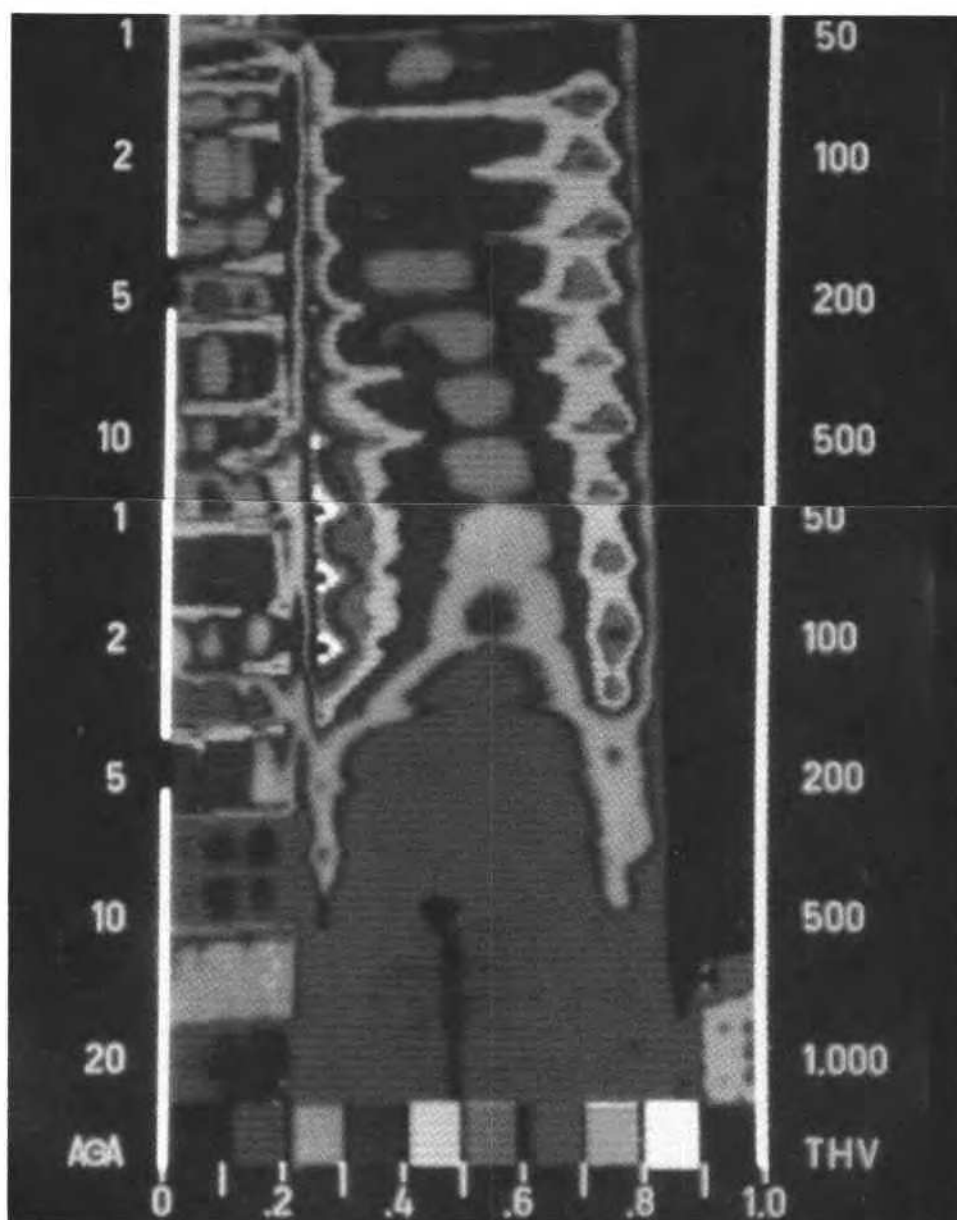
Plate 4: Thermogram of highrise art gallery showing temperature patterns in still air; taken several weeks after Plates 1 and 2, after holes had been drilled through the coping at the parapet.

Plate 4 is a colour thermogram taken two or three weeks after the first when temperature and pressure differences were smaller and the air was still. A sensitivity scale was selected that encompassed the full range of temperatures. Thermal patterns were similar, but the actual temperature peaks were more clearly defined and it was possible to confirm that the worst air leakage was occurring at the left side of the bay at the fifth floor.

One factor had changed; to reduce condensation behind the uppermost slab, holes had been cut through the coping at the

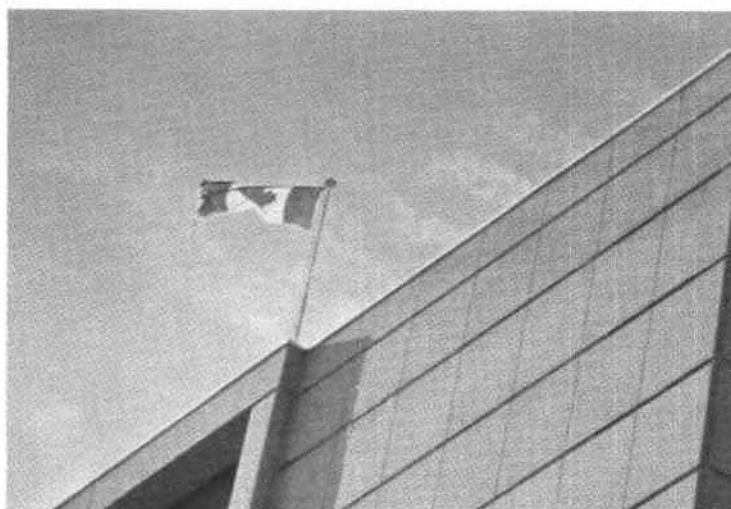
Plate 5: Upper section of wall of high-rise building showing streams of water vapour escaping from the top of the wall.

parapet. This allowed warm moist air to escape directly to the outside air (**Plate 5**) and appears to have lessened the heat loss from the upper right side of the bay. Consequently the temperature of this upper panel was generally lower than that of the panels immediately below, and it exhibits a slightly different thermal pattern from that in **Plate 1**.

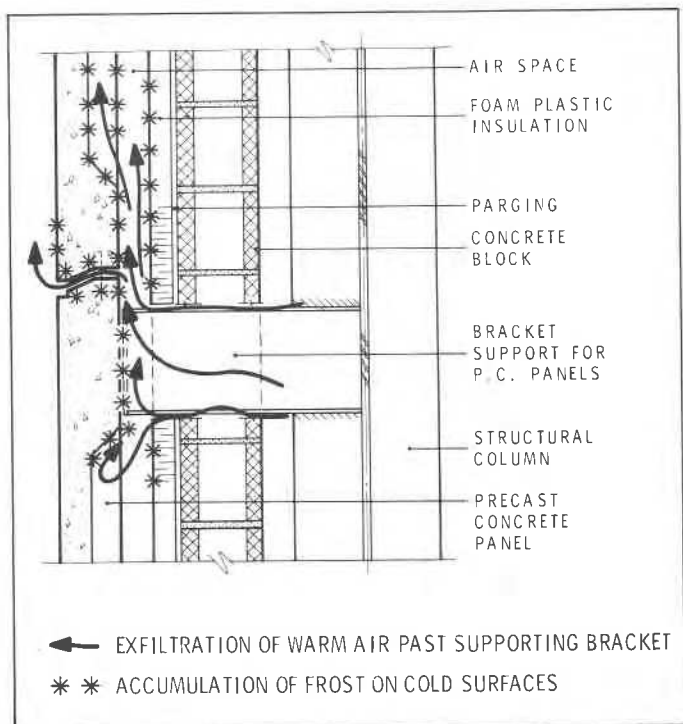
A second possible explanation was that warm air was leaking through the walls, probably around the brackets, and escaping into the air space between the insulation and the back surface of the concrete. Heat escaping to the back of the panels in such a manner would not be expected to result in uniform temperature patterns because the amount of air flowing through the wall at each bracket would depend upon the quality of the work done in closing the wall around steel sections (*i.e.*, on the size of the holes through which the air was leaking) and it would also depend upon the difference in air pressure across the wall. The pattern that generally develops in buildings under still-air conditions is one of exfiltration of warm air in the upper part of the building and infiltration of cold air at the bottom. Somewhere, usually near mid-height, the interior and exterior pressures are equal and no air flow occurs.

Figure 11. Air leakage past brackets supporting precast concrete panels.

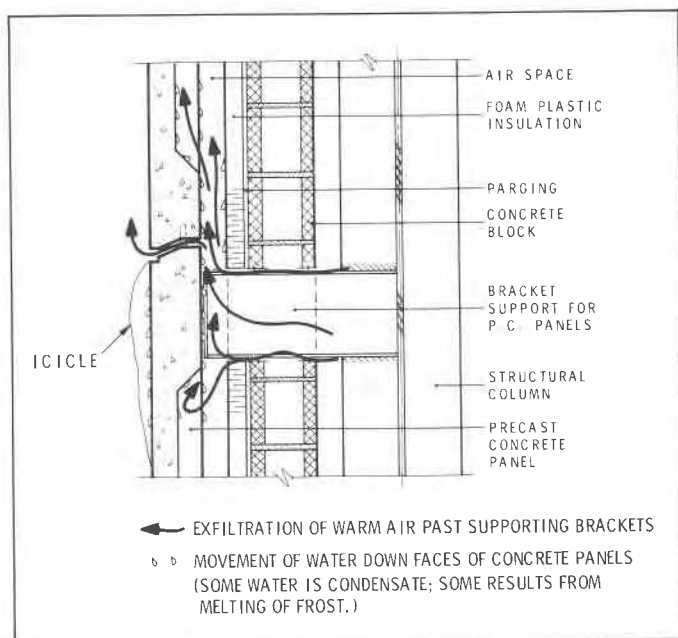
Although there were other indications of what was happening, the entire pattern of air movement could have been deduced directly from the thermograms: infiltration of cold dry air occurred below the third floor and as the internal air pressures increasingly exceeded ambient in the floors above this level, larger quantities of warm humid air were forced out round the brackets into the air space to impinge on the back of the precast concrete panels. Depending upon the temperature of the panels, the moisture condensed as water or frost (**Figure 11**). Some of the warm humid air not impinging on any cold surface escaped to the outside through horizontal joints between the panels. Under the right conditions this condensation or melting frost ran down the back of the concrete panels to the nearest horizontal joint where it was directed outward and simply wetted the face of the panel, or formed icicles if the external air temperature was sufficiently low (**Figure 12**).

Figure 12. Formation of wetting patterns and icicles on concrete panels.

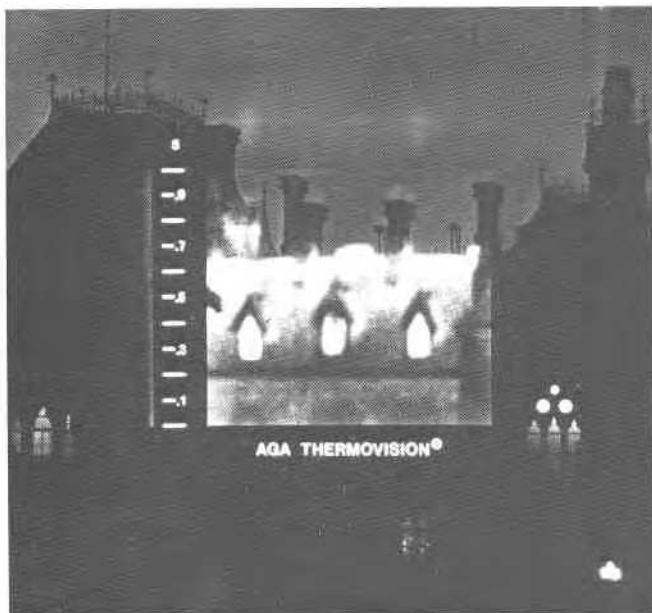
Figure 15 is a thermogram of the East Block, showing a relatively hot area at the open junction of the two slopes of the roof. It is due to leakage of large quantities of warm air. This thermogram was taken with a device called a "Super Viewer", which superimposes the thermal image on a visual picture with a wider field of view.

Figure 15. Thermogram of East Block, Parliament Buildings.
