### Structural fire performance of unprotected floor assemblies used in single family houses

# Structural Fire Performance of Unprotected Floor Assemblies Used in Single Family Houses

Ottawa Fire 2010 Symposium 20 May 2010

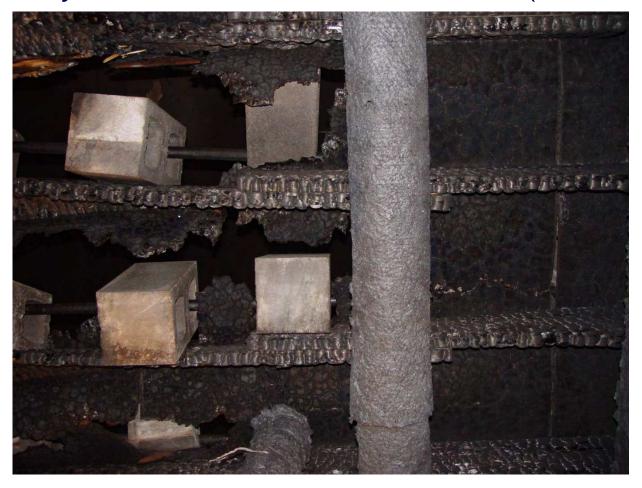
- Solid wood joist assemblies
  - subfloor failure (burn through)
  - most of the joists charred but still in place
- Engineered floor assemblies
  - joist or truss failure
  - collapse into the basement

Solid wood joist assemblies: subfloor failure (burn through)

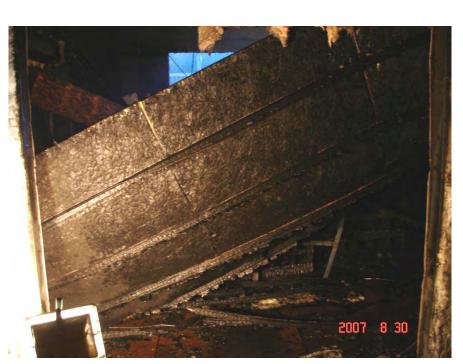
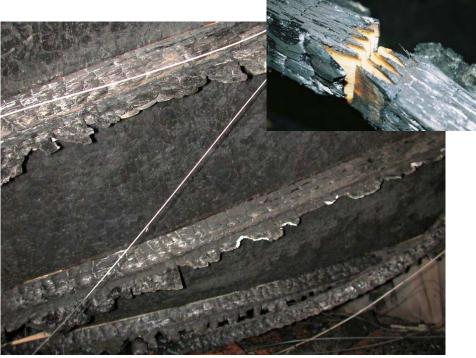
Wood I joists A and B: web materials burned through Wood I-joist B: breakdown at finger joints of lumber flanges

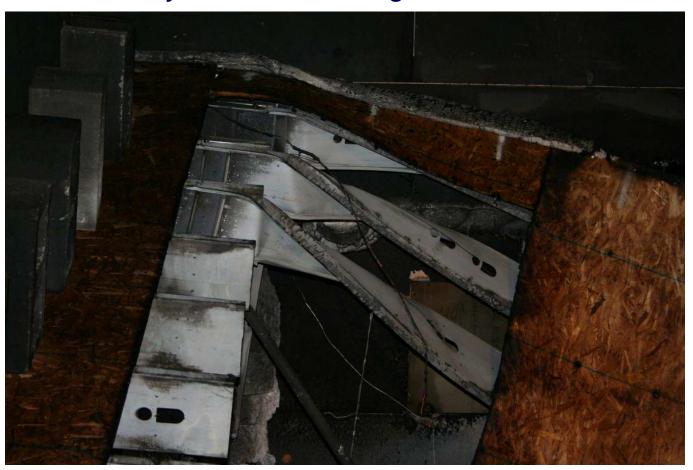
Steel C-joists: lost strength and deformed

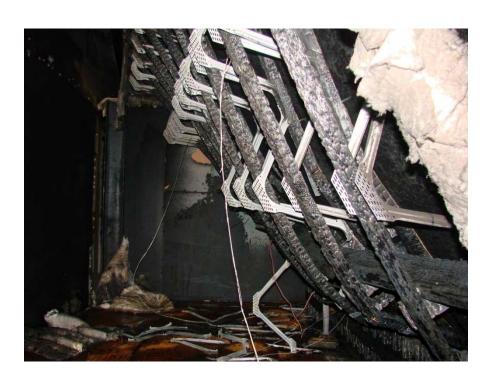
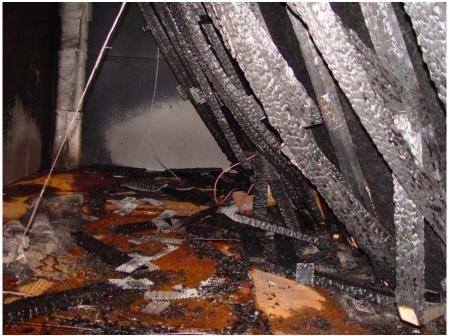
Metal-web & metal-plate wood trusses: metal-wood connections
