A Preliminary analysis of failures in grey cast iron water pipes

Makar, J. M.

Engineering Failure Analysis, 7, February 1, pp. 43-53, 2000-02-01

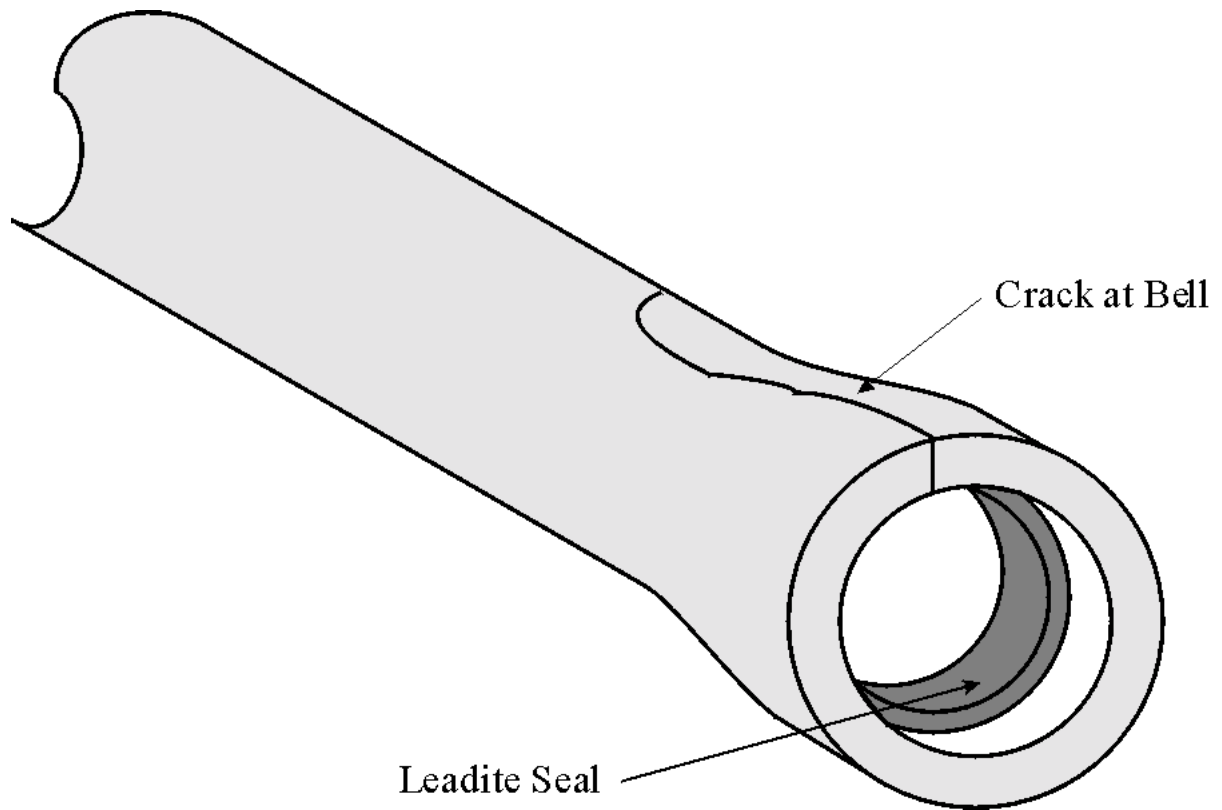
This pipe had failed at the bell with a 30 cm long crack that initially ran longitudinally at the bell end and then curved in a clockwise direction around the pipe circumference, producing an appearance similar to that in Figure 1. The seal material inside the bell was “leadite”, a sulphur based compound used in the 1930s and 1940s as a replacement for earlier lead seals¹⁹. Rope was wrapped around the pipe to fill up the joint between the bell and the spigot of the next pipe. Molten leadite was then poured in the joint to complete the seal. Localised tuberculation was observed on the inside of the pipe surface and there were small regions of graphitisation on the inside of the pipe. The spigot of the pipe inside the bell had not been damaged by the failure.

Bell splits are frequently associated with the presence of leadite seals in the pipes¹⁹. Leadite is rigid but non-metallic. As a result it has a different coefficient of thermal expansion than the cast iron pipes that surround it. Failures in these pipes are often considered to be due to the stresses that develop when the temperature of the pipe is either much lower or much higher than when it was installed. Analysis of the above evidence suggests a more complex failure process. The pipe appears to have failed because the small corrosion pit caused a localised weakness. The pipe then split at the bell, presumably because of the previously mentioned differences between the leadite seal and the pipe metal. However, the differences in the corrosion products along the fracture surface suggest that this split travelled only a short distance down the pipe, stopping once the internal stresses in the pipe had been reduced. This initial splitting was not enough to cause the pipe to fail.

At this point corrosion began to take place along the fracture surface. At some time later a significant amount of corrosion products had built up along the fracture surface. A second split in the pipe then occurred, extending the crack farther along the pipe axis. This second split was the cause of the failure that resulted in the pipe being taken out of service. It may have been caused by the forces exerted by the gradual build-up of expansive corrosion products along the pipe surface or by a second incident of thermally induced stress. Since the pipe was removed from service quickly once it had failed, only a thin coating of iron oxide formed along most of the fracture surface.

1. Split bell type failure, showing the bell end of the pipe. Differential thermal expansion between the bell and the leadite pipe seal causes this type of failure.

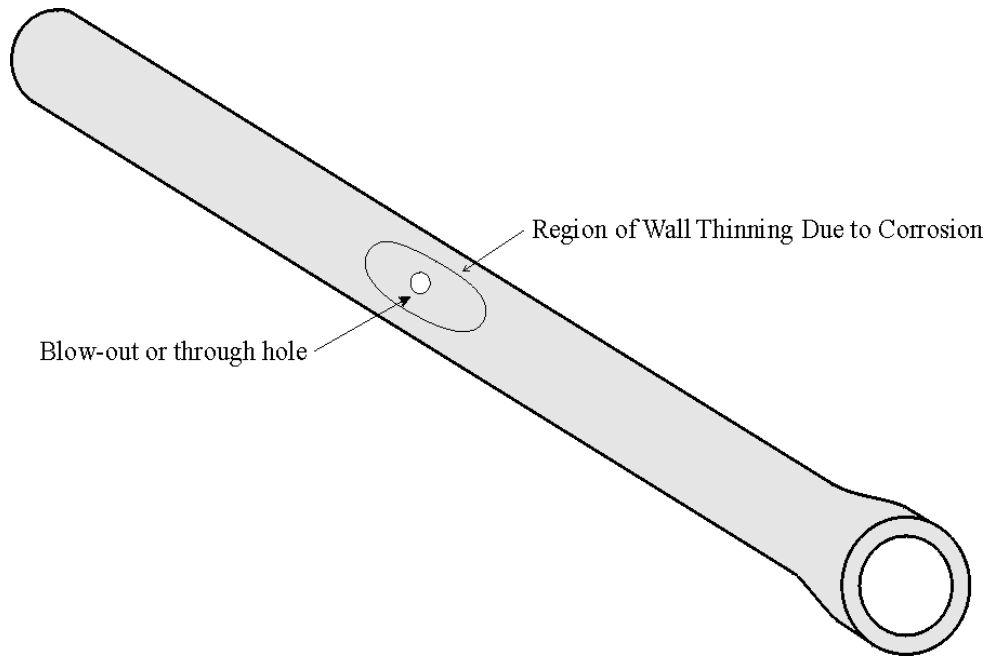
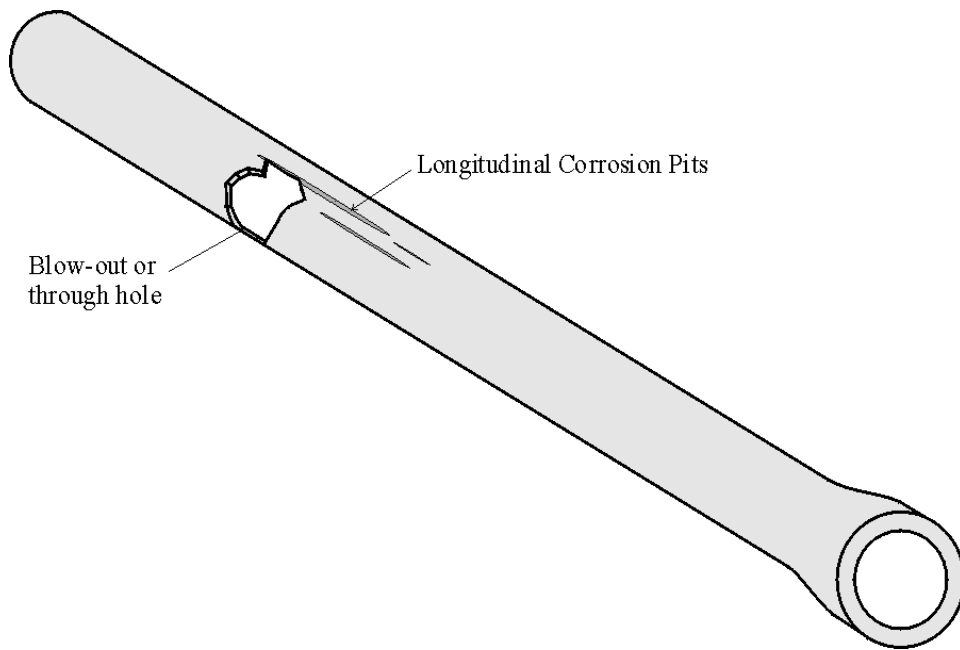
Pipe blow-outs tend to occur when corrosion or graphitisation has reduced the strength of the pipe wall in a local area to point where a pressure surge causes wall to rupture. Most such corrosion pits in grey cast iron pipes are roughly circular or in nature¹², but this pipe showed long, thin corrosion pitting that paralleled the pipe axis, similar to that shown in Figure 2b. It failed when one area of corrosion pitting had only

0.5 mm of wall thickness left. It then fractured along the length of the pit and broke open, leaving a 20 cm long, 23 cm wide hole.

This particular pipe was covered with a bituminous protective coating. There was no evidence of widespread corrosion or graphitisation along the body of the pipe. Instead the corrosion damage was restricted to several smaller regions and was primarily in the form of long corrosion pits of the type that caused the failure. This suggests that the protective coating had been damaged by scratching along the length of the pipe. Once the coating had been penetrated, external conditions would have been favourable for corrosion to take place along the scratches while being inhibited elsewhere. This accelerated corrosion would then have resulted in the observed failure.

2. Blow-out type failure. Localised wall corrosion weakens the pipe wall until internal pressure surges cause the failure. Figure a) shows the typical form of a blow-out, while Figure b) shows the form discussed in this paper.

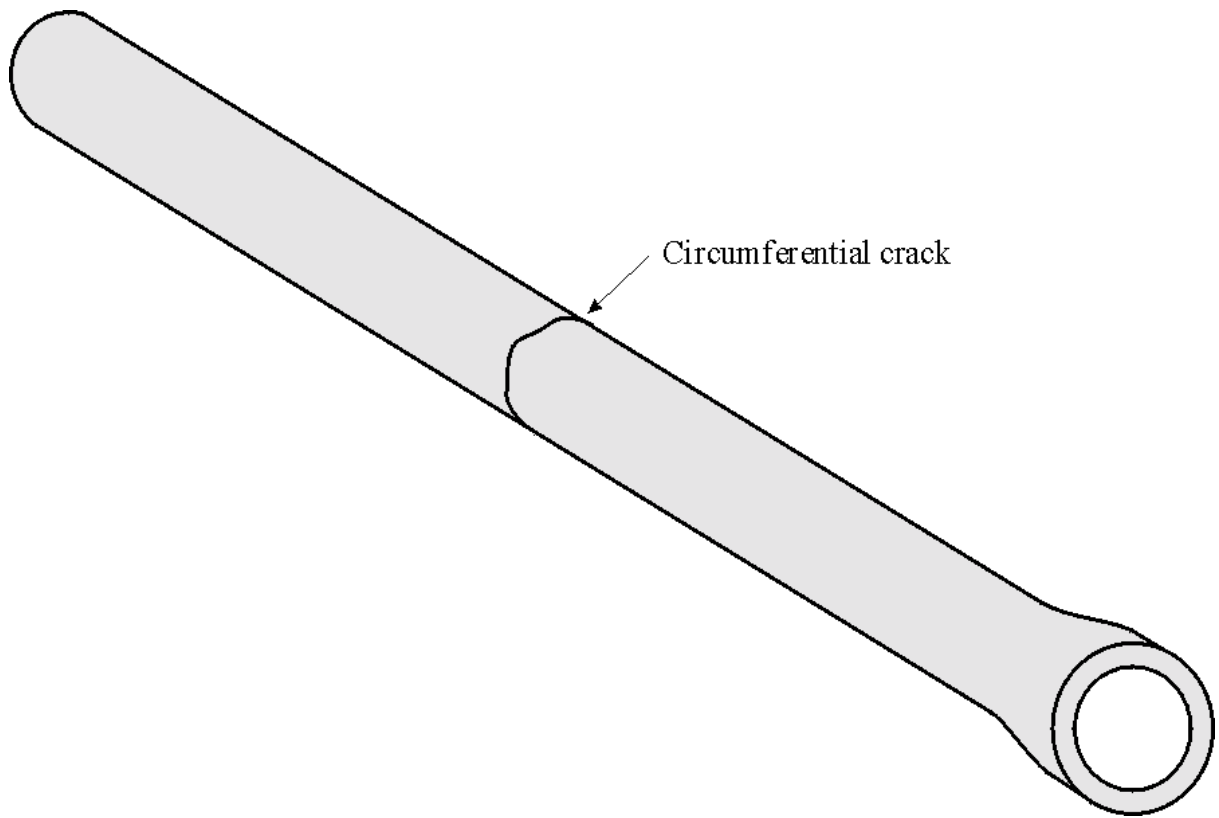
Most grey cast iron pipes fail by circumferential cracking (Figure 3). Unlike the blow-out and bell split described previously, this type of break is considered to be at least partially due to external forces as bending moments are required to produce a circumferential crack. Issues such as bedding supporting the pipe and the backfill that was used to fill in the trench in which the pipe was placed may therefore be important in determining the cause of failures. The first pipe that was examined had been installed in a rock bed and was backfilled with gravel with a maximum aggregate size of 15 mm. The pipe joints were sealed with lead.

a considerable amount of time between the two stages. The break appears to have initiated at the graphitised corrosion pit. It then propagated approximately half way around the pipe before stopping. Corrosion build-up then occurred along the fracture surface and then, at some later time, the rest of the pipe failed.

The shape of the fracture surface, the extent of corrosion on the fracture surface and the depth of the corrosion pit at the bottom of the pipe suggest that this pipe failed by a crack initiated at the corrosion pit. This would imply that sagging or external loading from above the pipe produced the forces that were responsible for the failure. The crack then propagated most of the way around but the pipe did not completely fail at this time. Some time later the final failure took place, severing the remaining metal.

3. Circumferential failure. External bending forces in combination with corrosion pitting cause this form of failure.

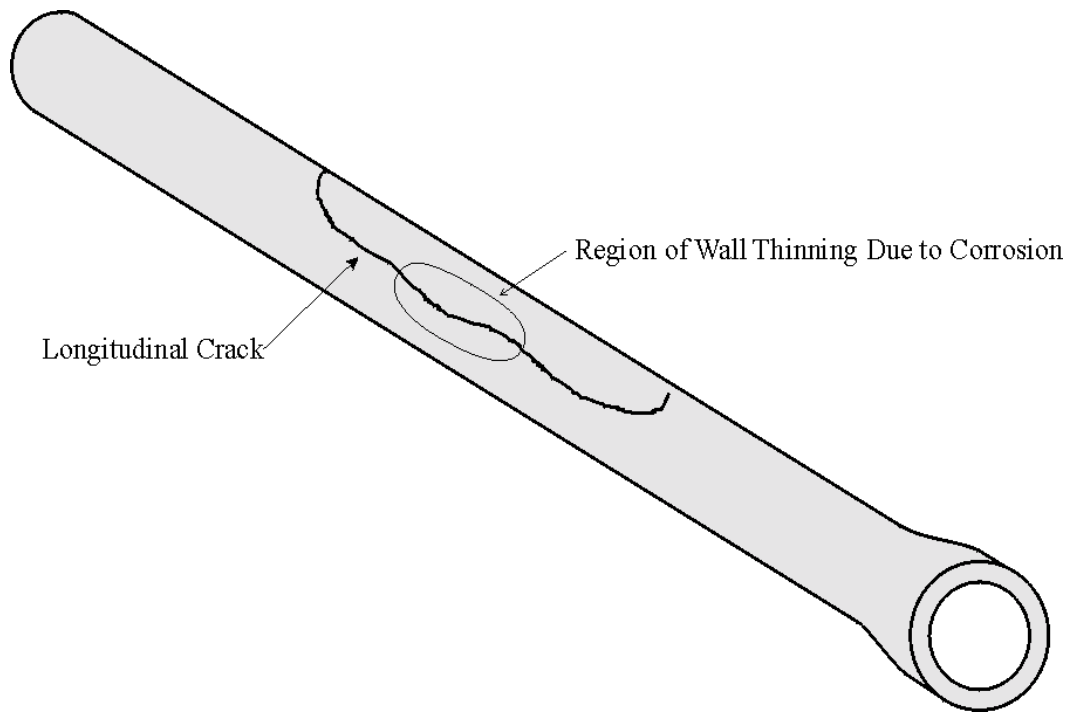
4. Longitudinal splitting. This type of failure is also caused by pipe wall thinning and pressure surges. The thinning can be produced corrosion or through pipe wall porosity. In some cases the crack will extend the length of the pipe.

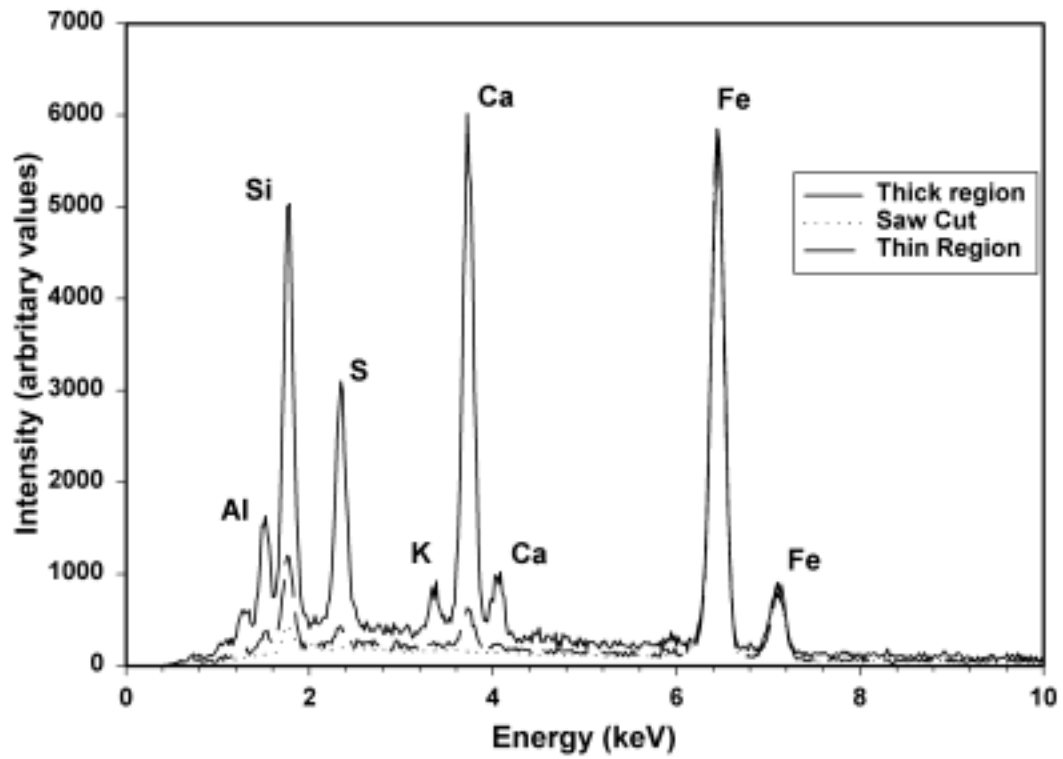
Figure 5 shows EDAX spectra from this pipe failure with the results of the spectra normalised against the larger (K_{α}) iron peak. The spectra from the clean metal shows a strong iron peak and a weak silicon peak. The carbon content of the pipe and the oxygen content of the corrosion products will not appear in an EDAX spectrum. The spectra from the lightly corroded fracture surface also shows small amounts of calcium and a larger proportionally larger silicon content. These constituents have been taken up from the surrounding earth as part of the corrosion process. Finally, the spectra from the fracture surface near the end of the bell shows aluminum, sulphur and potassium in addition to proportionally much higher amounts of silicon and calcium.

5. EDAX spectra of the pipe that had failed by a bell split. These spectra have been normalised against the iron K_{α} signal.

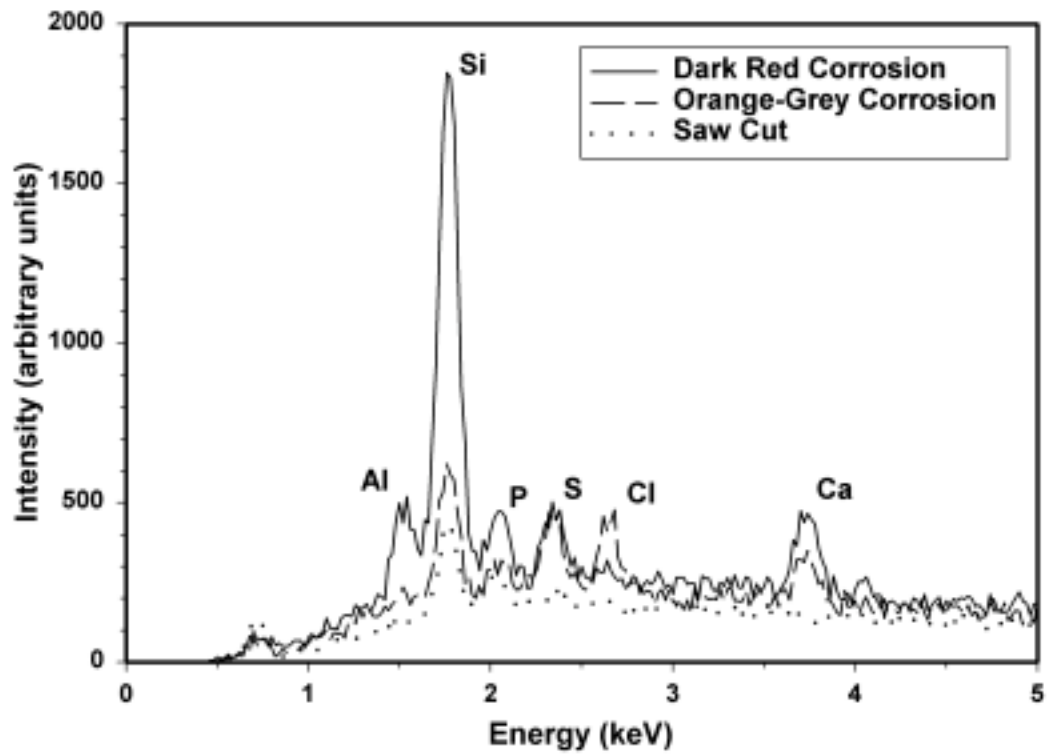
Figure 6 shows EDAX spectra for this pipe failure. In this case the lower ends of the spectra have been examined to show the differences between the regions of the fracture surface. The spectra have again been normalised against the K_{α} iron peak, which is not shown on the figure. The clean metal of this sample shows the presence of silicon and a small amount of phosphorus. The dark red corrosion region also shows aluminum, silicon, calcium and sulphur. The orange-grey region shows a much lower relative silicon content, sulphur, phosphorus, calcium and chlorine. The phosphorus in the latter two spectra is due to the pipe metal, while the calcium and sulphur content has come from the surrounding soil. The chlorine is likely due to the salt put on roads in the Ottawa region during winter. The EDAX spectra indicates that the orange-grey region of corrosion in the pipe was immersed in salt water long enough for the chlorine to become part of the corrosion products on the fracture surface.

6. EDAX spectra of a pipe that had failed by a circumferential split. These spectra have been normalised against the iron K_{α} signal.

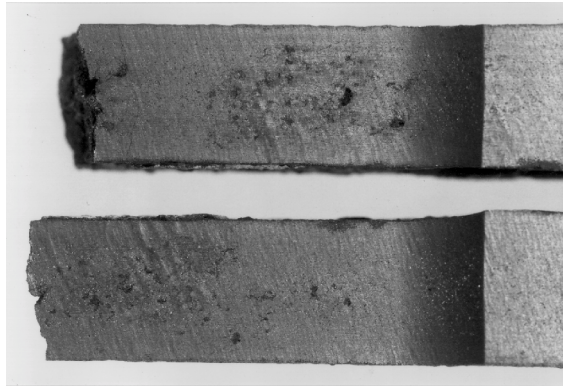
Many of the older pipes in use in North America were made using the pit casting process, in which the molten cast iron was poured into upright sand molds and left to slowly cool²⁰. In some cases the manufacturing process had poor metallurgical control and the result was a pipe with flawed metal and reduced strength. Figure 7 shows a cross-section from such a pipe, which dates from 1885 and was excavated from Minneapolis. The machined surface of the sample shows a network of pits that indicate that the pipe cooled with internal air pockets. This sample was fractured in the lab so that a fresh fracture surface could be examined. The fracture surface also showed evidence of visible pores, with the largest seen being approximately 2 mm across or 14% of the thickness of the pipe. A number of black, non-metallic inclusions were also seen on the fracture surface. These inclusions were approximately 1 mm across in width. An EDAX examination of the inclusions indicated that while they had a high iron content, they also had a much higher silicon content than the metal around it. This result suggests that the inclusions were un-dissolved ferrosilicon. Silicon is often added to cast iron in this form, suggesting that the metal in this pipe was not held at temperature longer enough for all of

Both the pores and inclusions in this sample produce weaknesses in the metal. As a result, it had a much lower tensile strength than is typical of pipes of its manufacturing type (33 MPa versus 130 MPa) and an equally low fracture toughness. Similar porosity has been described as the cause of the failure of a larger diameter cast iron pipe¹³, while two of the pipes excavated by the City of Toronto similar but larger porosities. These results suggest that high porosity may be a frequent problem in older grey cast iron pipes.

7. Pores in the machined surfaces of the Minneapolis pipe sample. These pores and the inclusions that accompanied them produced a pipe that was much weaker than is typical for its class of pipe.

Some pipes have been observed to fail due to manufacturing defects. If utility records shows a specific vintage of pipe from a specific manufacturer has a higher failure rate than might otherwise be expected, a metallurgical examination or failure analysis may be warranted. The porosity and inclusions seen here indicate that the pipe itself was partly the cause of the failure, rather than external conditions or forces. Utilities with similar, low quality pipes may wish to schedule them for early replacement or rehabilitation.
