DESIGN CHANGE BENEFICIAL IN REDUCING DOMESTIC HOT WATER TANK CORROSION

by
P. J. SEREDA

RESEARCH PAPER NO. 122
of the
DIVISION OF BUILDING RESEARCH

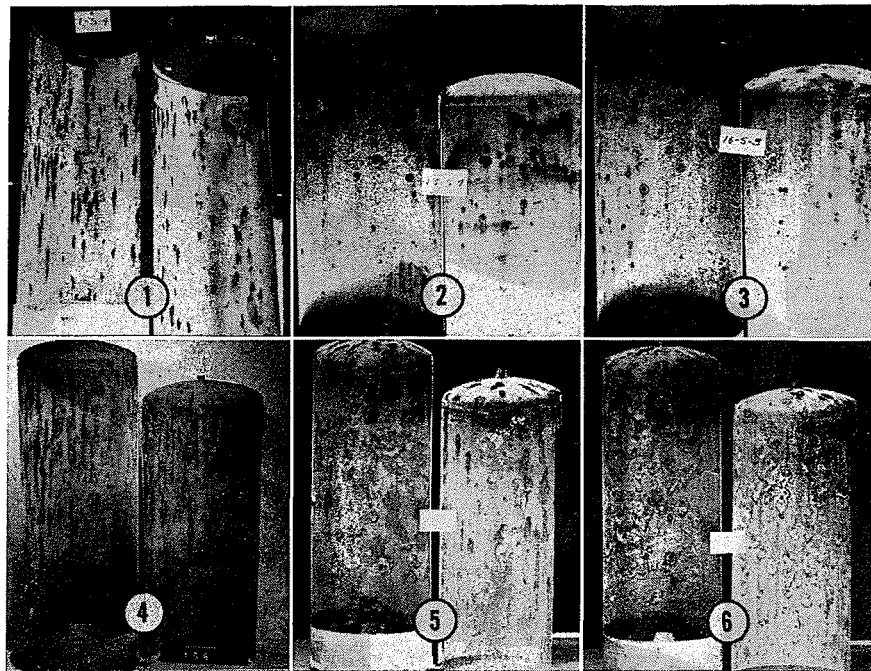
Figure 1—Appearance of tanks after failure at controlled temperatures. Example 1, 23 months at 170 F, Example 2, 17 months at 170 F, Example 3, 20 months at 170 F, Example 4, 80 months at 150 F, Example 5, 66 months at 150 F and Example 6, 60 months at 150 F. Examples 1 and 4 were from the Brantford Project; Examples 2 and 5 from the Belleville Project and Examples 3 and 6 from the Peterborough Project.

1. There was distinct difference in appearance of the pitting corrosion for each locality as seen in Figure 1.

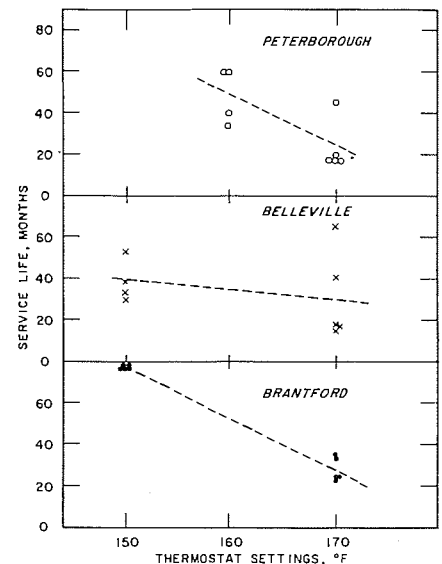
3. There was an indication that as temperature increased the corrosion rate also increased. This was very definite in the case of tanks from Brantford (Figure 2). Hoxeng and Prutton³ and Weast⁴ came to similar conclusions.

Figure 2—Service life of tanks controlled at different temperatures.

The study at Peterborough, Brantford and Belleville showed that temperature was an important factor in the corrosion of hot water tanks. Reducing the temperature by as little as 10 degrees would certainly add years of service life to the tanks, especially in Brantford.

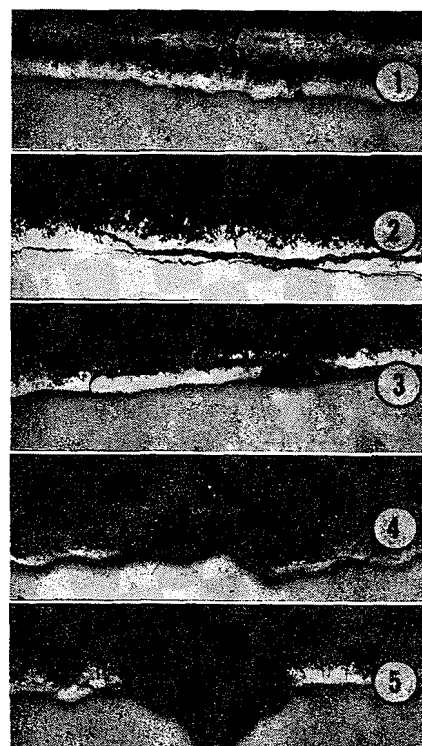
5. Evidence from the metallographic examination was much the same as was obtained in the preliminary work reported.¹ Micrographs from tanks in service in Brantford indicated that there was a reversal of polarity of the steel and zinc. This is in support of the measurements made by Hoxeng and Prutton³ and Guest.² There is also evidence of fissures and separation in the zinc alloy layers. Although the rate of corrosion of the tanks was about twice as rapid at 170 F as at 150 F the micrographs of the tank surfaces at the two temperatures do not reveal differences in the pattern of corrosion (Figure 4).

Figure 4—Micrographs from tanks removed from Brantford showing the characteristic corrosion attack on the galvanized coating. Magnification 96X. Number One shows an uncorroded edge. Numbers Two and Four are examples of a corroded edge from tanks operated at 170 F with failure after 3 years' service. Numbers Three and Four are of corroded edges from tanks operated at 150 F with failure after 6½ years' service. Number Five indicates a reversal of polarity.

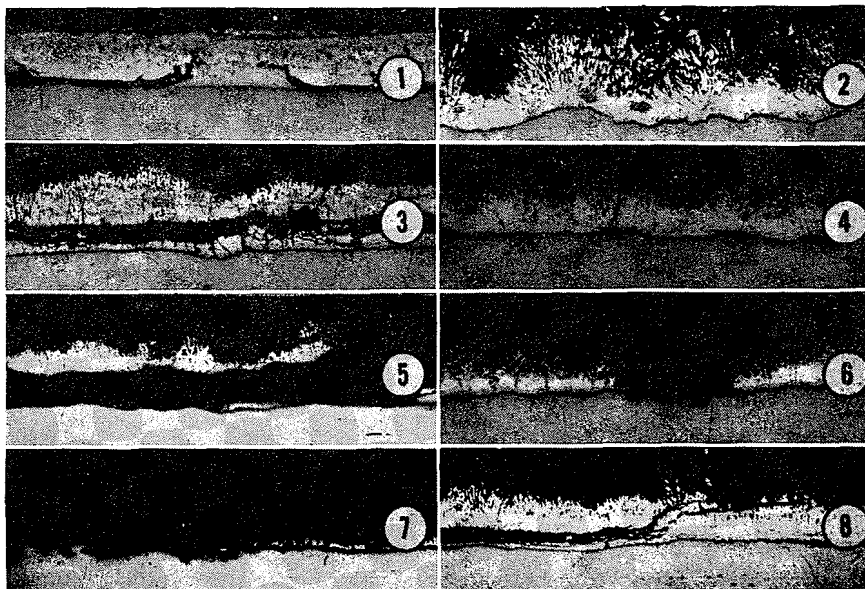
4. Figure 5 shows micrographs of the corroded and uncorroded edges of the sample tanks removed from Windsor. The pattern of the corrosion attack on the zinc, zinc-iron layers and steel interface is the same as that observed previously. The tanks heated by side-arm heaters and having galvanized pipe were corroded least, with an irregular attack on the zinc-rich layer. Tanks heated by

side-arm heaters and having copper piping showed increased attack with fissures and pits in the zinc-iron layers and complete lifting of the galvanized layer from the base. Finally, tanks heated by immersion heaters showed very serious disintegration and removal of the zinc-iron layers. Inhibitors had no apparent effect on the pattern of corrosion attack revealed in these micrographs.

Figure 5—Micrographs of galvanized tanks removed from Windsor, Ontario. Number One is an uncorroded edge (96X). Number Two is a side arm heater with galvanized piping (161X). Numbers Three and Four are side arm heaters with copper piping, silicate inhibitor (161X). Numbers Five and Six are immersion heaters with copper piping, silicate inhibitor (96X and 161X respectively). Numbers Seven and Eight are immersion heaters with galvanized piping, phosphate inhibitor (161X).

The study at Windsor showed that design of the hot water system and the resulting manner of operation has great effect upon the extent of tank corrosion. The change from a small capacity immersion heater to a large capacity side arm heater combined with a manual on-off switch was the most effective single factor in decreasing the corrosion of the galvanized tanks in this locality.
