EARTHFLOWS AT THE BEATTIE MINE
QUEBEC, CANADA*

W. J. EDEN†

In June 1943 an earthflow involving more than one million cubic yards of varved clay occurred at the Beattie Mine. Subsequent remedial measures resulted in further large landslides. This paper describes the soil conditions, the sequence of events, and attempts to assess the stability of the clay slopes. It was found that the undrained analysis led to an unsafe assessment but that Terzaghi's rule for critical heights of slope gave a better indication of stability.

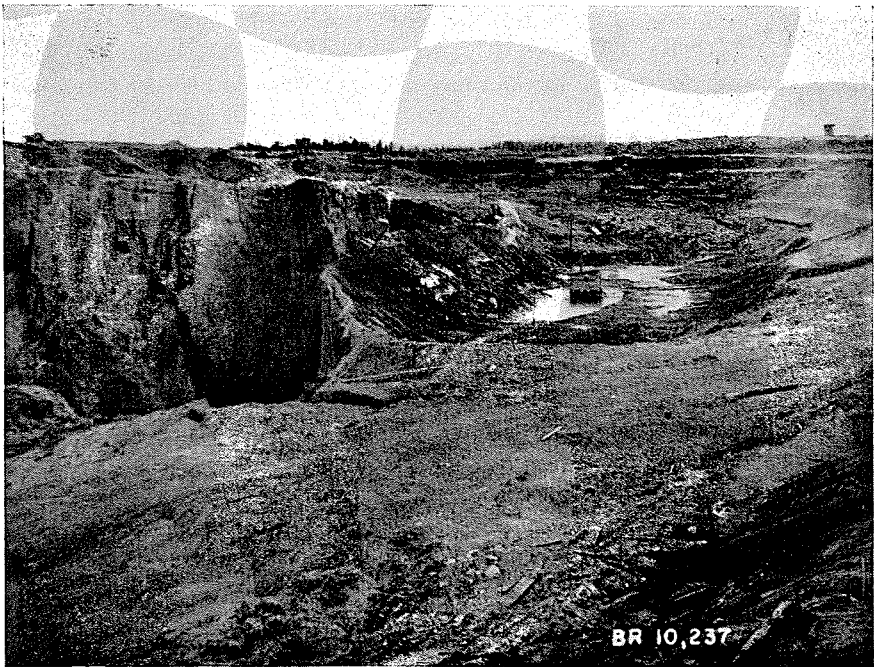
FIGURE 2. Clay slopes, 15 June 1943 (courtesy of Mr. F. E. Patton)

On the night of 15 June 1943, however, a very large earthflow involving more than one million cu. yd. occurred. The glory-hole was completely filled, and owing to the fluidity of the clay many of the underground workings were penetrated. Some of the clay ran nearly half a mile along the sixth level drift towards the neighbouring Donchester Mine, which was connected to the Beattie Mine on this level. The immediate cause of the landslide appears to have been the collapse of a main pillar in the pit; this caused a rockfall on the north side and, in turn, initiated the earthflow. As indicated on Figure 3 the landslide involved a large area of clay north and east of the pit. Borings made in 1960 and 1961 indicate that nearly all the clay in this area of the pit was removed by the earthflow.

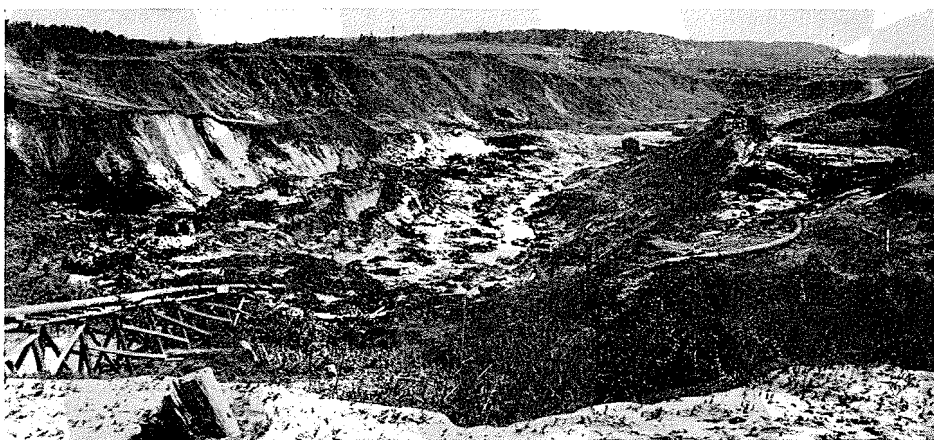
During 1945 further landslides occurred at the west end of the crater, undoing some of the work of the dredges. These continued into 1946, the largest, on 25 June 1946, involving about 250,000 cubic yards. Figure 4 shows photographs taken in July 1946 that illustrate the landslides. From information obtained from the former mine engineer, it appears that the slides at the

FIGURE 4. View of Mine from west end showing recent landslides, July 1946 (courtesy of Mr. F. E. Patton)

west end were rather shallow, involving perhaps the top 20 to 25 ft. of the clay. The first evidence of a slide would be a tension crack; two or three days later a sudden movement would occur, causing the clay to liquefy and flow rapidly towards the dredges located several hundred feet to the east. Observers could not associate the occurrence of the slides directly with the operations of the dredges. Slides continued, however, until September 1946 when dredging work was suspended.

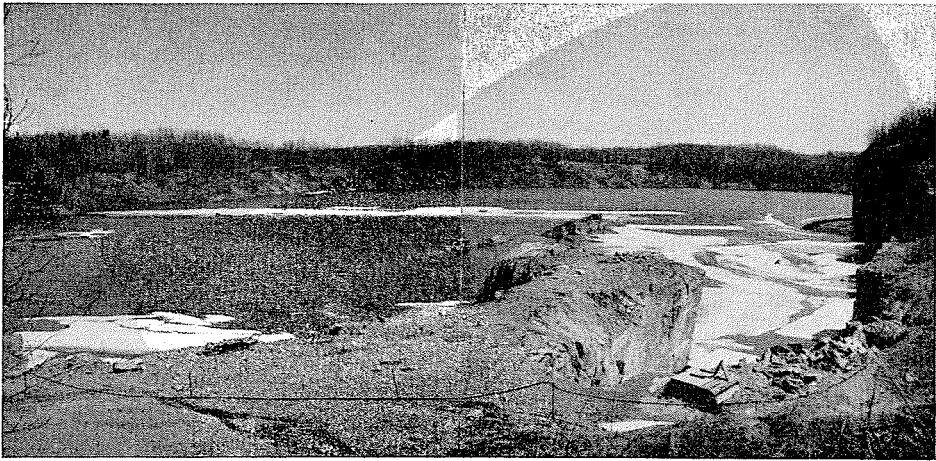
In the fall of 1946 a decline in the price of gold brought an end to large-scale operations at the Beattie Mine. From 1946 to 1956 the pit area was kept free of water, and a shallow shaft was sunk at the west end to reach a lode of comparatively rich ore. Since 1956 no further work has been done, and the pit area has been allowed to flood from local drainage. Figure 5 is a photograph illustrating the area in May 1960. This view is approximately the same as that in Figure 4. The shores of the lake that can be seen are the scarps left

FIGURE 5. View of Mine from west end, May 1960

by the landslides; the rock wall at the right is the former footwall of the pit and the rock point jutting out of the water is the top of the hanging wall.

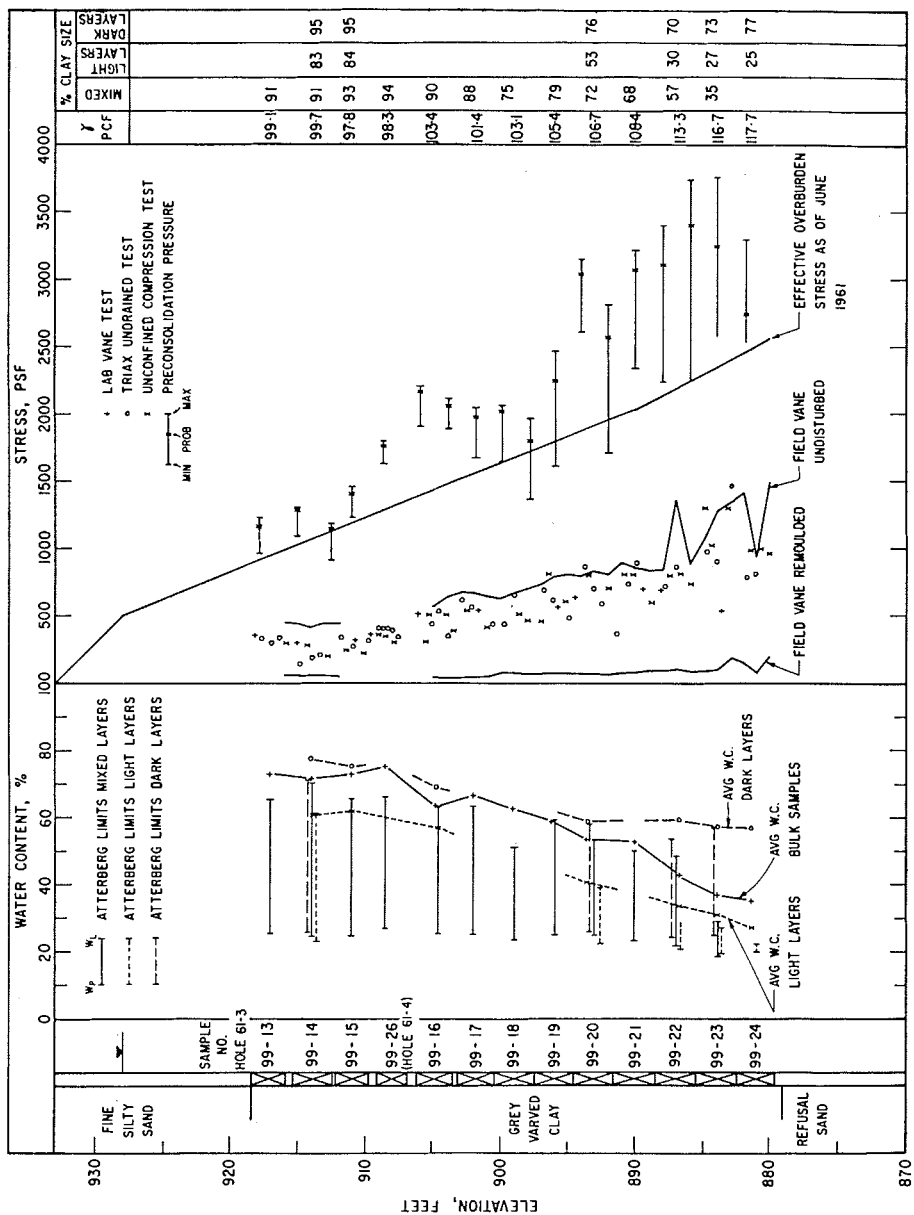
In Figure 6, the boring log shows that the top 15 ft. consist of silty sand—very loose material that was easily penetrated by the drill casing. The varved clay stratum extends from 15 to 55 ft. Near the top of it the dark layers are thicker than the light layers, although both may be considered clay

FIGURE 6. Boring log showing test results

materials. With increase in depth the ratio of dark to light layer changes, until at the bottom of the clay the light layers are thicker than the dark layers and consist of sandy silt. The dark layers continue to be clayey with reduced plasticity; the water content profile shows this tendency.

The undrained shear strength increases with depth, with the apparent c/p ratio remaining nearly constant. Field vane strengths range from about 400 lb./sq. ft. at an elevation of 915 to 1000 lb./sq. ft. at an elevation of 880. The apparent c/p ratio is about 0.4, this value being partially attributable to an overconsolidation process. The consolidation test results indicate that the clay has been affected by the mine drainage system. It is postulated that this drainage caused a full draw-down and the initially normally consolidated clay tended to be consolidated by the full overburden pressure.

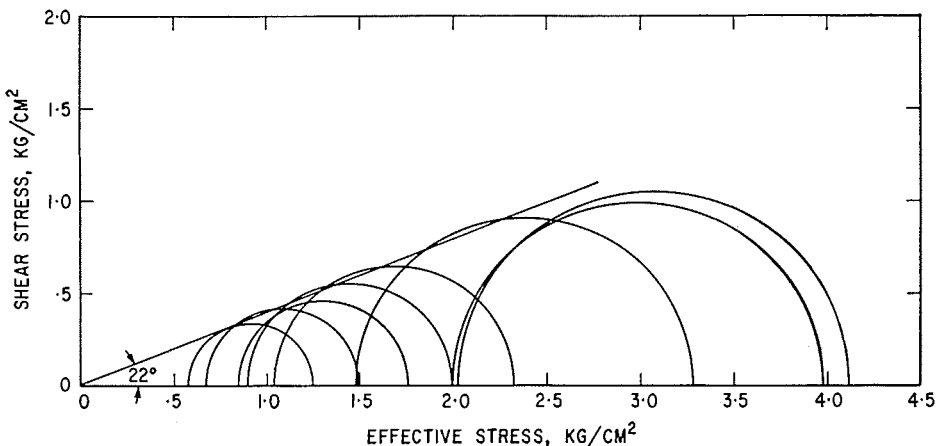
Consolidated undrained (CU) triaxial tests were conducted on a number of specimens. A change in the shear characteristics of the material is indicated as occurring at an elevation of about 890, the material below this elevation having an angle of shearing resistance ϕ' of about 28 degrees and that above it about 22 degrees. Results of the tests on the upper clay are presented in Figure 7, which is a Mohr diagram showing the effective stress circles at the maximum deviator stress obtained during the test. All these tests were conducted at consolidating pressures greater than the preconsolidation pressure of the samples. The average c/p measured was 0.29.

FIGURE 7. Mohr diagram of triaxial test results on upper clay

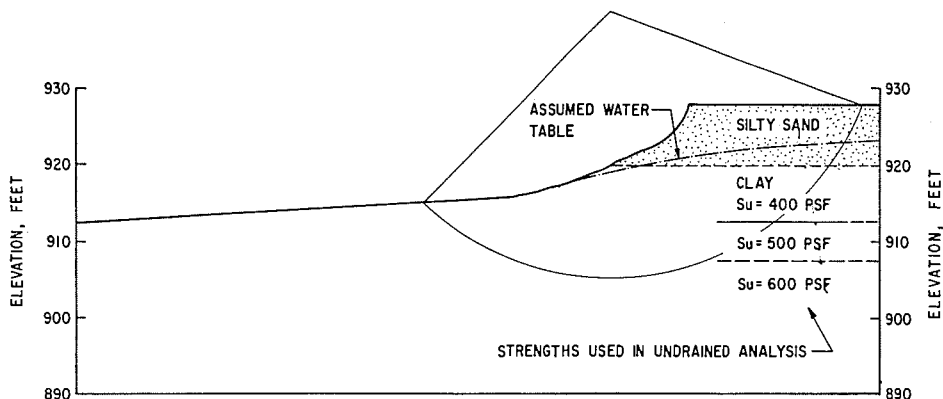
FIGURE 8. Profile X-X at west end

Using the aerial photographs taken in June or July 1945, it was possible to obtain reasonably reliable slope profiles for the west end of the mine where slope failures were occurring. The steepest profile obtained is shown on Figure 8. Both total stress and effective stress analyses were attempted on this profile.

For the undrained analysis several shallow circles were tried using shear strengths of 400, 500, and 600 lb./sq. ft. according to the depth of the circle and the measured field vane strengths at corresponding elevations. No strength was assigned to the silty sand stratum on the surface. Although the strengths measured with the vane in 1961 were considered to be slightly higher than the strengths at the time of the landslide because of consolidation, this analysis might be expected to give a reasonable indication of potential instability. However, the minimum safety factor obtained was 2, and the analysis cannot therefore be considered satisfactory. The large discrepancy between the calculation and the observed behaviour of the clay cannot be accounted for by the consolidation effect alone.

An effective stress stability analysis (Bishop, 1955) was made assuming the position of the zero water pressure line shown in Figure 8. Using $\phi' = 22$ degrees, and $c' = 0$, the minimum safety factor of 0.9 was obtained from a number of trial circles. Because of the consolidation of the clay, however, the assumption that $c' = 0$ is probably too stringent. On the other hand, the zero water pressure line probably conformed very nearly with the ground surface during the period of spring thaw. Since the effective stress analysis is influenced greatly by both the value of c' and the pore water pressure, this analysis cannot be considered a reliable confirmation of the method.

The undrained analysis, although apparently successful for cases involving loading (Milligan *et al.*, 1962; Eden and Bozozuk, 1962) does not seem to be reliable in assessing the stability of some cuttings, particularly cuttings subjected to rapid changes in stress conditions. Experience at both Steep Rock and the Beattie Mine indicates that Terzaghi's rule concerning the critical height of a slope is a good indication of stability. Hence, it is suggested that deep cuts in these clays should be carried out by a system of benches and berms, with the height of the upper benches less than the critical height.
