### Shattering of unreinforced PVC roof membranes: problem phenomenon, causes and prevention

Paroli, R. M.; Smith, T. L.; Whelan, B. J.

*Building Better Roofs - IRC Technical Seminar, pp. 93-107, 1996-09-01*

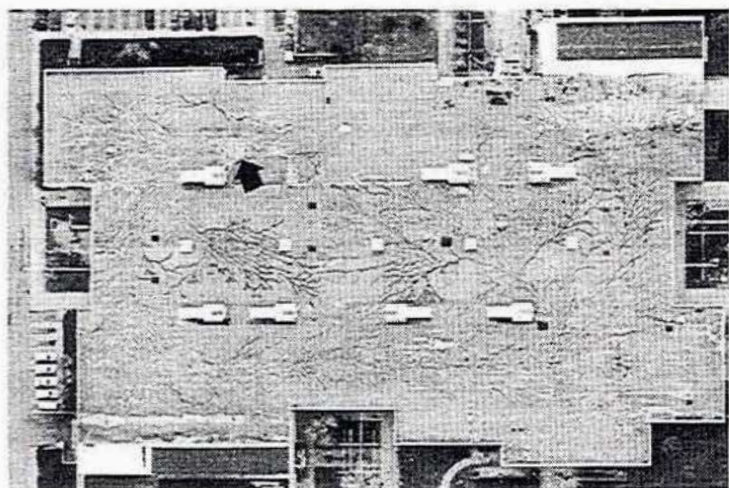
Shattering typically has the potential to be quite devastating, since the building can suddenly become vulnerable to water infiltration throughout virtually the entire roof area. Dupuis described this type of roof problem as a "failure level IV."<sup>8</sup> A level IV failure is "abrupt, total, and in most instances without warning." (See Figures 1 to 4.)

If an unreinforced membrane accumulates enough tensile stress, it may rupture. The rupture may be spontaneous or it may occur by someone walking on the roof or by some object falling on the roof. Upon rupture, the membrane usually lacks sufficient strength to prevent propagation of the split. As the split propagates, it branches into multiple lines of rupture, as can be seen in Figures 1 to 3.

**Figure 1** Aerial view of shattered ballasted unreinforced PVC roof system. Shatter initiated at the upper left, where indicated by the arrow. The shatter propagated in a counter-clockwise direction. One area at the top center portion of the roof did not initially shatter. However, it shattered a few days later. Membrane replacement is underway at the upper right and lower left corners.

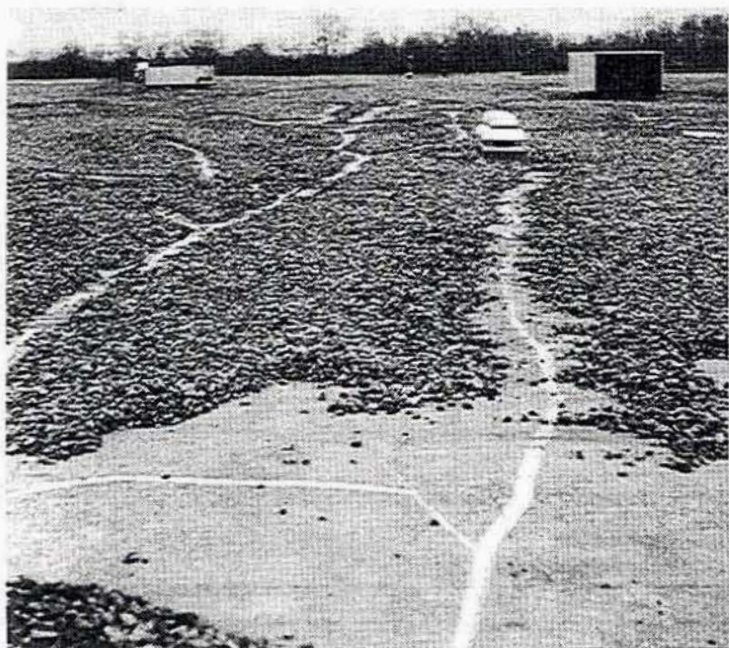
**Figure 2** General view of a shattered ballasted unreinforced PVC roof system.

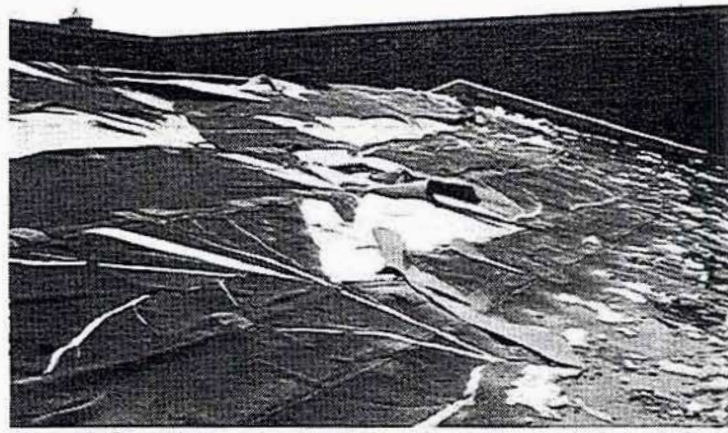
**Figure 3** General view of a shattered mechanically attached unreinforced PVC roof system.

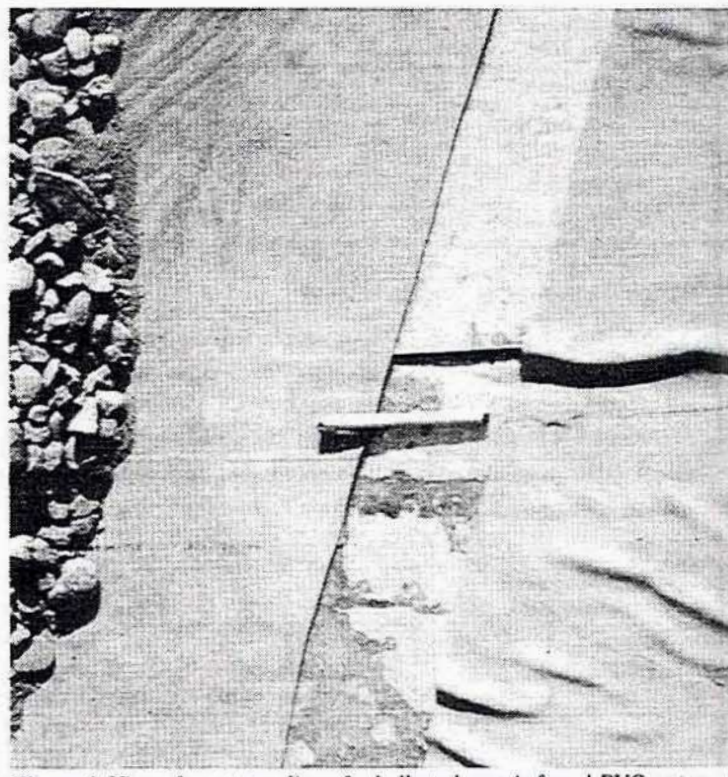
**Figure 4** View of a rupture line of a ballasted unreinforced PVC system. A seam line occurs to the right of the ink pen. On the other side of the rupture line, the seam line is below the pen. Hence, the membrane moved left-right and top-bottom. At lines of rupture, the membrane is often open by several inches, as it is in this figure.

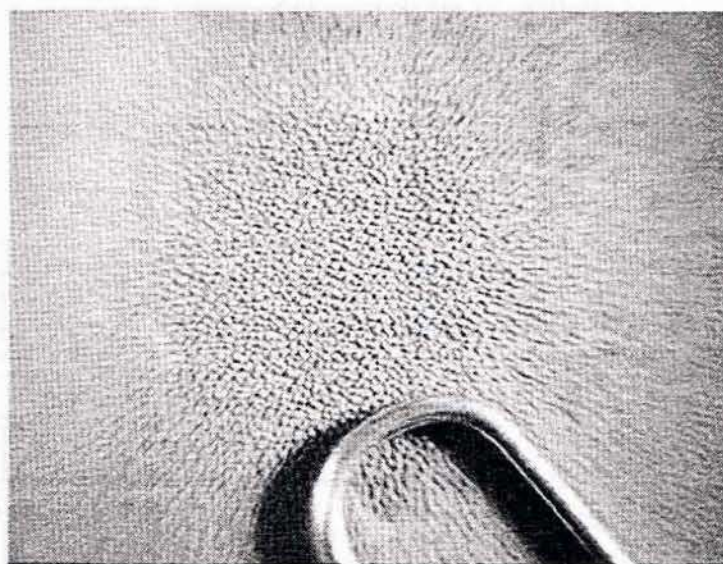
When examined under 8x magnification, weather-induced checking on the exposed side of the samples from mechanically attached membranes could be easily seen. It appeared that the checking depth was minor. On sample 90/91-20 (10 years old, from California), pronounced surface checking was visible with the naked eye. Surface checking was also visible on 90/91-23 (7.5 years old, from Michigan). (See Figure 7.) Under 8x magnification, the width of the check lines on this sample was greater than that observed on samples from other mechanically attached jobs. All of the mechanically attached samples included in this study were of the same manufacturer, except for 90/91-23. Samples from ballasted membranes were examined under 8x magnification, but checking was not observed.

Figure 7 Surface checking of a 7.5 year old mechanically attached unreinforced shattered PVC roof system (90/91-23). A paper clip shows the scale of the checking, which is visible with the naked eye.

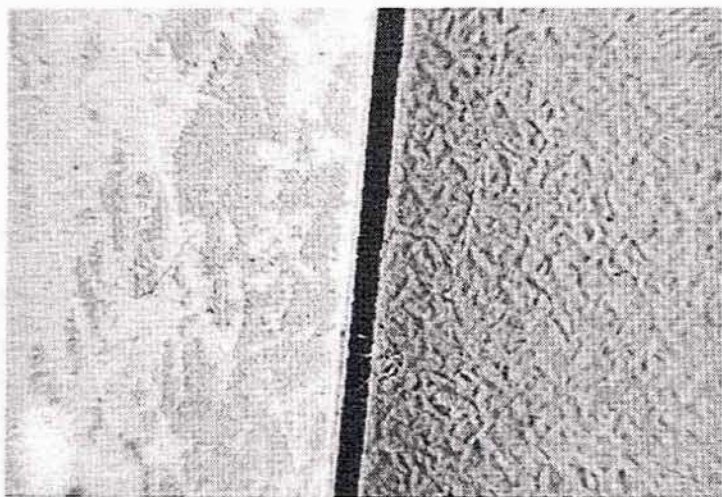
On some of the samples from 90/91-2 (10 years old, ballasted, Virginia), an "orange peel" surface was visible on the top side of the sheet. This only occurred on samples that were fairly clean. Other samples from this job had a good deal of dirt on the membrane. These samples exhibited a smooth surface after the dirt was removed. (See Figure 8.)

Figure 8 Side-by-side comparison of two samples from the same shattered ballasted unreinforced PVC roof system. The sample on the right side has an "orange peel" surface. This sample was fairly clean. The sample on the left was fairly smooth. This sample had a good deal of dirt on it (most of which was washed off prior to taking the photo).

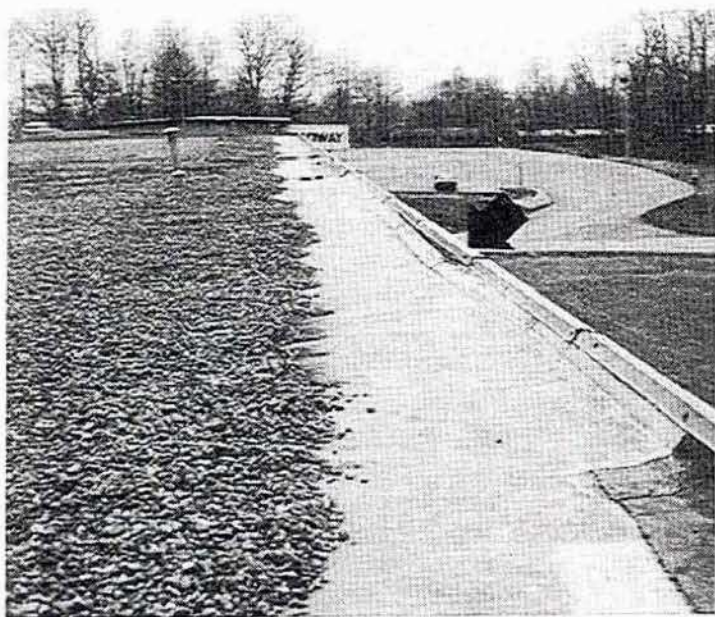
**Figure 10** Shrinkage of an unreinforced ballasted PVC roof system: the ballast has moved inward away from the parapet by a few feet. Also, the exhaust pipes have been slightly pulled over, and a portion of the base flashing has pulled away from the parapet (see arrow). These conditions are potential early warning signs of shattering.

- If potential early warning signs are observed, membrane replacement or repair work is recommended.

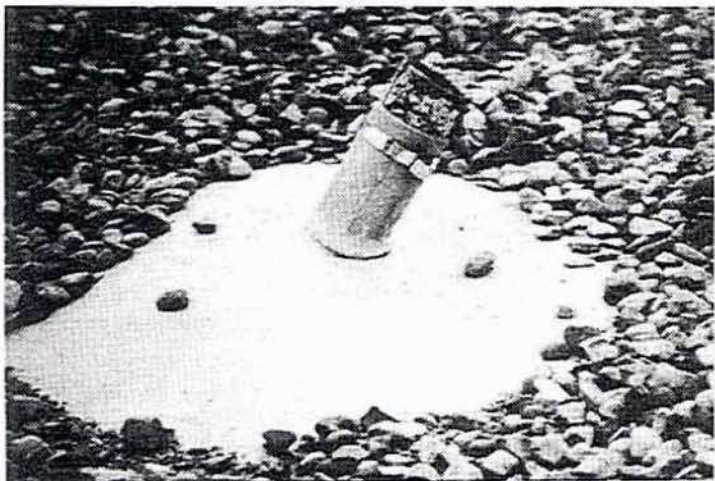
**Figure 11** Shrinkage of an unreinforced ballasted PVC roof system has resulted in displacement of this plumbing vent. This too, is a potential early warning sign of shattering.

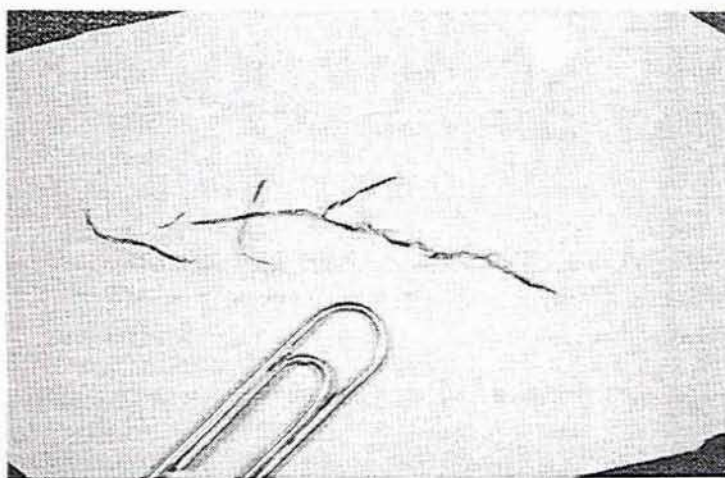
Figure 12 is of a reinforced PVC membrane that has cracked completely through the sheet (however, the reinforcement is still intact). While repairable, this condition does allow water infiltration. And if this type of problem occurs extensively, repair is problematic.

**Figure 12** Cracked reinforced mechanically attached PVC membrane roof system. The crack extends completely through the membrane. However, the reinforcement that bridges the crack was not ruptured. Surface checking is also visible to the naked eye. The roof had approximately 10 similarly cracked areas, none of which appeared to be due to abuse or neglect. This sample was 35 mils thick. Unlike shattering, cracking may be repairable, and it is not a catastrophic failure. This job was approximately 12 years old when the problem was reported in 1991. A strengthened ASTM D 4434 is needed to differentiate between those sheets that offer a long service life from those that do not.
