FROST HEAVE DURING WINTER CONSTRUCTION OF A BUILDING IN OTTAWA, CANADA

by K.N. Burn and R.K. Beach

Reprinted, from
Proceedings, International Symposium on Frost Action in Soils
held at U. of Lulea, Sweden, February 1978
Vol. 1, p. 185 - 194

DBR Paper No. 763
Division of Building Research

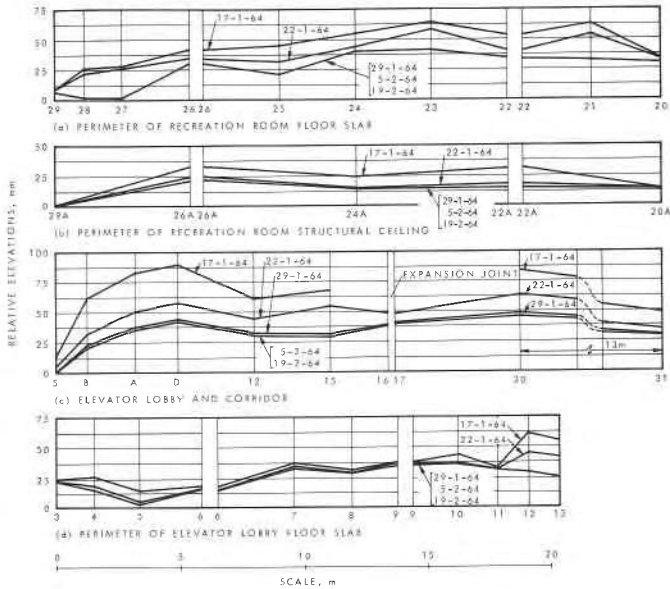
Fig. 3. Profiles showing movements caused by frost heave

also shown. The results of the surveys are shown graphically in Figure 3.

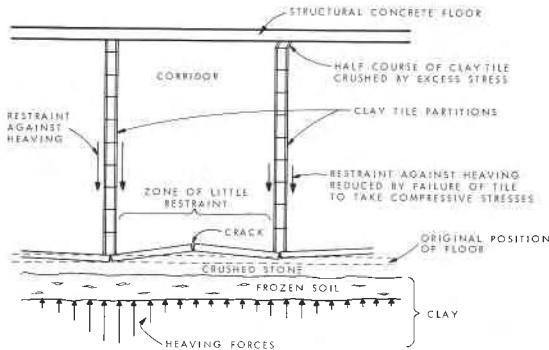
Fig. 4. Cross-section showing heaving of floor in corridor

These bending moments were greatest in the corridors where the "spans" are comparatively small and in the elevator lobby where cooling was most intense (Figure 4 and Plate II). The concrete failed in tension and the relatively wide cracks that opened were filled with fine particles of construction debris. During a mild spell, when free water stood in some areas of the corridors, some of the cracks were filled with a bituminous material to prevent leakage through the floor to the soil beneath. When the soil thawed, the footings settled. The floors at ground level, however, remained in the form of shallow arches with spaces between the bottom surface of concrete and the top of the crushed stone. Without a surface load the soil could not return to its former density but retained a loose structure as shown by the soil core recovered from beneath the lobby floor.

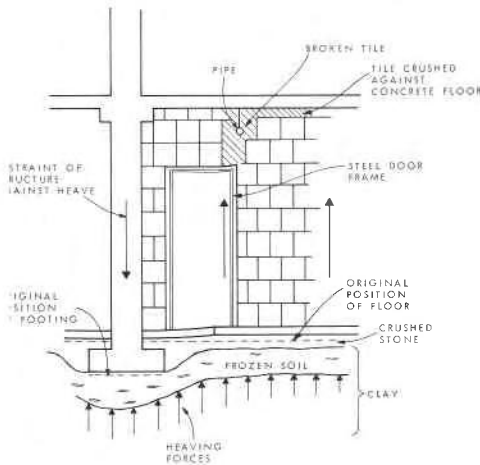
Fig. 5. Distortion of steel door frame

In some instances broken pieces of tile were used to complete filling around service pipes which pass through the partitions. When this occurred near door openings the only resistance to movement was from the concrete floor and steel door frame, both of which failed (Figure 5 and Plate IV). Some partition walls on both floors were

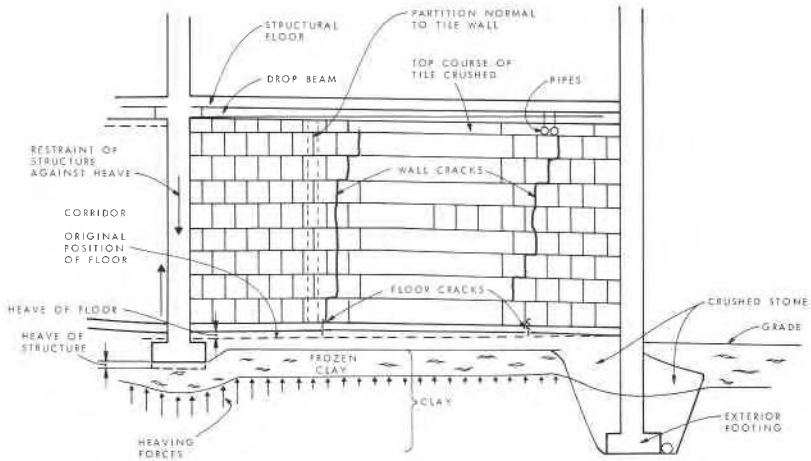
Fig. 6. Heave of structure and damage to clay tile partitions

upward between 12 mm and 15 mm (Figures 3, 6 and Plate V). The exterior columns appear to have been unaffected by the frost heave. The footings for the interior columns rest on clay only 500 mm below the top of the floor slab and were therefore at least 100 mm above the observed depth of frost penetration. Actual frost penetration beneath the columns was probably deeper than that below the floors because of the potentially higher rate of cooling at these locations. The exterior columns rest on footings more than 1200 mm below the surface. These conditions in the recreational room were representative of the whole of the 2-storey section of the building and it is probable that heaving of the amount measured here occurred throughout.

The series of readings taken on the structural ceiling and underside of beams in the recreation room showed that the three interior columns moved

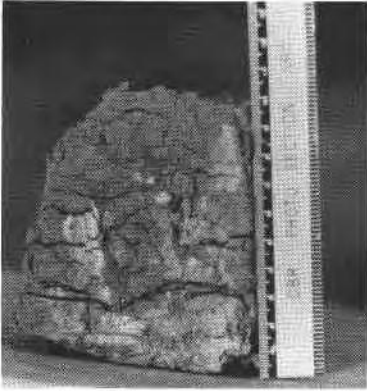
Plate I

The frozen cores were split open revealing fine ice lenses about 1 mm wide at roughly 10-mm spacings in planes parallel to the surface of the floor (Plate I). A small block sample of frozen soil was dug from a pit opening through the floor and this, too, showed fine ice lenses on planes roughly parallel to the exposed soil surface. In the fourth hole (located in the elevator lobby) no frozen soil was encountered, probably as a result of the large amount of heat that had been supplied at this point after the heaving occurred. A core sample was recovered, however, and the soil structure showed partings in the same manner as the frozen cores but no ice remained.

Typical core of frozen soil
removed from below floor
resting on grade

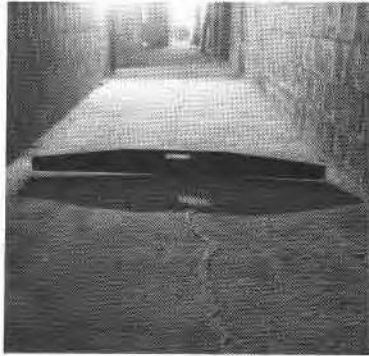
Plate II

Heaving of floor in corridor

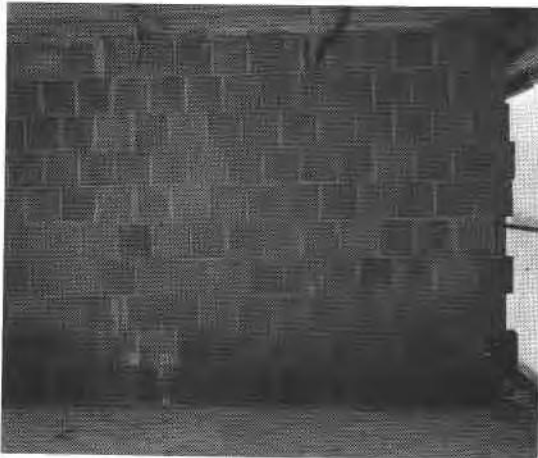
Plate III

Movement of the basement floor was transmitted to the ground floor by closely spaced non-loadbearing partitions causing damage such as that shown in Plate III.

Damage to partition
resting on struc-
tural floor which
was distorted when
displacement was
transmitted from
floor on grade
through closely
spaced partitions

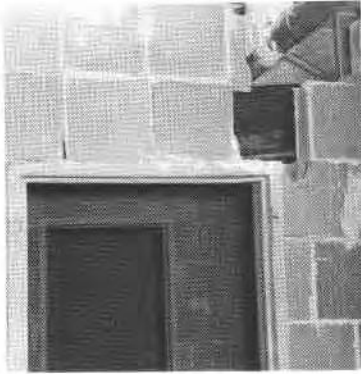
Plate IV

Steel door frame stressed out
of shape by heaving floor

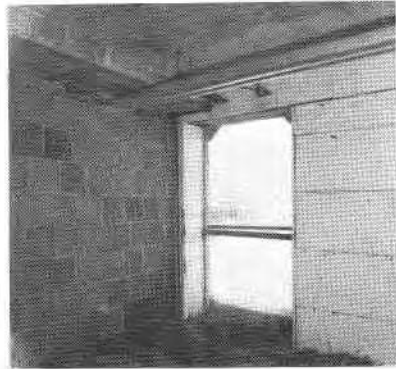
Plate V

beams above. This generally occurred in the top course which was less than 150 mm high. It was constructed of pieces of tile roughly fashioned by chipping with a trowel so that it was already weakened before the high stresses developed (Plate V).

Damaged partition
perpendicular to
exterior wall
