Vibration measurements on a steel joist floor: Montreal

573

TECHNICAL NOTE

SUBJECT VIBRATION MEASUREMENTS ON A STEEL JOIST FLOOR - MONTREAL

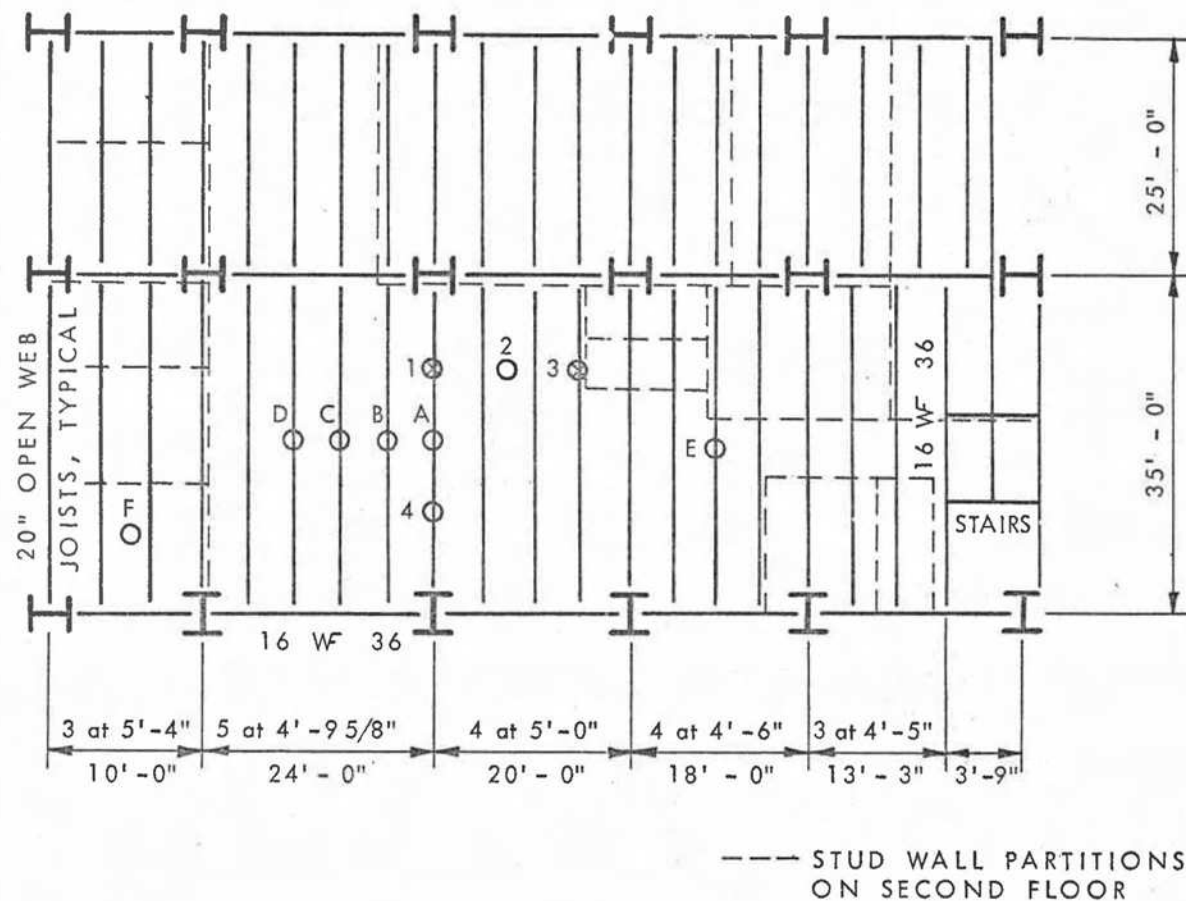
FIGURE 1

The locations of the observation points are shown in Figure 1 by letters A to F. Points 1 to 4 refer to measurements during a trial remedial solution, which will be discussed later. Point A was generally used as the reference signal, the other points were monitored in turn by the second accelerometer. Floor excitation consisted of walking, heel impact (up on toes, down on heels by a man weighing 220 lb. (100 kg)) and man-made steady state excitation of the floor at its resonance frequency.

The floor joists are supported on a 16 WF 36 exterior beam spanning 24 ft between columns (Figure 1). Assuming the beam is simply-supported and supports half the floor span, Eq. (1) results in a fundamental frequency of 5.0 cps for the WF support beam; this should result in a fundamental frequency of the floor system considerably less than 6 cps. Thus measured frequencies indicate a much higher beam stiffness, which could be due to beam interaction with the wall, beam continuity, etc.

SECOND FLOOR FRAMING PLAN AND TRANSDUCER LOCATIONS
(A TO F, 1, 2 AND 4)

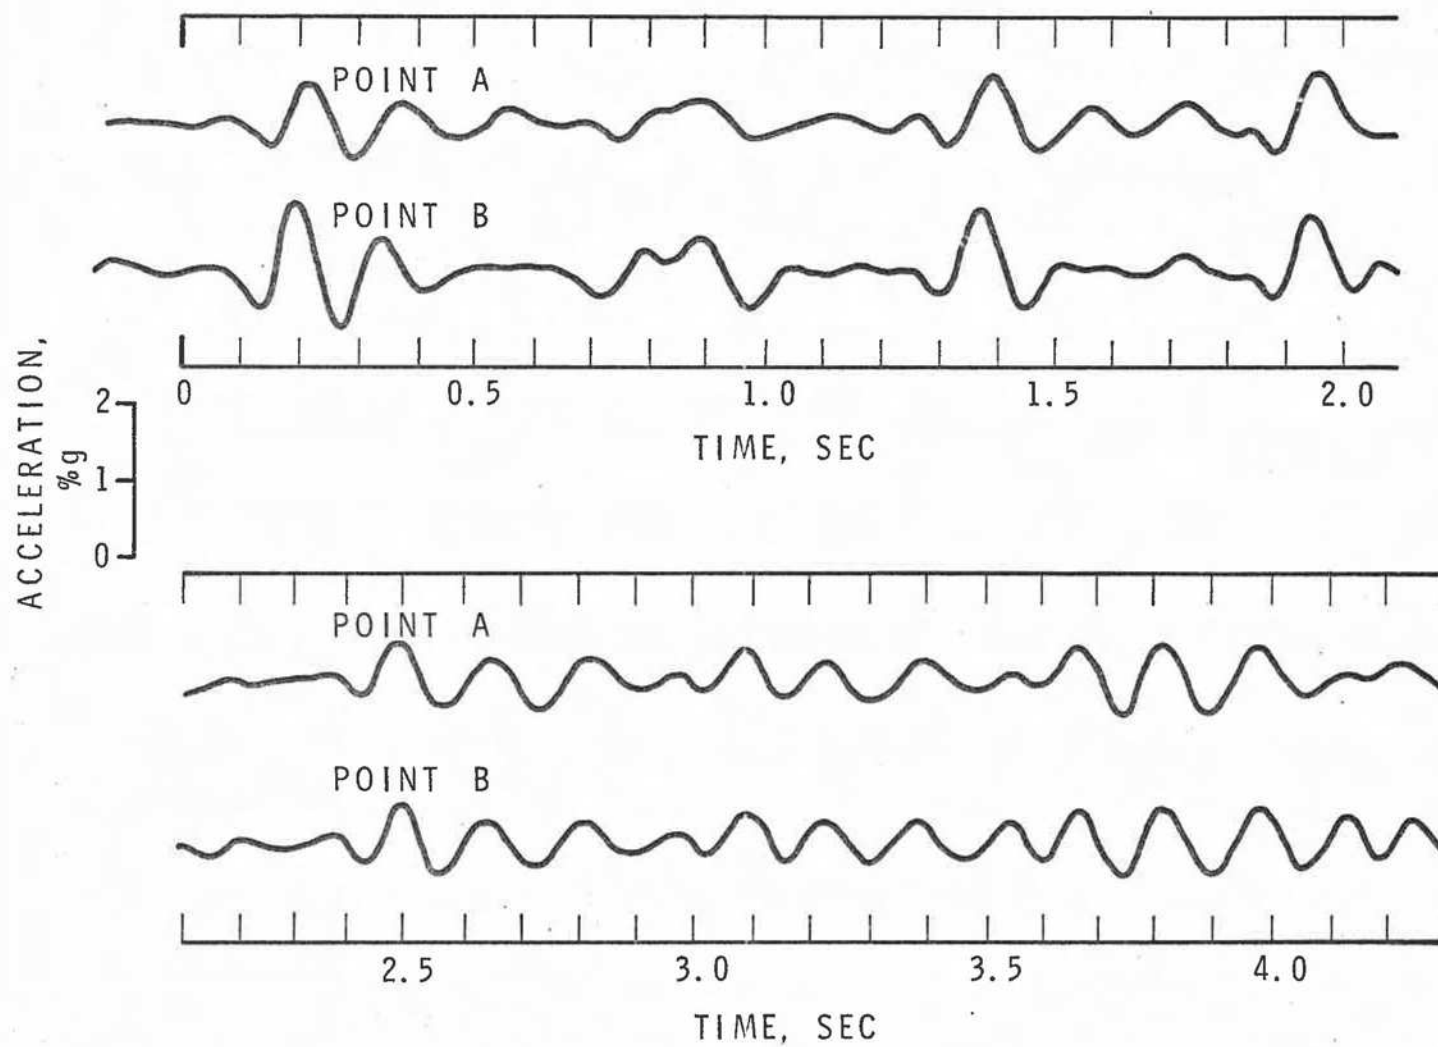
FIGURE 2

Figure 2 shows that the floor vibrations resulting from a normal brisk walk resemble a steady state vibration of the order of 0.005 g peak acceleration. According to Reference 1, this places it within the perceptible region of continuous vibration.

FLOOR VIBRATION RESULTING FROM A PERSON WALKING NORMAL TO
JOIST SPANS

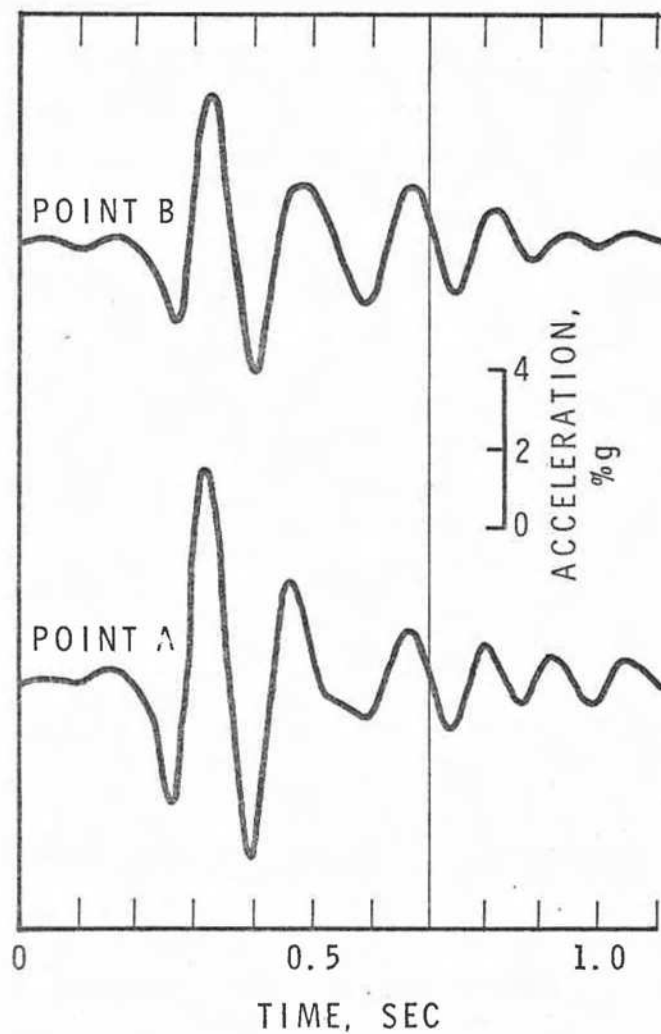
The heel impact tests shown in Figures 3, 4, 5, 7, and 8 provide an indication of the transmission of vibrations normal to the joists. Figure 3 shows that points A and B vibrate essentially in phase when excited at A and the acceleration amplitudes transmitted to B are approximately $2/3$ of those at A. As shown in Figure 4, at point C the vibrations induced at A are slightly out of phase and the acceleration amplitudes are reduced by about $1/2$. Figure 5 shows that at point D, three joists away from A, the vibrations are essentially 180° out of

FIGURE 3
VIBRATION OF POINTS A AND B DUE
TO HEEL IMPACT AT A

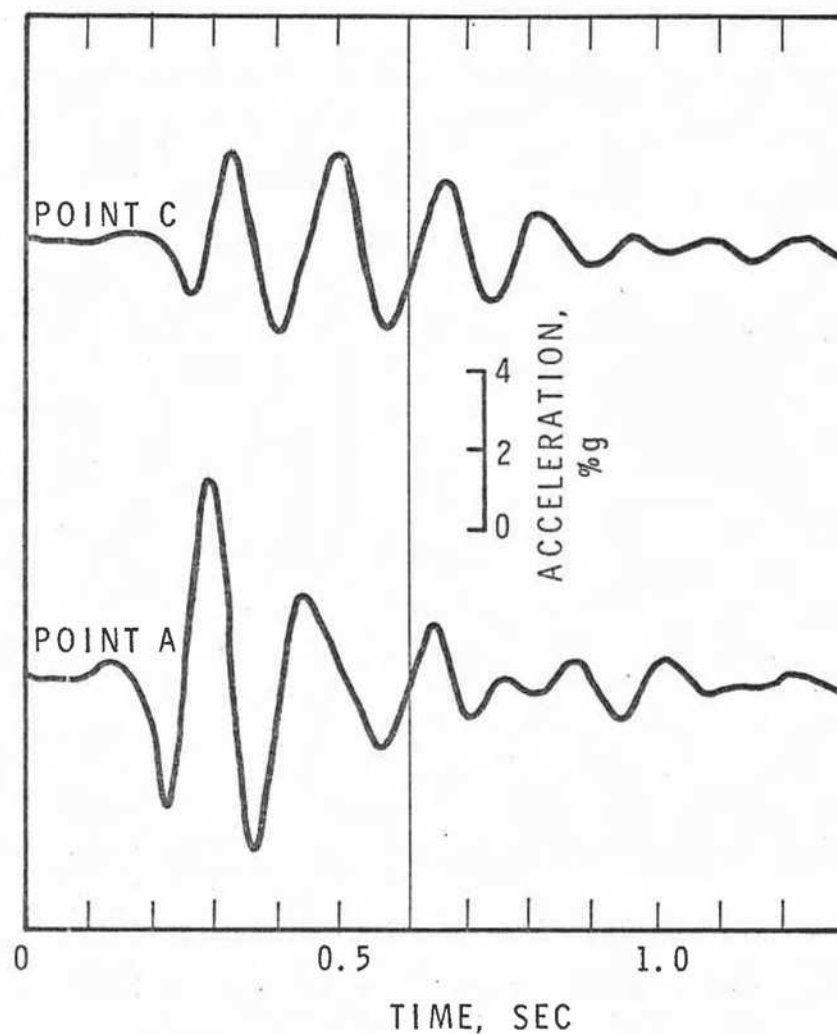
FIGURE 4
VIBRATION OF POINTS A AND C DUE TO HEEL
IMPACT AT A

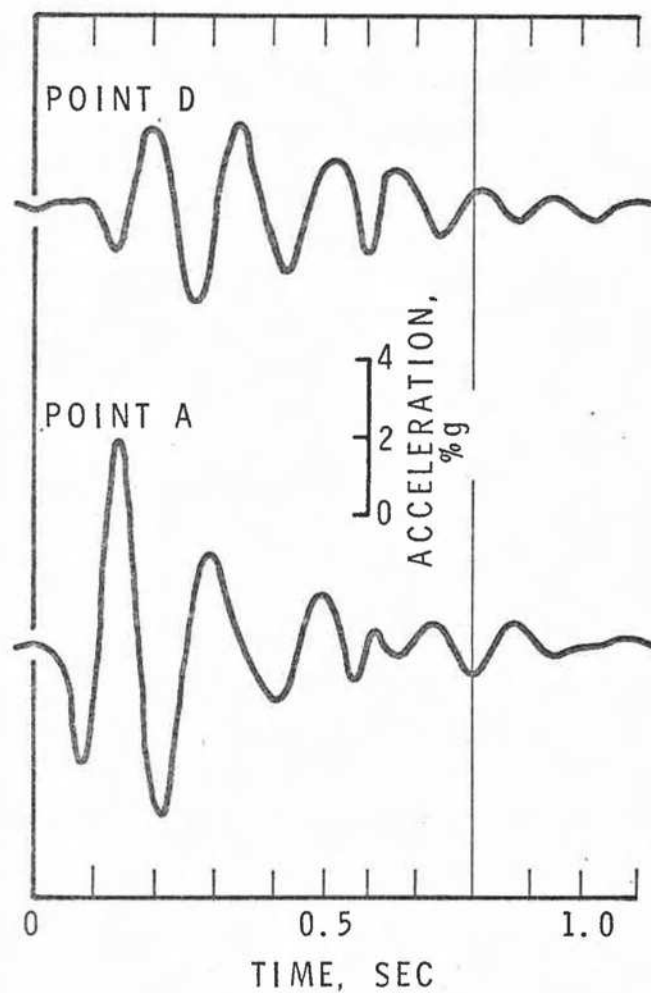
phase with vibration amplitudes comparable to those transmitted to C. In all these records the time history is seen to be more complex than that of a simple single-degree-of-freedom decaying system. This is typical for such floors, which are actually two-way systems supported on flexible beams, containing partitions and other objects that give the floor system irregular properties.

FIGURE 5
VIBRATION OF POINTS A AND D
DUE TO HEEL IMPACT AT A

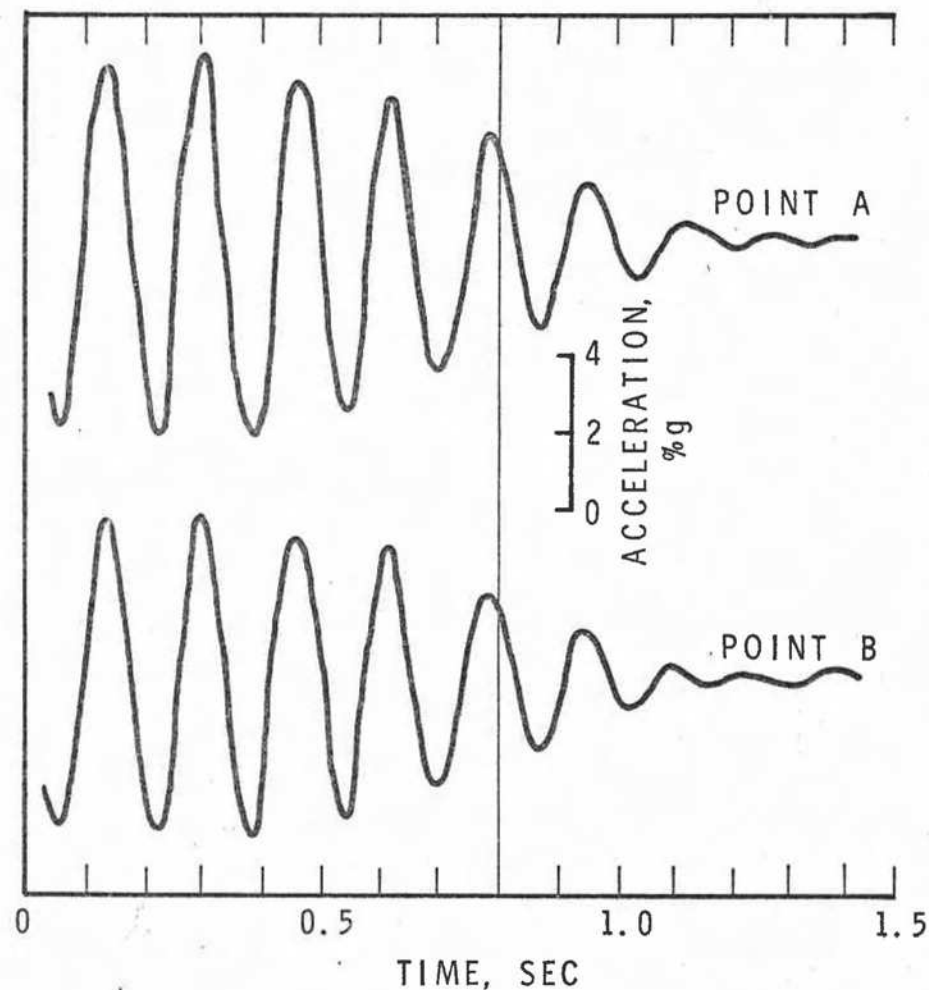
Figure 6 shows the decay of steady state vibrations at the fundamental frequency induced by a person. The rapidly decaying envelope indicates substantial damping in the floor system.

FIGURE 6
VIBRATION DECAY FROM STEADY STATE EXCITATION
AT POINT A

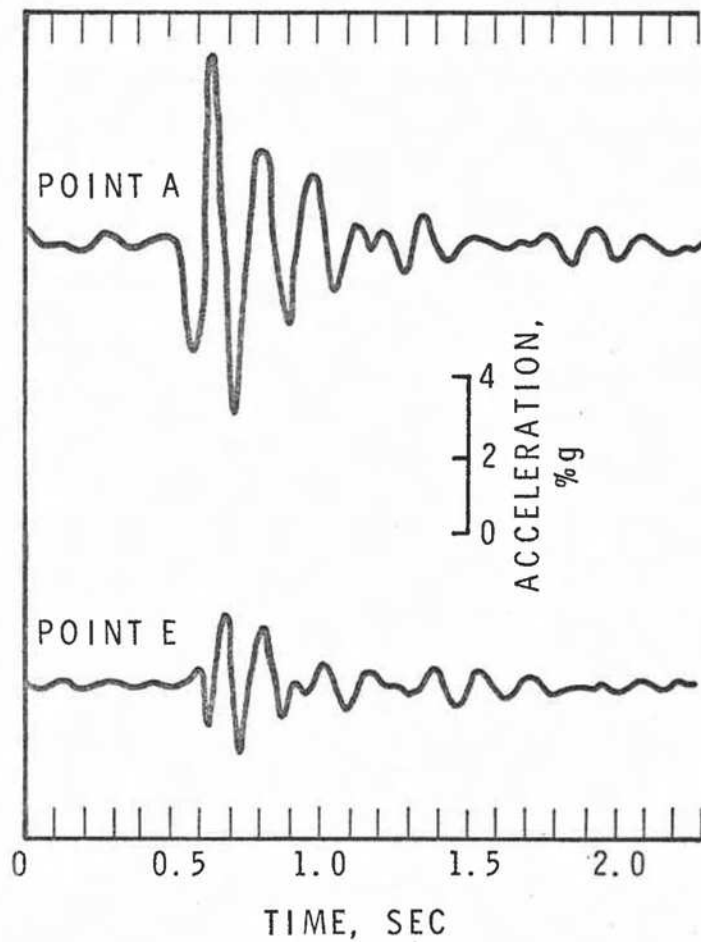
The transmission of vibrations from A to E and E to A is indicated in Figures 7 and 8, respectively. At point E the amplitudes are approximately $1/3$ of those produced at A by a heel impact. A comparison between Figures 7 and 8 shows that a heel impact produced by the same person at point E results in acceleration amplitudes which are about $1/2$ of those produced at A. Figure 8 indicates a transmission of approximately $1/2$ the amplitudes from point E to A.

The results from Figures 7 and 8 can be related to the presence of partitions near point E and demonstrate a reduced level of impact response. The partitions also reduce the vibration amplitudes transmitted from other slab locations that do not contain partitions. Since there are no significant changes in the resonant frequencies of the joist with nearby partitions at E, the reduced response can be ascribed primarily to increased amounts of damping provided by the partitions rather than an increase in stiffness.

FIGURE 7
HEEL IMPACT TEST AT POINT A

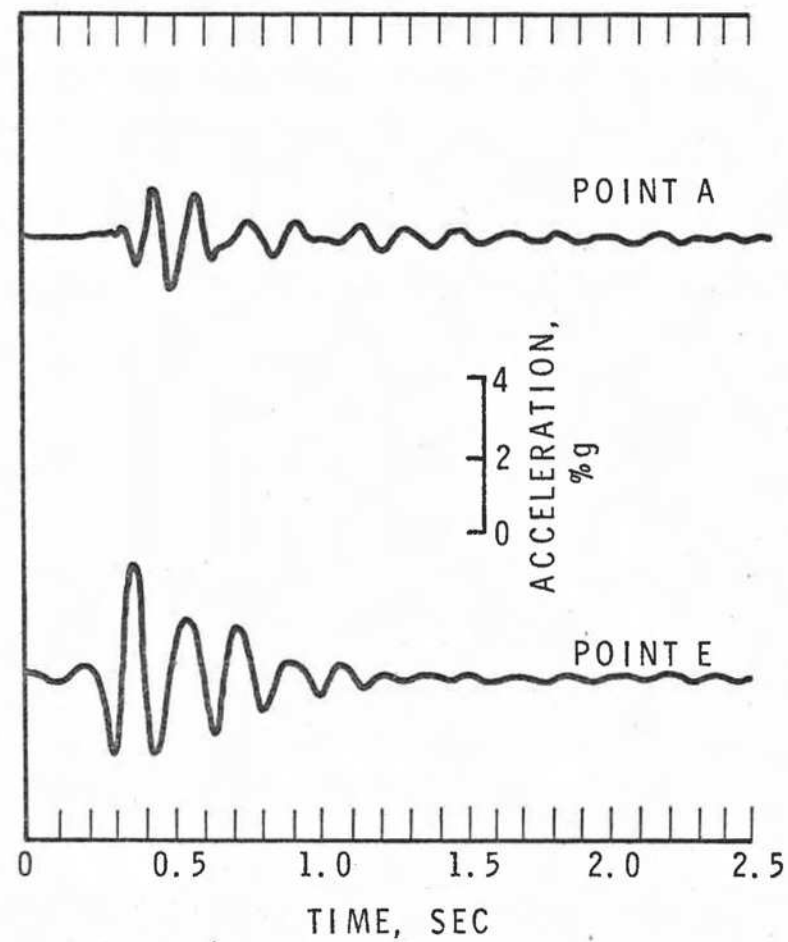
FIGURE 8
HEEL IMPACT TEST AT POINT E

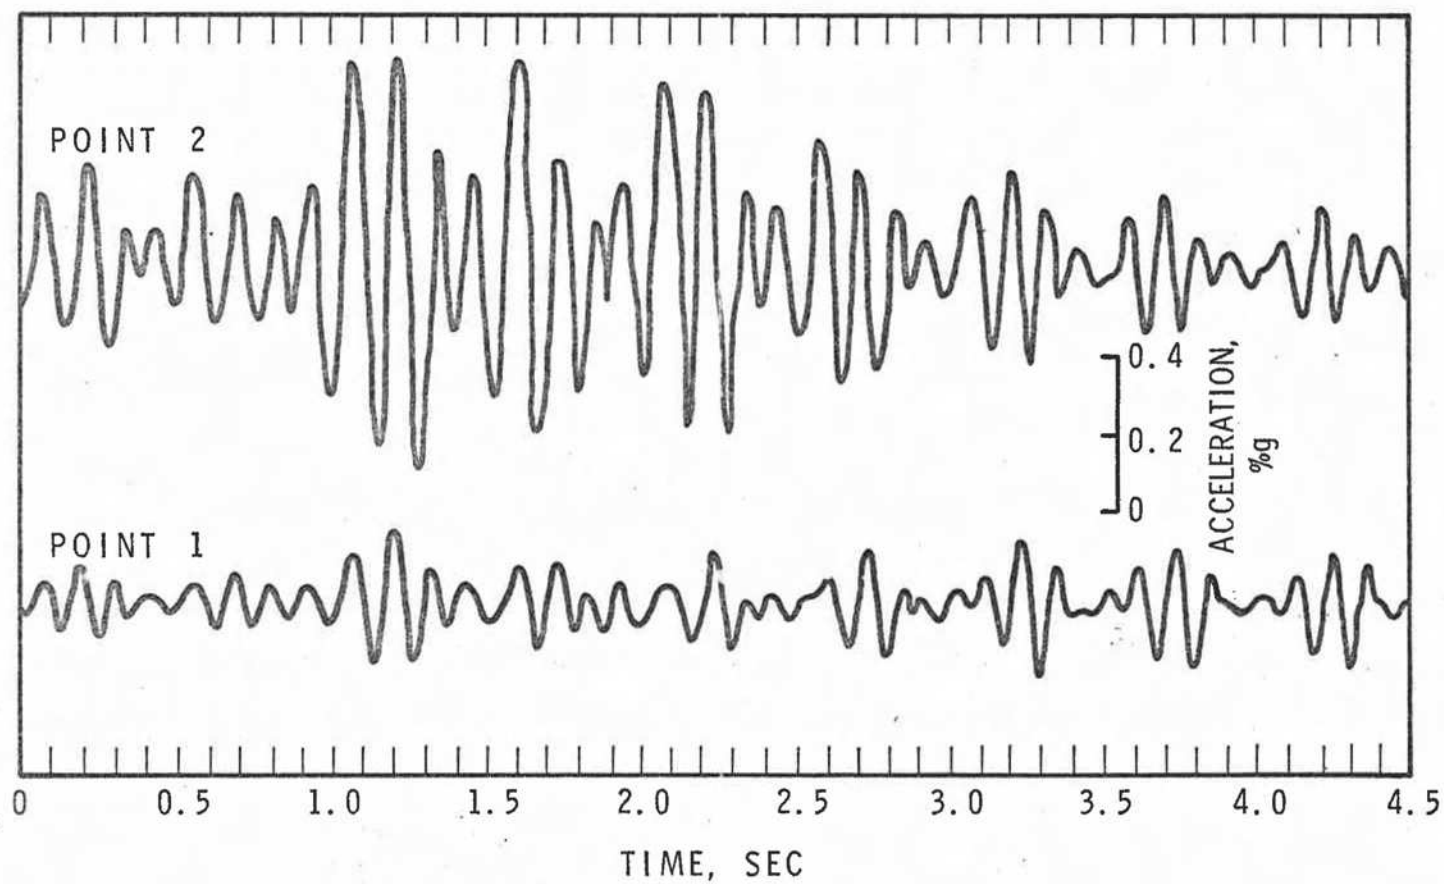
FIGURE 9

Figure 9 shows the vibration records at points 1 and 2, as a result of a person walking down the floor (perpendicular to joists) between points 1 and A with a temporary pipe column under point 1. The peak accelerations over the support are seen to be approximately 0.0015 g, whereas at point 2 they reach 0.005 g. Figure 10 shows vibration records at points 1 and 4 due to similar walking disturbance. The peak amplitudes at point 4 reach approximately 0.005 g. From both the traces in Figure 10 the frequency of vibration of the joist with the support at point 1 can be seen to be approximately 8 - 9 Hz, whereas from Figure 9 the frequency of the unsupported joist under point 2 is seen to be near 6 - 7 Hz.

VIBRATIONS FROM PERSON WALKING NORMAL TO JOISTS. SUPPORT UNDER POINT 1

The results of the temporary remedial posts show that the amplitudes of acceleration due to walking are decreased considerably near the point of support, but not elsewhere. If, however, temporary posts were placed near mid-span and on a more solid support, the amplitudes of motion all along the supported joist would be decreased considerably. Furthermore, since the frequency of vibration of the supported joist has been raised, the disturbance has been moved from the range of highest human sensitivity located in the 3 to 6 Hz range. (Reference 1, Figs. 44-8, 9, and 10.) Finally, the uniform vibration pattern of the floor system has been broken up into components having higher resonance frequencies. In terms of human perception this may have a beneficial effect.

If the insertion of the posts at every third joist from the second floor to the main floor slab is not entirely satisfactory, the floor between the stiffened joists could then be further stiffened by insertion of cross bracing along the line joining the posts. This may become necessary if the slab cracks longitudinally over the supported joists.

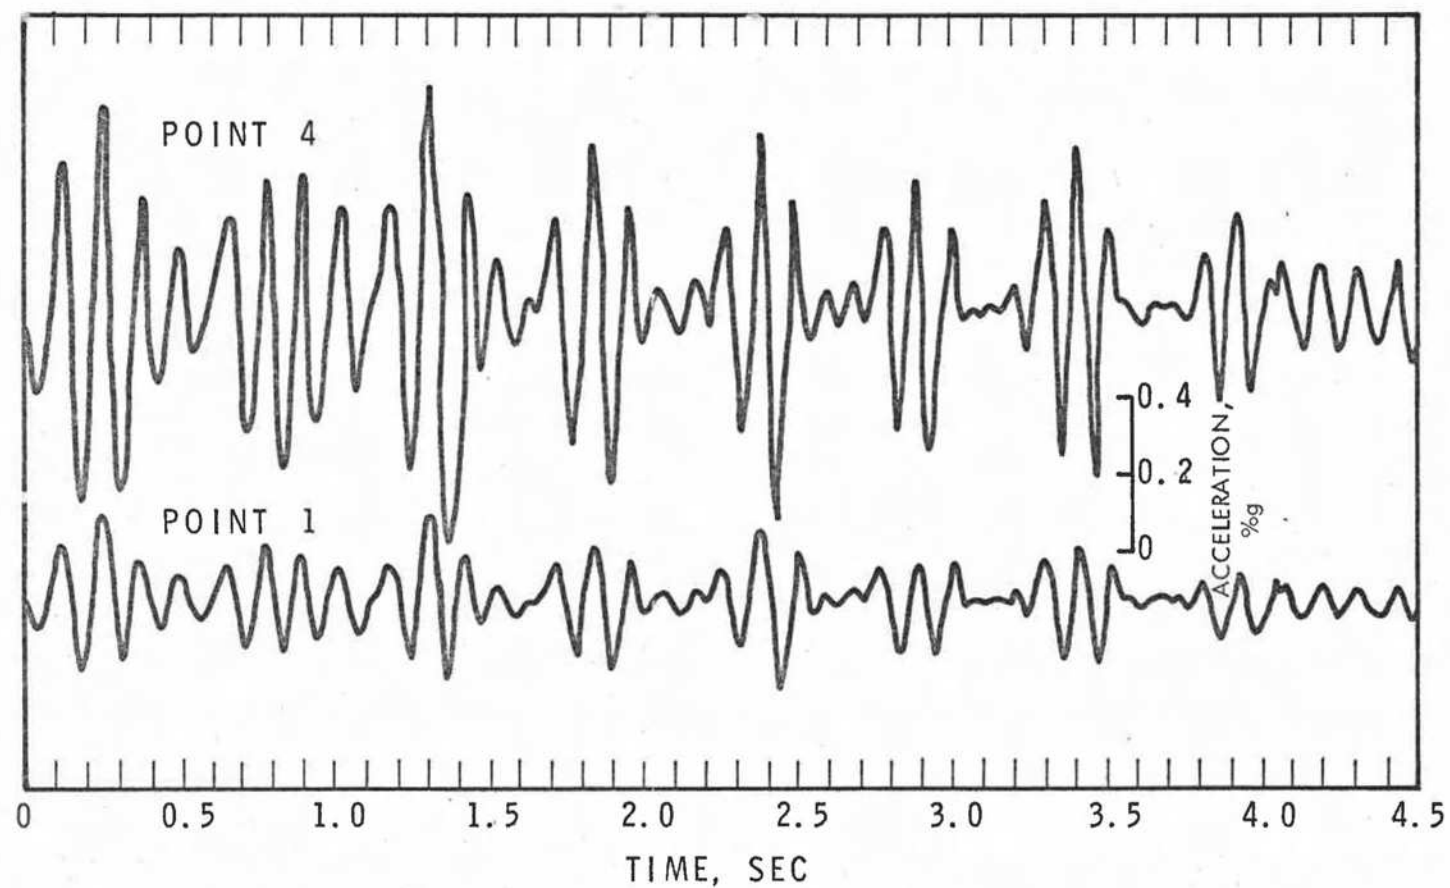
FIGURE 10

VIBRATIONS FROM PERSON WALKING NORMAL TO JOISTS. SUPPORT UNDER POINT 1
