The facts and the lessons of Listowel: a study of the factors relating to the collapse of Listowel arena and the lessons to be drawn from the tragedy in the interests of public safety

Canadian Consulting Engineer, 2, 5, pp. 36-47, 1960-05-01

The Collapse of the Listowel Arena

Technical Paper No. 97
of the
Division of Building Research

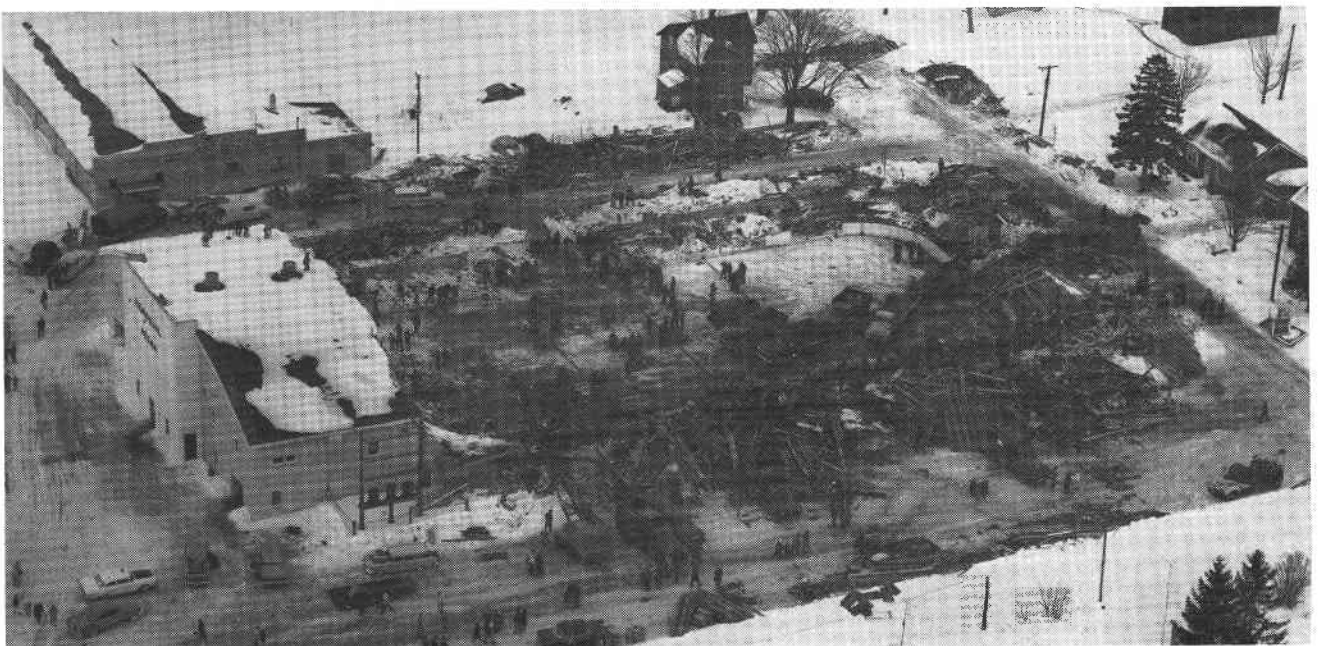
Fig. 1. An aerial picture of Listowel arena shortly after the roof collapse

On Saturday, February 28, 1959 about 9 a.m., a peewee hockey game got under way in the Listowel, Ont. Arena. Suddenly, at 9.27 a.m., without any immediate warning, the roof and the walls of the rink section of the arena collapsed with thundering noise. Seven boys and one adult were killed and thirteen boys were injured. Of those who were on the ice and in the players' box, only two climbed out of the debris unharmed. Only a small part of the arena remained standing, namely the entrance section at the western end which had interior partitions.

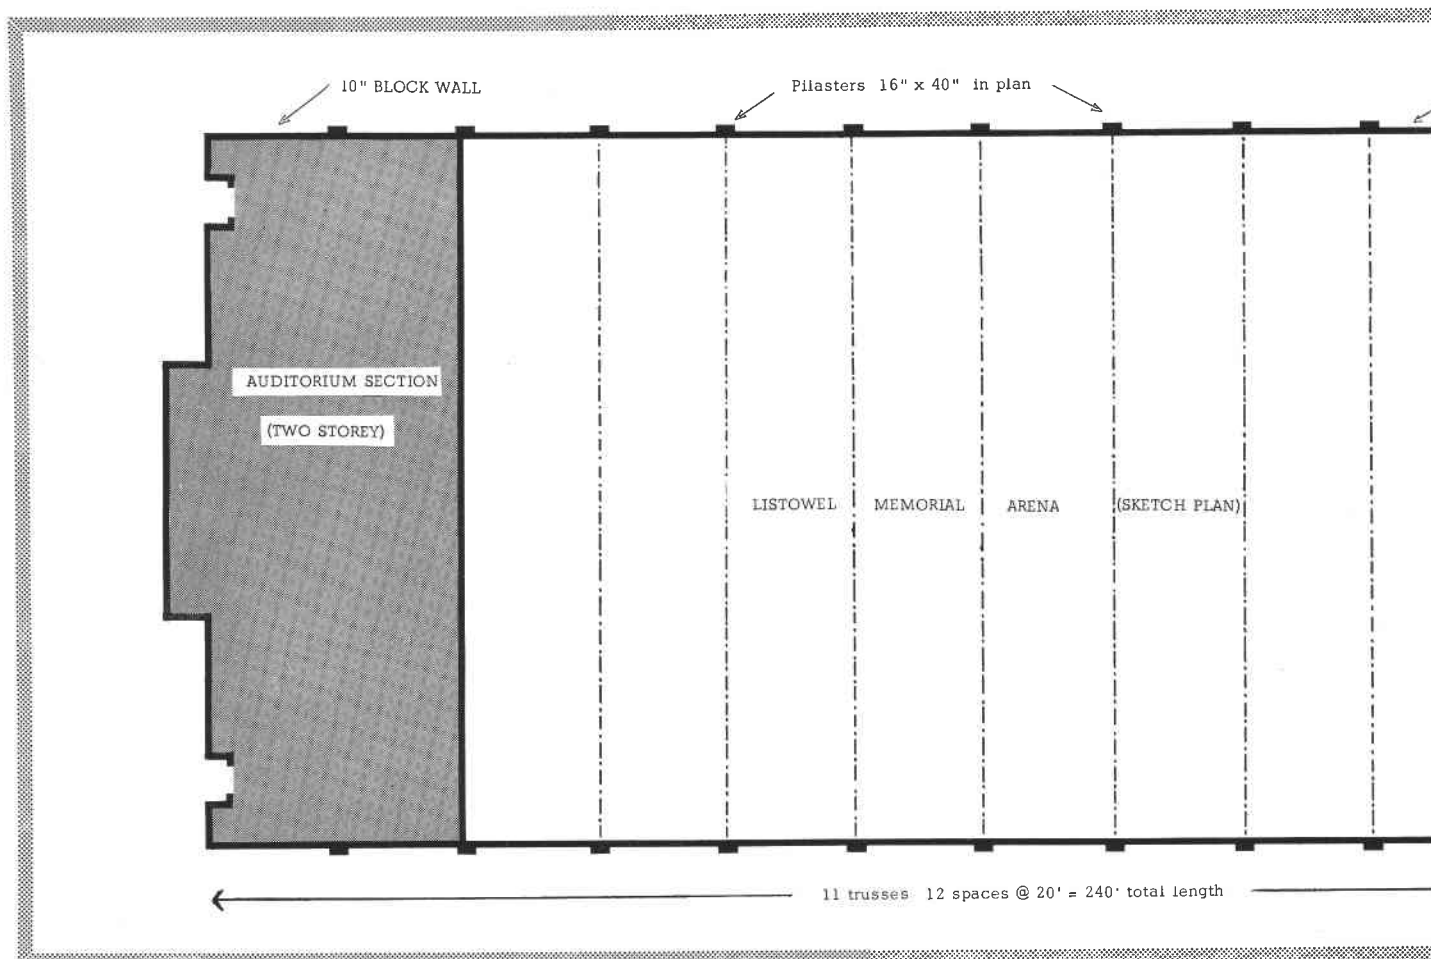
Figure 2 shows a plan view of the building and an elevation of one of the roof trusses. The building was 110 ft. wide and 240 ft. long. The portion of the building over the ice was 200 ft. long and 20 ft. high at the eaves. The remainder of the building, 40' x 110', was two storeys high and housed dressing-rooms, entrance lobbies, services and an as-

Fig. 2. Plan view of the building and an elevation of one of the roof trusses

been supplied but that only 11 were installed. Originally it was planned that the trusses were to be spaced 16 ft. apart thus having 15 spaces in the 240 ft. length of the building. This layout would have required 14 trusses. Later it was decided to use twelve 20 ft. bays for the 240 ft. length. This arrangement required only 11 trusses. This is a perfectly reasonable revision in layout and there is good reason to believe that the trusses were designed for the wider (20 ft.) spacing.

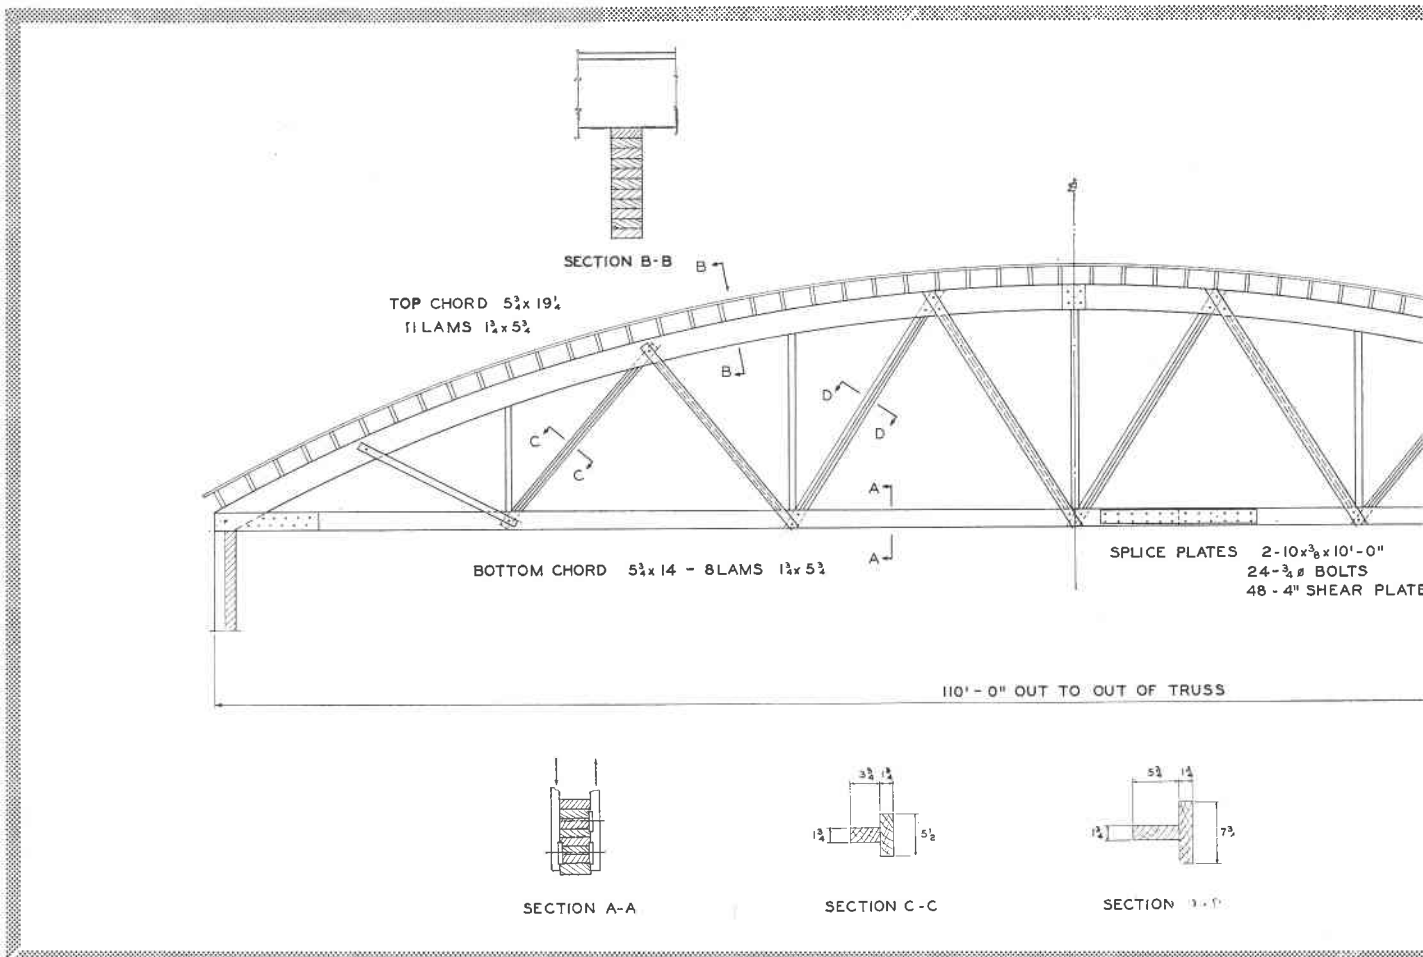
(5) An unsymmetrical distribution of snow load may occur and this condition must also be considered in the design of the truss members. Each diagonal web-member shown on the design drawing and used in these trusses was connected to one face only of each chord. This arrangement is undesirable because the effect of forces in the web-members connected eccentrically is to apply a torque to the chord and, as a consequence, to cause serious second-

ary stresses. This eccentric joint arrangement is shown in Sect. A-A of Fig. 3.

(3) The truss chords as shown on the designer's drawing would not have been overstressed by a symmetrical snow load of 40 psf. but would have been seriously overstressed by a snow load of 60 psf. The web-members, particularly because of the eccentricity of the end connections, were undesirable for the pronounced unsymmetrical loading which should have been anticipated and which did occur.

Fig. 3. A drawing of one of the trusses as originally designed

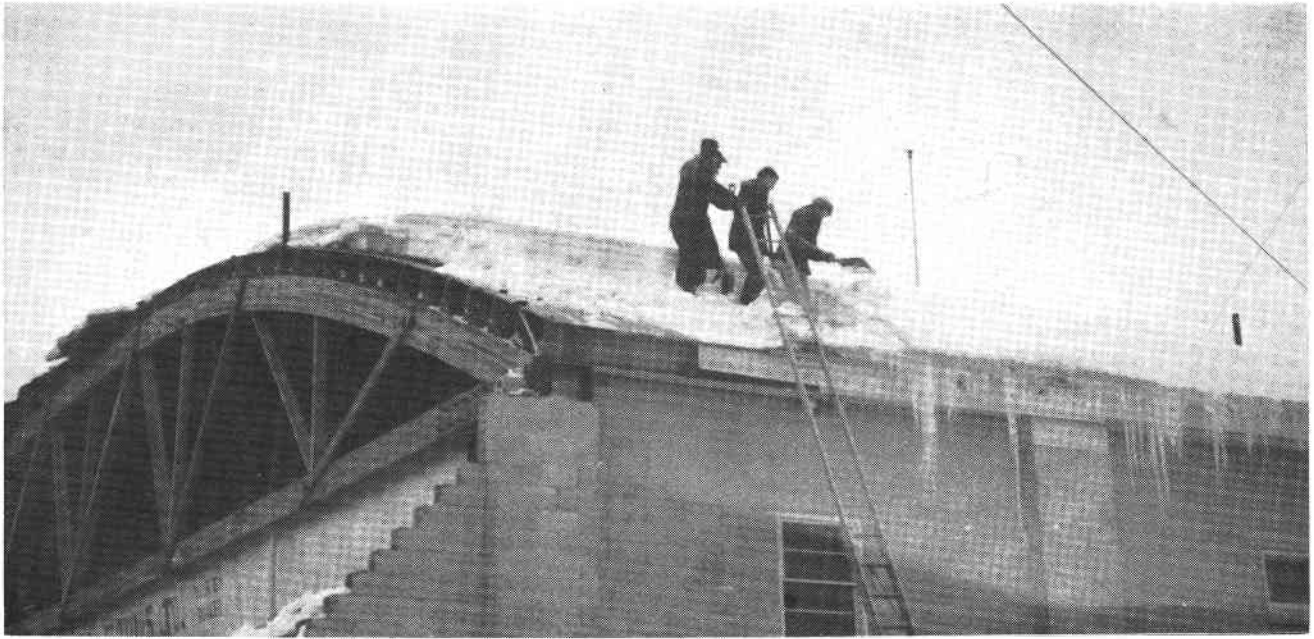
As was already mentioned, the snow had accumulated to considerable depth along the north edge of the roof early in the winter, and it was along this edge that some snow was removed on January 7 by a group of four people who used a length of barbed wire to saw off the overhang of snow. From the statements of these people, it appeared that the snow was approximately 4½' deep at the eave, tapering to practically zero at the peak, and also that the depth of snow was approximately the same along the entire length of the roof. One of the witnesses stated that the snow was removed from the eave to a point approximately 20' back where the snow left was about 2½' deep. No snow was removed, however, after January 7.

Fig. 4. Snow condition on north side of roof over Auditorium section of the arena shortly after the collapse. Photo by courtesy M. Rice, Listowel
