Research Paper No. 501
of the
Division of Building Research

Weathering Study of Glass-Fiber Reinforced Polyester Sheets by Scanning Electron Microscopy

A. BLAGA

*Division of Building Research
National Research Council of Canada
Ottawa, Canada*

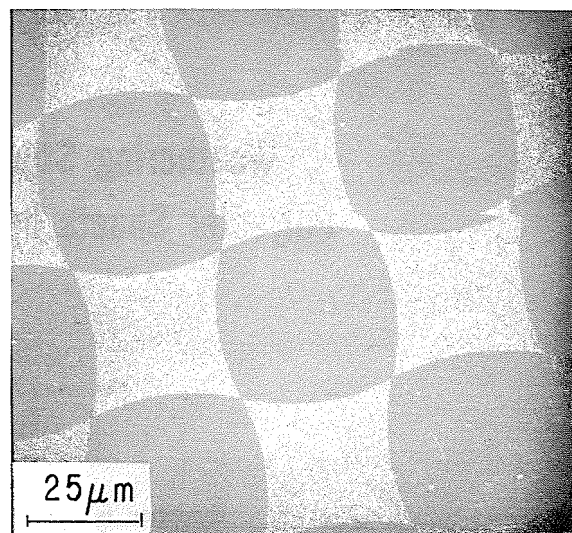
Fig. 1. GRP sheet. Control.

A number of selected scanning electron micrographs (Figs. 1-12) are presented to illustrate the processes and features of the physical breakdown of GRP sheets under outdoor weathering conditions in a temperate northern climate. *Figure 1* shows the surface microtopography of the control sample; the surface appears homogeneous and intact. *Figure 2* shows the exposed surface of a specimen weathered for 16 months. The micrograph reveals some pitting and particles lying on the surface; ridges can also be detected on the fiber. This fiber ridging may indicate incipient debonding of the fiber, with subsequent occlusion of air. The debonding is believed to be initiated by swelling of the matrix resin caused by absorption and chemical action of water. In their studies on the glass-resin bond, James and coworkers (14) indicated that this can take place.

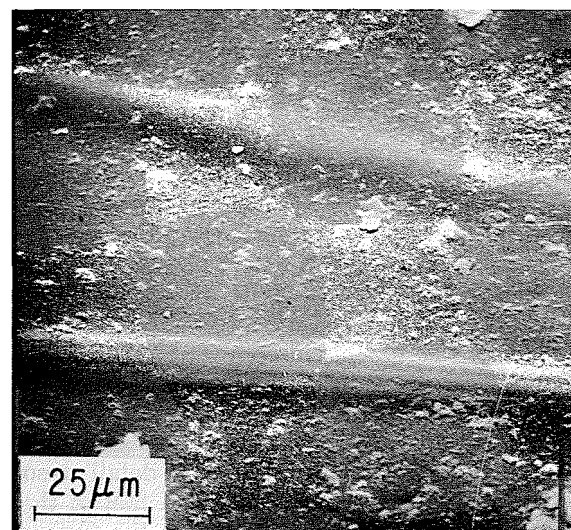
Fig. 3. GRP sheet weathered for 29 months.

Dimensional changes due to temperature variations may also be a contributing factor. The surfaces of samples weathered for 29 months are shown in Figs. 3-6. The micrographs reveal extensive littering of the surface with various particles and debris of

what is probably resin material. At this stage the ridging of fibers is much more evident (Fig. 3). Figures 4-6 display a sequence of events of great significance in the physical breakdown of GRP sheeting. These events result in the most common failure in glass-fiber reinforced plastics, the so-called "fiber prominence" (Fig. 6).

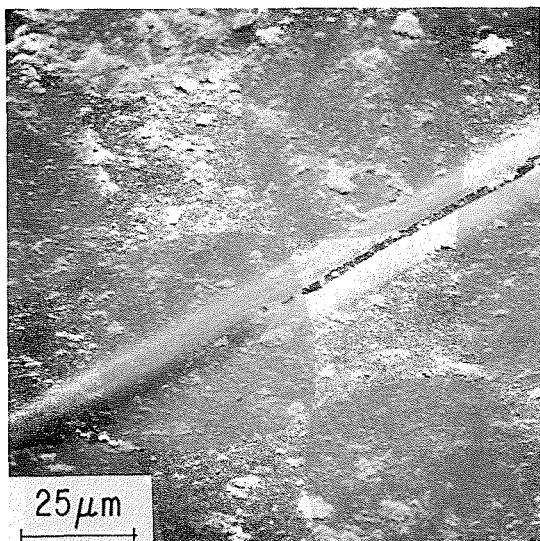
Fig. 4. GRP sheet weathered for 29 months.

This failure is produced by a complex process of erosion that results from the interaction of the composite with the physical and chemical agents operating in the environment. The main environmental forces exerting a type of stress fatigue on the composite are the cyclic variations of temperature and humidity. The coefficient of thermal expansion of resin ($70-100 \times 10^{-6}/^{\circ}\text{C}$) is considerably greater than that of E-glass ($4.9 \times 10^{-6}/^{\circ}\text{C}$), so that resin expands and contracts to a greater extent. This produces relatively large, localized stresses at the glass-resin interface. Stresses may also be produced by differential cyclic swelling and shrinking of the resin and glass because of changes in moisture content within the composite. The point of initiation of damage is generally at the glass-resin interface where these localized repetitive stresses are operating during outdoor weathering; in combination with the chemical action of water, these stresses probably cause the destruction of the glass-resin bond (debonding of the ridging glass-fiber, Fig. 3). The next step is microscopic rupture of the resin layer surrounding the ridging fiber or that covering fibers running close to the surface (Figs. 4, 5). It is postulated that it is caused by stress fatigue. Hydrolytic scission of a high proportion of ester linkages in the resin, however, or even ultraviolet light initiated cleavage of covalent bonds may also occur and contribute to rupture.

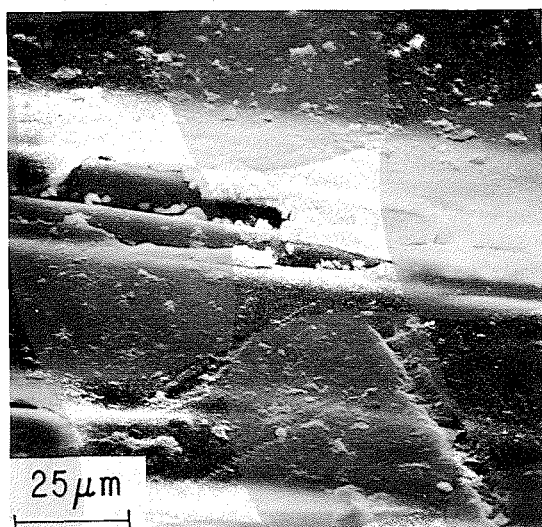
Fig. 5. GRP sheet weathered for 29 months.

As weathering progresses, localized spalling of the resin at the site of the failure takes place (Fig. 5). A contributing factor may be frost action, where the water present in voids or cavities formed by the above process freezes, expands, and mechanically disrupts the plastic component. As the ice melts and the resulting water eventually evaporates, it leaves bigger voids that make ingress of water easier, so that rate of damage increases with time. The chips or debris of resin produced by the action of these factors are carried away by wind and rainwater, although some microscopic debris or particles adhere to the surface of the weathered sheets. As will be seen, they play a role in the subsequent phase of the physical breakdown of the composite. Particles or debris are visible in most of the electron micrographs of the weathered surfaces.

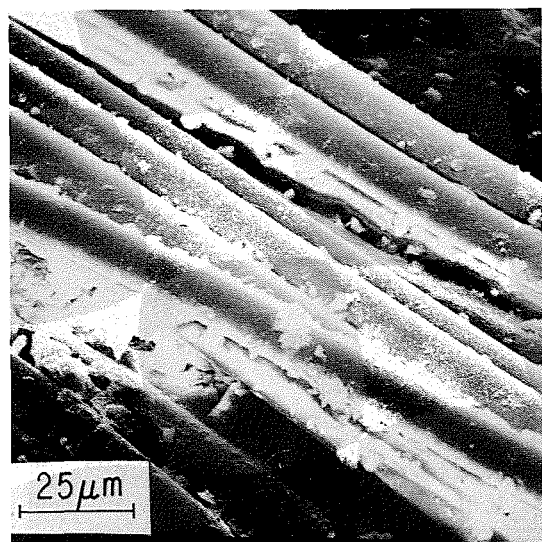
Fig. 6. GRP sheet weathered for 29 months.

The strands of fibers shown in Fig. 6 are still held together and partly attached to their resin bed, although some filaments appear to be free of resin over most of their surface. As erosion progresses, the individual filaments become completely denuded and separate, lying free above the surface except for the end still embedded in the matrix (Fig. 10). Figure 7 shows a fiber cross-over in a surface weathered for 47 months. The bed, or "clear mold"

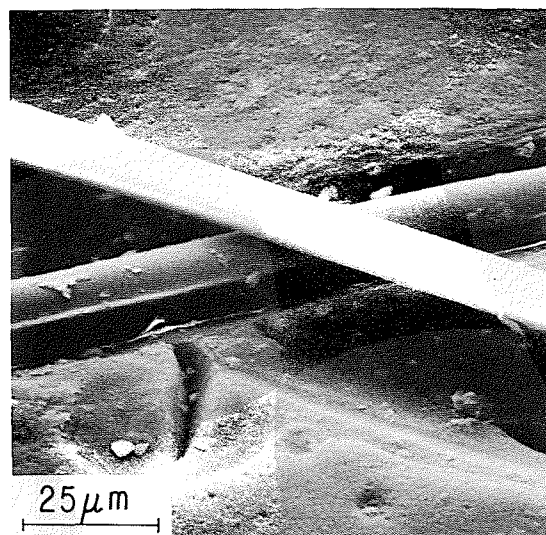
Fig. 7. GRP sheet weathered for 47 months.

as it is called in fracture mechanics of composites (12), has flattened and its walls have been eroded away. The severity of the fiber prominence will increase with weathering time. The scattered fibers and voids diffuse the light instead of transmitting or reflecting it, giving an opaque appearance to the originally translucent sheet. In its advanced stages fiber prominence makes the GRP sheet unsightly, so that the material fails to meet one of its use requirements. If fiber prominence is very severe, it will also have a dramatic effect on mechanical properties.

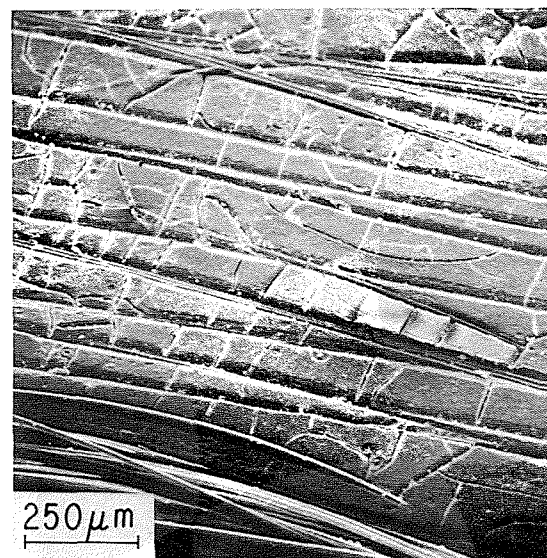
Fig. 8. GRP sheet weathered for 47 months.

Figures 8-11 illustrate, with different degrees of magnification, another type of failure occurring in GRP sheets during outdoor weathering. The surface of these samples shows a network of microscopic cracks. The severity of microcracking increases with weathering time, as shown by samples weathered for 62 months (Figs. 10 and 11).

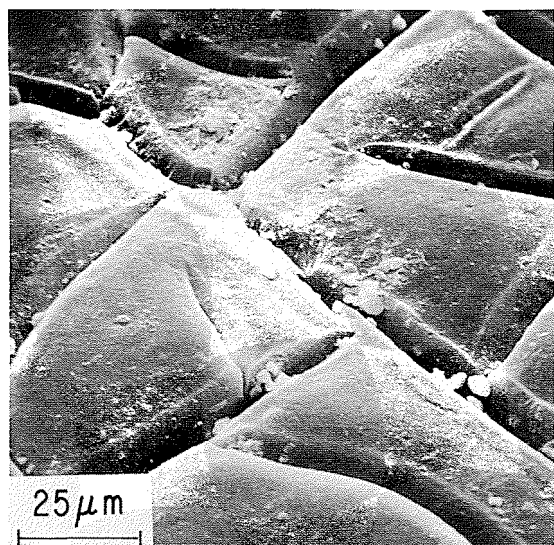
Fig. 11. GRP sheet weathered for 62 months.

The network of microscopic cracks divides the surface into small, mostly four-sided areas of varying size; the size of these four-sided areas decreases as weathering time increases, indicating that the areas split to form new cracks (Fig. 11). The surfaces of the areas show considerable defects such as round holes, depressions (former sites of departed particles), shallow cavities, blisters, microscopic particles of resin or impurities adhering to the surface or completely fused to it, and various other non-homogeneities. The microcracks are almost completely empty (Figs. 9 and 11), containing only occasional minute particles of matter. While earlier workers (1-4, 15) sometimes referred to microcracks as crazes, they have none of the features of crazes as the latter term is currently understood (16, 17), i.e. sharply bound areas of oriented material mechanically continuous with the surrounding bulk polymer.

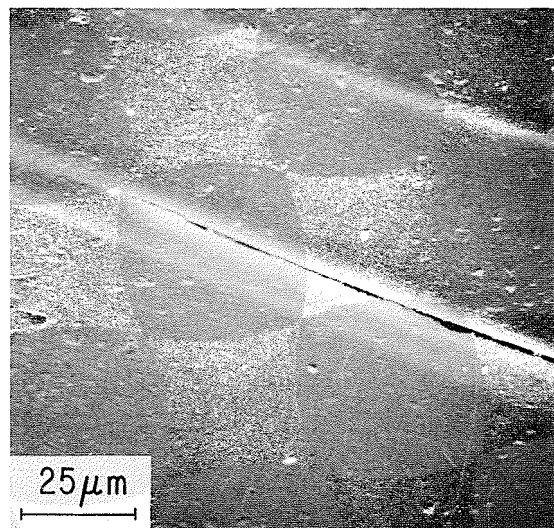
Fig. 12. The under side of GRP weathered for 62 months.

Examination of the under side (the unexposed surface) of GRP sheeting revealed little damage even after 62 months of weathering (Fig. 12). Some fiber ridging and rupture of the resin layers above the fibers close to the surface were detected, as were pitting, resin debris, and various particles adhering to the surface. The under side had not been subjected to the direct action of solar radiation, so that photolytic or photo-oxidative action was almost absent and thermal effects (caused by infrared radiation) were considerably reduced. This indicates that solar radiation is important in the physical breakdown of GRP sheets on weathering. The thermal effects have a dual role. First, they affect dimensional changes of the material; this may occur in the presence or absence of moisture. Second, they control the kinetics of the various chemical reactions that the material may undergo. It is thus understandable that the surface of the under side shows only signs of incipient breakdown.
