FIRE INVESTIGATIONS BY THE FIRE
SECTION, 1956

G.W. Shorter and C.G. Burnett

Report No. 140
of the
Division of Building Research

Ottawa
March 1958

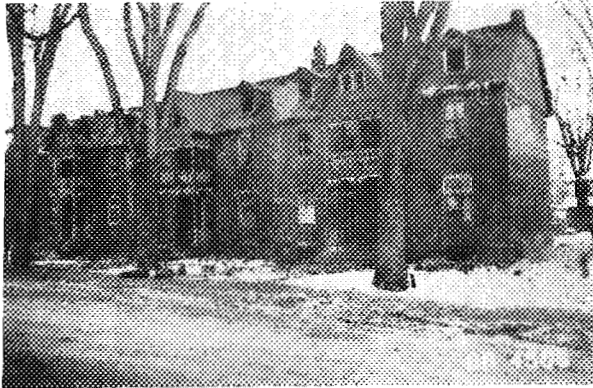
GENERAL. - The brick veneer six-door tenement accommodated approximately fifty people most of whom were in residence at the time of the fire. The fire is believed to have started in the south end of the building on the third floor (Fig. 1) but a definite cause could not be determined. The fire was discovered by an occupant who noticed that the temperature was becoming abnormally high in the building.

Fig. 1. View of six-door row;
fire originated on the
third floor.

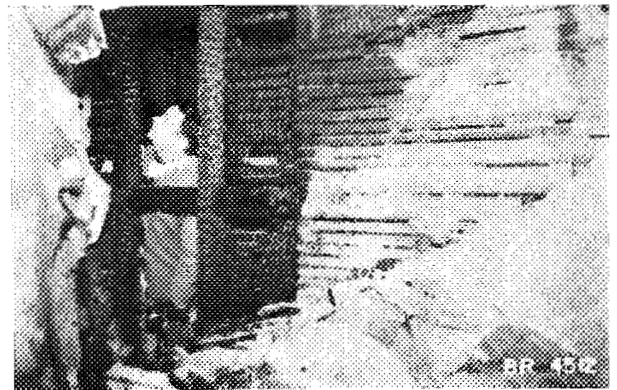
SPREAD OF FIRE. - The fire was believed to have started on the third floor level (Fig. 2) extending to the space under the roof and in the walls to the second floor (Fig. 3).

Fig. 2. Member of Fire Section
examining open wall
space.

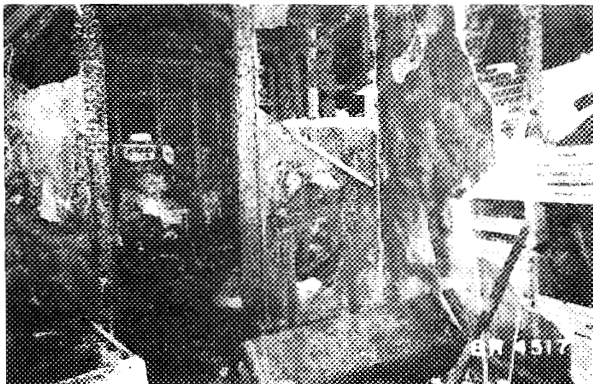
Fig. 3. View showing how fire
spread through rooms on
third floor.

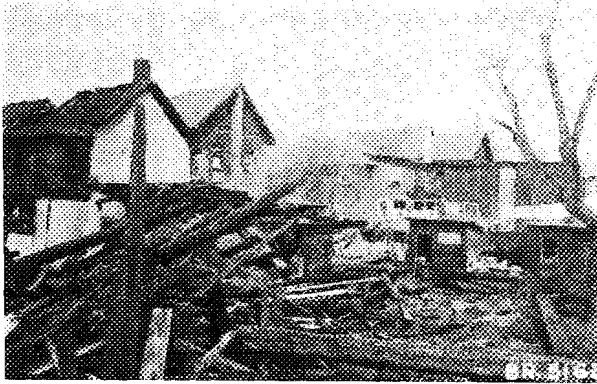
Fig. 4. Remains of wood frame warehouse. Note number of wood shingle roofs involved.

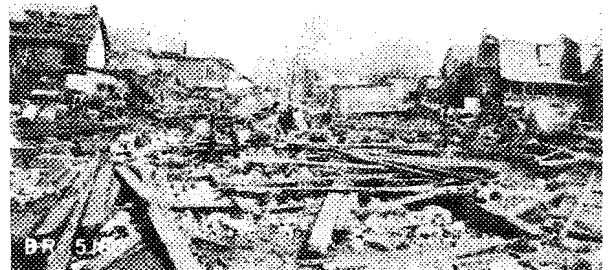
GENERAL. - At approximately 7.15 p.m. exploding firecrackers ignited a large wooden building formerly used as an ice-house and presently being used as a storage shed for machinery and equipment. The building was located in an area of wood construction with wood shingle roofs (Fig. 4). Heat radiation and flying embers ignited a number of roof tops threatening to spread the fire in the area (Fig. 5).

Fig. 5. View of wood frame construction in the area.

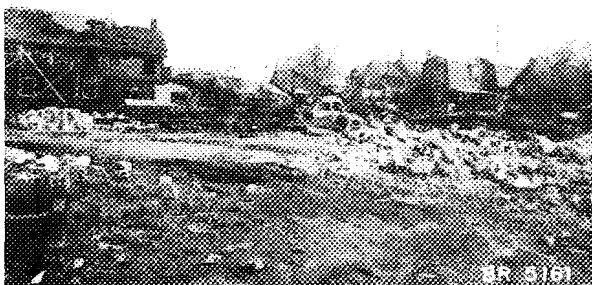
SPREAD OF FIRE. - The fire spread rapidly in the building of origin releasing flying brands that ignited the surrounding wood shingled roofs (Fig. 6).

Fig. 6. View of fire spread.

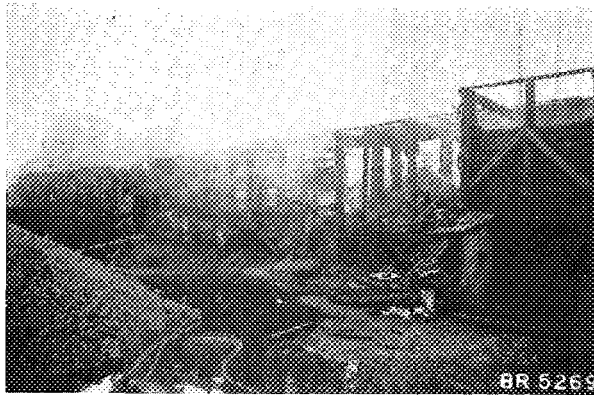
Fig. 7. Remains of coal dispersal chute after fire destroyed frame-covered section.

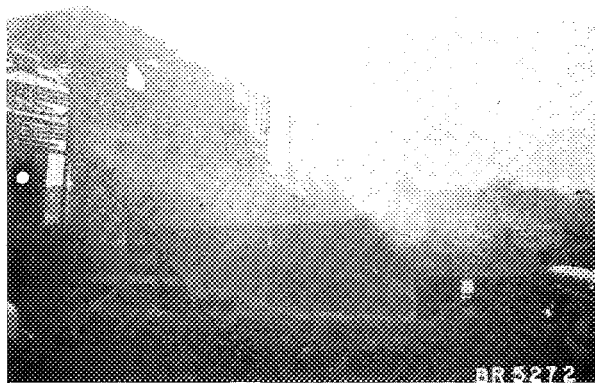
CONSTRUCTION. - The wood-frame coal-storage shed was 150 feet in length, 30 feet in width, and two storys in height. The flat and pitched roofs were sheathed with rolled roofing and large wood joists were used to support the dispersal chutes on the second floor (Fig. 8).

Fig. 8. View showing entrance to coal chutes, where coal remains burning.

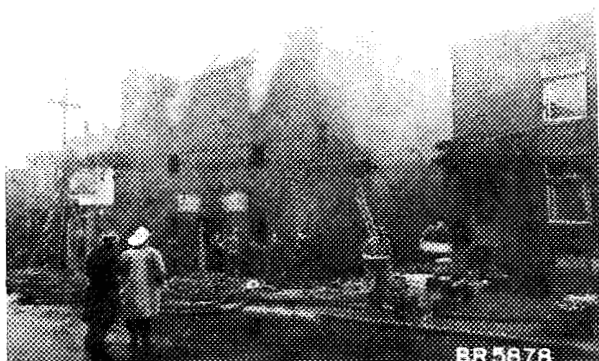
GENERAL. - This fire was discovered by a passer-by when smoke was noticed coming from the building. The building was formerly occupied as a theatre (Fig. 9) but was being used for furniture storage and contained a number of wood-constructed lockers in the basement and upper floors (Fig. 11). Due to the extensive damage, the cause of the fire was not determined. Dense clouds of smoke issued from the building and blanketed the surrounding area.

Fig. 9. Front view of converted theatre used for furniture storage.

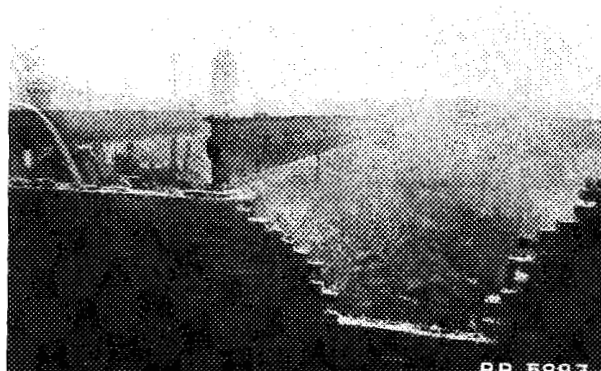
SPREAD OF FIRE. - The fire was confined to the building of origin. The collapse of the roof and north wall prevented entry to the building (Fig. 10).

Fig. 10. Roof collapse made entry difficult.

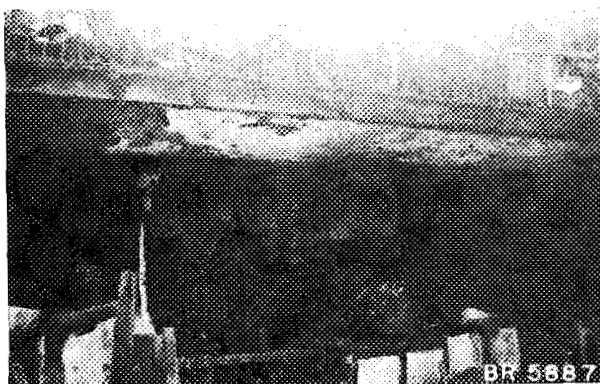
REMARKS. - This fire is a good example of what can occur when the occupancy of a building changes without proper alterations to the building structure (Fig. 11). This fire is believed to have originated spontaneously, although it was not possible to definitely establish the cause.

Fig. 11. View of interior of building showing furniture storage in wooden lockers.

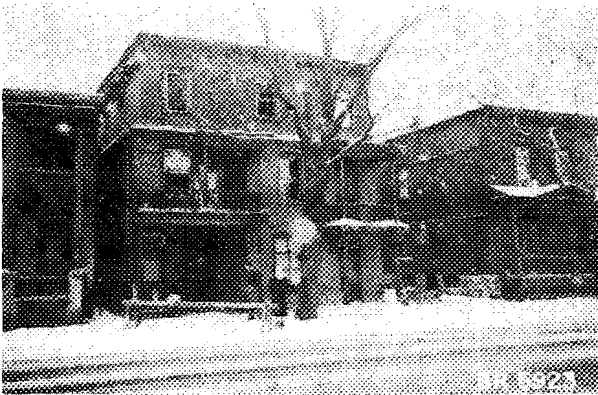
GENERAL. - Young children playing with matches in the third floor apartment of the building ignited comic books placed on the hot-air register. The fire advanced up the walls to the roof before being detected, causing considerable damage to the building and contents, and requiring many of the occupants to vacate their premises (Fig. 12).

Fig. 12. View of apartment dwelling. Fire involved the third floor.

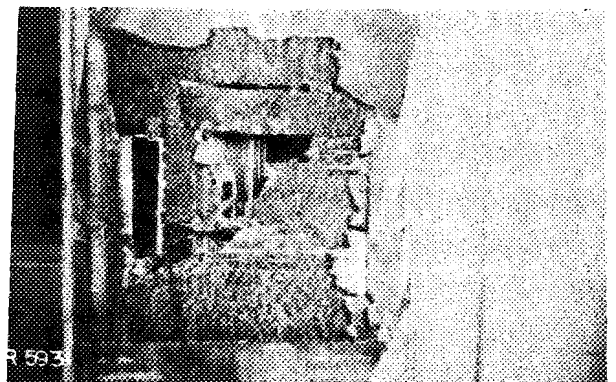
SPREAD OF FIRE. - Fire damage was mainly confined to the third floor where lack of fire stops in the walls permitted the fire to spread in a vertical direction (Fig. 13) to the open unused attic space under the roof (Fig. 14).

Fig. 13. Lack of fire stops permitted fire to spread.

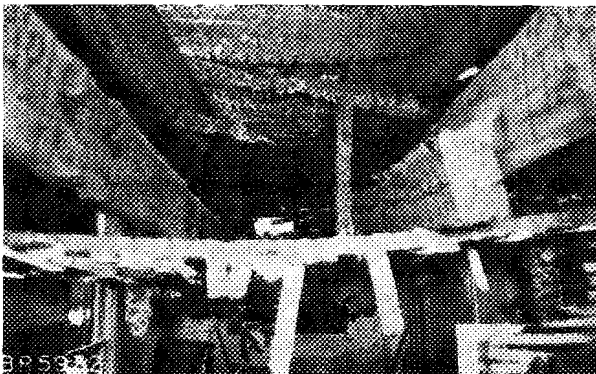
Fig. 14. View of attic space under roof where fire spread.

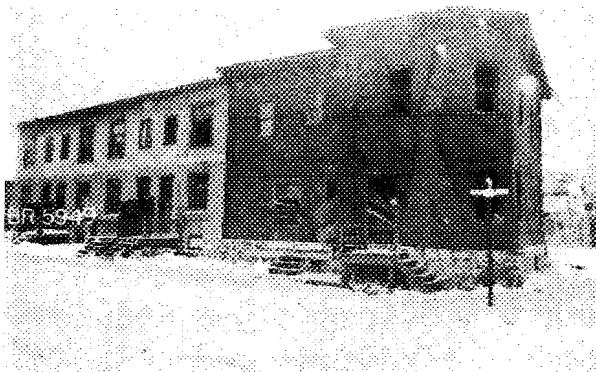
GENERAL. - Five of the dwellings in this six-door tenement row were vacant to provide for renovation of the building (Fig. 15). Fire was discovered burning in one of the vacant residences but its cause could not be determined. It was assumed that children playing in the building had been responsible.

Fig. 15. View of vacant row. Fire occurred in end dwelling

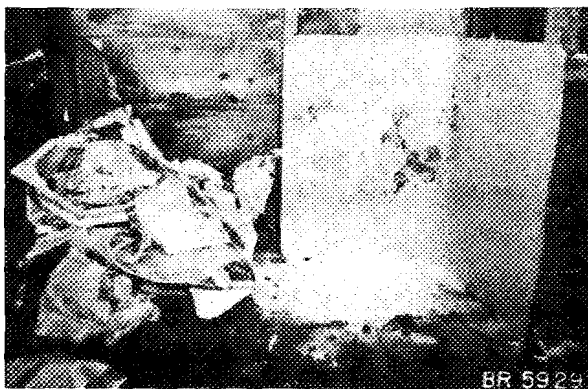
REMARKS. - Buildings, in which good housekeeping has been neglected and an accumulation of waste material is present, are a fire hazard when not protected (Fig. 16).

Fig. 16. Accumulation of rubbish creates a fire hazard.

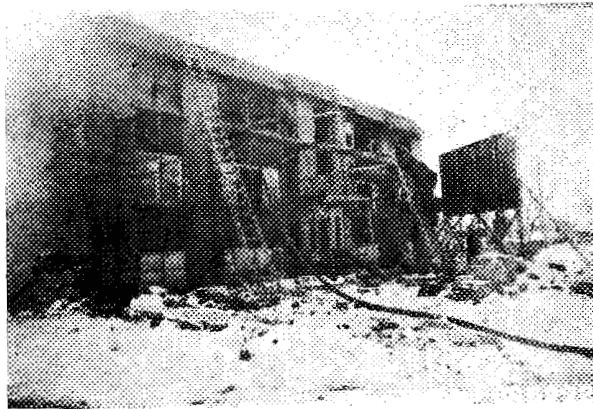
GENERAL. - This fire occurred in a six-unit apartment block while it was under construction (Fig. 17). The interior of the building was being prepared for plastering when an oil heater on a scaffold at the second-floor level ignited a tarpaulin. The fire spread rapidly in the unfinished wood construction and entered the unused attic space under the roof (Fig. 18).

Fig. 17. Front view of apartment (under construction).

REMARKS. - This instance, and many others, of fires occurring in incompleted buildings emphasizes the need for fire prevention regulations to be enforced during construction.

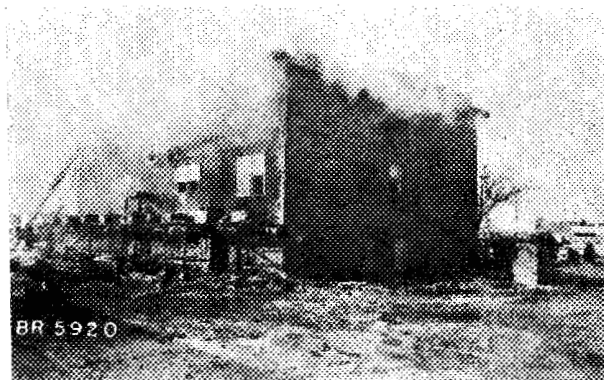
Fig. 18. Rear view of building. Fire involved the attic space.

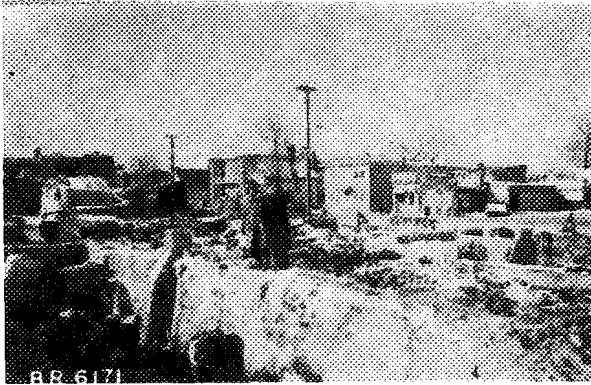
The fire was discovered burning at the rear of a three-story building on the northwest corner of Cousineau Street and Grand Ile Avenue (Fig. 19). On arrival of the fire department it was reported that the fire had made rapid progress in the building and immediate rescue operations were necessary from the apartments on the second and third floors. As the fire progressed, buildings to the north on Cousineau Street for a distance of 150 feet were ignited and destroyed by radiated heat and flying brands (Fig. 20). At the same time, the fire was advancing east on Grand Ile Avenue to involve two- and three-story buildings, the upper floors of which were apartments.

Fig. 19. Member of Fire Section and Fire Chief of Valleyfield inspect location where fire originated.

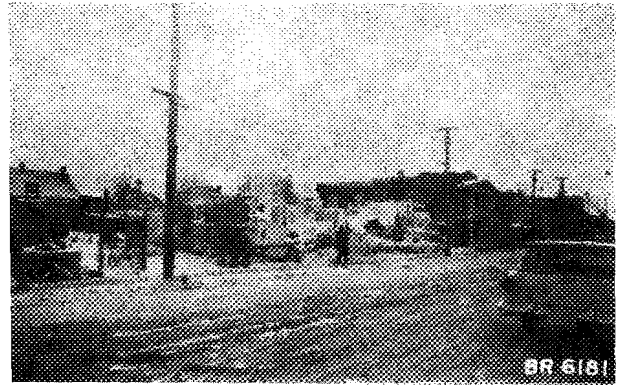
Fig. 20. View showing how fire spread in a northerly direction.

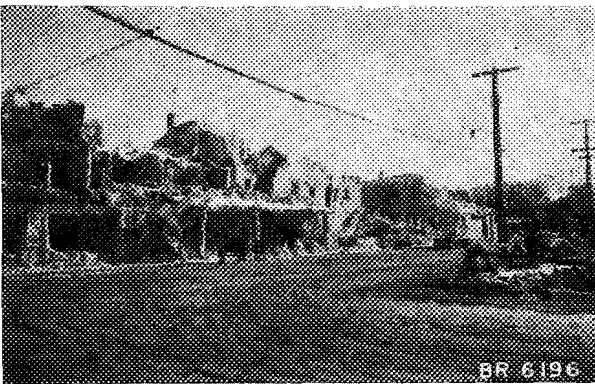
The fire became more intense as many of the buildings in the block on the north side of the street became involved in fire. Strong winds fanned the fire and flying brands ignited the frame buildings on the south side of the street opposite the fire (Fig. 21). The fire then spread rapidly in an eastern and western direction to destroy all the buildings in the block fronting on Grand Ile Avenue (Fig. 21) and was stopped at the laneway on Havre Blvd. (Fig. 22).

Fig. 21. Wood frame constructions opposite fire were also ignited.

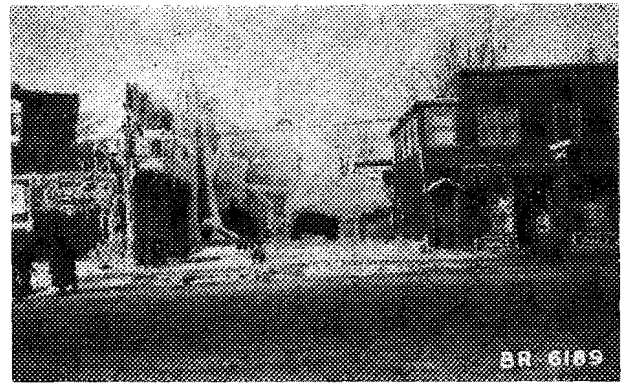
Fig. 22. Laneway provided fire-break in a westerly direction.

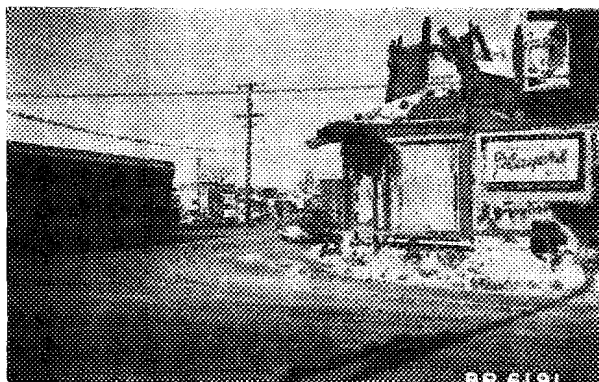
The fire was checked on the south side of the street at street intersections (Fig. 23). A masonry wall separated by a laneway prevented further spread of the fire in a westerly direction on the north side (Fig. 24). It was considered under control at 12 noon 30 December, after destroying or damaging eighteen business and residential buildings.

Fig. 23. Fire was checked at street intersections.

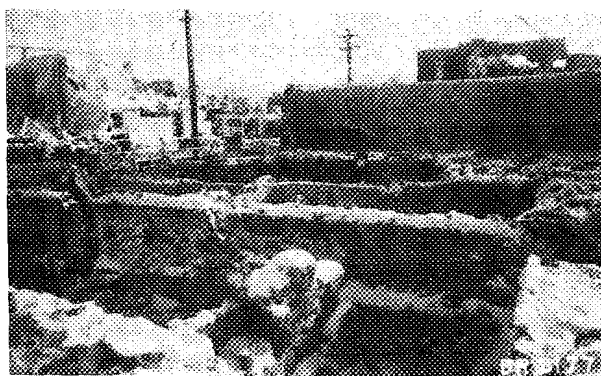
Fig. 24. Solid wall prevented further fire spread in a westerly direction.

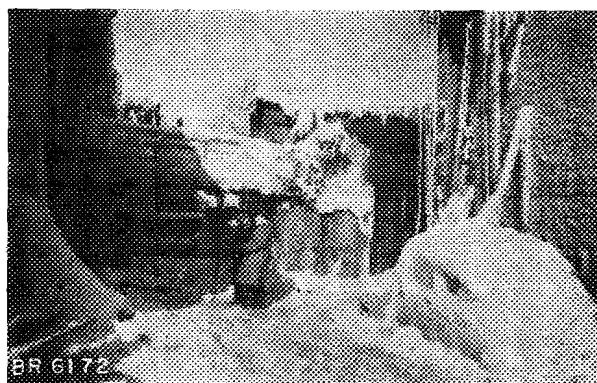
Fig. 25. Fire Chief and member of Fire Section inspect frame construction. Note evidence of climatic conditions.

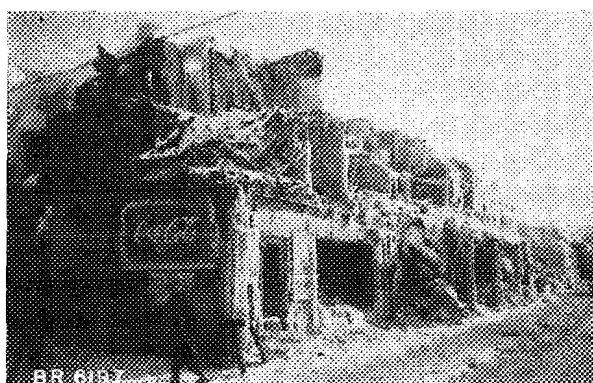
REMARKS. - This fire emphasizes the fact that structural conditions must be controlled by adequate building laws. It is obvious that standard fire walls, parapets and proper protection of exposed buildings would have aided materially in preventing the spread and bringing this fire under control. Conflagrations such as this are a result of unfavourable structural conditions and in many cases of inadequate fire-fighting facilities to cope with severe fire conditions (Fig. 26).

Fig. 26. Unseparated wood-frame construction permitted rapid fire spread.
