356

TECHNICAL NOTE

DATE January 1962

SUBJECT THIRD VISIT TO MARK II HOUSE, FOREST LAWN, ALBERTA

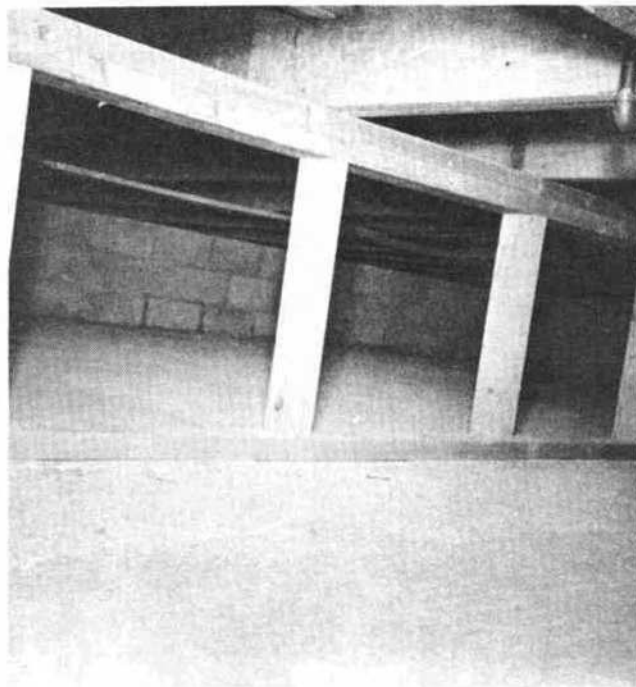
Examination of the crawl space indicated no significant change from previous visits in the condition of walls or footings. The slight displacement between the concrete floor and centre footing appeared to have remained constant (Fig. 1) and no cracks were evident in the slab. The dark areas at mortar joints, noted during the previous visits, were no longer evident.

Figure 1 Crawl space bearing partition

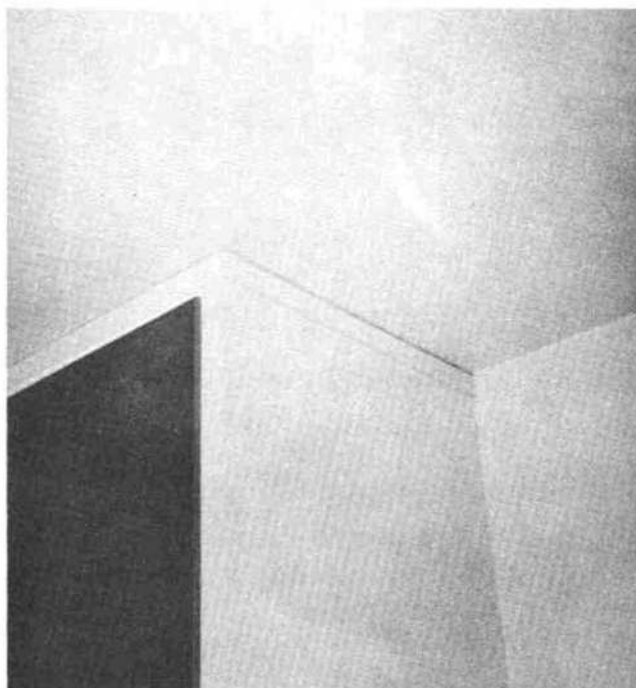
The separation between the top of the storage cabinet and the ceiling (Fig. 2), and between the base of the stub wall and the floor in the kitchen (Fig. 3) appeared to have remained the same or to have decreased somewhat. Gaps between the edges of plywood flooring were no more severe and surface checking of the painted plywood floor was no more pronounced.

Figure 2 Kitchen storage cabinet

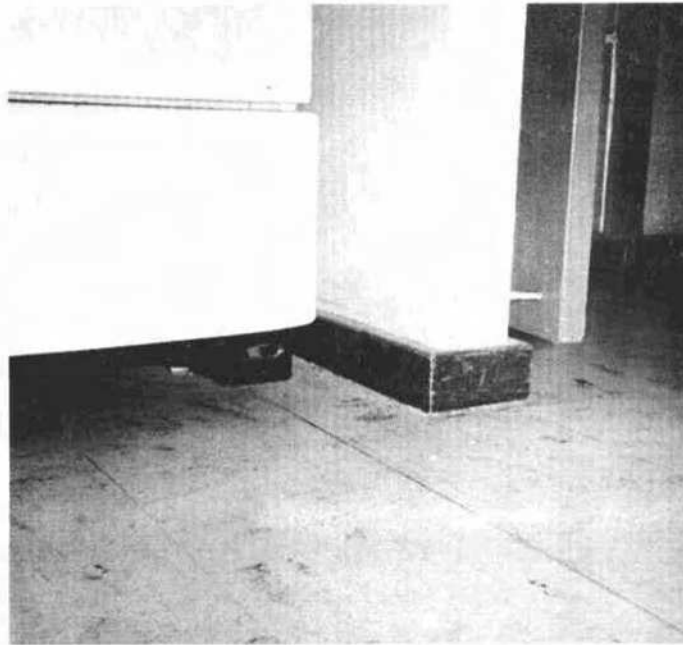
Figure 3 Stub wall in kitchen

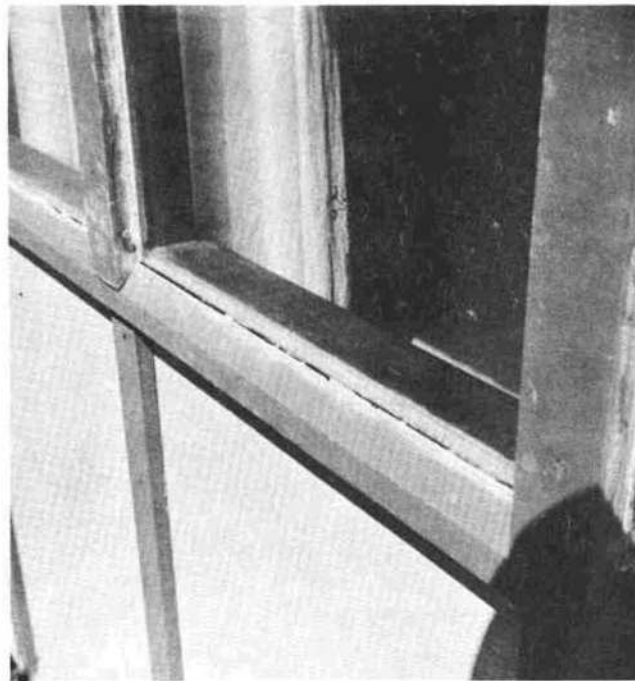
The caulking around the sealed double-glazed window units had become brittle and hard, providing very little protection against the entry of water behind the wood stops, particularly at the sill (Fig. 4). The occupant had recaulked some of the windows but expressed dissatisfaction with subsequent performance of the material.

Figure 4 Deterioration at sill of window

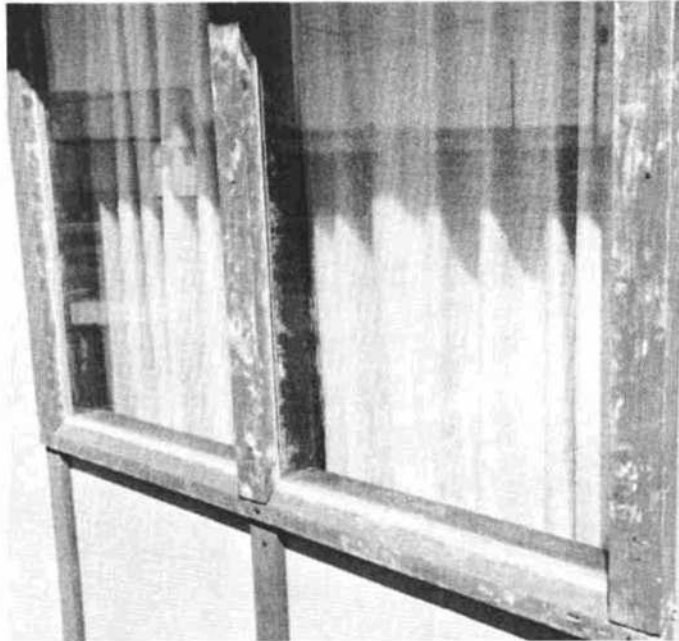
The occupant reported that some condensation had occurred within the sealed units during the winter, and had been particularly severe in the centre bedroom unit. Droplets of water were evident in this window at the time of visit, although difficult to see in the photograph (Fig. 5).

Figure 5 Centre bedroom window

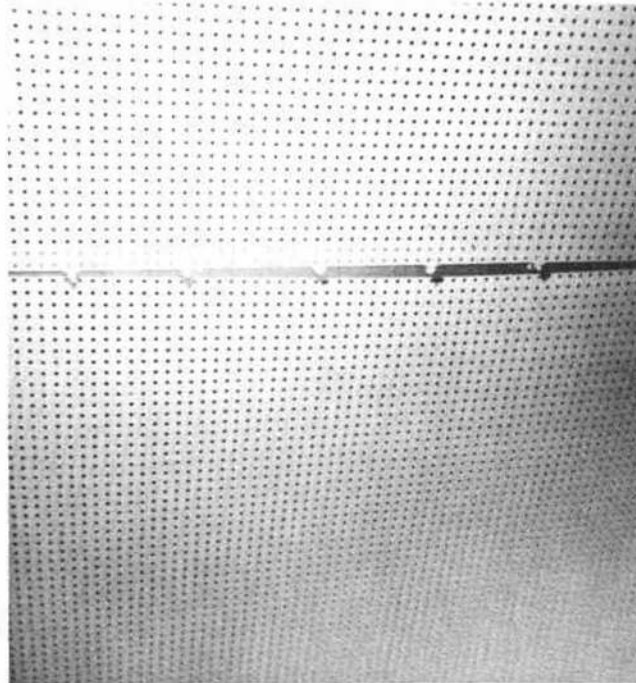
Failure at panel joints in the perforated hardboard had occurred at almost all locations with the ends of boards sagging in many places (Figs. 6 and 7). This appeared to be due to excessive shrinkage of the hardboard causing failure of the board in tension at nails. It clearly indicated the need for some simple means to allow for expansion and contraction when employing this type of material.

Figure 6 Joint failure in hardboard soffit

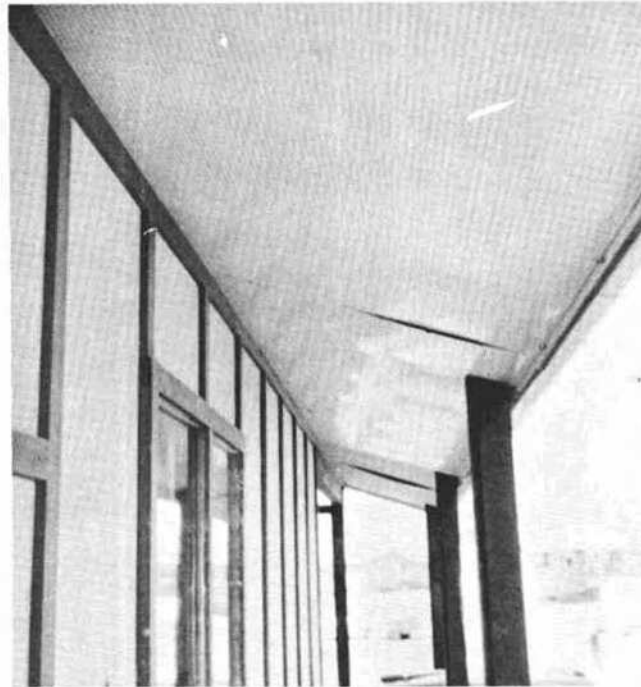
Figure 7 Failure at joints in hardboard soffit

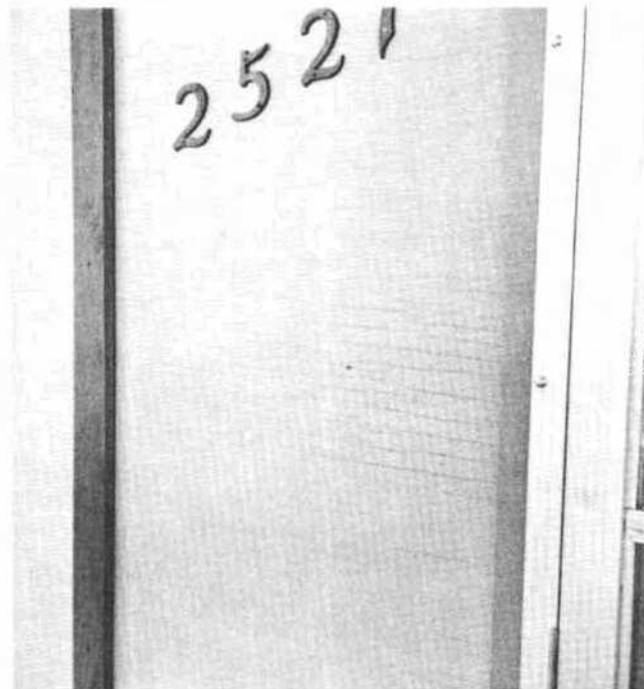
Checking of the plywood exterior finish had become more severe (Figs. 8, 9) and delamination was evident in some areas (Fig. 10). Checking of the plywood was general, however, and not particularly confined to one exposure. Painting or restaining of the house was being considered by the occupant.

Figure 8 Checking of plywood exterior (east wall)

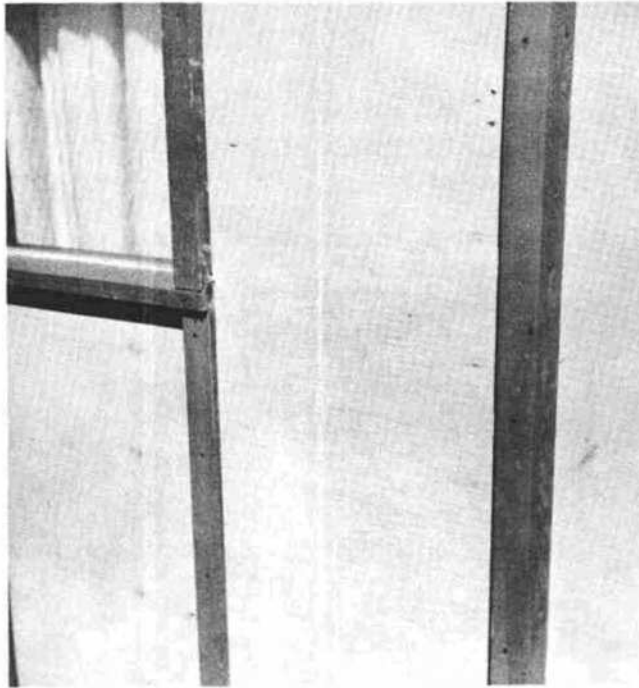
Figure 9 Checking of plywood exterior (s.w. corner)

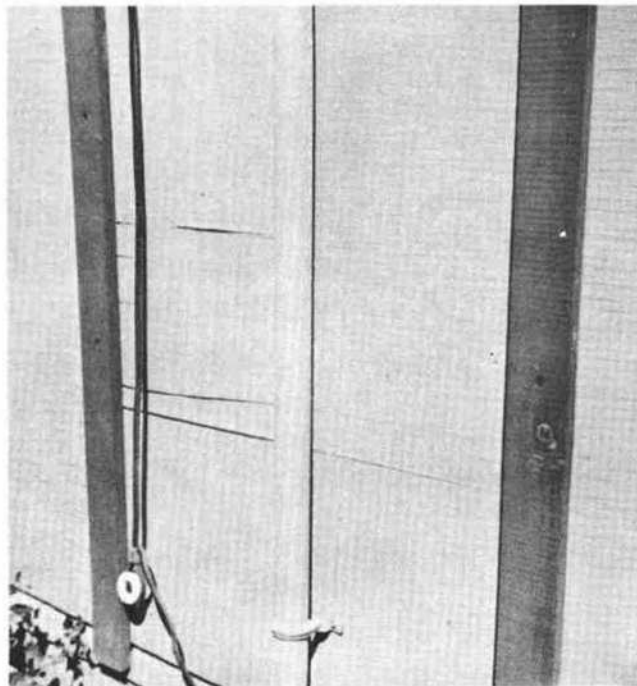
Figure 10 Checking and delamination of plywood exterior
(west wall)

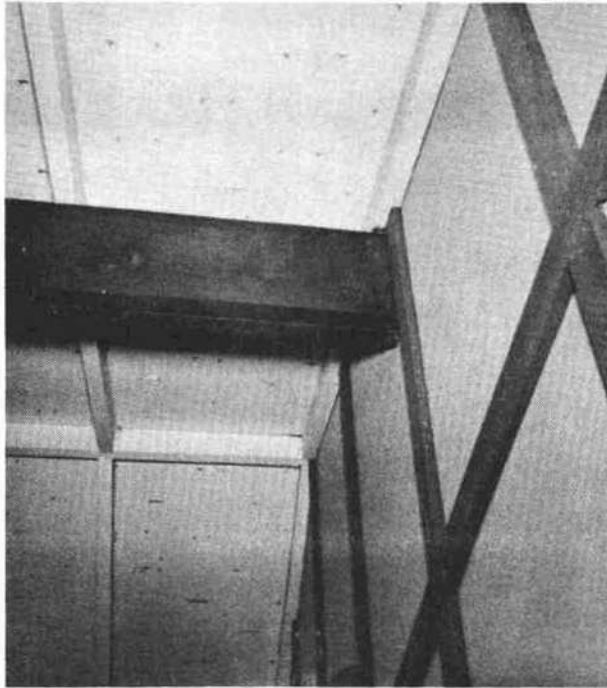
A slight sag toward the extremity of the carport roof ridge was observed. On further examination it appeared to be due to shrinkage and twisting of the supporting beams rather than to any foundation movement. Shrinkage of the ridge beam was evident at the junction of the wall of the house (Fig. 11) where an unpainted area of the rafter was exposed. The outer ends of the two mid-span beams showed that twisting had occurred in a manner which tended to spread the outer rafters and resulted in a lowering of the ridge at the extremity (Fig. 12).

It is interesting to note the unsightly appearance of the nails projecting through the roof cladding in the carport (Figs. 11 and 12). These resulted from the necessity of shingling the roof after the failure of the original plastic coating.

Figure 11 Shrinkage of carport beam

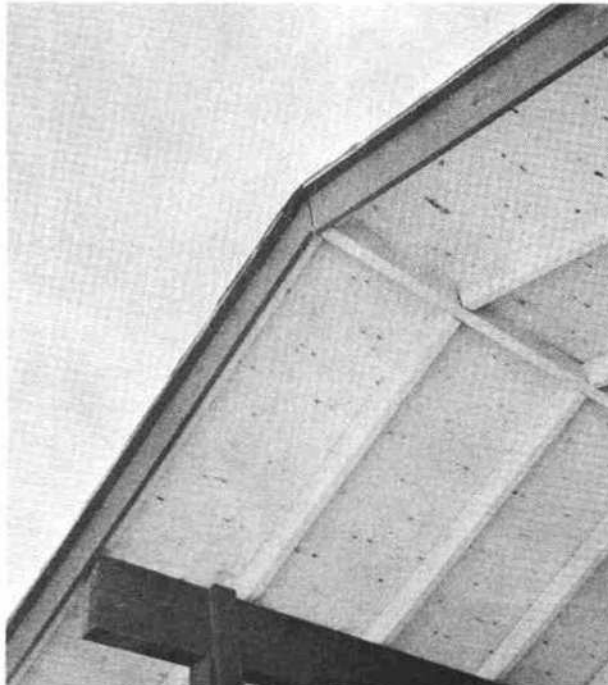
Figure 12 Evidence of sag in carport roof ridge
