LANDSLIDE AT ORLEANS, ONTARIO

by W. J. Eden and P. M. Jarrett

Technical Paper No. 321
of the
Division of Building Research

Ottawa
March 1971

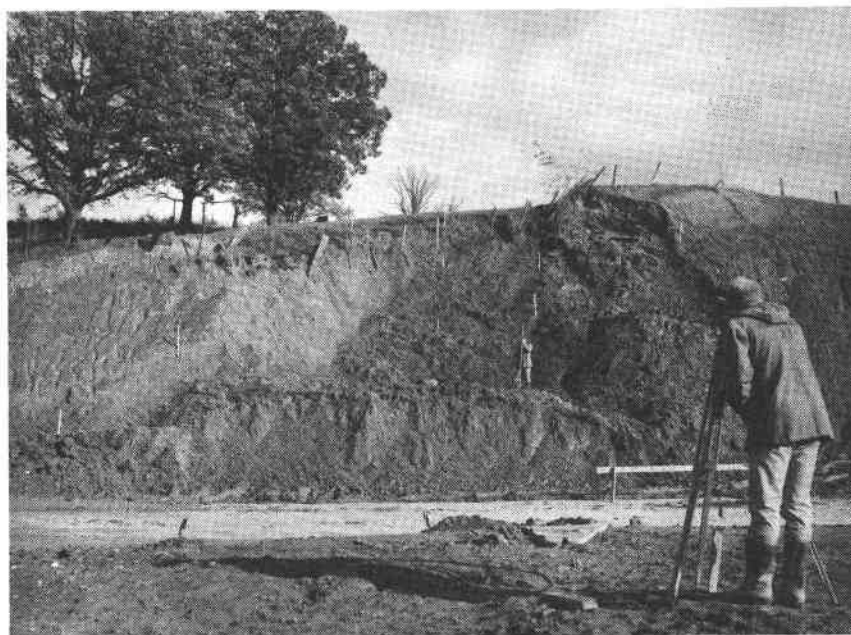
The initial slip occurred at 8.30 a.m. following a period of heavy rainfall (1.4 in. in the three preceding days). The slip involved the total height of the slope, and covered the road with debris. Figure 2 shows a view of the crater, after the spoil had been removed from the roadway. Figure 3 is a plan of the landslide prepared from stereoscopic photographs.

Figure 2
View of crater of first slide

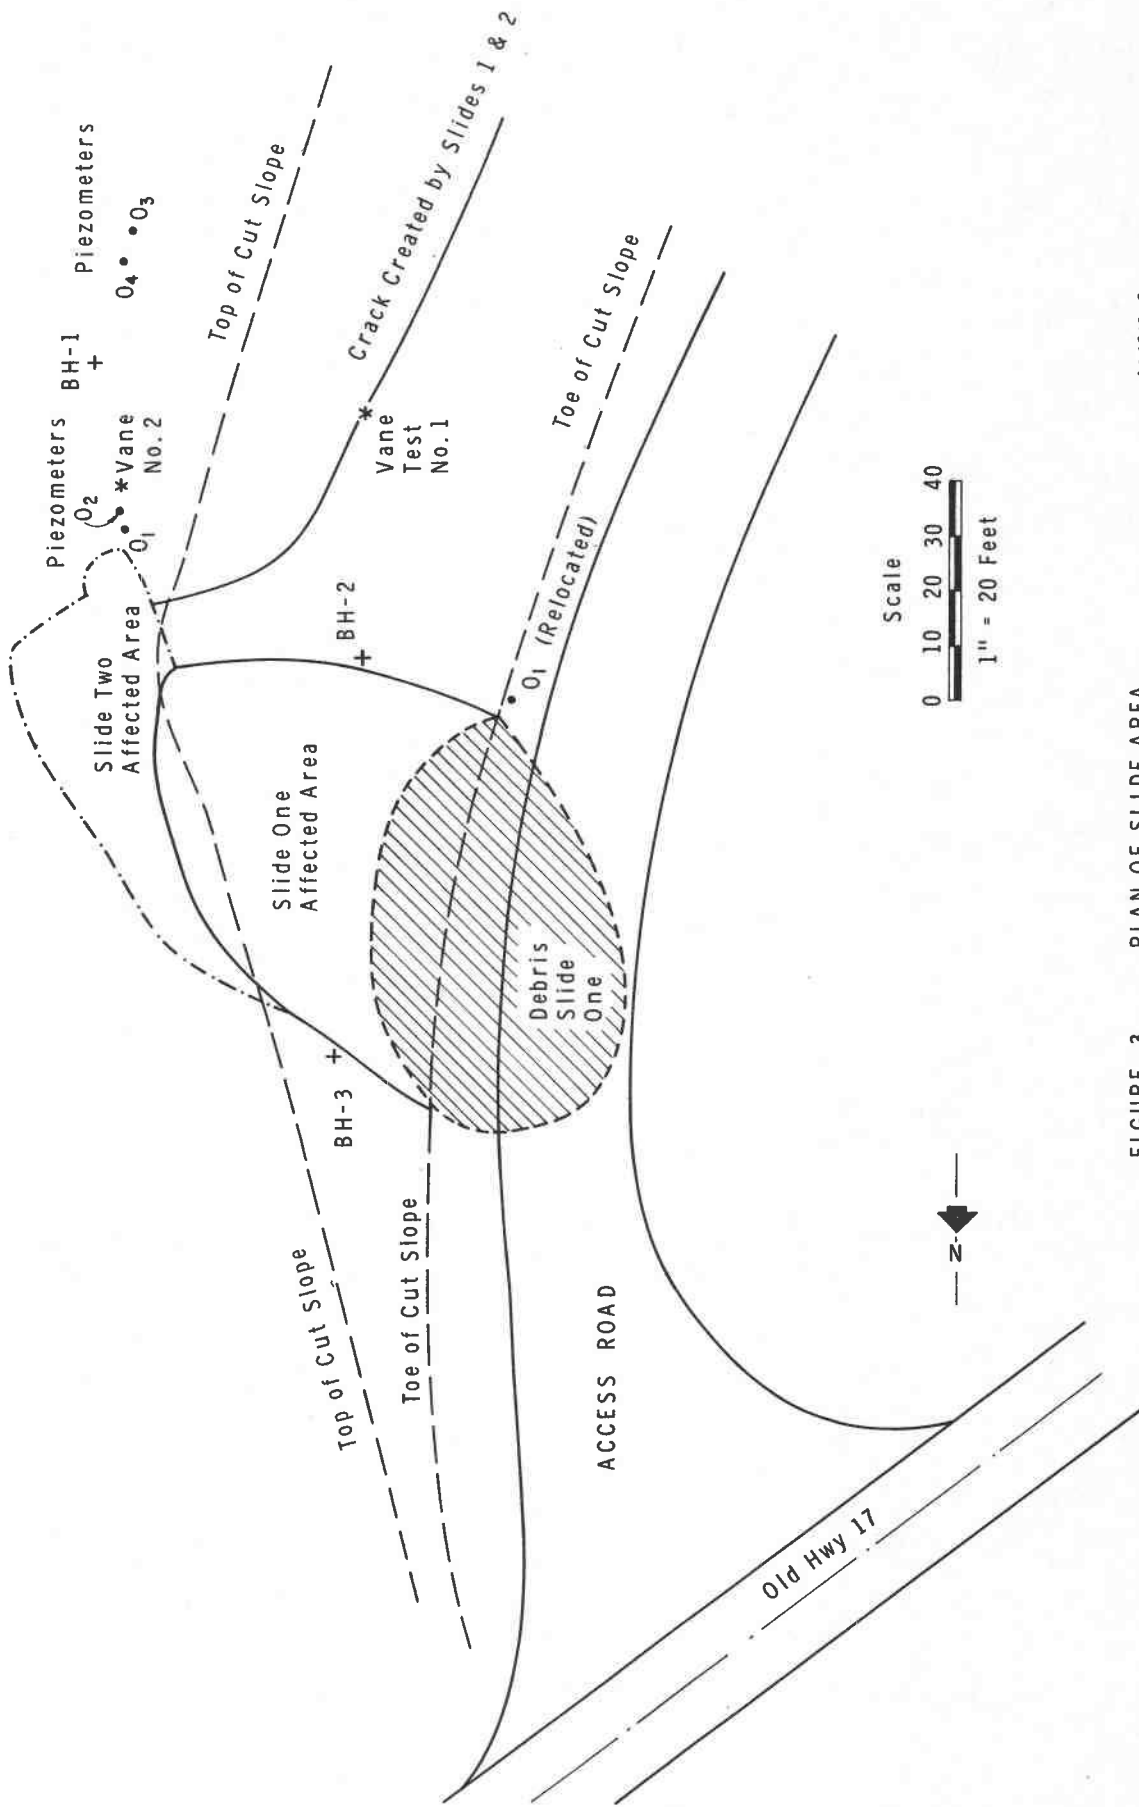
FIGURE 3 PLAN OF SLIDE AREA

After the first slide, a narrow tension crack was observed running along the cut face to the south of the crater (Figure 3). After the second slide, a vertical movement of about 2 ft was noticed between the ground level on one side of the crack relative to the other. The crack (Figure 6) was about 3 in. wide. Another slide was considered to be imminent but in spite of frequent rainfalls, failure did not occur. Between December and February 1966, a third slide occurred below the crack but it was confined to the cut face and failed well above the toe of the slope. When the road was repaired, some spoil material was placed at the toe of the slope. The stabilizing effect of this material is evident because the third slide failed above the fill material and slid over it.

Field work began immediately after the first slide. Surveys were taken of the crater and immediate area. Through the cooperation of the Photogrammetry Section of the Division of Applied Physics, stereoscopic photographs with a photo theodolite were used for preparation of a detailed plan (Figure 3). It is believed that the failure plane passed through the toe of the slope, since a culvert passing under the road just beyond the toe was left intact. In the upper region of the failure, very little debris obscured the failure surface. The lower regions were probed with a hand auger and the failure surface was established (see Figure 7, a profile of the slide).

Shortly after the first slide, piezometers O_1 and O_2 were installed to the south of the crater, and vane test No. 1 was carried out at the location shown on Figure 3.

After the second slide, a survey was made of the extended crater. Two more piezometers (O_3 and O_4) were installed. Vane test No. 2 was made and undisturbed samples were taken at locations shown on Figure 3. The samples were taken continuously from a depth of 4 ft to 49 ft using a 54 mm N.G.I. fixed piston sampler. The

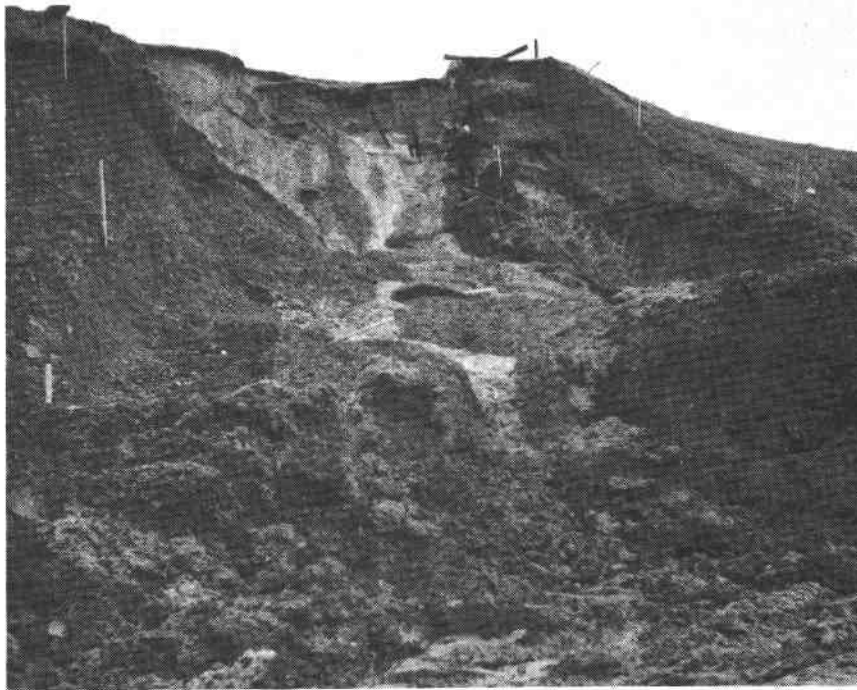
first slide (see Figure 3). Figure 4 shows the tension cracks at the top of the slope preceding the second slide. It is apparent that hydrostatic pressure acting in the cracks initiated the second slip. Figure 5 is a view of the crater after the second slide. Debris from this slide also spilled onto the roadway.

Figure 5
Crater after second slide

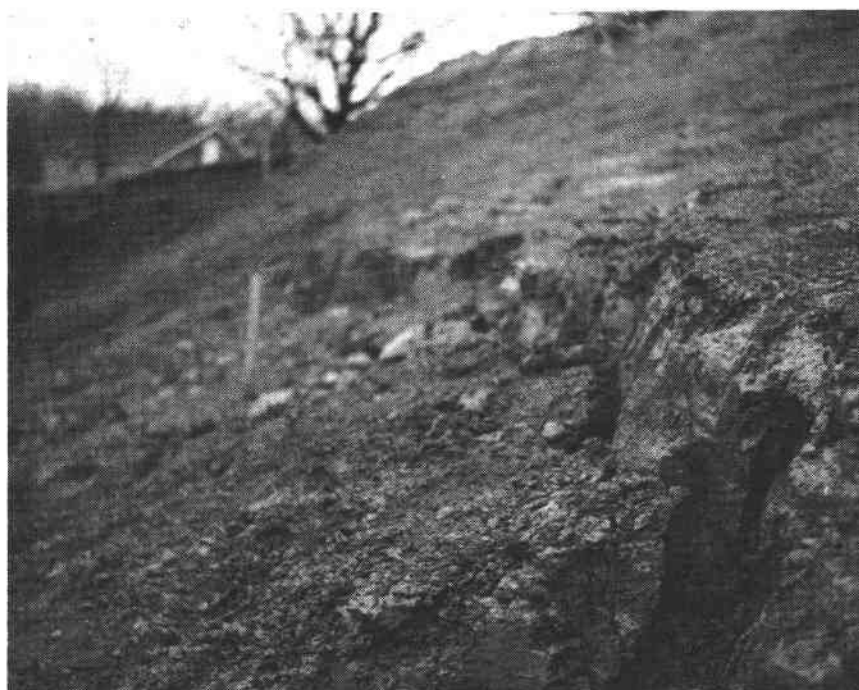
Figure 6
Tension cracks right of crater

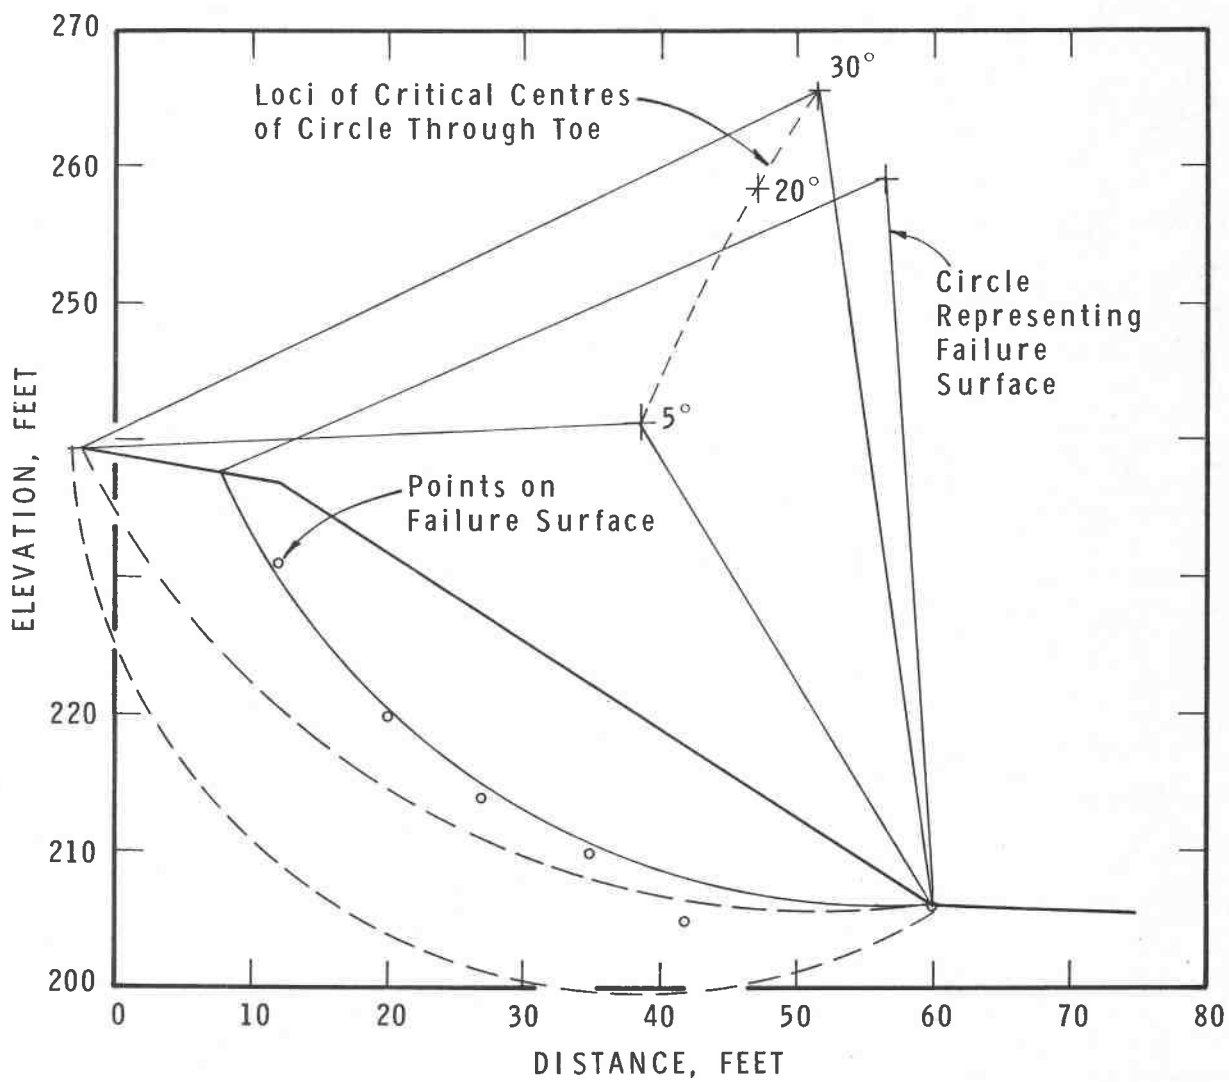
FIGURE 7 PROFILE OF ORLEANS SLOPE

2. The computer analysis indicated a higher strength required for stability than that actually mobilized along the failure surface. No allowance was made in the computer studies for tension cracks or anisotropic effects in the soil. The actual failure surface was somewhat shallower, with its centre displaced towards the toe, than the critical circles determined by the computer analysis. The actual failure surface was reasonably circular. It is possible that imperfections such as fissures or anisotropic properties of the clay, or strain incompatibility along the failure surface, influenced the position of the failure surface.

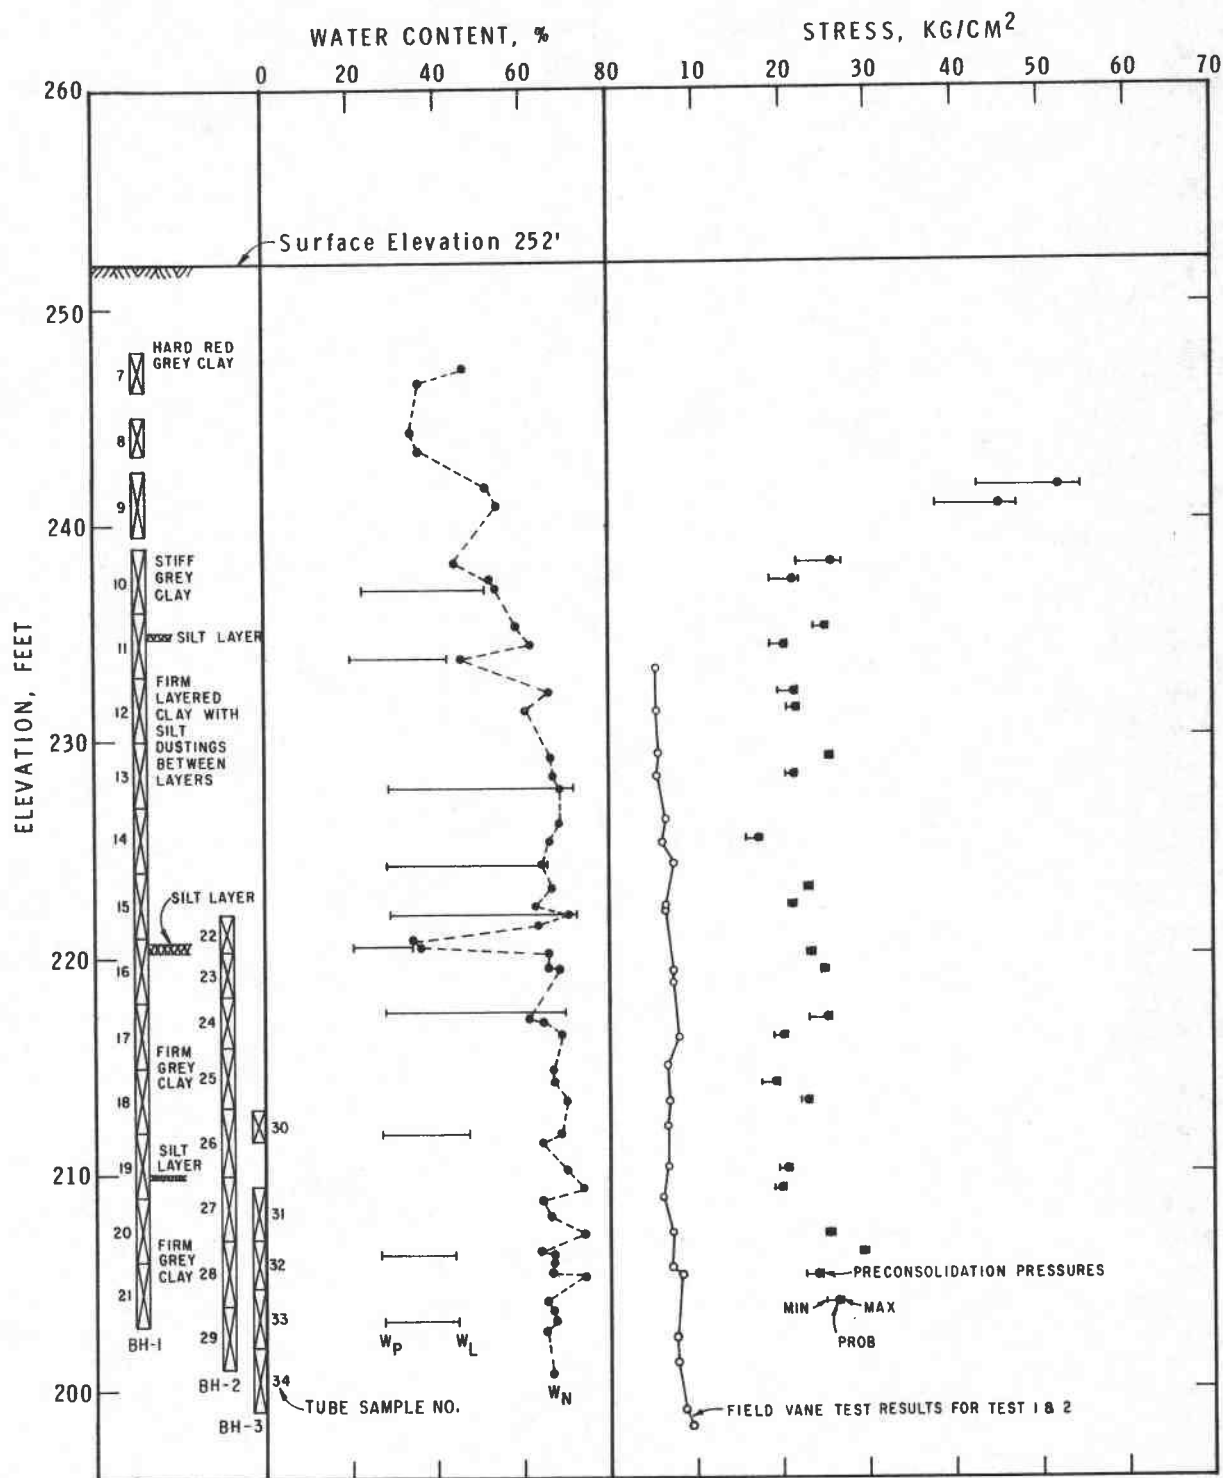
FIGURE 8
BORING LOG & TEST RESULTS - ORLEANS SLIDE

The borings revealed that the clay terrace was formed mostly of clay with some silty layers. Figure 8 is a boring log and a profile of test results. There are three major clay layers separated by silt layers a few inches thick. The top layer is hard grey clay with some red bands. It appears to be somewhat overconsolidated, probably due to weathering. From elevation 235 to elevation 220 the second, softer layer consists of stratified clay with some silt dustings between the layers. The liquidity index of this layer is close to unity. The lower layer (below elevation 220) consists of firm clay with a liquidity index well above one. Pore water salt concentration determinations indicated less than 1 gm per litre throughout the borings. Only the lower two layers of clay were involved in the landslide.

Field vane tests were conducted at two locations (Figure 3) and results from both holes are shown on Figure 8. Preconsolidation pressures determined from consolidation tests on 54 mm piston samples are also indicated on Figure 8.

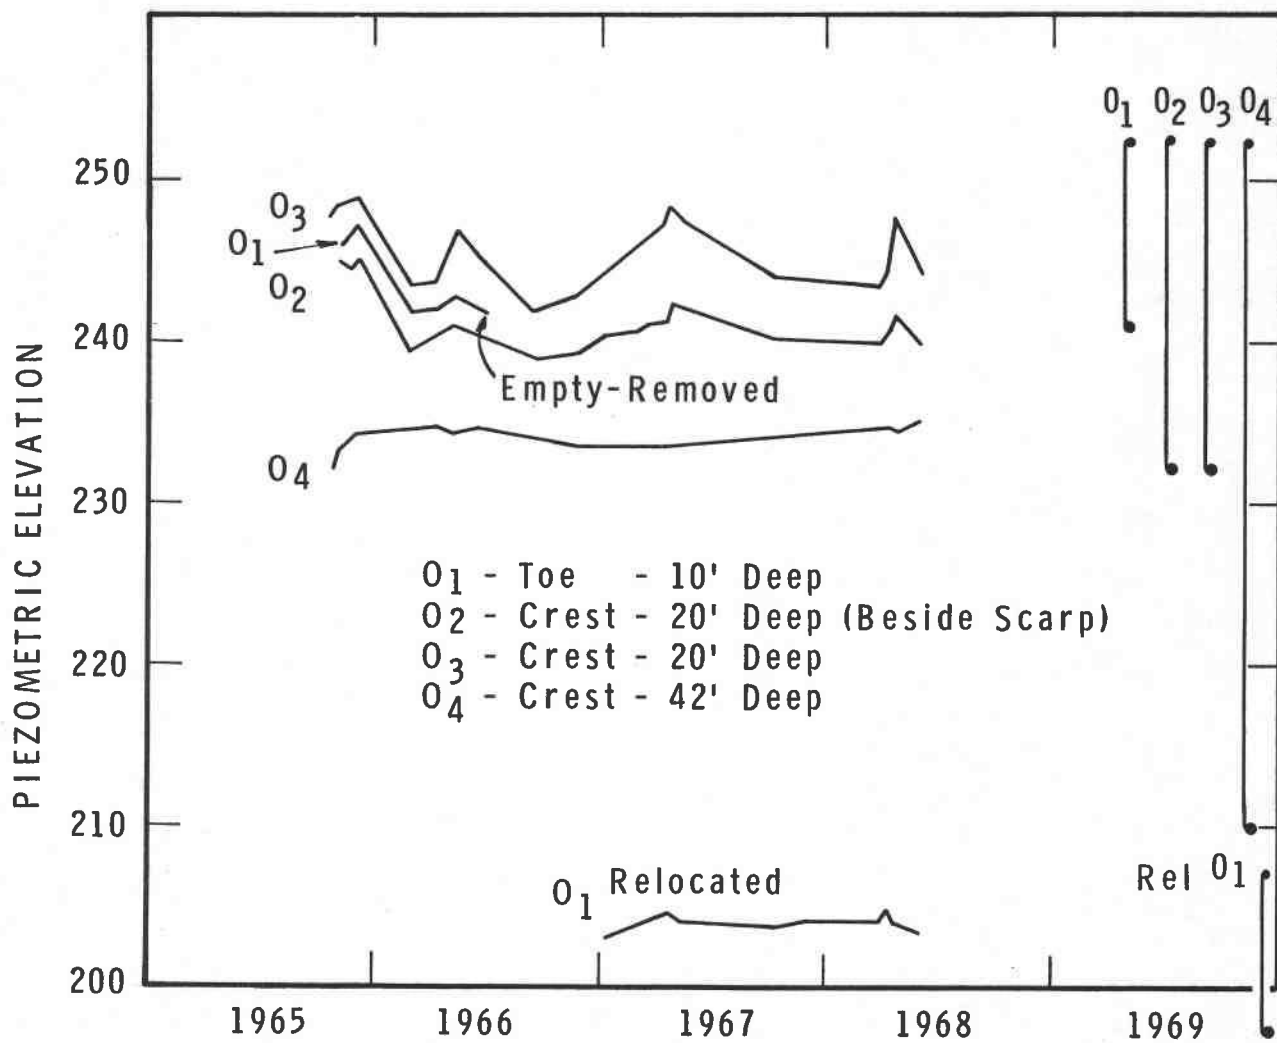
FIGURE 9
VARIATION OF PIEZOMETRIC ELEVATIONS

The four piezometers installed after the landslide were located at the top of the slope. After one year, one piezometer, 0_1 , was removed from the top and reinstalled at the toe of the slope. The location of the piezometers is indicated on Figure 3. The piezometers were installed at the following depths: 0_1 - 10 ft, 0_2 and 0_3 - 20 ft and 0_4 - 42 ft. Figure 9 gives the measured piezometric elevations with time. A substantial downward gradient of nearly 10 ft in 20 ft is

indicated by piezometers 0_3 and 0_4 . Piezometers 0_1 and 0_2 , located close to the top of the scarp, were soon influenced by the presence of the slide crater.

Using the maximum readings recorded in 0_3 , 0_4 and 0_1 (relocated), an approximate flow net was constructed. The slide surface was superimposed and an approximate average value of $r_u = 0.4$ was determined along the slide surface. Because of the downward gradient and the low permeability of the clay, it is conceivable that conditions approaching full hydrostatic pressure could exist for a shallow slip surface after a prolonged wet period.

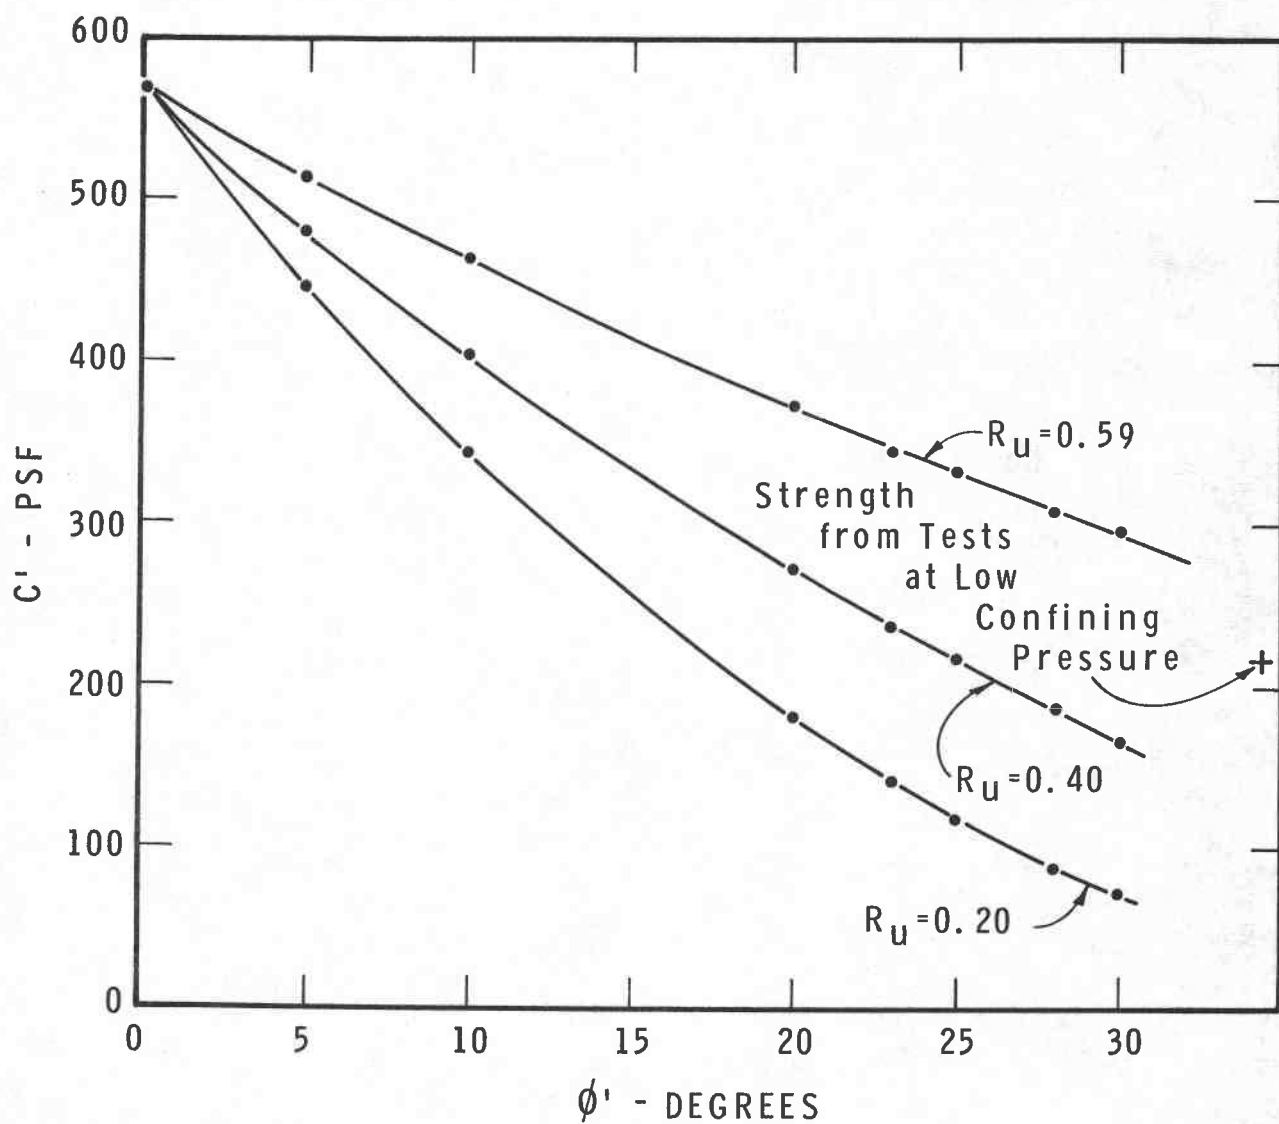
FIGURE 10
ORLEANS SLOPE STRENGTH REQUIRED FOR STABILITY

Following the procedure outlined by Crawford and Eden (1), the required cohesion necessary for stability was computed for various values of ϕ^t and r_u . The results of these computations are presented on Figure 10, and critical circles for $\phi^t = 5^\circ$ and $\phi^t = 30^\circ$ and $r_u = 0.59$ are shown on Figure 7. It will be noted that the actual failure surface is somewhat shallower, with its centre located at a point above the toe, than any of the critical circles derived from the computer analysis.

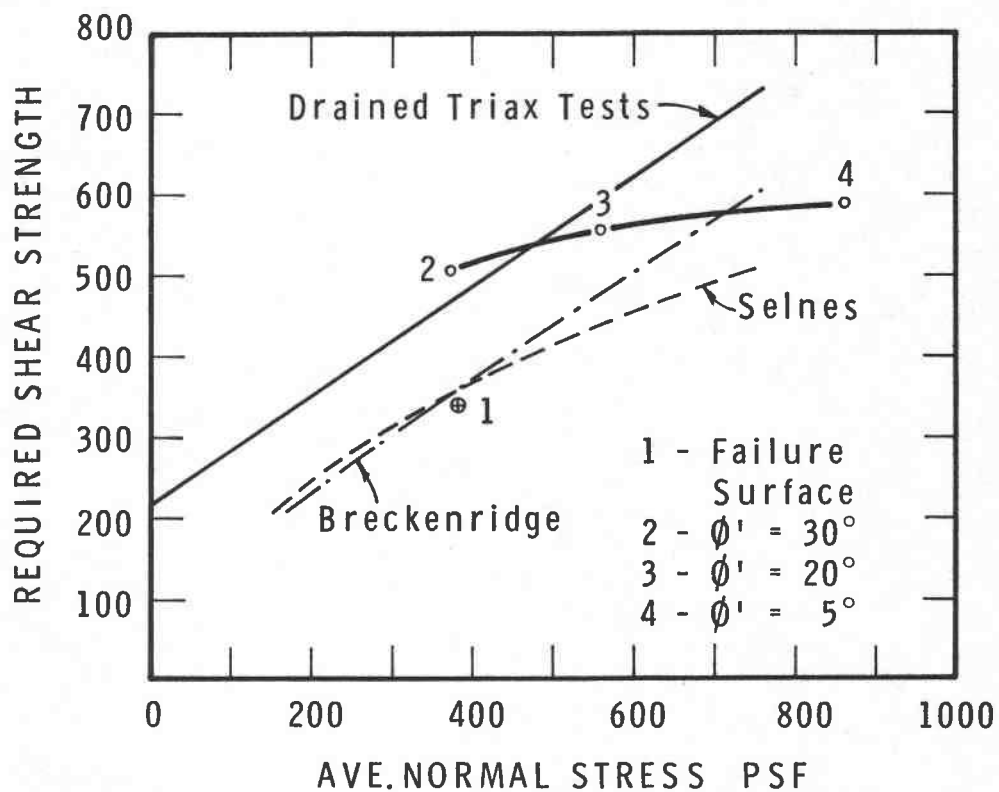
FIGURE 11
CRITICAL STRESS CURVE FOR ORLEANS SLIDE

The studies with the computer also can define an envelope relating the average effective normal stress on the failure plane and the required shearing resistance (2). This envelope is presented in Figure 11, along with envelopes established by Kenney (3) for the Selnes and Breckenridge slides. Also plotted on Figure 11 are the average normal stress and the required undrained shear strength for the actual failure surface (Point 1). It plots well below the envelope.

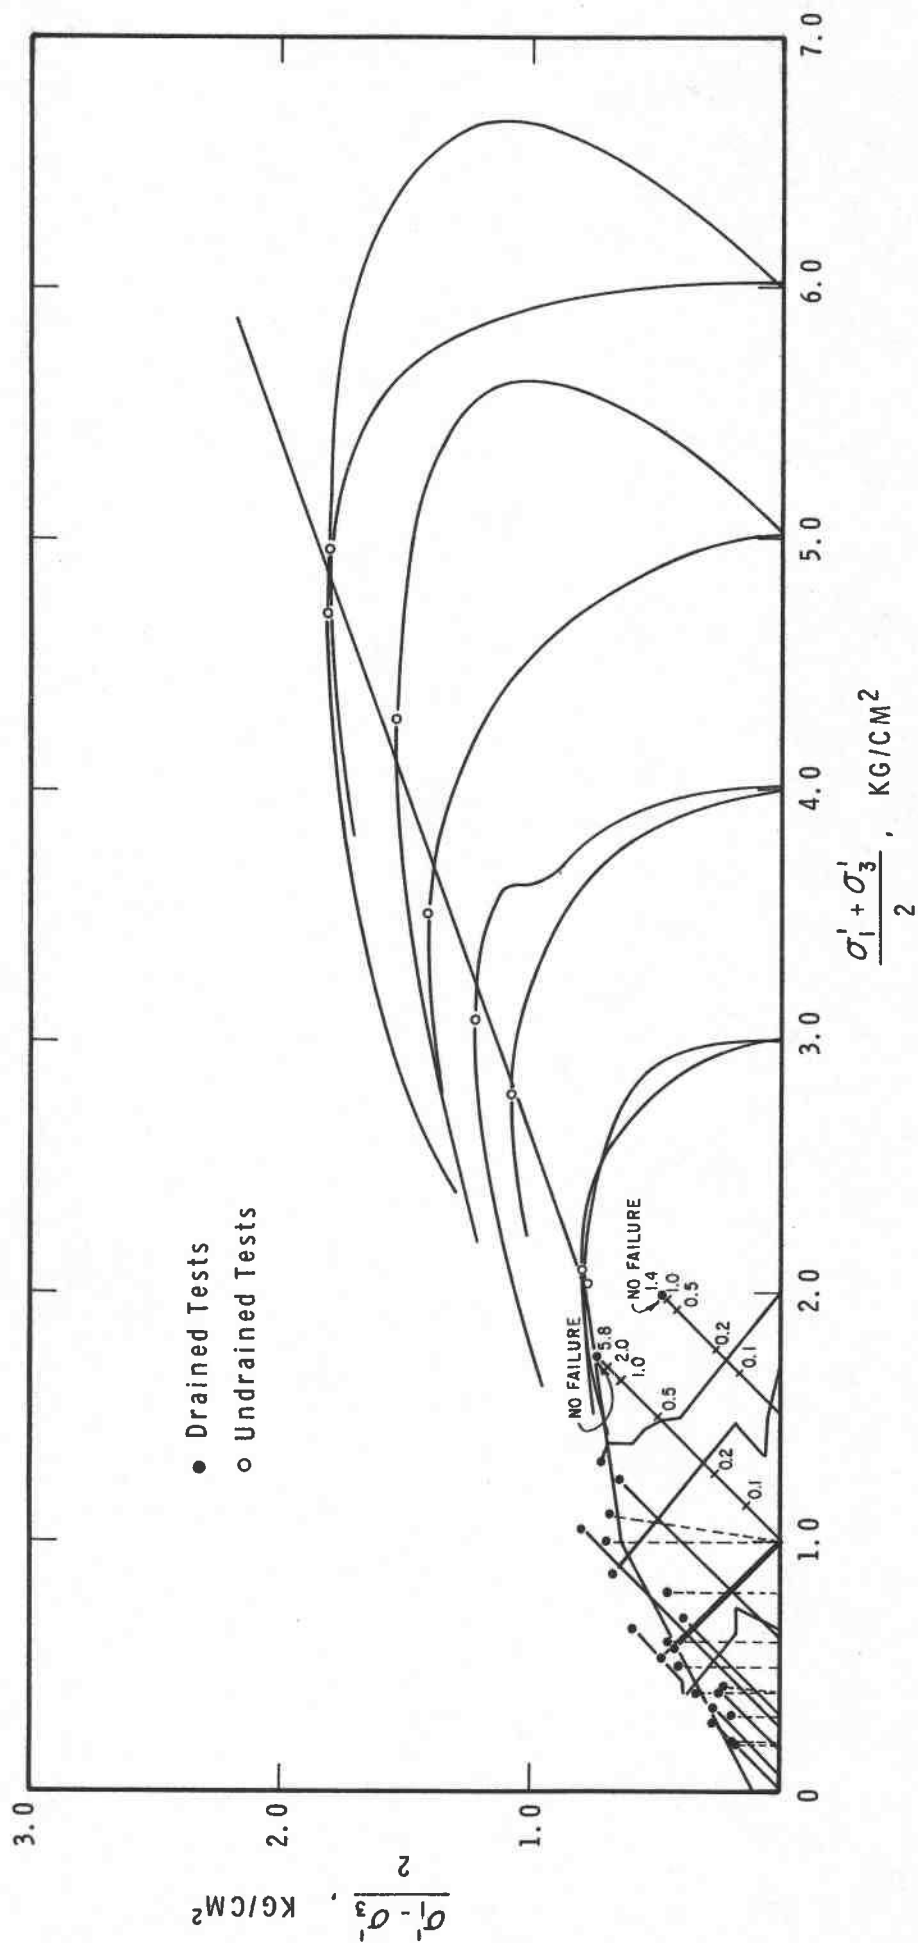
FIGURE 12 STRESS PATHS FOR TRIAXIAL TESTS

Figure 12 is a plot of the stress paths of the tests. Tables II, III and IV are summaries of these tests.

Of the drained tests with σ_1 increasing, two results were considered unsatisfactory (148-17-5 and 148-17-8) because the stress levels were sufficient to cause large volume changes and the specimens could not be brought to a well-defined state of failure.

When all the triaxial results are considered, it appears that there are three distinct behaviour zones for the clay on this site. At low confining pressures, a brittle nearly elastic behaviour is evident. Drained tests at a constant rate of strain exhibited a peak followed by a significant drop. At consolidation pressures between 1.0 and the preconsolidation pressure, a complex behaviour pattern was evident. Tests 148-17-5 and 148-17-8 are typical of this behaviour. Figure 12 indicates the strain at various stages and it is evident that in later stages a work-hardening process was occurring, with associated large volume changes. In the normally consolidated range, a work-hardening process begins at low stress levels.
