VISIT TO THE CONSTRUCTION SITE OF A HOUSING PROJECT
IN PANGNIRTUNG, BAFFIN ISLAND, N.W.T.

R.L. Quirouette

Ottawa
January 1980

DBR INTERNAL REPORT NO. 459

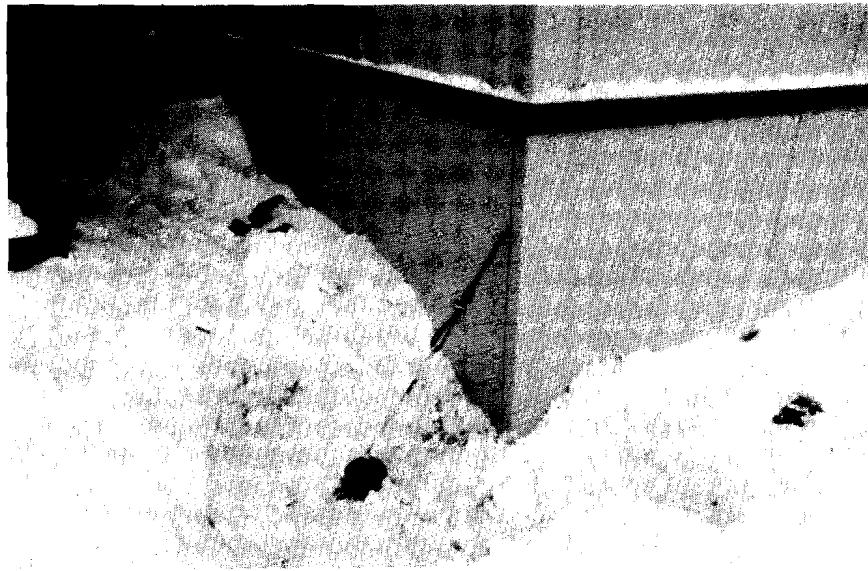
Temperatures during our visit varied from -20°C to -30°C. There was, however, almost no wind. At other periods, particularly during January and February, Pangnirtung may experience winds up to 160 km/h. The size and strength of the anchor cables holding down buildings are clear evidence of this (Fig. 2A).

Fig. 2. Typical 2-unit, 4-bedroom house
(A) - anchor cable; (B) - front view of unit

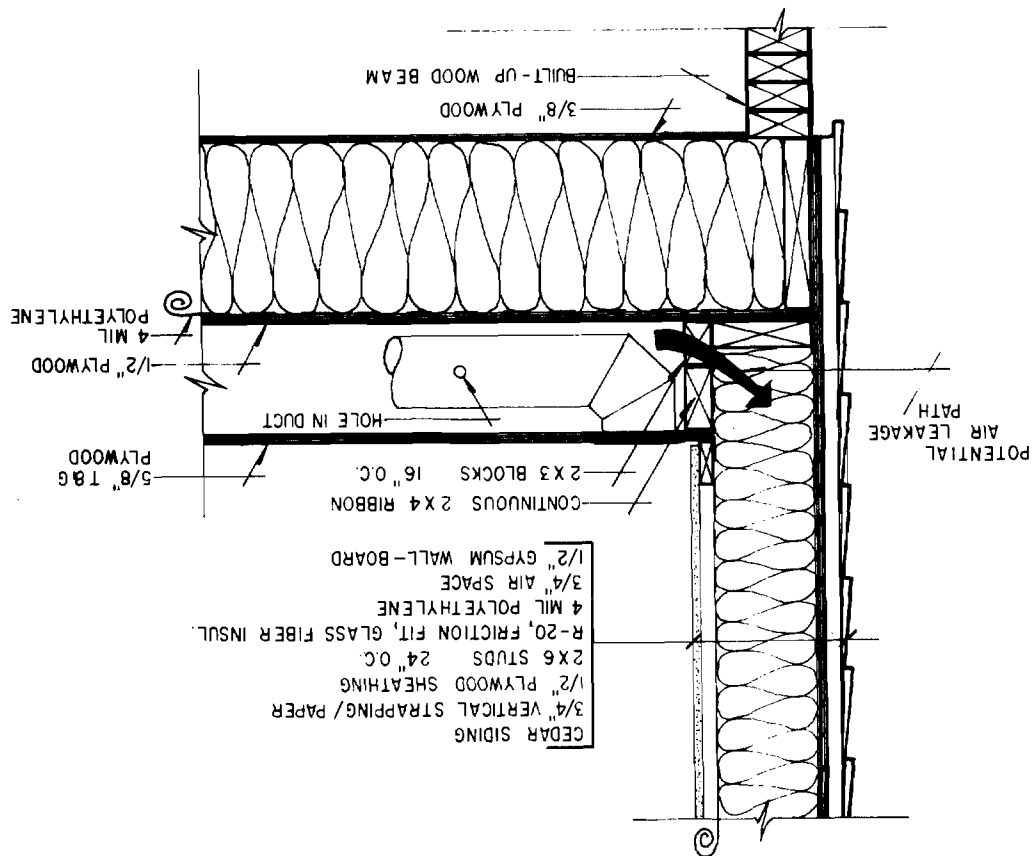
Fig. 5. Construction details of wall-floor section
(taken from building drawings)

On the morning of 1 December 1978, Mr. Perreault and I continued our examination of the buildings, especially those whose constructions were most advanced. We discussed the pressurized base and the problems it could lead to, the 19 mm cavity behind all drywall, the use of plywood as exterior sheathing and the multitude of holes created by chimneys, plumbing and wiring. We concluded that pressurizing the floor cavity could lead to serious condensation problems, either in the insulation of the floor or in the wall cavity defining the perimeter of the building. In addition, it was discovered that three of the 16 units had 38 x 53 x 250 mm spacer blocks instead of a continuous 38 x 53 mm ribbon around the perimeter, thereby creating gaps at least 25 x 250 mm leading directly into the outside wall cavity behind the polyethylene sheathing (Fig. 5). The harshness and long duration of the winter can make even a minor air leak a serious problem; openings of this size might well cause the exterior walls to fill with condensation in a matter of weeks. To avert this potential problem, Mr. Perreault and the field superintendent decided to insert 38 x 140 mm wood blocks between the studs and complete the seal by caulking. To reduce further the risk of air leaking into the wall, it was recommended that additional outlet grilles be installed in the floor to relieve cavity pressure. Further discussion of this problem with Mr. Pierre DeCourval revealed that such pressure relief had been intended and was specified but the necessary hardware was not available. The intent was to install specially designed grilles in which forced warm air from the duct outlet would draw floor space air by venturi action. This would have assured a continuous flow of air in the false floor, thereby maintaining the intended uniform floor temperature at a minimum air pressure difference.

In principle, the object of constructing a service cavity between drywall surfaces and the structure is commended, but in practice it may lead to far more air leakage than if the drywall had been applied directly over the structural elements. Since the cavity between the drywall and the structural elements is continuous between the walls and roof surfaces, any openings on the interior are now connected to any other opening on the exterior regardless of the location of each one. Therefore, the probability of air leakage through the building is very high in comparison with a construction technique which would cellularize or compartmentalize the building envelope as occurs when the drywall is applied directly over the structural elements.

Another area of construction detailing which seemed to deserve more attention was the openings formed by the plumbing and electrical services. Although there was no way to seal off all possible penetrations through all walls, it was suggested that, where several of these service pipes punched through in a cluster in a chase space, a wire mesh be used to span the opening, attached to all service pipes, and filled with a plaster or cement. This would minimize the area of openings while providing necessary fire protection around pipes such as chimney flues. Smaller holes, cracks and crevices, such as those created by wiring and intersections of sheathing materials and structural components where shrinkage could occur should be sealed with caulking.
