REPORT ON ROCKWOOD COURT APARTMENTS
SAINT JOHN, N. B.

by
D.C. Tibbetts

Report No. 97
of the
Division of Building Research

Ottawa
September 1956

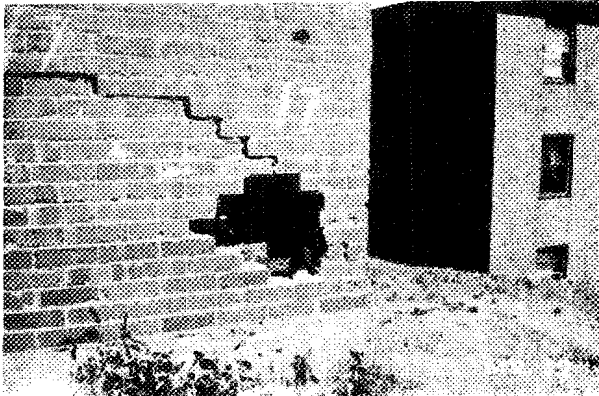
Openings made in the walls (Fig. 1) indicate that the sheathing paper was properly applied and is in good condition. Masonry ties are at proper intervals and are free from corrosion. There is an excessive amount of mortar droppings between the veneer and sheathing at the corners. It is not known if this is general throughout the walls.

Fig. 1 Openings in walls showing sheathing paper in good condition.

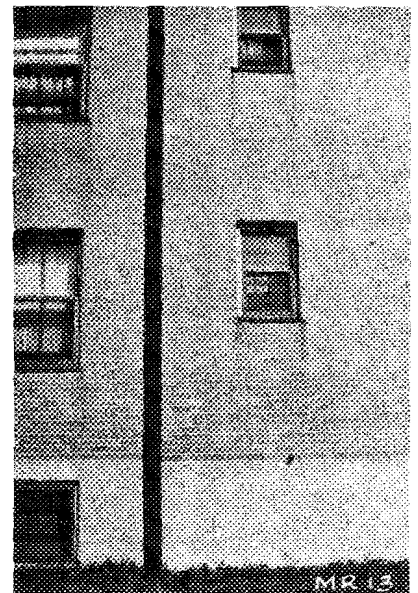
These cracks predominate at the corners of reveals and are straight-line through mortar and brick. They occur in most of the buildings and are just as extensive in buildings

known to be founded on bed-rock. This type of cracking could be caused by expansion and contraction of the masonry materials on wetting and drying. In nearly all instances where such cracking exists, foundation cracks outlining large spalls at corners are in evidence.

Fig. 2 Vertical cracks at reveals extending from top of foundation wall to roof.

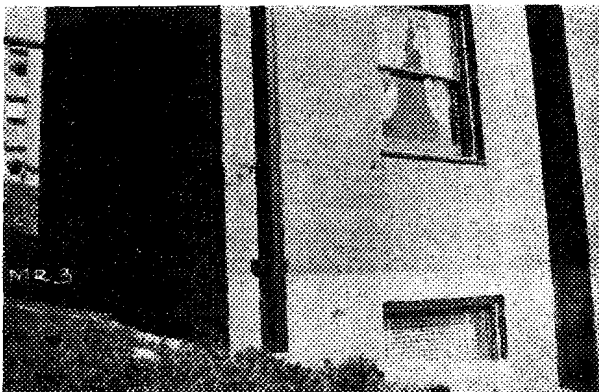
- (4) Fifteen buildings have diagonal cracks in rear only;
- (5) Eight buildings have diagonal cracks both front and rear;
- (6) Fourteen buildings have severe cracks in one form or another;
- (7) Nine buildings have vertical cracks at reveals (Fig. 2) that extend from top of foundation walls to roofs. These are all rated severe because of their length as opposed to width of crack. The width of cracks vary from hairline to 1/16 inch;
- (8) Almost without exception there are no cracks in the brickwork of end walls. There is an instance or two where diagonal cracks occur at corners but these are a continuation of larger diagonal cracks in side walls (Fig. 3). There are no openings or projections in these walls.

Fig. 3 Diagonal cracks at corners.

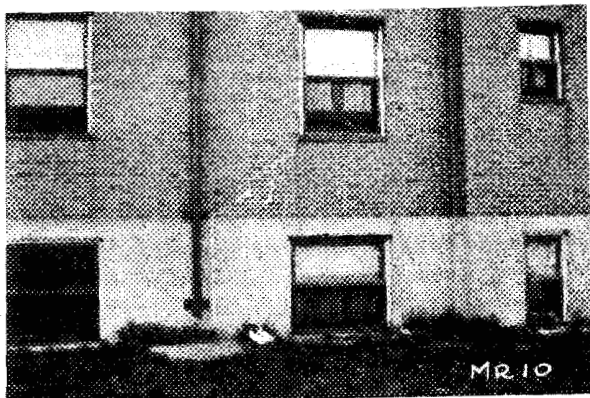
Foundation cracks are common at the junction of buildings. These are particularly noticeable where there is a difference in elevation of two adjoining foundations and are usually accompanied by diagonal cracks in the supported brickwork (Figs. 4, 5 and 6).

Fig. 4 Crack in foundation and diagonal crack in supported brickwork.

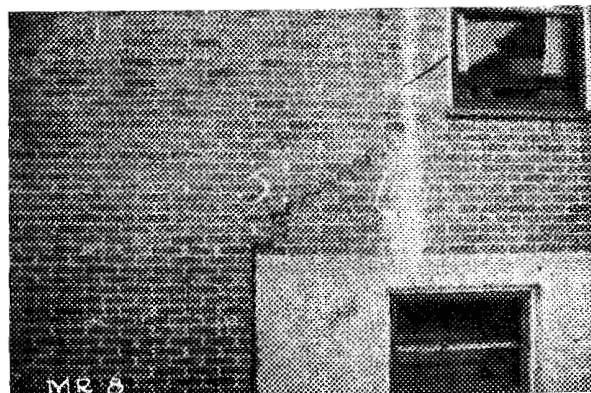
Fig. 5 Crack in foundation and diagonal crack in supported brickwork.

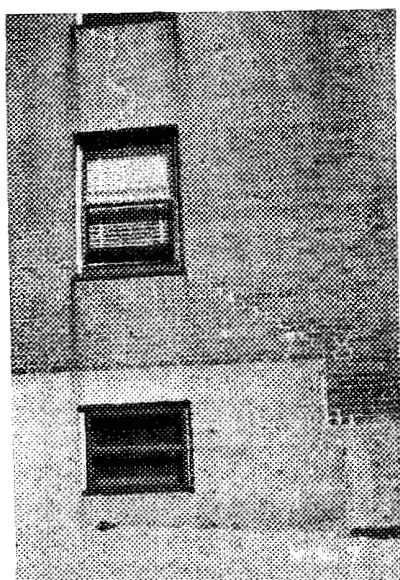
Fig. 6 Foundation and brickwork cracks at point where elevations of adjoining foundations are at different levels.

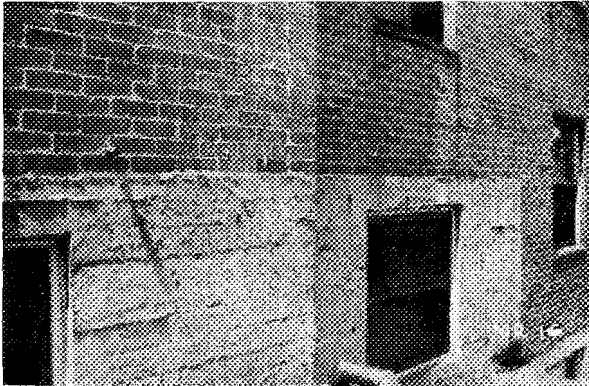
The most general, and certainly the most peculiar type of cracking, occurs near the top of the foundation walls at end corners and at corners of reveals. These cracks are typical of those shown in Fig. 7, and appear to be caused by expansion of the supported masonry. There is no vertical movement of these corners and it is unlikely that cracking is due to the weight of the brickwork.

These cracks (Fig. 7) are not believed to be due to loads from the brickwork. It is unlikely that the walls are carrying any load because the foundation corners are cracked from both sides; conversely, it would appear that the brickwork is, in some cases, holding the concrete spalls in their present position. There is no evidence of downward movement of these spalled sections.

Fig. 7 Cracking near top of foundation wall at end corners and at corners of reveals.

Sections at the corners of foundations outlined by cracks should be removed and replaced with concrete. The face exposed when the cracked sections are removed should be cleaned, roughened, and washed with a cement and water grout to effect a good bond with the new concrete. It may be necessary in some instances to dowel the new sections to the corners. The corners will have to be formed to maintain the concrete until it sets. This will probably require a course or two of brick to be removed immediately above these corners.

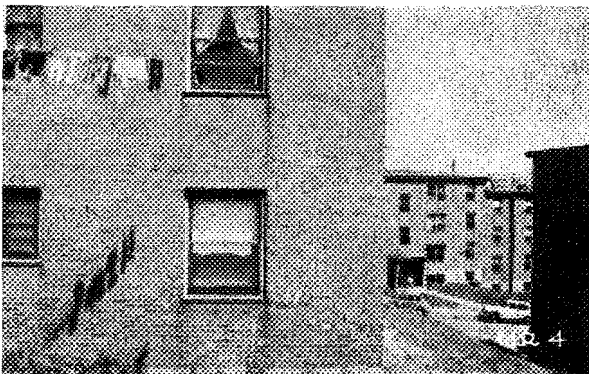
- (1) Buildings Nos. 17 and 18 have severe diagonal cracks at the rear corners and have severe vertical cracks at reveals. These two buildings are separated only by a fire wall. The diagonal cracking is more severe in these two buildings than in others (Figs. 8 and 9).

These buildings are founded on bed-rock at the centre and soil at either end. This condition is thought to contribute to the severity of the cracking due to consolidation of the base material at the ends with no movement at the centre.

Fig. 8 Severe diagonal cracking.

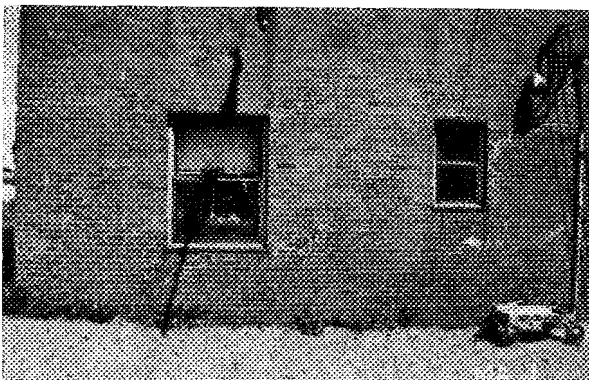
Fig. 9 Severe vertical cracks at reveals and diagonal cracks.

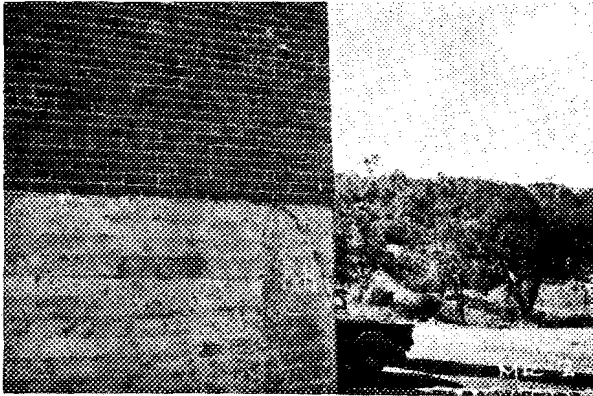
This building shows little evidence of the cracking in the brickwork common to the apartment buildings. Cracks in some foundation corners do resemble those of the other buildings (Figs. 10 and 11). This is a one-storey building of concrete block faced with brick. There are several large vertical cracks on the interior surface of the blocks.

The foundation cracks would indicate expansion (Fig. 10); however, it is possible that there has not been enough drying-shrinkage to cause cracking of the brickwork.

Fig. 10 Crack in
foundation corner.

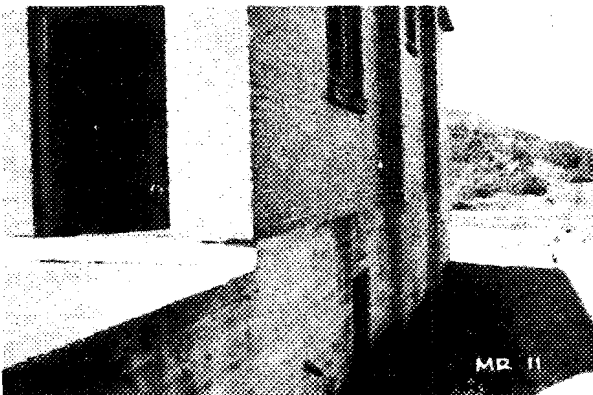
Fig. 11 Cracks in
foundation but no
cracks in brick-
work.

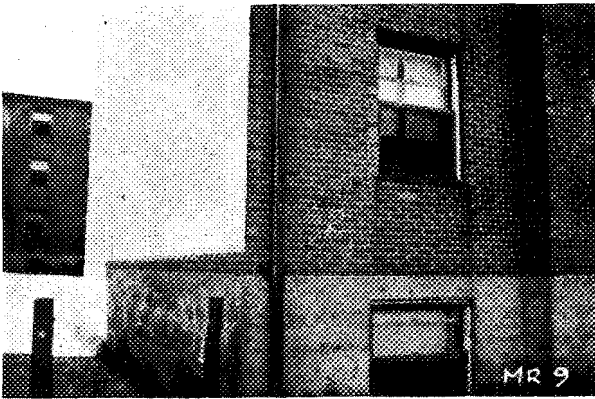
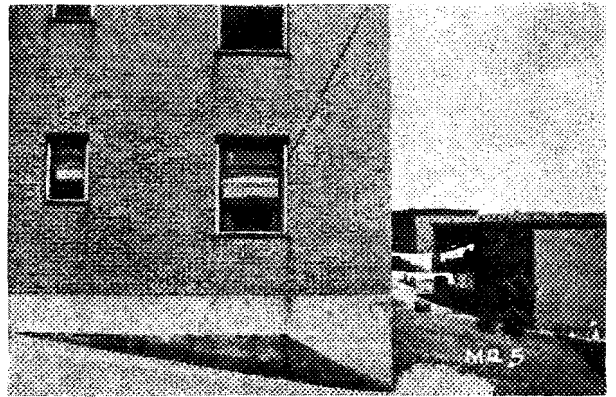
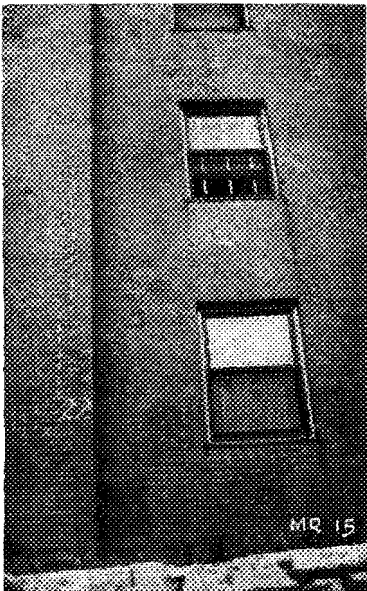
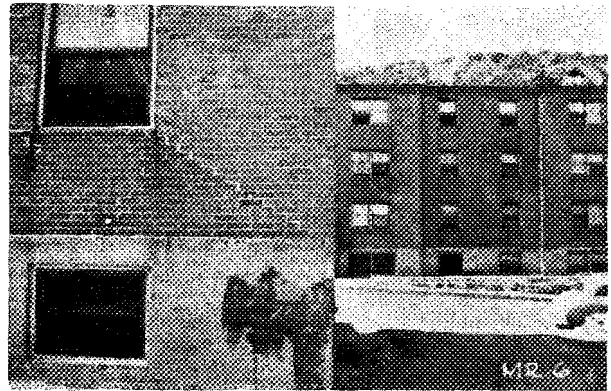
Examples of cracking in foundation
and brickwork at Rockwood Court
Apartments, N.B.
