FIELD MEASUREMENTS ON FIRST PRODUCTION MODEL
OF AN/MPQ - 501 COUNTER MORTAR RADAR,
AT CAMP SHILO, MANITOBA, 25 - 28 MARCH, 1958

A. HENDRY

MARCH 1958

ABSTRACT

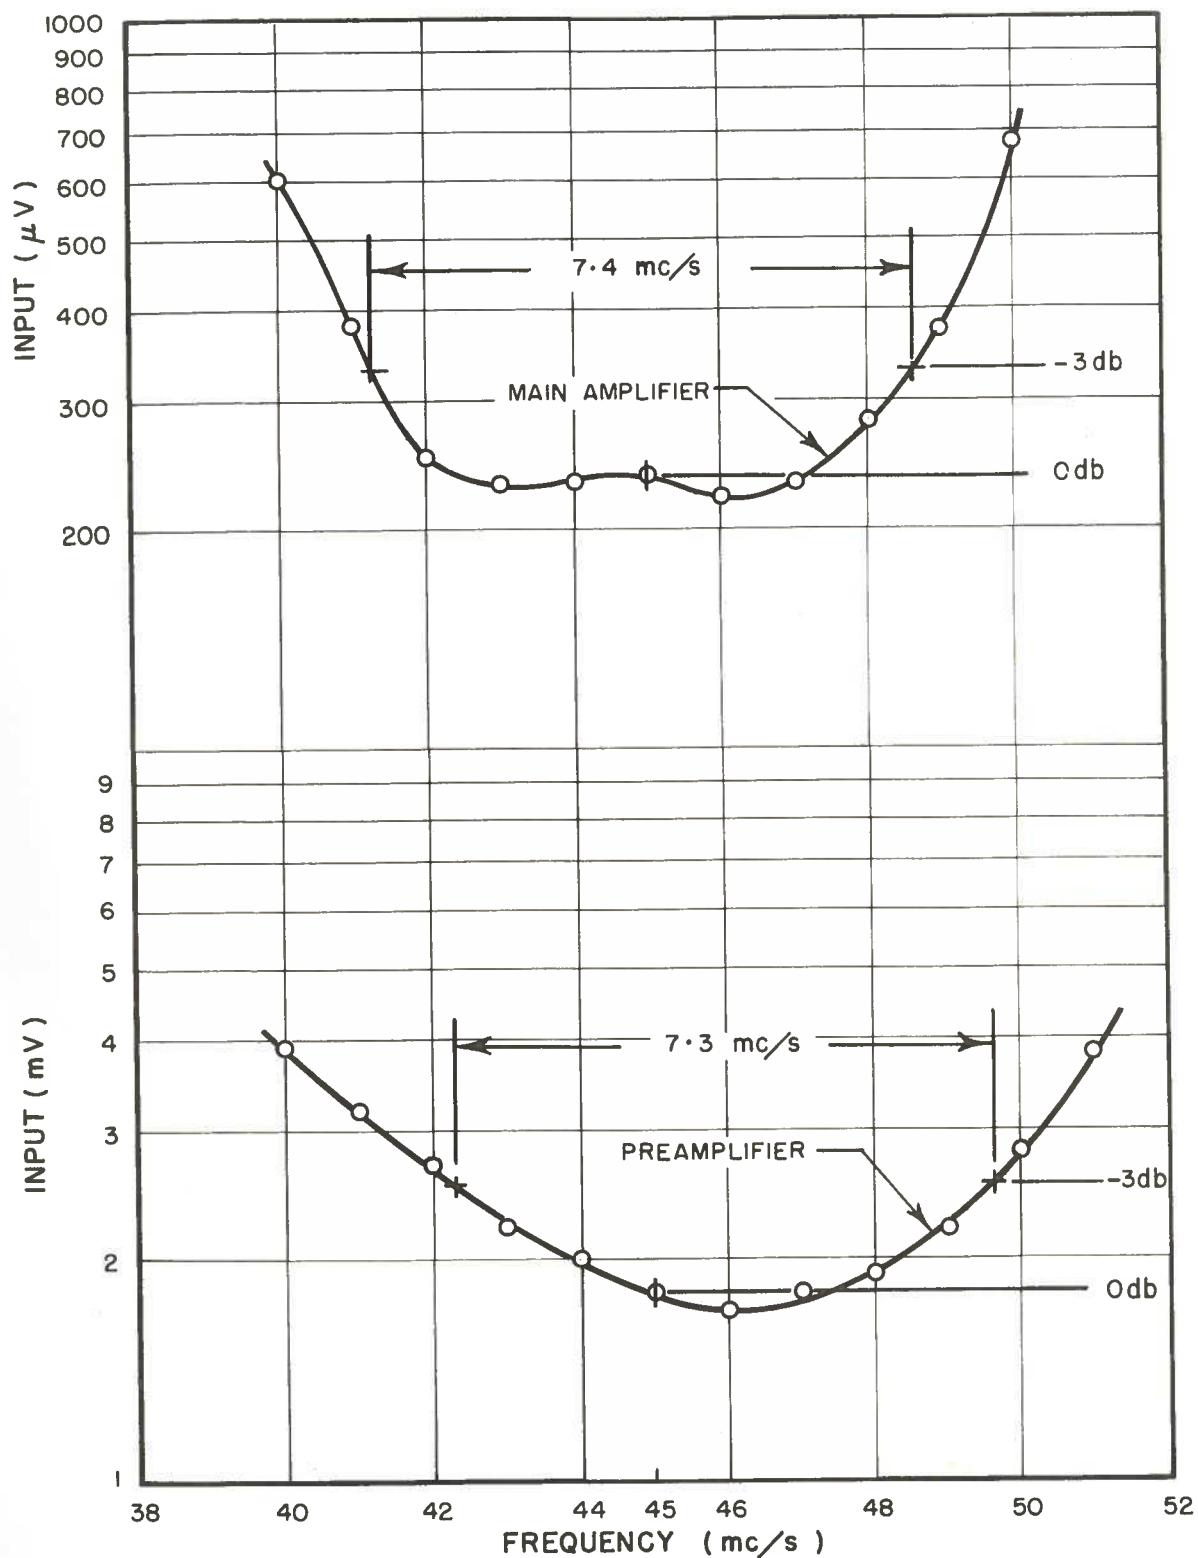
FIG. 1. FREQUENCY RESPONSE CURVES OF I-F AMPLIFIERS

The response curve for the preamplifier indicates that it is slightly mistuned; however, the effect of this is probably barely noticeable. The computed overall bandpass curve, obtained by multiplication of the ordinates of the two individual bandpass curves indicates that the overall i-f bandwidth is approximately 6 mc/s, with some asymmetry introduced by the preamplifier. This asymmetry, however, is not serious, but should be corrected in future production. The bandwidth is less than the 7 mc/s design figure, but this will probably be corrected if the preamplifier curve is made symmetrical about 45 mc/s.

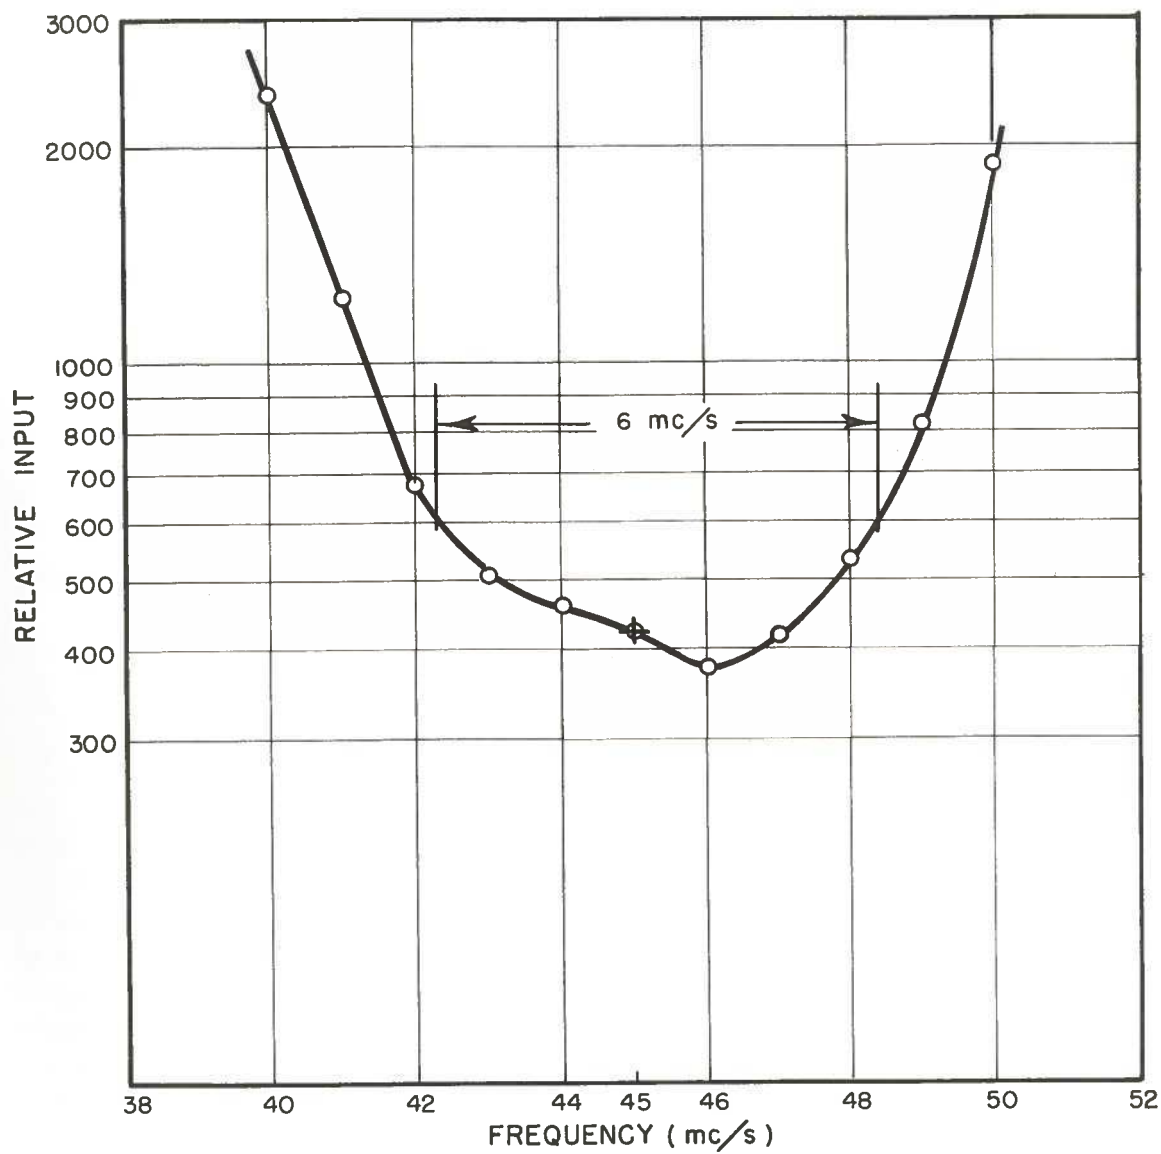
FIG. 2. COMPUTED OVERALL I-F RESPONSE CURVE

The overall bandwidth of the i-f amplifiers, as determined from the individual passbands of the preamplifier and main i-f amplifier, is 6 mc/s, with slight asymmetry. This bandwidth is slightly less than the design figure of 7 mc/s, but is not expected to cause appreciable trouble.

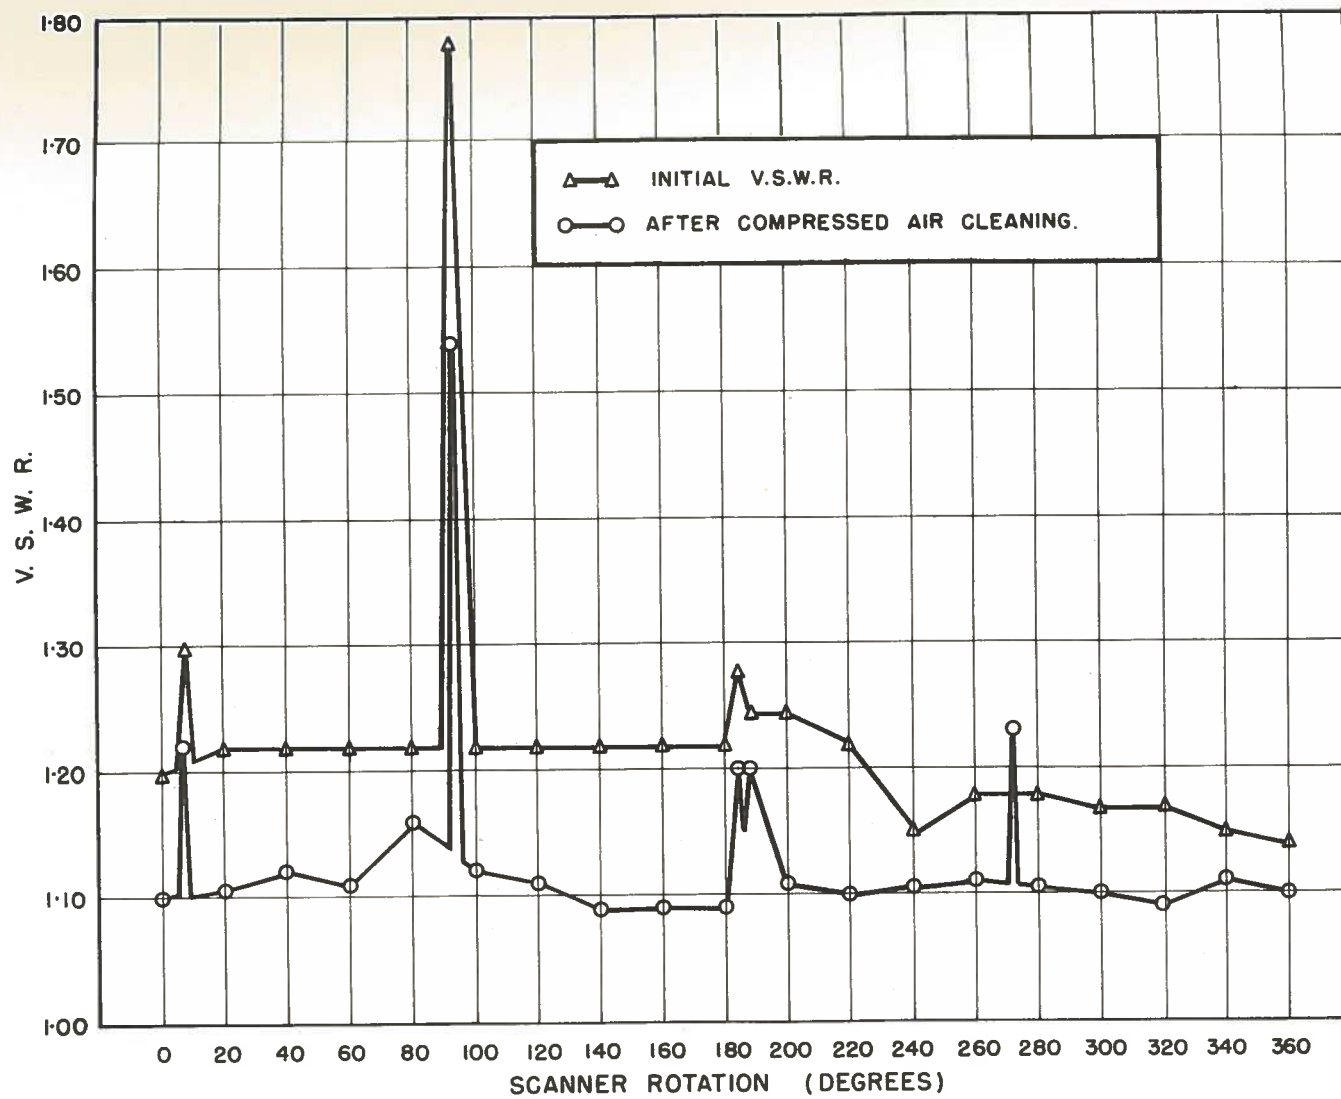
FIG. 3. SCANNER VSWR AT 16,000 MC/S

Measurements of the input VSWR of the scanner plus rotary joint were made and are given in Fig. 3. Initially, the measured VSWR varied between 1.14 and 1.30 over the useful portions of scanner rotation, with higher VSWR at the "cross-over" points. At one cross-over, the VSWR reached 1.8, but high reflections were obtained only over a very narrow sector. A large number of less important peaks were observed as the scanner was rotated. It was evident that the results were somewhat erratic, as difficulty was experienced in obtaining the same readings when the scanner was re-set to a given reading after rotation. (Note in Fig. 3 that the reading at 360° is not equal to the reading at 0° .)

The rotary joint was taken apart, and inspected at this time. No physical damage was evident, but some minute specks of dust were blown out. Upon re-assembly, the entire VSWR versus rotation curve was changed. Further improvement was obtained when compressed air was blown through the waveguide leading to the scanner (see Fig. 3). Subsequent measurements indicated that the VSWR changed after each air blast, indicating that loose particles were present in the scanner. No further measurements were made, because they would be meaningless; however, the air blast resulted in a definite improvement. Subsequent investigation indicated that metallic dust and chips had entered the scanner through inspection holes at the small end. These particles had probably been formed when the pulley on the scanner motor drive shaft shifted so as to rub on the casting supporting the motor. Considerable wear is evident at that point, and various mechanical failures had occurred in that region (see Table I). All loose dust was cleaned out of the scanner drive pulley region, and the pulleys are now being inspected regularly to prevent a recurrence of this condition.

Metallic dust particles, which have entered the small end of the scanner through holes in the end casting behind the drive pulley, are causing higher than normal VSWR in the scanner. The particles probably were introduced while the pulley on the scanner drive motor was rubbing on the end of the scanner casting. The presence of the metallic particles in such critical locations as the chokes, rotary joint, and waveguide radiator probably accounts for arcing in the scanner and subsequent failure of the pressurizing windows which had been observed previously.

2. The small end of the scanner should be tightly sealed against the entry of dust, oil, and metal particles, since there is a pressure differential along the axis of the scanner under operating conditions which tends to draw foreign material into the scanner through holes now open in the end casting.

3. The scanner rotor should be removed at a suitable date, and all foreign material removed from the interior of the scanner.

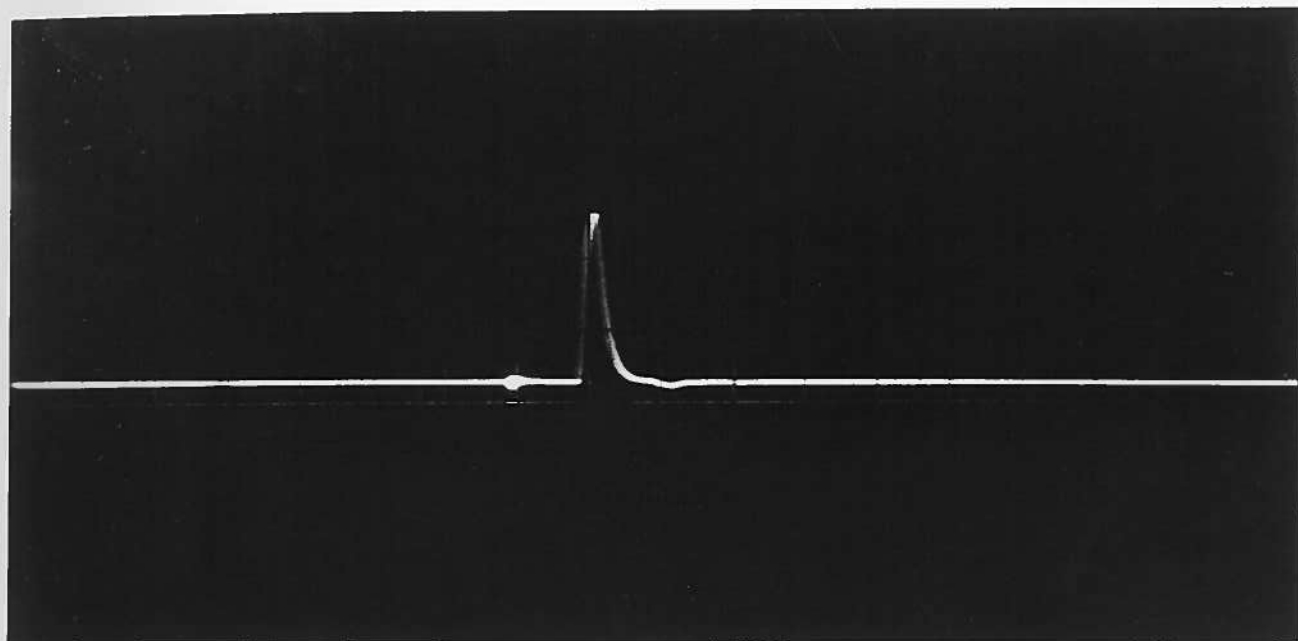
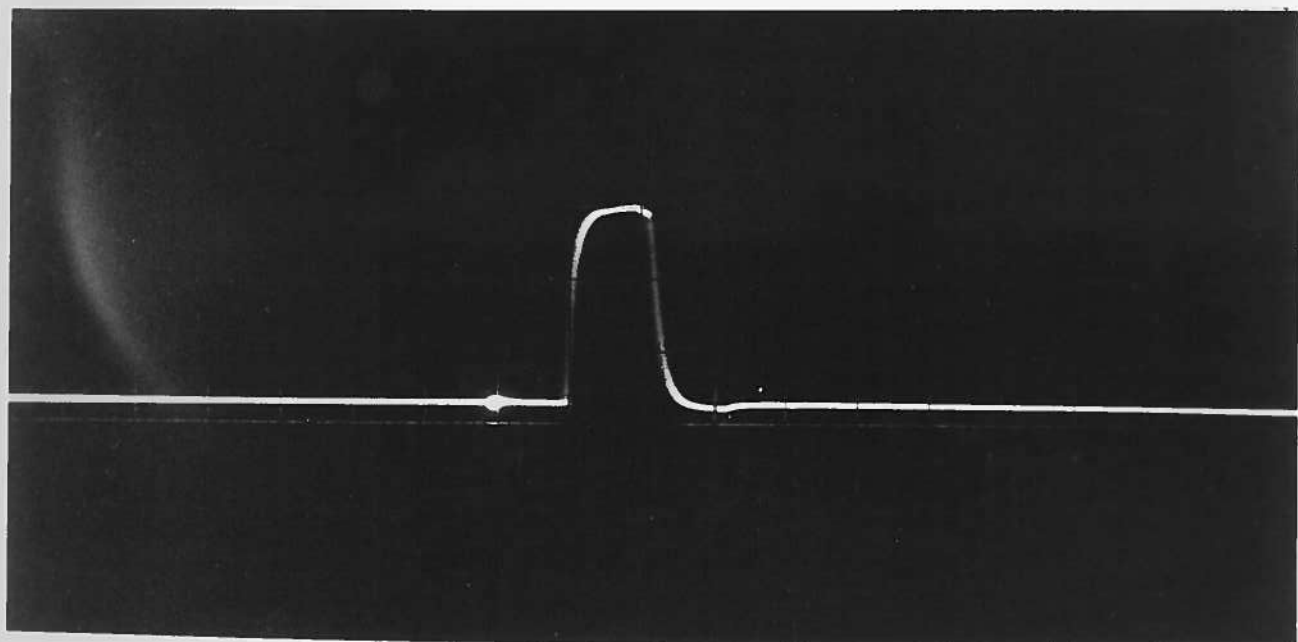
The output pulse from a Hewlett-Packard 212A pulse generator was applied to the input of the video amplifier, using a 50-ohm termination at the point of entry of the signal to the video chassis. The pulse was then observed on the radar cathode-ray tube using the type-A display (see Plates I and II). The sweep length displayed in all plates is 2000 meters. The rise time from the 0 to 90% points was estimated to be 0.25 μ sec. This was confirmed by using the range marker to determine the range interval between these points, range readings of 32 to 40 meters being obtained. ($C/2 = 150$ meters/ μ sec, where C = velocity of light; thus 0.25 μ sec corresponds to $37\frac{1}{2}$ meters.) Plates III and IV show the shape of the transmitter pulse on the "A-scope" display, while Plate V shows the shape of signals obtained from stable permanent echoes. The poor video amplifier rise time is evident from these plates.

The "A" video amplifier rise time is 0.25 to 0.3 μ sec and the "B" video amplifier rise time is approximately 0.17 μ sec. This makes precise determination of the range of an echo difficult. The stages causing this pulse distortion have been isolated.

PLATE I OUTPUT OF "A" VIDEO AMPLIFIER
WITH 0.2 μ sec PULSE INPUT

PLATE II OUTPUT OF "A" VIDEO AMPLIFIER
WITH 1.0 μ sec PULSE INPUT

4. The video amplifier bandwidth should be increased as soon as possible to decrease the pulse rise time.

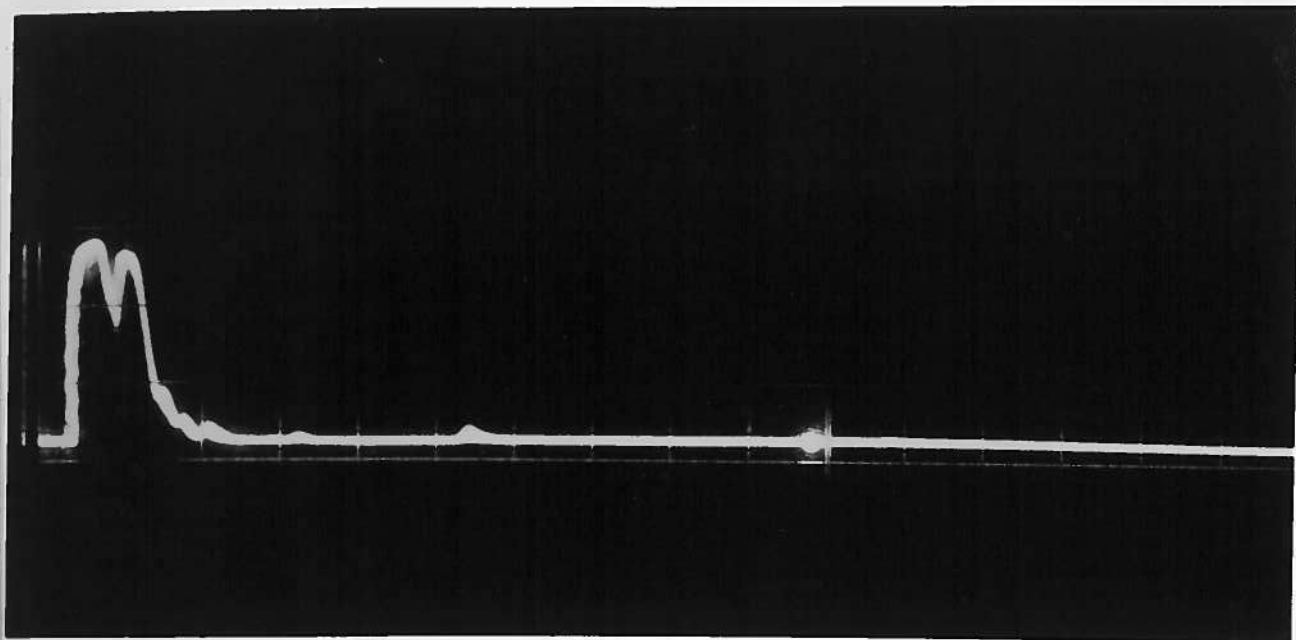
PLATE III OUTPUT OF "A" VIDEO AMPLIFIER
SHOWING TRANSMITTER PULSE AT LOW GAIN SETTING

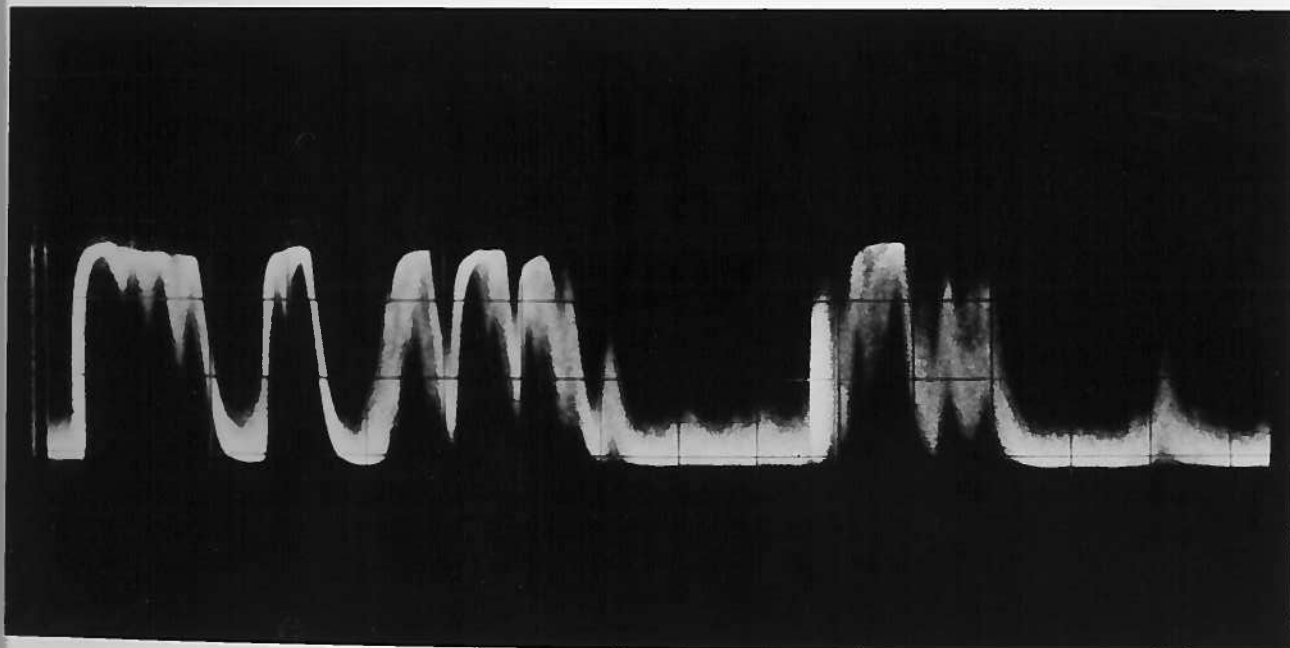
PLATE IV OUTPUT OF "A" VIDEO AMPLIFIER
SHOWING TRANSMITTER PULSE AT NORMAL GAIN SETTING

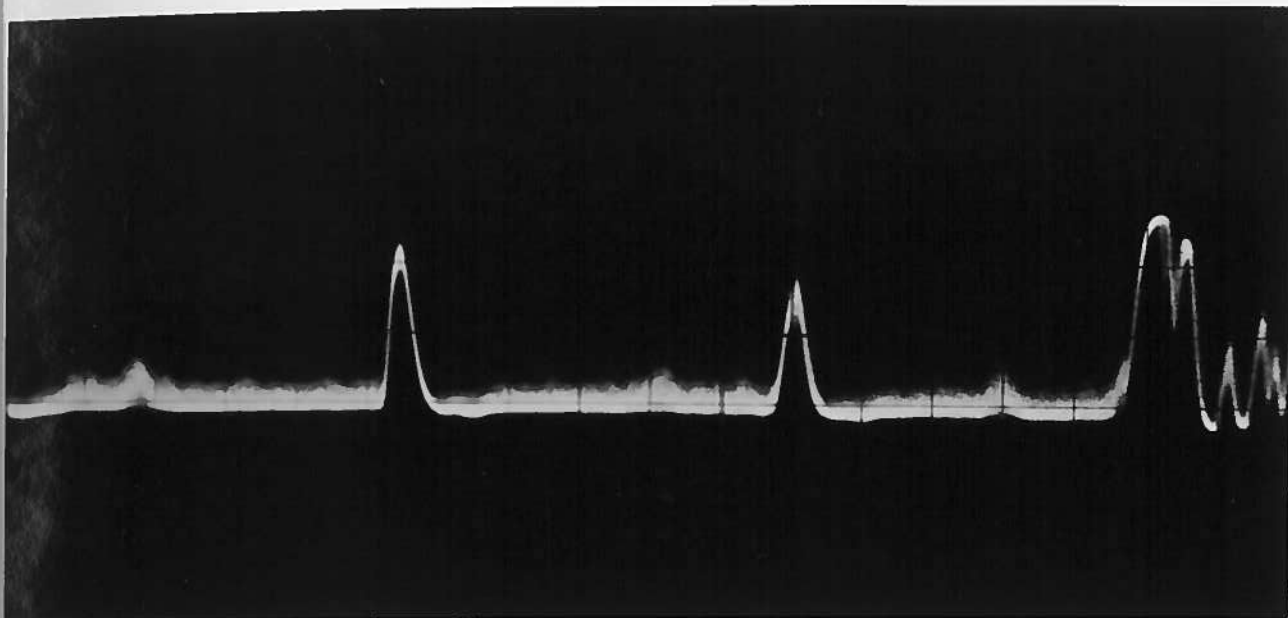
**PLATE V OUTPUT OF "A" VIDEO AMPLIFIER
SHOWING STABLE PERMANENT ECHOES**

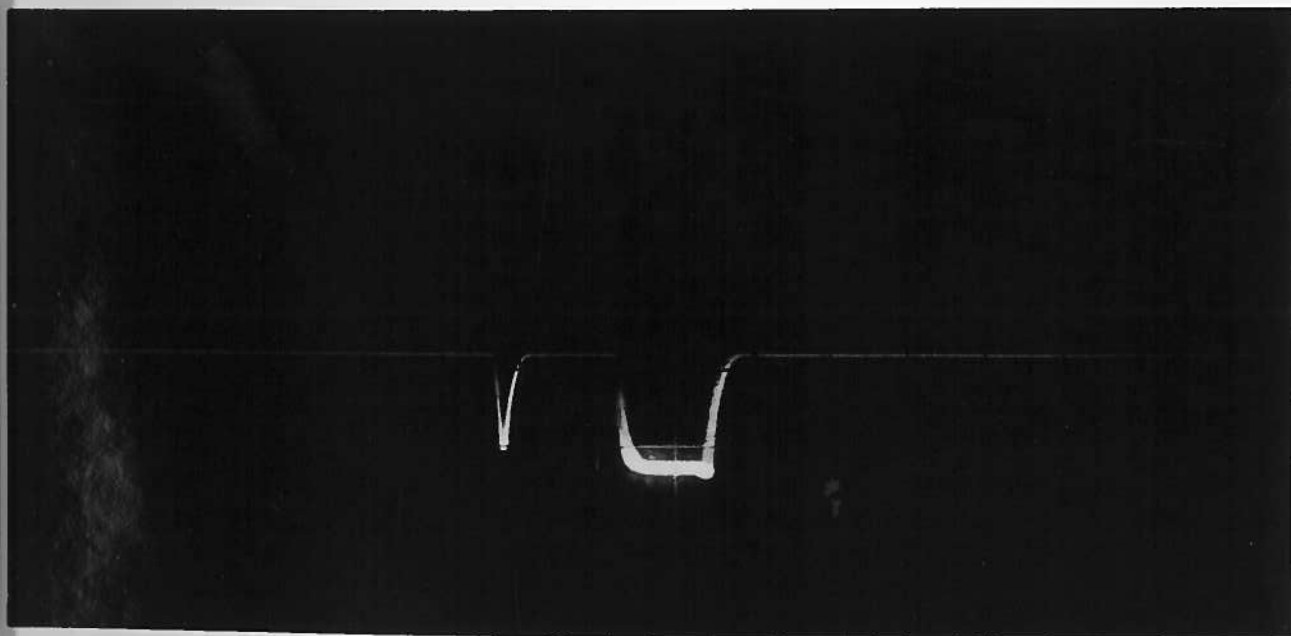
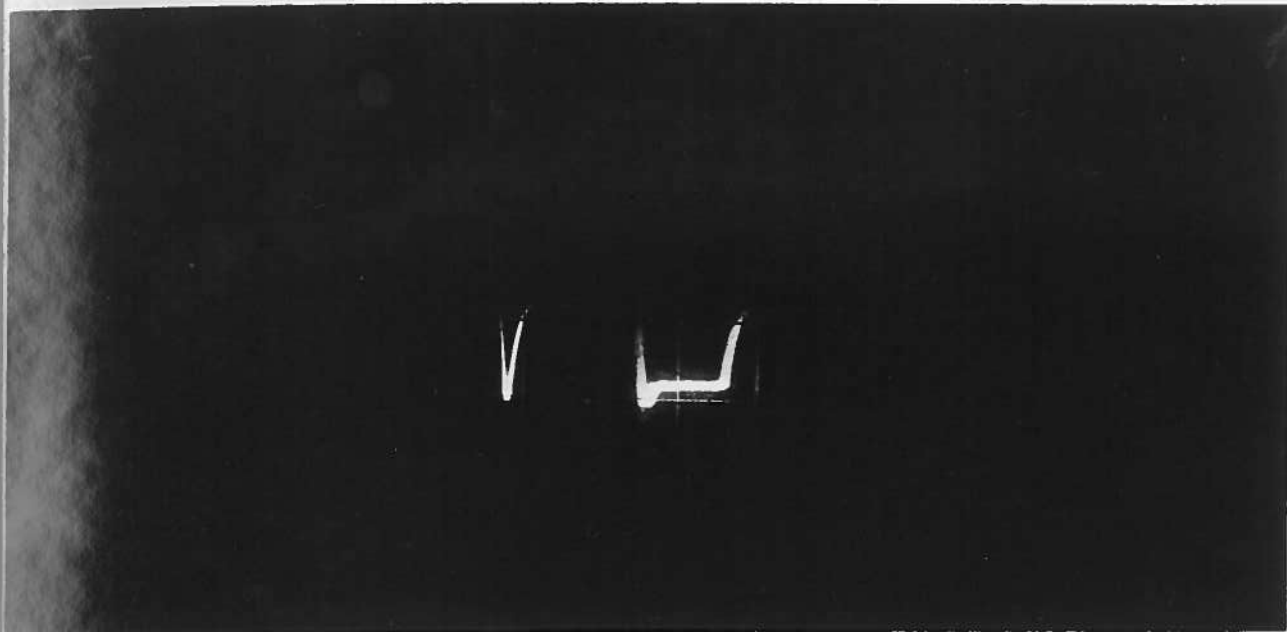
The output of the B amplifier (J18) was applied to the A-scope plates (J12), the A-B changeover relay actuated by an external jumper and video pulses applied as in (i) above from the pulse generator. (Jack numbers refer to Canadian Arsenal Limited video amplifier schematic drawing.) It was then observed that the rise time of signals from the B amplifier depended on the signal level. For signals above limit level, the rise time was approximately 25 meters (0.17 μ sec) (see Plate VI). For signals below limit level, the rise time was reduced to perhaps 15 meters (0.1 μ sec) (see Plate VII).

**PLATE VI OUTPUT OF "B" VIDEO AMPLIFIER ABOVE LIMITING.
MARKER AND 1.0 μ sec PULSE VISIBLE (NEGATIVE PULSES)**

PLATE VII OUTPUT OF "B" VIDEO AMPLIFIER BELOW LIMITING.
MARKER AND 1.0 μ sec PULSE VISIBLE (NEGATIVE PULSES)

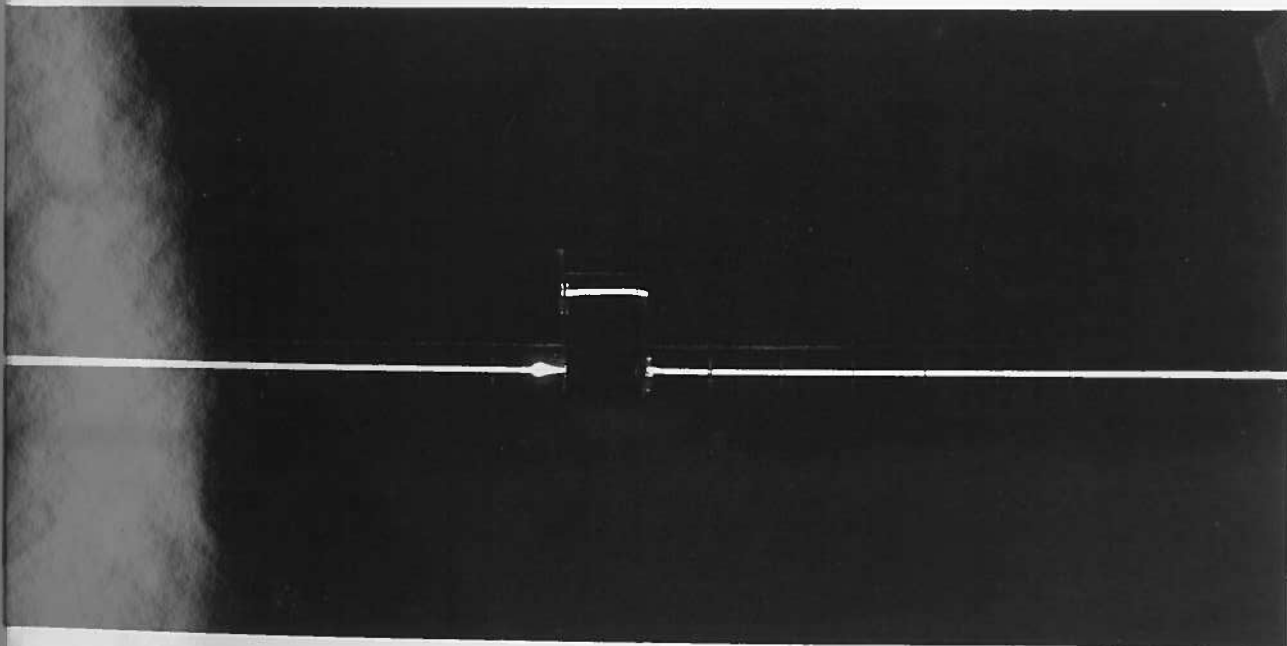
Essentially zero rise time was observed under condition (i) (see Plate VIII). When the signal was applied to the marker channel, the rise time observed on the cathode-ray tube was approximately $0.1 \mu\text{sec}$. There was no change in rise time when the pulse was applied to J14 as compared with input to the normal video input jack. From this evidence it may be concluded that the first stage of the video amplifier does not contribute appreciably to the pulse distortion, and that the bandwidth following the marker input is fair. The deterioration of the pulse, therefore, occurs in the intervening two stages.

PLATE VIII OSCILLOGRAM OBTAINED WHEN 1.0 μ sec PULSE
IS APPLIED TO CRT PLATES
