## **Report on Renfrew Cold Storage Plant**

# TECHNICAL NOTE

DATE June, 1953.

#### SUBJECT Report on Renfrew Cold Storage Plant

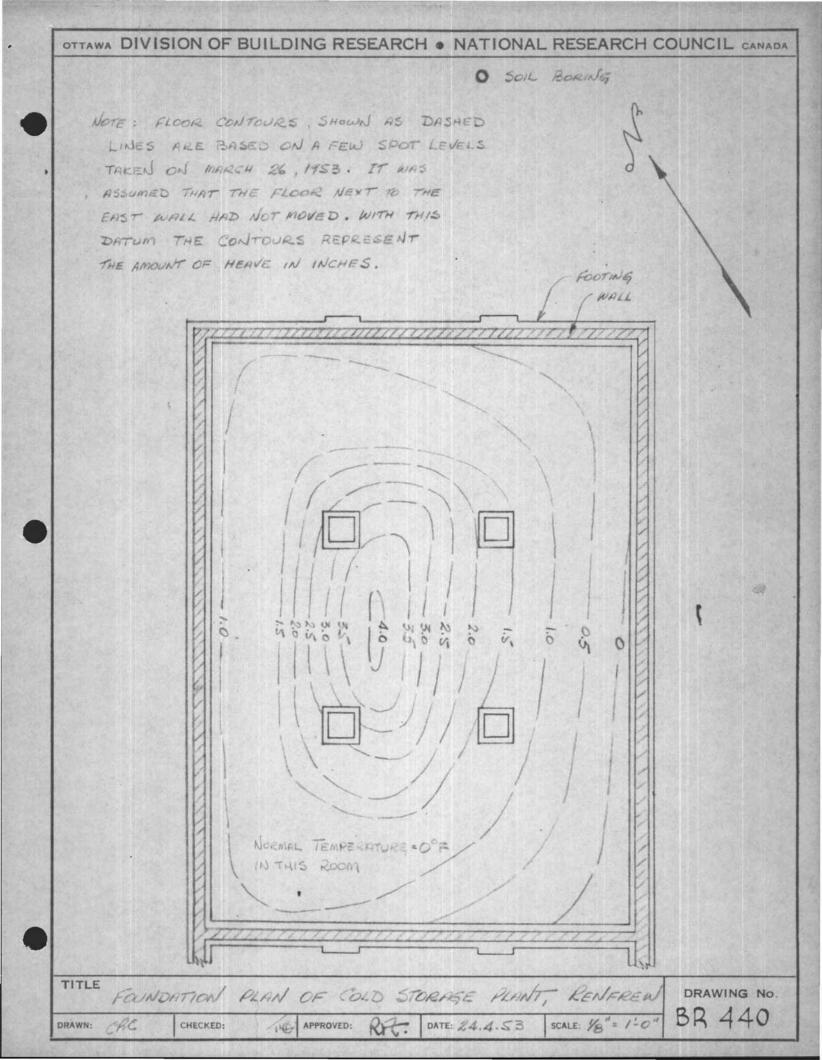
# PHOTOGRAPHS TAKEN AT RENFREW COLD STORAGE PLANT

The exterior of the building is practically undamaged except for cracks at the northwest and northeast corners and two small cracks along the east wall. Level readings on the exterior of the perimeter footing indicate little, if any, differential movement around the building. A maximum variation of about 1/2 inch was found in the elevation of this footing.

Damage is most evident inside the cold room. Around the centre of the room, the floors are badly cracked and heaved. Along part of the northeast wall the ceiling and the wall have separated by about one inch vertically.

N.E. Corner Looking West

N.W. Corner Looking South

Interior Floor Cracks Looking South

East Wall Looking West
