Corrosion Behaviour of Metal-Coated Panels at Eight Canadian Locations - Summary of a Fourteen-Year Program

CORROSION BEHAVIOUR OF METAL-COATED PANELS AT EIGHT CANADIAN LOCATIONS. SUMMARY OF A FOURTEEN-YEAR PROGRAM

Technical Paper No. 354
of the
Division of Building Research

Ottawa
October 1971

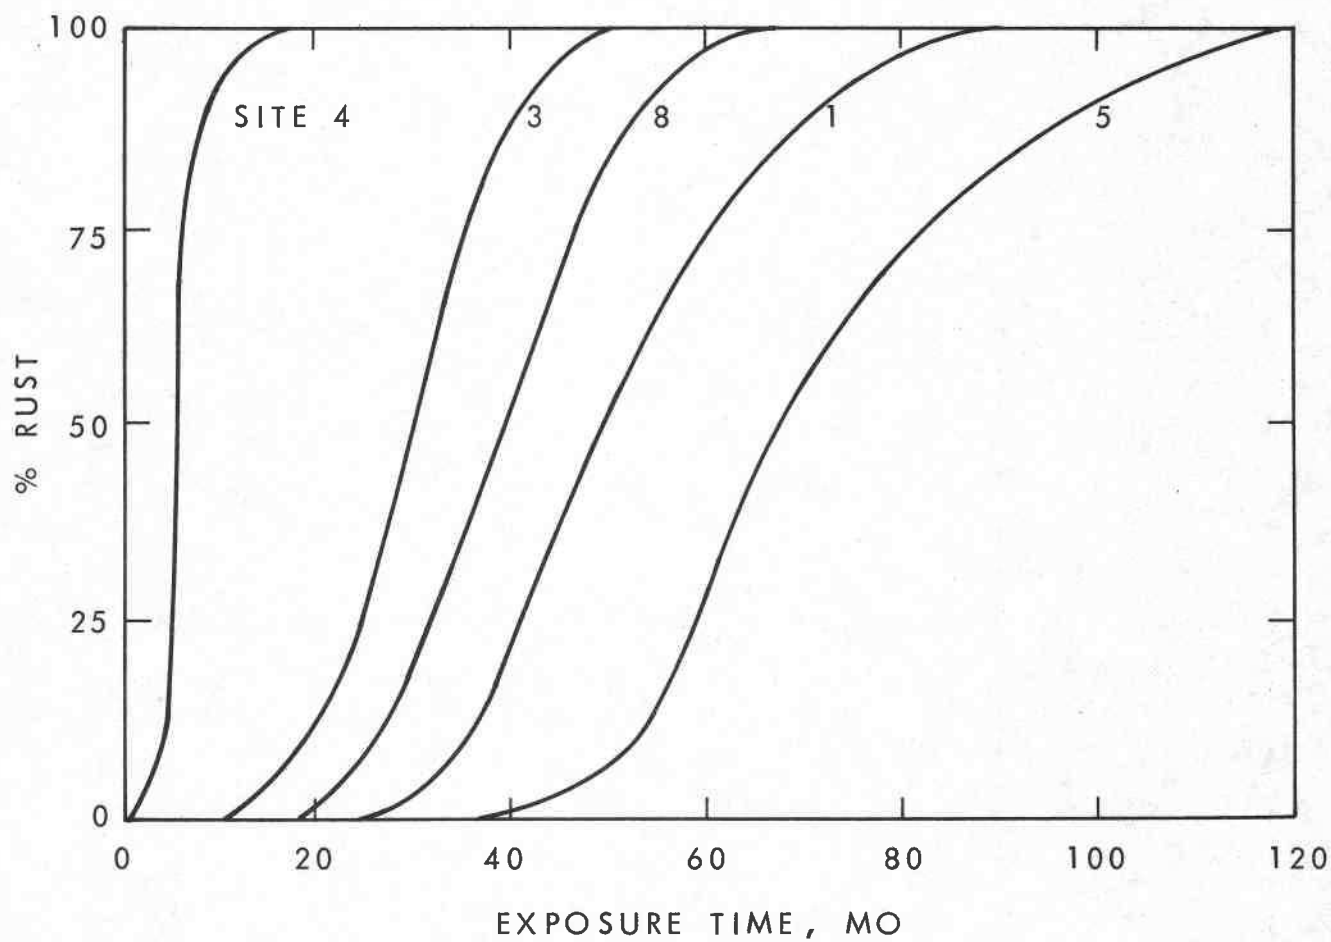
FIGURE 1
PERFORMANCE OF CADMIUM ELECTROPLATED STEEL : A-6

8. Cadmium electroplated steel (A-6). Coatings have failed at all sites except No. 2 (Saskatoon), 6 (Norman Wells), and 7 (Esquimalt). The thinness of the coatings is responsible for their relatively short service lives.

5. Thin cadmium coatings, as applied to the A-6 panels, have relatively short service lives at all but the non-aggressive rural locations. Similar coatings are applied in practice to fasteners, small stampings and miscellaneous small articles.

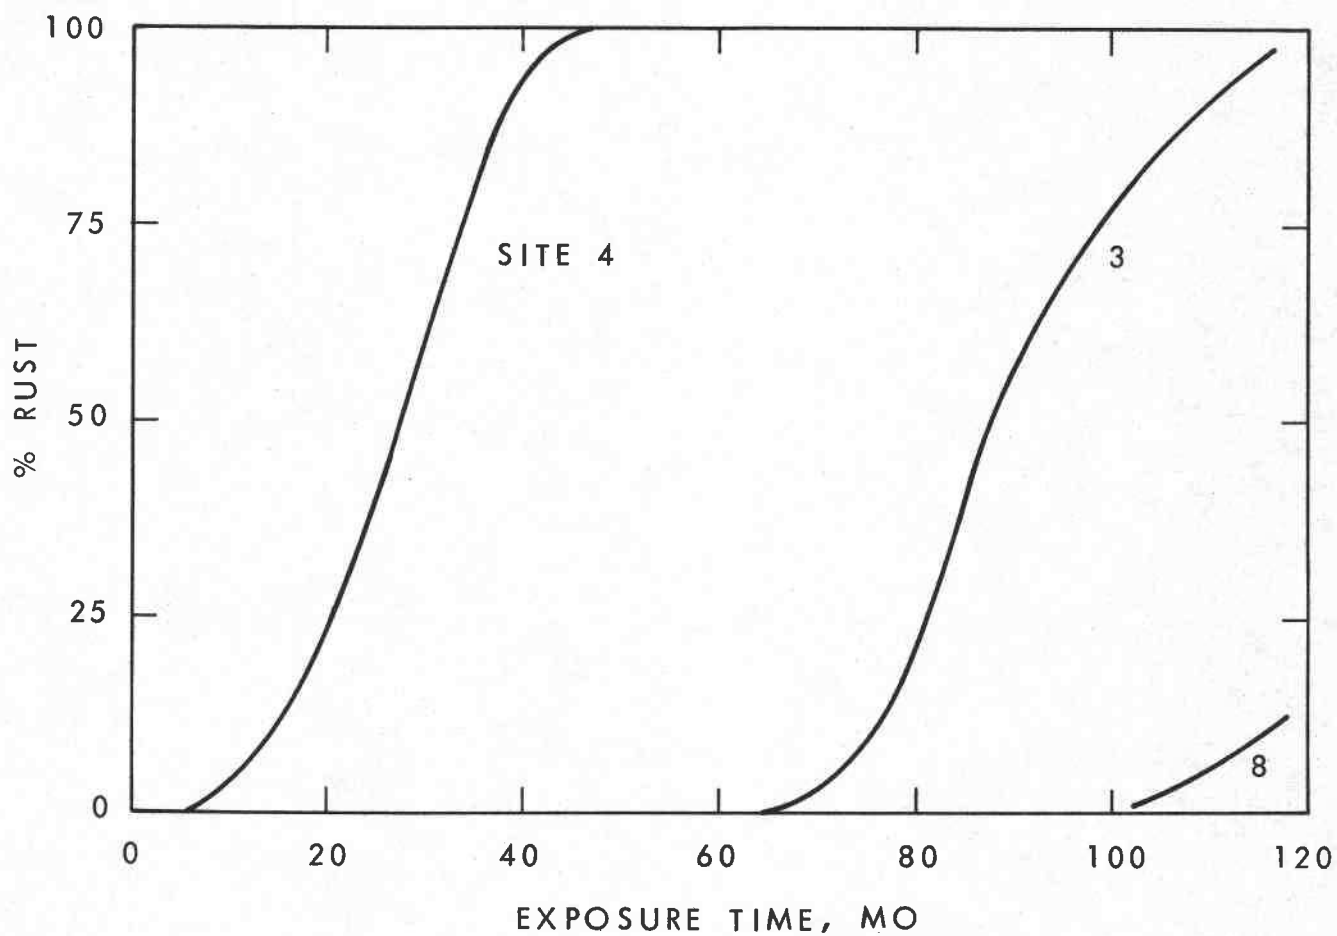
FIGURE 2
PERFORMANCE OF HOT-DIP GALVANIZED STEEL : B - 6

6. Hot-dip galvanized steel (B-6). Coatings have completely failed at Sites 3 (Montreal) and 4 (Halifax); base metal rusting has begun at Site 8 (Trail); alloy stain is present at Sites 1 (Ottawa), 5 (York Redoubt) and 8; elsewhere the coatings are intact and free from defects. This coating differs from the other zinc coatings under test in that it has a composite structure. Iron-zinc intermetallics are present as a distinct layer adjacent to the basis steel; a pure zinc layer overlays these. With this type of coating, once the zinc layer has been consumed, the iron-zinc alloys

corrode to produce yellowish-orange coloured products. This accounts for the "alloy stain" terminology above. Alloy stain is an appearance defect and is not indicative of base metal attack.

Coating thickness on the B-6 panels is 2+ mils. They were exposed on the same dates as the thinner B-7 panels, and contrary to expectations, showed earlier failure at Montreal and similar life at Halifax. The accelerating effect of sacrificial corrosion adjacent to cut edges probably accounts for this.

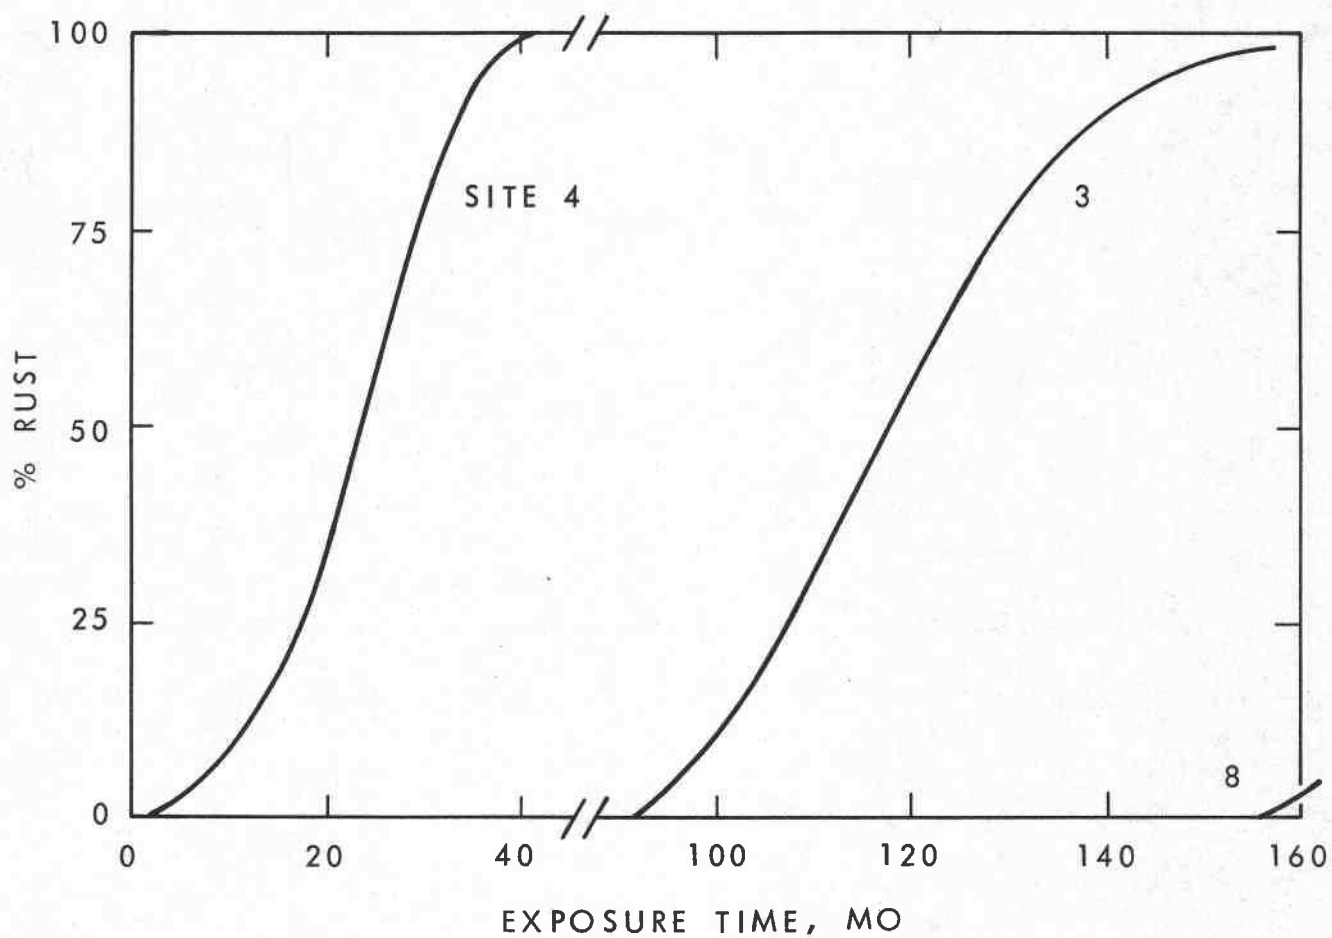
FIGURE 3
PERFORMANCE OF ZINC ELECTROPLATED STEEL : B-7

5. Zinc electroplated steel (B-7). Coatings have completely failed at Sites 3 (Montreal) and 4 (Halifax); first signs of failure are evident at Site 8 (Trail); elsewhere coatings are intact and free from defects. If one considers a criterion of 50 per cent rust as failure, the service lives of coatings at Montreal and Halifax are as might be estimated from a knowledge of corrosion rates for zinc developed during the first ten years of exposure of these panels (0.130 and 0.532 m.p.y. respectively (2)) and the applied coating thickness (1.5 mils average).

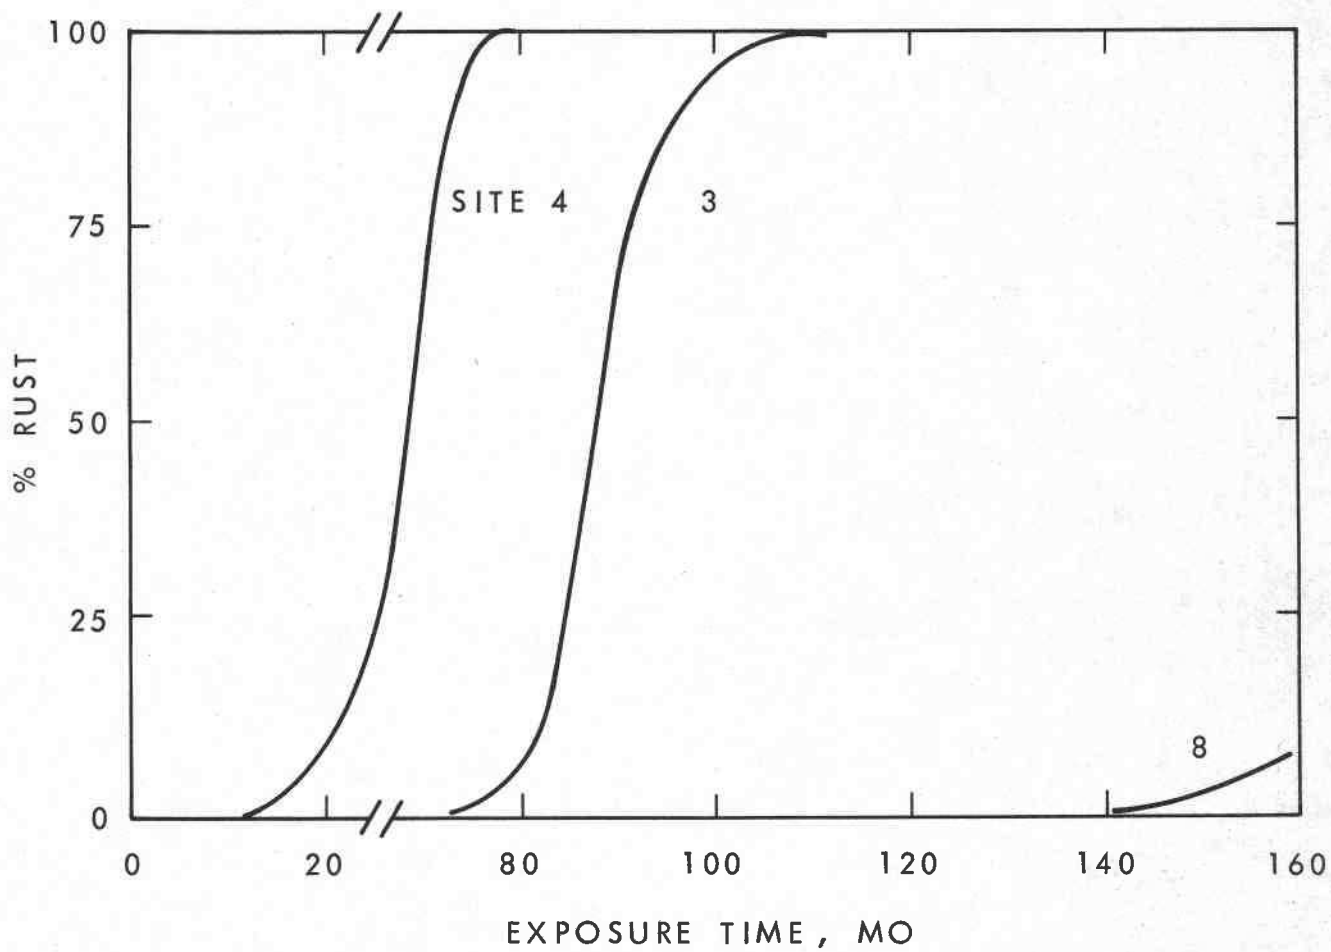
FIGURE 4
PERFORMANCE OF CONTINUOUS GALVANIZED STEEL : B-9
BR4812 - 4

7. Continuous galvanized steel (B-9). Coatings have completely failed at Site 3 (Montreal) and 4 (Halifax); first rusting has begun at Sites 8 (Trail), 1 (Ottawa) and 5 (York Redoubt) -- traces of rust at the edges only are present at the latter two; elsewhere the coatings are intact and free from defects. Performance, as compared to series B-6 and B-7, was better than expected. The improvement could be due to deviation from the reported nominal coating thickness of one mil and/or a different exposure date (1956 rather than 1955). Documentation in the technical literature (3, 4) suggests that climatic conditions prevalent at the time of initial exposure can exert marked effects on the initial corrosion rate of zinc and that these can persist for long periods of time. Thus, rates can vary from exposure period to exposure period, even though they overlap time-wise.
