### Condensation in flat roofs, II Kuester, G. H.

CONDENSATION IN FLAT ROOFS, II

Internal Report No. 387

## REPORT OF TEST HUT, 1969-1970

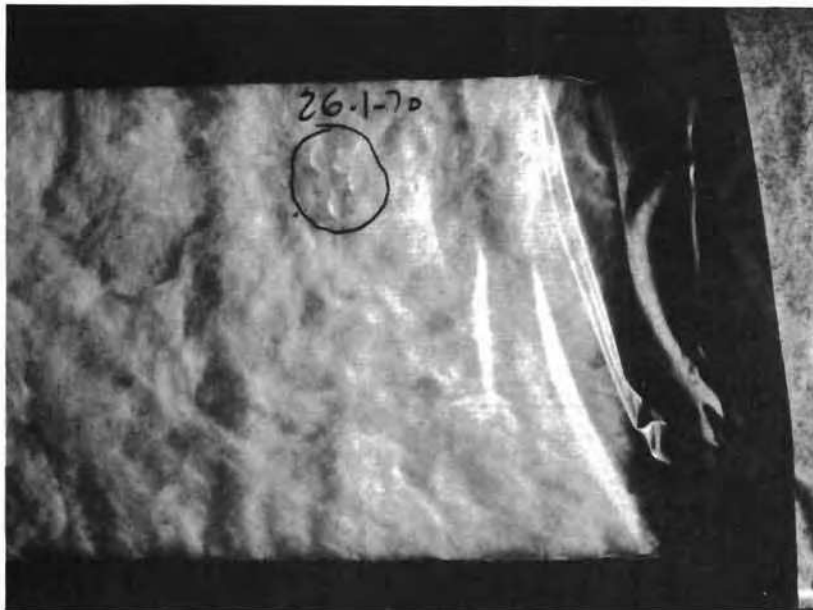
Figure 14

One small water puddle (Figure 14) was observed on a "window" of space No. 2 while stains on the vapour barrier paper of the insulation of spaces 1 and 3 indicated that water had accumulated at some time during the test. The quantity of water collected on the paper was relatively small. Nevertheless the existence of water and the increase in the moisture content of the roof deck proves that moisture from within the building had migrated into the space above the vapour barrier paper on the insulation and had condensed inside the insulation or on the roof deck of panel A. All joints between the insulation batts and ceiling joists were carefully sealed with tape. Air leakage, therefore, would have to be ruled out as a force in moving vapour into the space. It is suggested that vapour diffusion through the paper backing and through and from the wood joists would account for this moisture.

Panel A, space 2. Small water puddle on "window" indicates that condensation on roof deck had occurred.

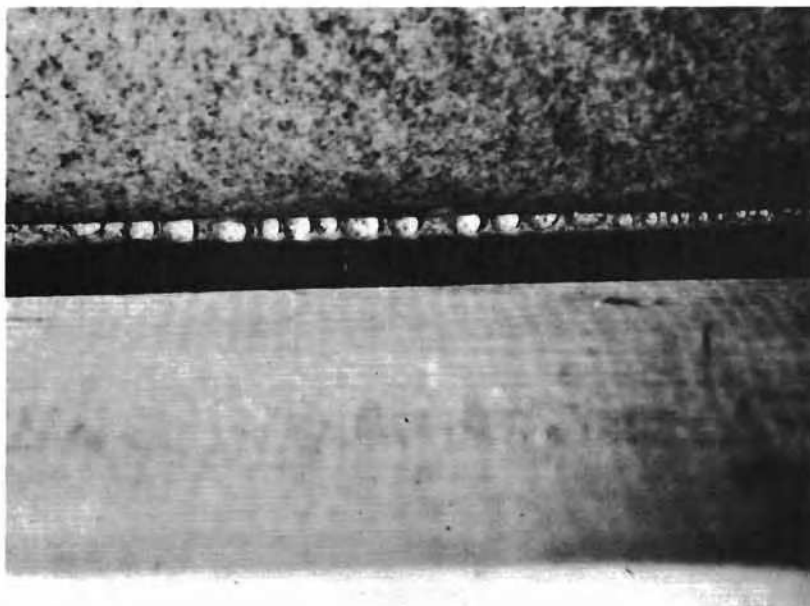
Figure 15

Panel A, space 3. Water droplets on paper backing of insulation where insulation taped to ceiling joists.

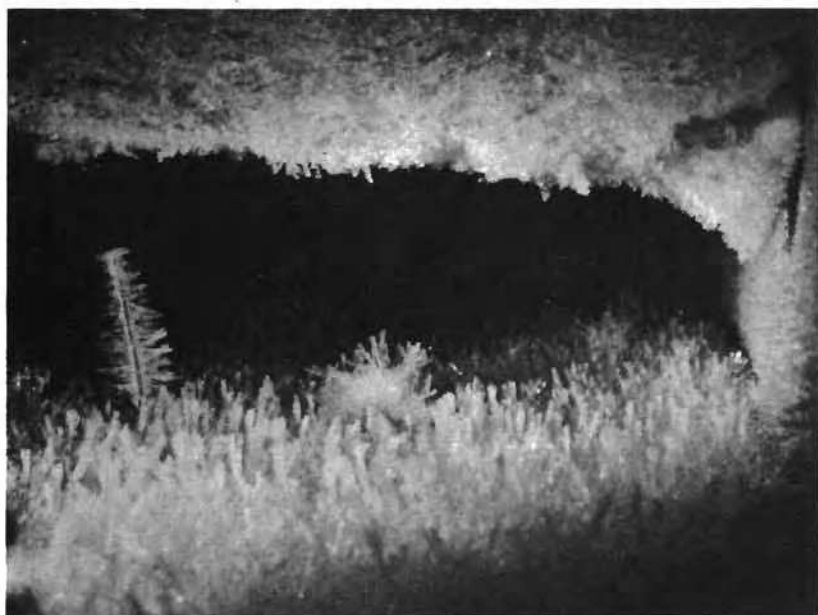
Figure 17

Heavy condensation was observed from November 1969 to the middle of February 1970, both on the roof deck and on the top layers of the insulation (Figures 17 and 18). The insulation was never dry during this period. Large water puddles were observed on top of the polyethylene vapour barrier in all three spaces of panel D (Figures 19, 20). The water was drained from space No. 10 twice during the test period. The amount on December 9, 1969 was 1,250 ml and on January 27, 1970 almost the same quantity was drained. No measurement of the water retained in the insulation after drainage was possible.

Panel D, space 11. Condensation on roof deck and top of insulation.

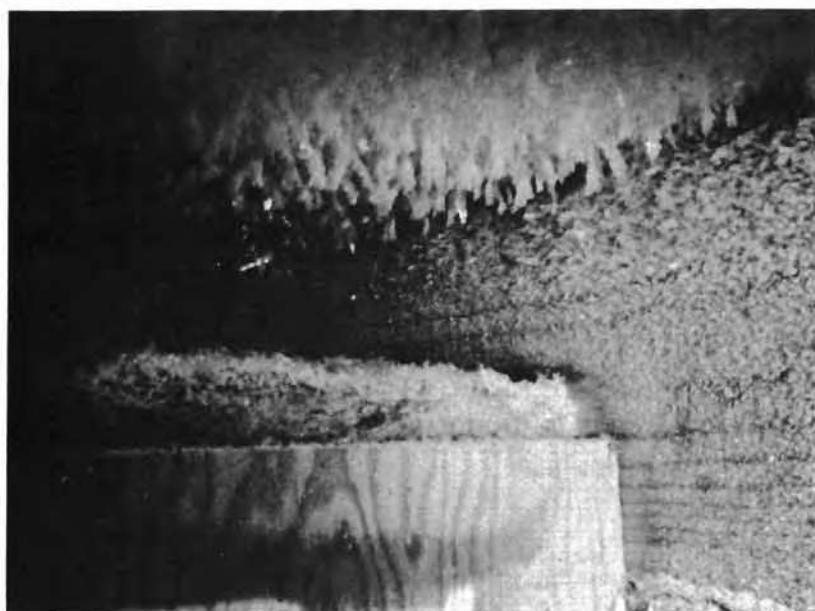
Figure 18

Panel D, space 11. Condensation on roof deck ceiling joists and top of insulation.

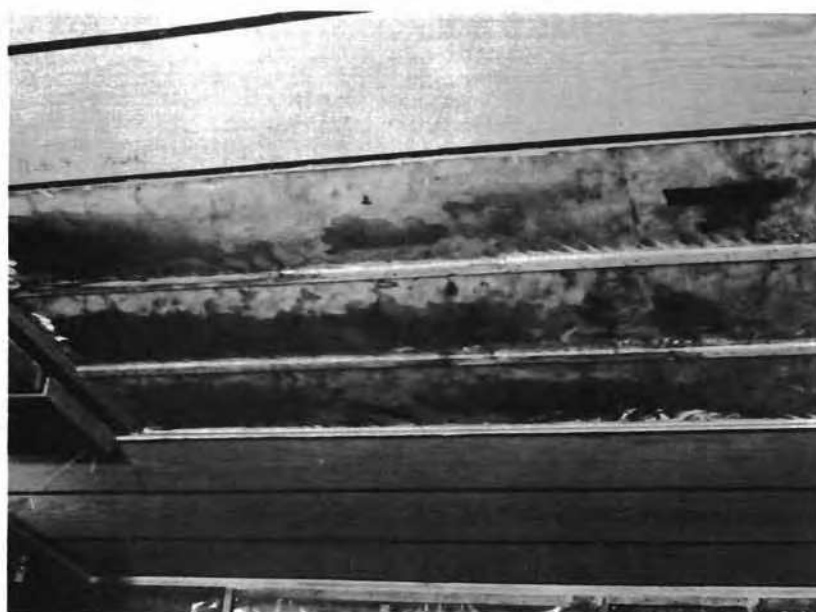
Figure 19

Panel D, spaces 10, 11, 12. Water from condensing surfaces accumulates on top of polyethylene.

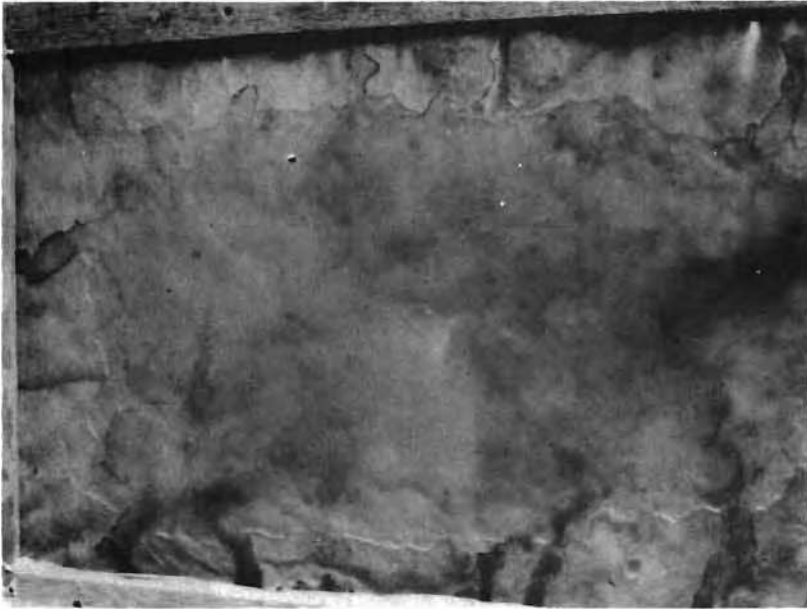
Figure 20

Panel D. Close-up of Figure 19.

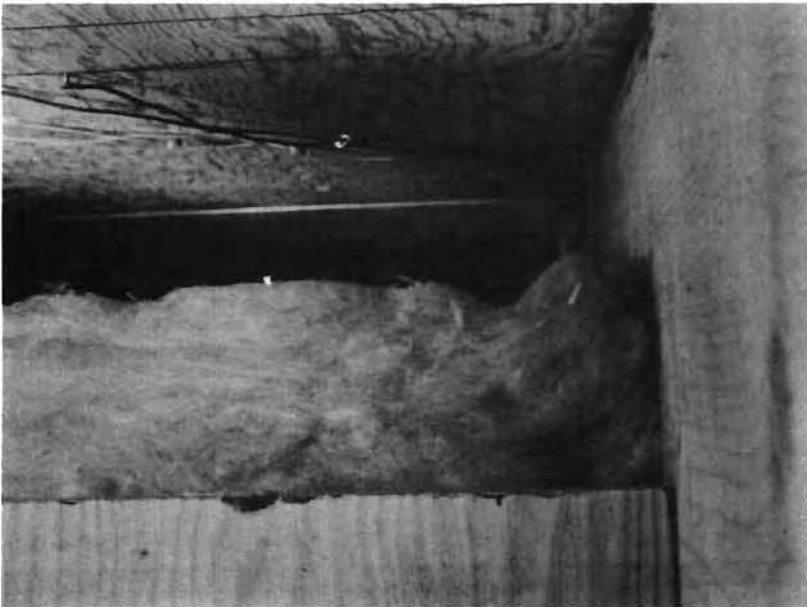
Figure 21

6-mil polyethylene film, panel C  $\frac{1}{4}$ -in. plywood sheet. Throughout the test period it was observed that no condensation in the form of frost or water occurred inside these panels (Figure 21). The moisture content as measured at the moisture meter pins remained constant at 11 to 12.5 per cent (Figure 7). The pins near the exterior walls had a slightly higher reading ( $\frac{1}{2}$  per cent) than the pins in the centre and near the centre of the building.

Panel C. Airtight ceiling, no condensation throughout winter.

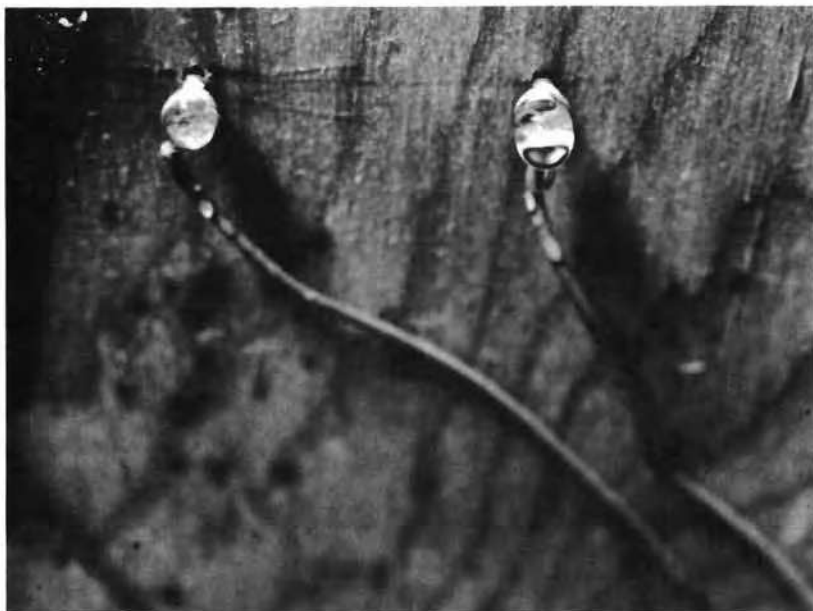
Figure 22  
Panel D, space 11. Fungus on  
wet roof deck.

Fungi or mold was observed near the south end of the test panel (Figure 22) and subsequently analyzed to be of a kind known not to deteriorate wood (coadostorium species).

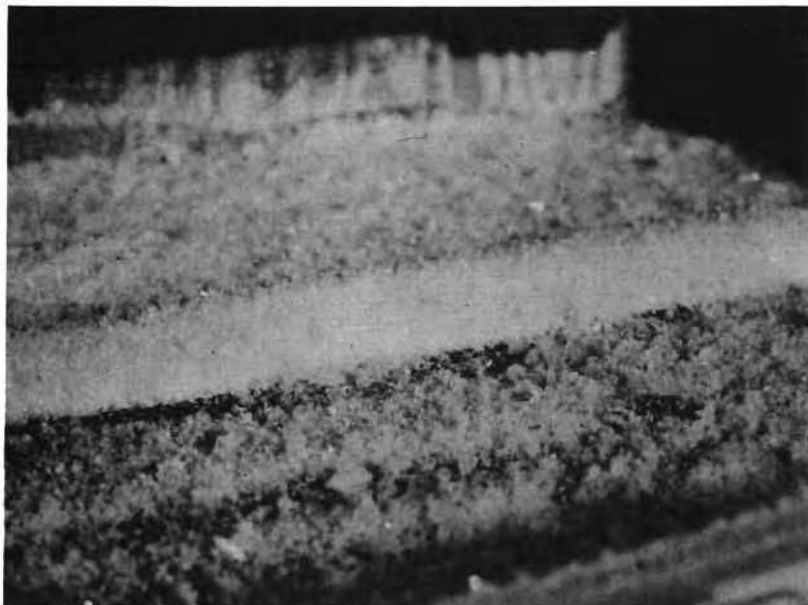
Figure 24

Panel D, space 11. Frost on fly screen of soffit ventilation.

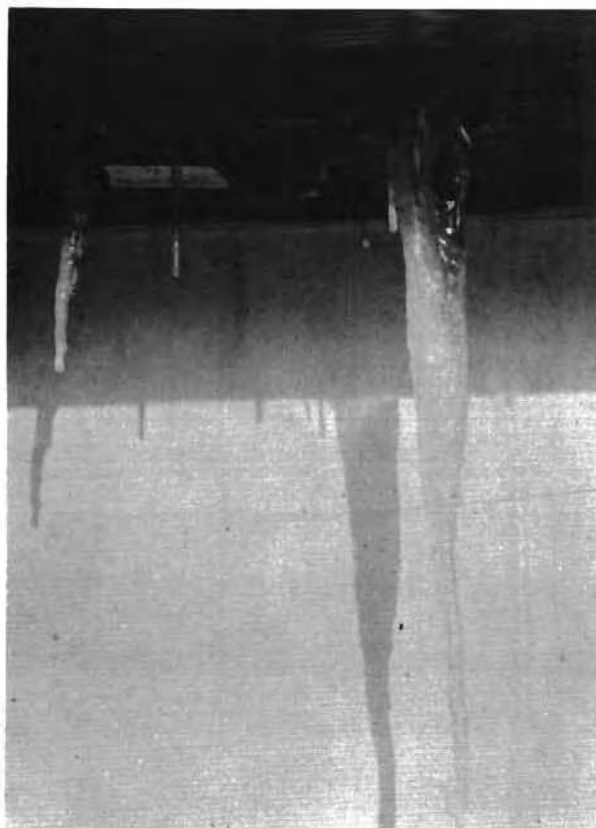
Figure 25

Panel D, space 12. Icicles, indication of air leakage into roof space.
