REPORT ON THE NICOLET LANDSLIDE OF
NOVEMBER 1955

by
C.B. Crawford and W.J. Eden

Report No. 128
of the
Division of Building Research

OTTAWA
August 1957

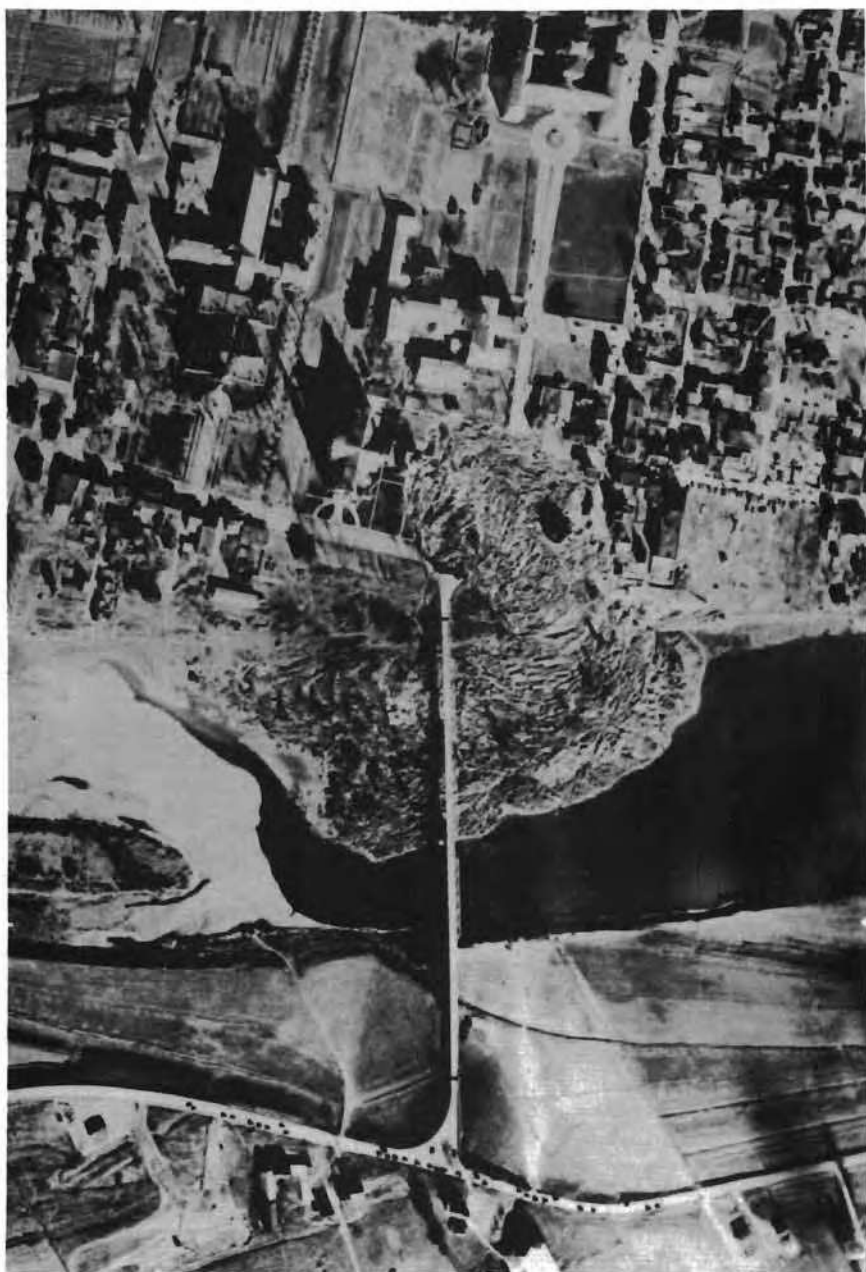
Figure 1 Airphoto of Nicolet landslide

Fortunately, during the summer of 1955, aerial photographs of Nicolet were made and, just a few days after the slide, the area was rephotographed. This has made it possible to study features of the slide both before and after the failure. Figure 1 shows an aerial view of the slide and Fig. 2 is a sketch made from this photograph showing the crater, the relative position of structures and vegetation before the slide, the general outline of debris after the slide and the

In the one-day visit, it was impossible to make more than a general reconnaissance of the area and obtain a few soil samples. It was unfortunate that the visit was not possible until approximately 6 months after the failure since the significant features of the flowed material had been destroyed during this interval. The mode of failure however, can be inferred from a study of aerial photographs.

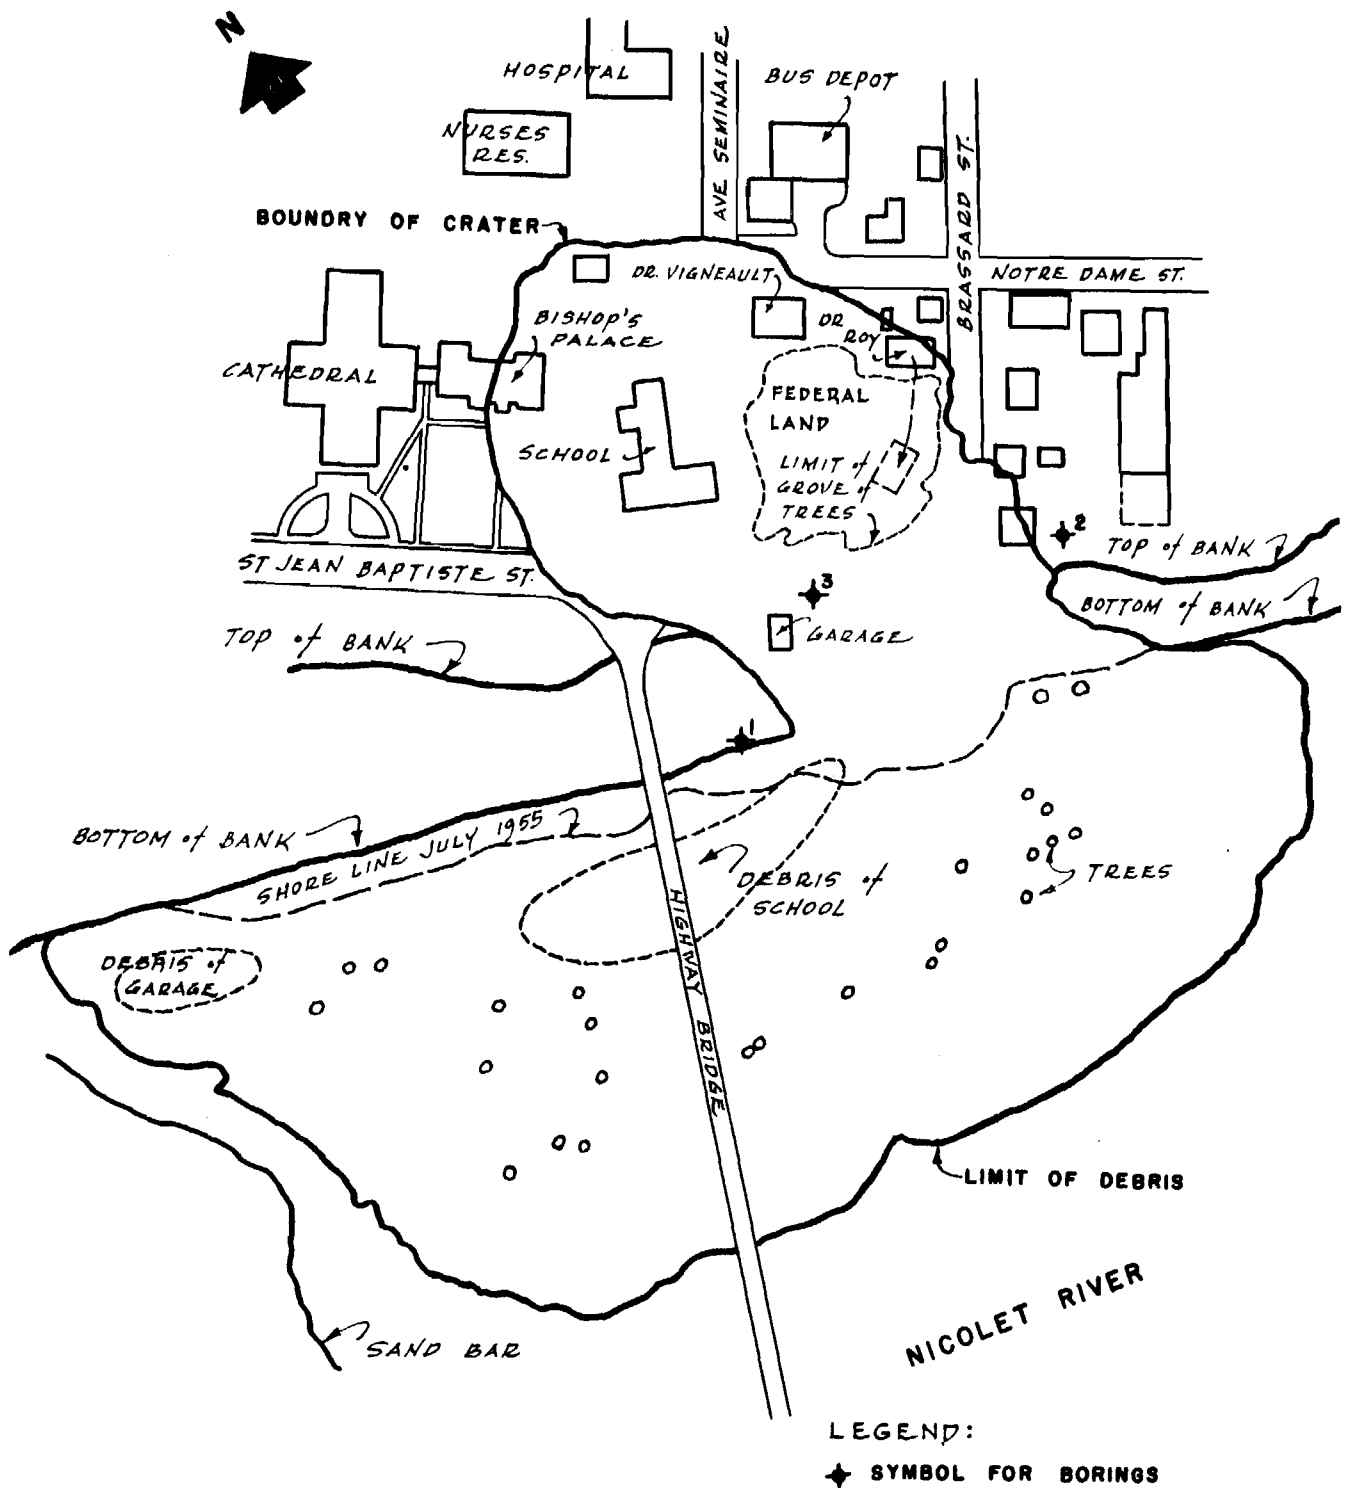
FIGURE 2
PLAN OF NICOLET LANDSLIDE - NOV. 1955

Boring No. 1 (see Fig. 2) was put down by the river's edge near the northeast edge of the mouth of the crater from elevation 28 to elevation 13. Boring No. 2 was located near the crest of the river-bank south of the crater. It extended from elevation 50 to elevation 35. A third boring was made in the slide crater to obtain a sample of the clay involved in the slide. Eight samples were obtained using a 3-in. \varnothing piston sampler.

A study of the aerial photographs and of the debris in the river suggests a series of events which describe the progression of the slide. In Fig. 2 the original position of a grove of trees is shown and the final location of some of these trees is plotted in the debris. The approximate limits of the debris of the garage and school are shown. Of particular significance is the final location of rip-rap at the upstream extremity of the slide. The position of the moved rip-rap indicates a rotational movement like the opening of a gate. Also the orientation of large blocks of clay give some indication of the direction of movement. From these observations it is believed that the initial movement occurred at the upstream edge of the slide with material moving straight out into the river and flowing either way. This would be followed by retrogression until the grove of trees moved out into the river and was deflected downstream by previously flowed material. The final location of the debris of the garage suggests that it was swept away after part or all of the grove of trees had slipped into the river since it appears to have been confined to a path along the river-bank by previously flowed material. The school structure, located north of the garage, apparently followed the path of the garage until movement stopped. Finally, two occupied houses (Dr. Roy and Dr. Vigneault) and a portion of the Bishop's Palace which were destroyed by the slide, moved through a relatively short horizontal distance. Dr. Roy's house remained relatively intact as it came to rest (see Fig. 2). Other buildings involved in the slide were reduced to rubble.

Landslide or "flow" slides of this type cannot be analysed by standard methods. As a matter of interest, one cross-section of the failed river-bank was analysed by two of the standard methods and was found to have a factor of safety of about 0.6. This cross-section at the foot of Avenue du Seminaire (Section H on DPW Plan 34-58 dated 1938) had a slope of about 45° . It is apparent therefore, that any theories on the failure of this bank must be open to question until the engineering properties of the marine clay are more fully understood.
