Investigation of vibrations through soil caused by heavy vehicles in Winnipeg Sutherland, H. B.

Report (National Research Council of Canada. Division of Building Research); no. DBR-R-15, 1949-10-01

AN INVESTIGATION OF VIBRATIONS THROUGH SOIL
CAUSED BY HEAVY VEHICLES IN WINNIPEG

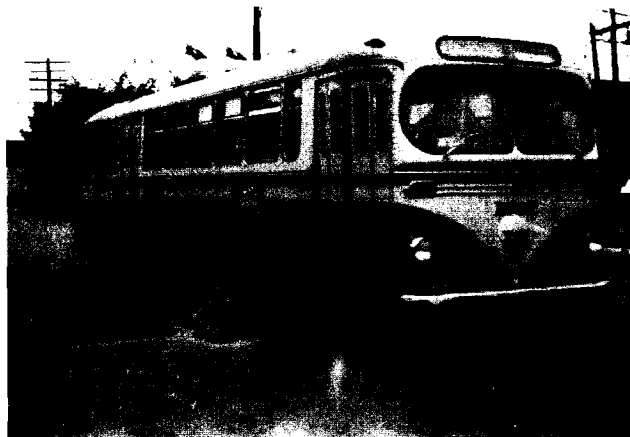
FIG. 8 BRILL TROLLEY BUS 1682
PASSING OVER $3\frac{1}{16}$ "
RAMP IN CENTRE STRIP,
NEAR SIDE.

18,510 lb., was loaded with sand bags to bring it up to a total vehicle and passenger load of 25,000 lb. The bus is shown in Figure 8, Sheet 4. The second vehicle was a gasoline bus of a type used in other transport routes operated by the Company. The test weight of this vehicle was approximately 15,000 lb. The operation of these two vehicles, at controlled speeds and under conditions of braking and acceleration, enabled control to be exercised over factors (a), (b), and (c).

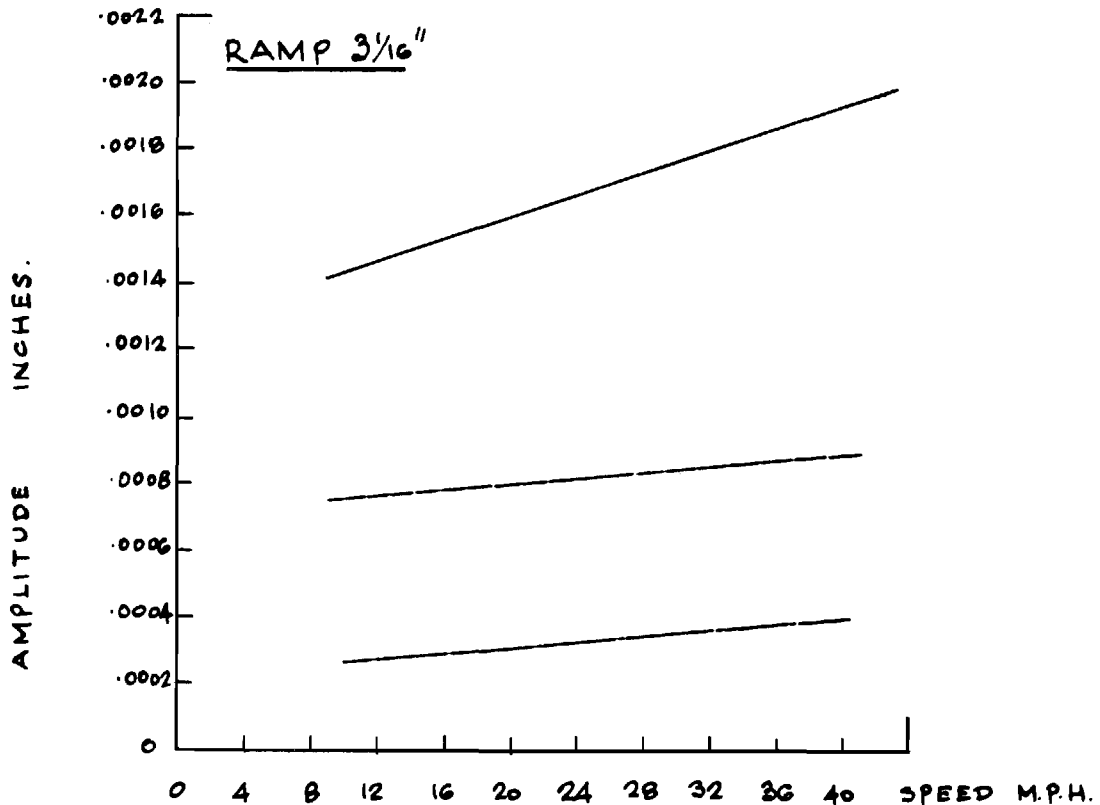
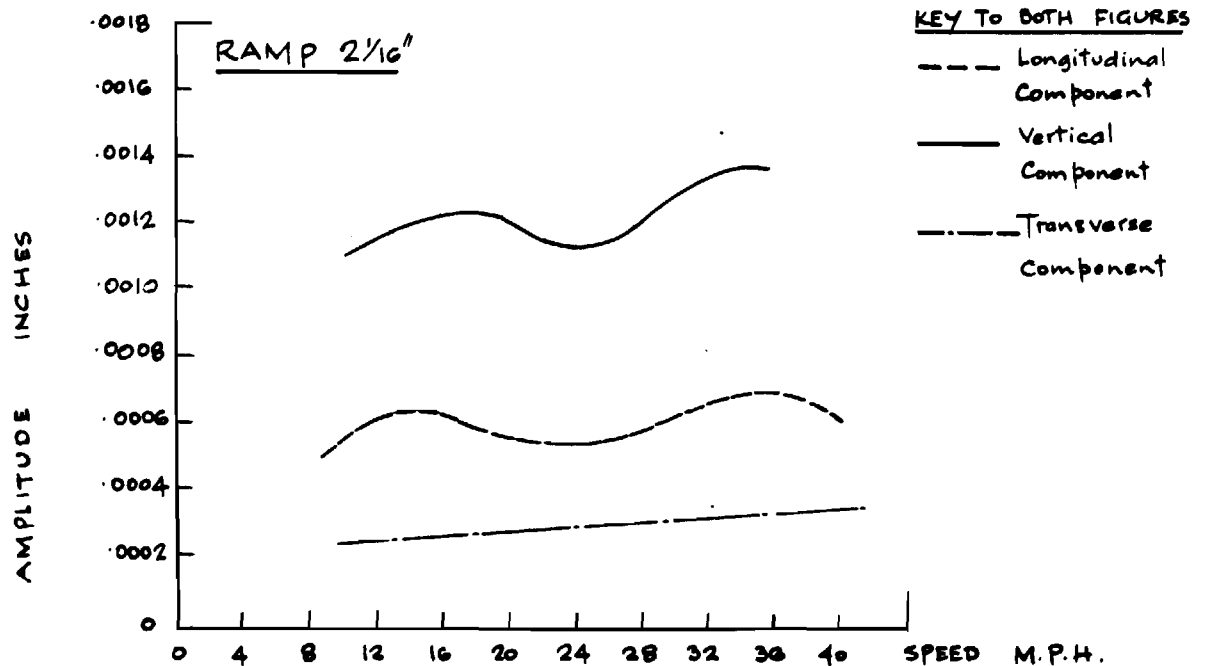
COMPARISON OF COMPONENTS OF VIBRATIONS
OUTER STRIP NEAR SIDE
VEHICLE: BRILL TROLLEY BUS 1682.

Sheets 14 and 15 give a comparison of the three components of the vibrations as the Brill trolley bus ran over various ramps placed in the outer strip, near side. These sheets show that, when observing downstairs, the vertical component is greatest, the longitudinal next, and the transverse least. Record No. 1 on Sheet 5 also shows this condition clearly. Accordingly, since the vertical component of vibration is greatest and the frequency of vibration is approximately the same in all cases, this component has been used as the basis of comparison between all tests where observations were made downstairs.

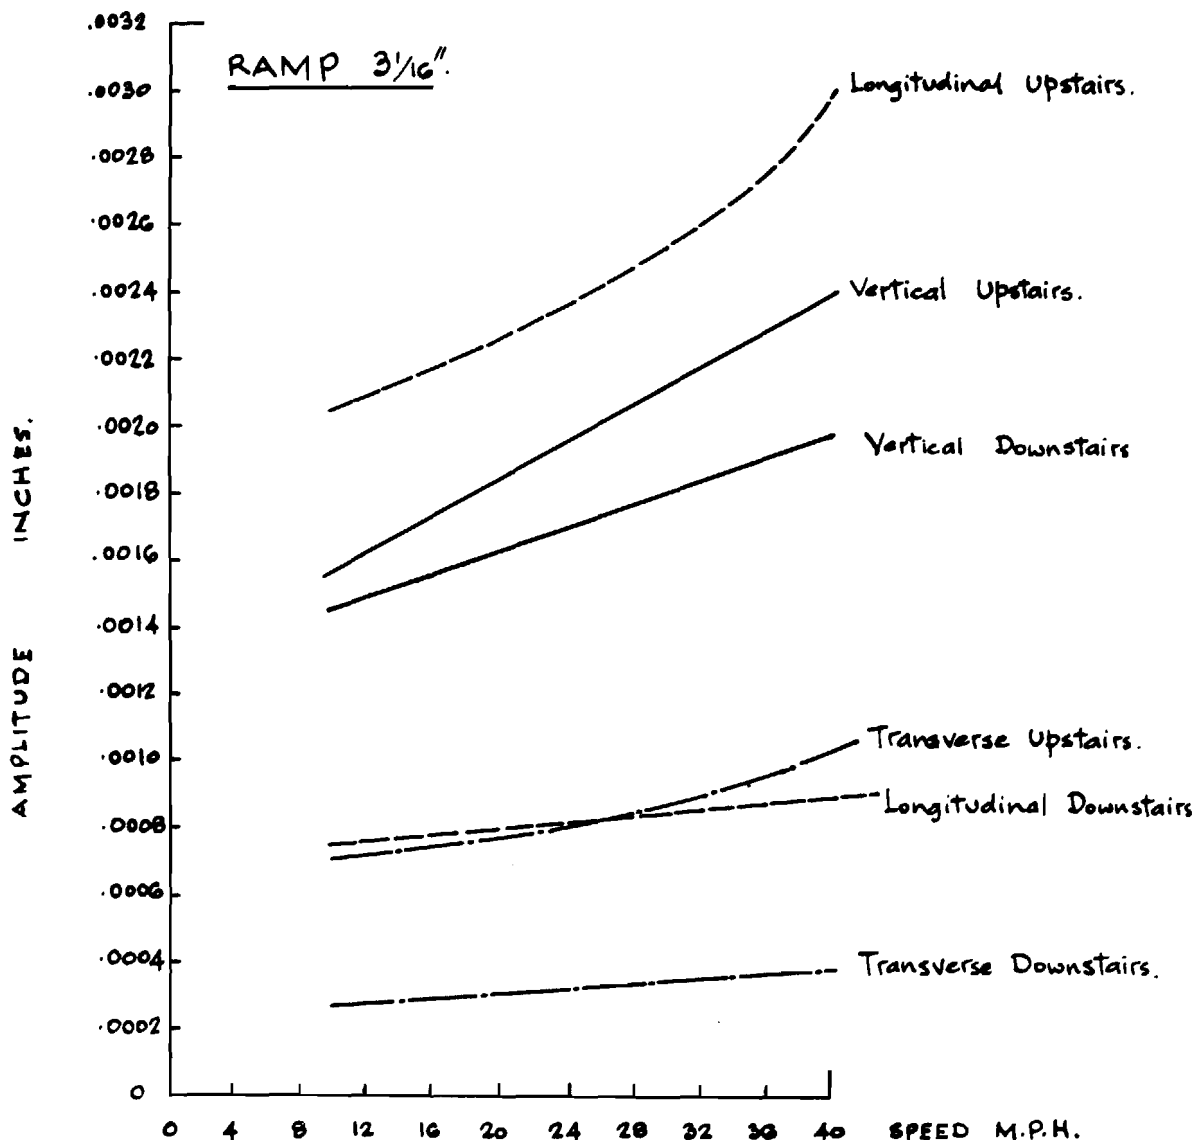
COMPARISON OF VIBRATIONS PRODUCED UPSTAIRS
AND DOWNSTAIRS IN DR. BEATTIE'S HOUSE

When the tests were conducted upstairs in Dr. Beattie's, it was seen that, while the vertical and transverse components were approximately the same as those obtained from similar tests observed from downstairs, the longitudinal component had increased to a large extent to become the strongest component. This, no doubt, is the reason for the complaints that vibrations are much more severe upstairs than downstairs. This increase is probably due to the lack of lateral stiffening in the frames of the buildings, so giving little resistance to the thrust of the longitudinal component.

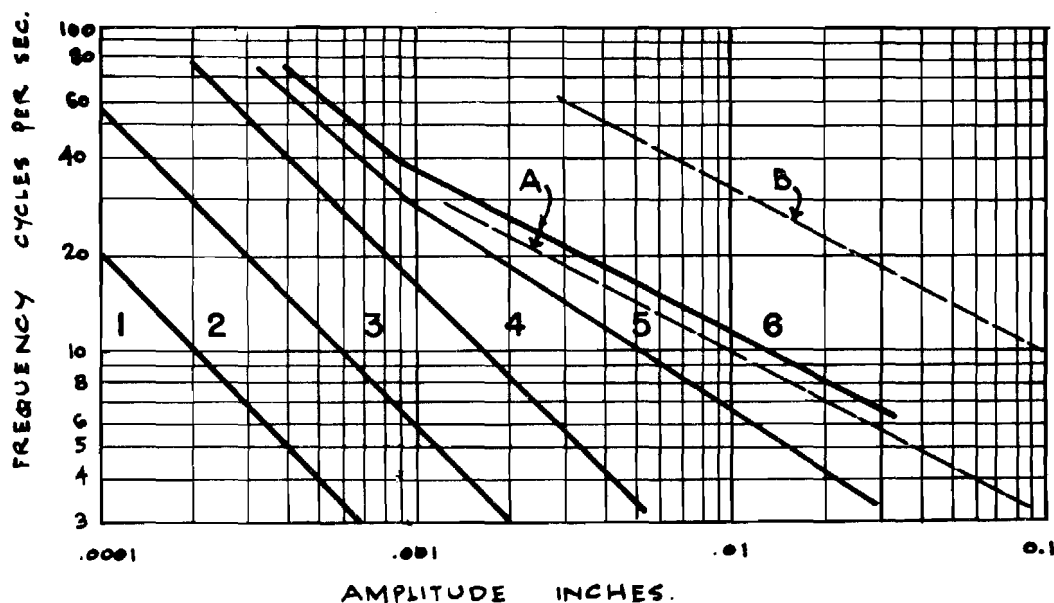
ZONES OF RESPONSE OF HUMANS STANDING TO DIFFERENT INTENSITIES OF THE VERTICAL COMPONENTS OF VIBRATIONS.

Considering the vibrations produced in the tests described in this Report, the most severe vibrations come into Zone 4, on Sheet 16, that is, strongly perceptible. Under normal running conditions of the trolley buses, no vibrations as severe as this would be experienced.

Lines A and B have been superimposed on Reiher's and Meister's graph on Sheet 16. These lines have been taken from the U. S. Bureau of Mines Bulletin No. 442 (1942). In this report, entitled "Seismic Effects of Quarry Blasting", zones of damage due to vibrations are determined. Line A, which represents an acceleration of one tenth that of gravity, indicates the caution stage. Between lines A and B, there is likely to be some plaster damage due to vibrations. Beyond line B, which represents an acceleration of g , that of gravity, some structural damage will result. Acceleration cannot always be taken as a comparison of damage likely to be caused by vibrations, since energy transmitted should be the sole criterion of judgment. However, for specific conditions, e.g. earthquakes, or for similar types of structures, standards of intensity, based on acceleration alone, can be set up.

A decision can be made from the vibrations observed, the research of Messrs. Reiher and Meister, and the investigations carried out by the U. S. Bureau of Mines. From Sheet 16, it can be seen that people are aware of vibrations long before there is any possibility of damage to the structure. Vibrations which would cause extreme discomfort to a person still would barely cause plaster damage to the house.
