CONDENSATION PROBLEM IN  
BUILDING ATTACHED TO PUBLIC GARDENS  
GREENHOUSES, HALIFAX, N.S.

Report No. 118  
of the Division of Building Research

April, 1957

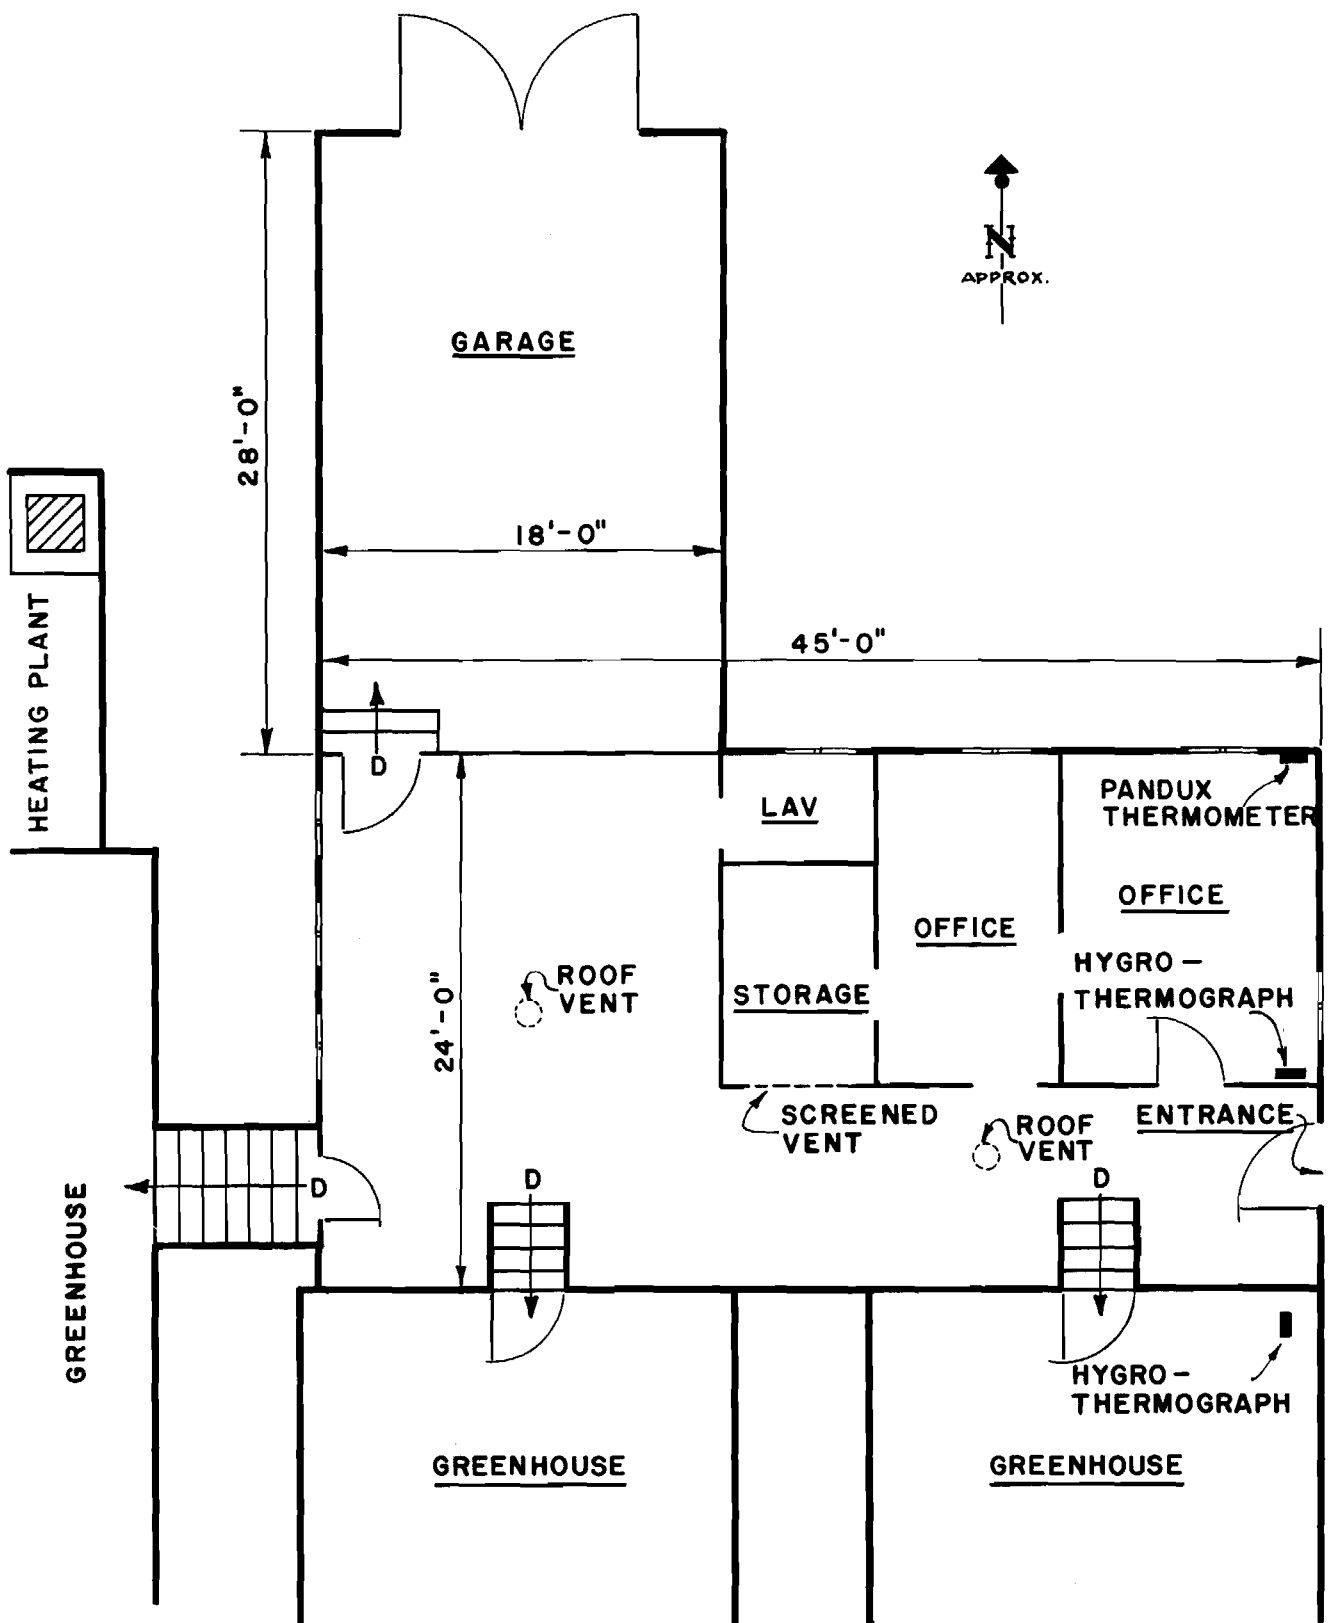
**FIGURE I**  
**SKETCH OF BUILDING**

The building is a one-storey (12 ft.) concrete block structure (Fig. 1). The outside surface of the block has been coated with "Thoroseal" which serves as the exterior finish. The roof is flat, flashed at the edges, and has no overhang. The roof framing is standard wood joist decked with wood sheathing and covered with conventional built-up roofing. Two metal stack vents (8 in. in diameter), have been provided through the roof, one near each end of the building. The concrete foundation encloses a shallow cellar or crawl space. Access to this is by means of a trap door and ladder. The cellar has no floor and a considerable quantity of earth is stored there for potting plants during the winter. One small vent (6" x 6") was open but was partially blocked by snow. More vents were originally provided but are now closed-off by wood blocks.

Three greenhouses are attached to the office building, each having a direct access door to this building (Fig. 1). Two of these doors are located on the south side of the building and the third is at the west end. In the past they have been left open for the convenience of the workmen. The greenhouse framing is attached directly to the block wall on the south side of the building; access to the greenhouse at the west end of the building, however, is through a short block tunnel-like appendage to the main building.

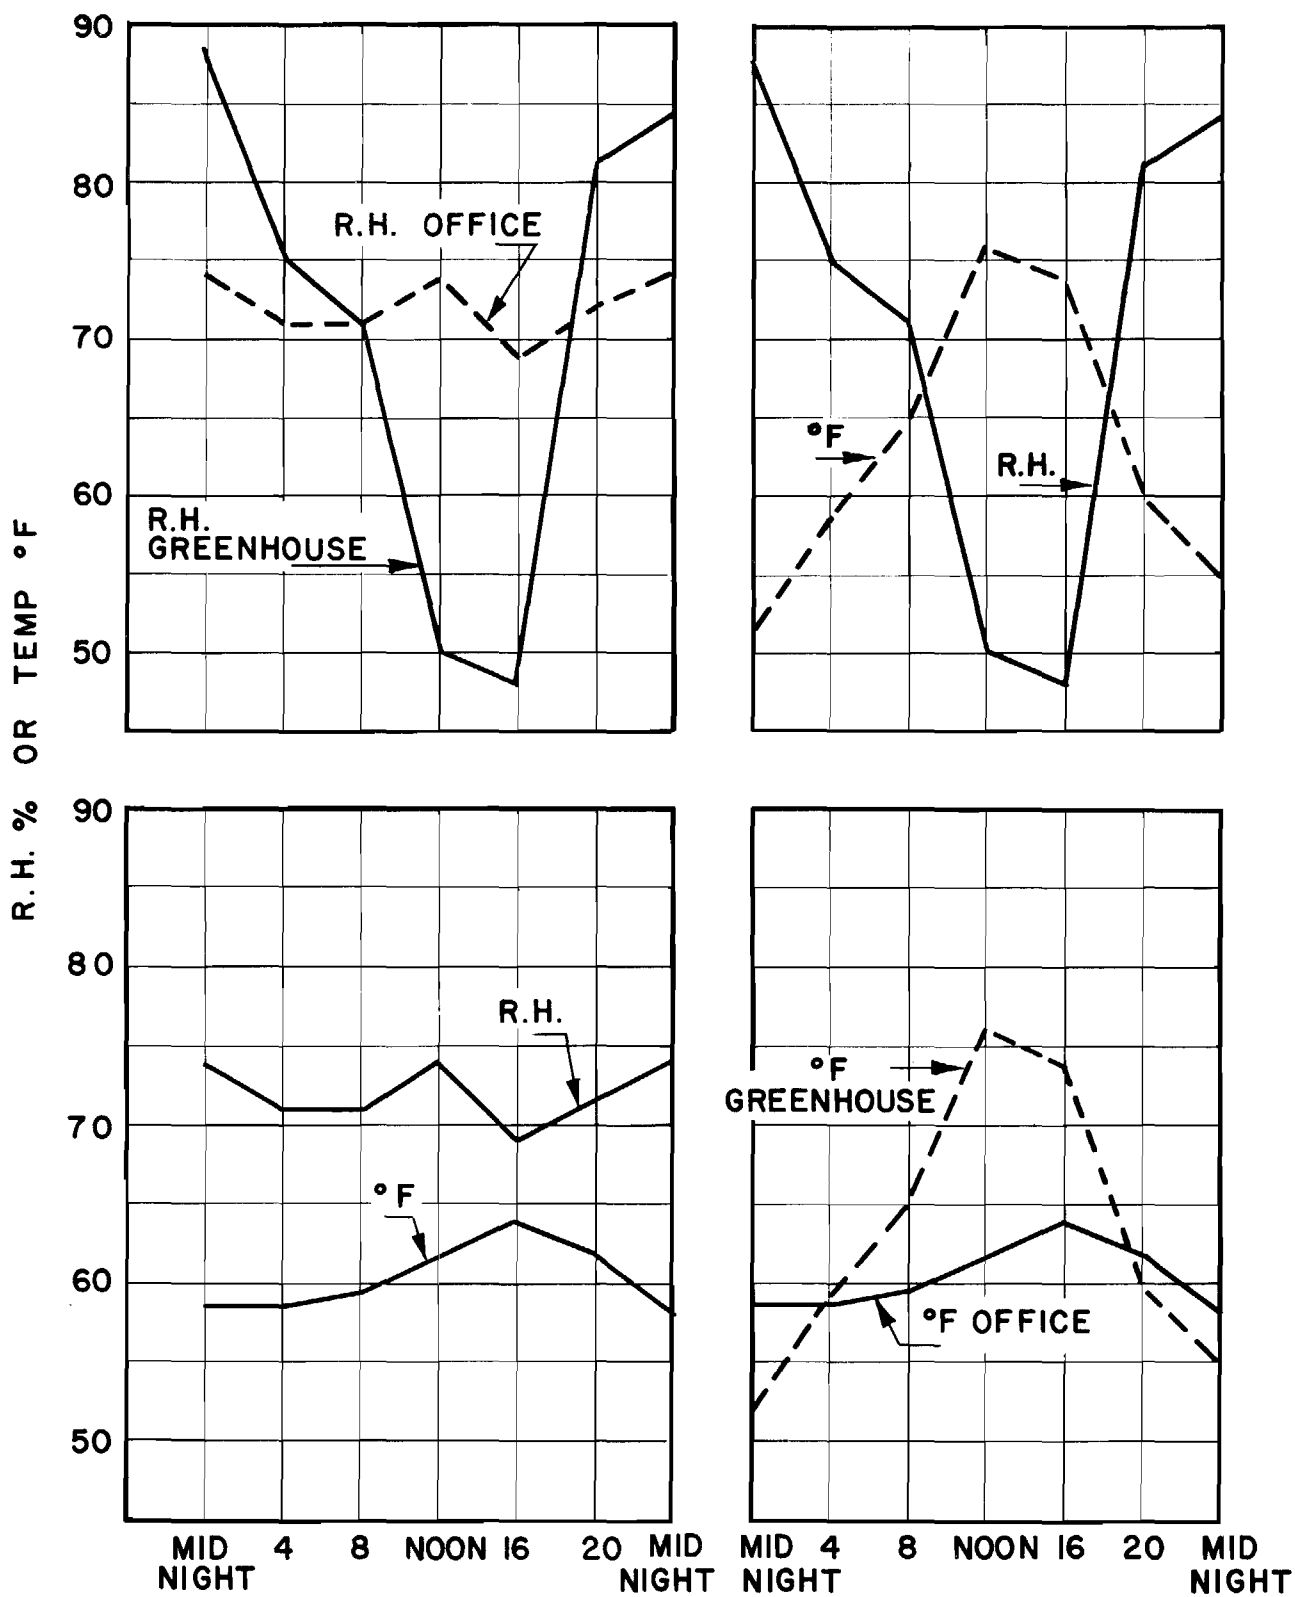
FIGURE 2

A more detailed tabulation of relative humidities and temperatures is given in Appendix I of this report. In addition, a number of graphs are provided for reference purposes (Fig. 2).

NOTE: GRAPHS SHOW COMBINED AVERAGES DURING MARCH AND APRIL FOR PERIODS RECORDED

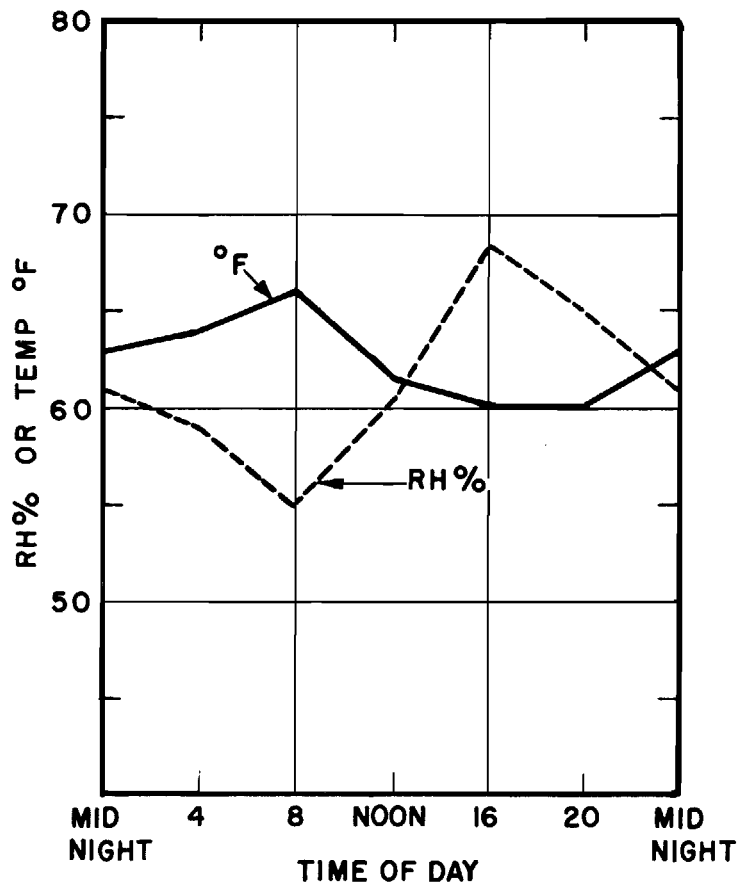
**FIGURE 3**  
**READINGS TAKEN IN OFFICE**  
**(AVERAGE FOR PERIOD RECORDED**  
**FEBRUARY 1957)**

A detailed tabulation of relative humidities and temperatures is given in Appendix I as an addendum to the 1956 readings. An additional graph to those provided for 1956 has also been added (Fig. 3).
