Experimental Painting Studies: Central Mortgage and Housing Corporation Rental Projects in Cornwall and Montreal - Preliminary Assessment of Project

483

TECHNICAL NOTE

Experimental Painting Studies: Central Mortgage and Housing Corporation Rental Projects in Cornwall and Montreal - Preliminary Assessment of Project.

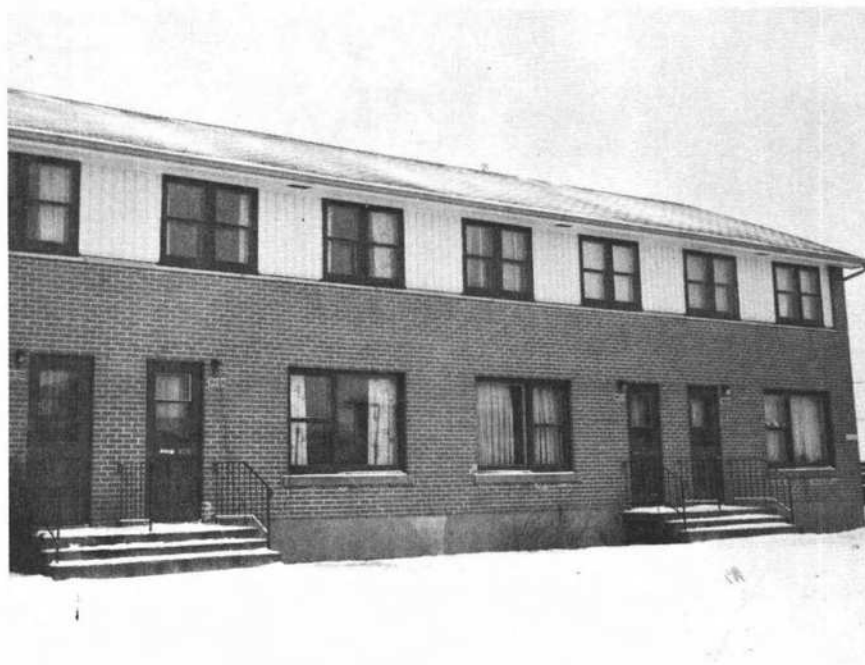
Paint was generally in good condition at this project (Figure 1) except for the storm windows and doors which showed excessive peeling. Although the soffits were plywood there was no visible peeling. There were some fresh paint patches on the vertical siding on the face of some blocks but these were the result of installation of new galvanized flashing at the brick line. Apparently there had not been time to repaint all the siding before the onset of winter. There was some cracking and peeling on the bottom 6 inches of the large end panels because of moisture retention at the water table (Figure 2). The end panel of one block was in poor condition but this was because of the inferior grade of lumber used in its construction (Figure 3). The panel should be repaired probably by recovering it with overlay plywood. Caulking was in poor condition around windows and doors.

Figure 1 Row housing at Brookdale Terrace, Cornwall

Because the paint was generally in good condition it was agreed not to undertake any experimental painting at this site in 1966.

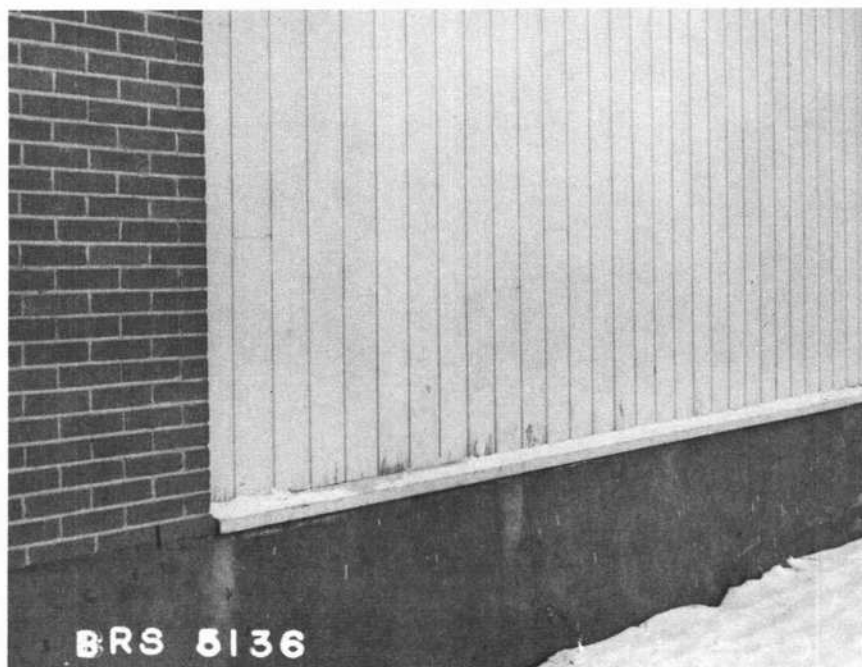
Figure 2 End panels of buildings at Brookdale Terrace, Cornwall, showing cracking and peeling of paint at bottom of panel

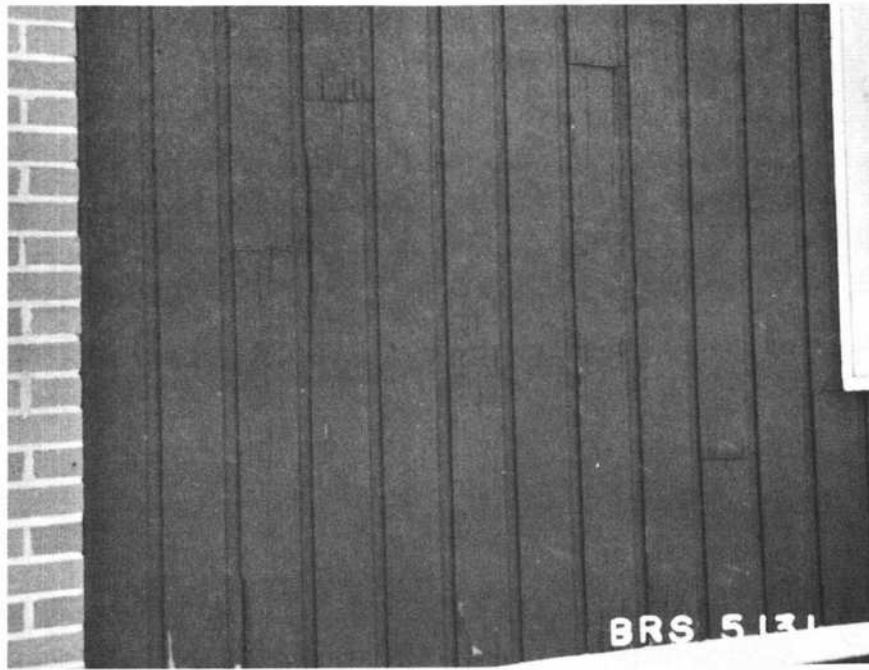
Figure 3 End panels of buildings at Brookdale Terrace, Cornwall, showing poor wood used in construction

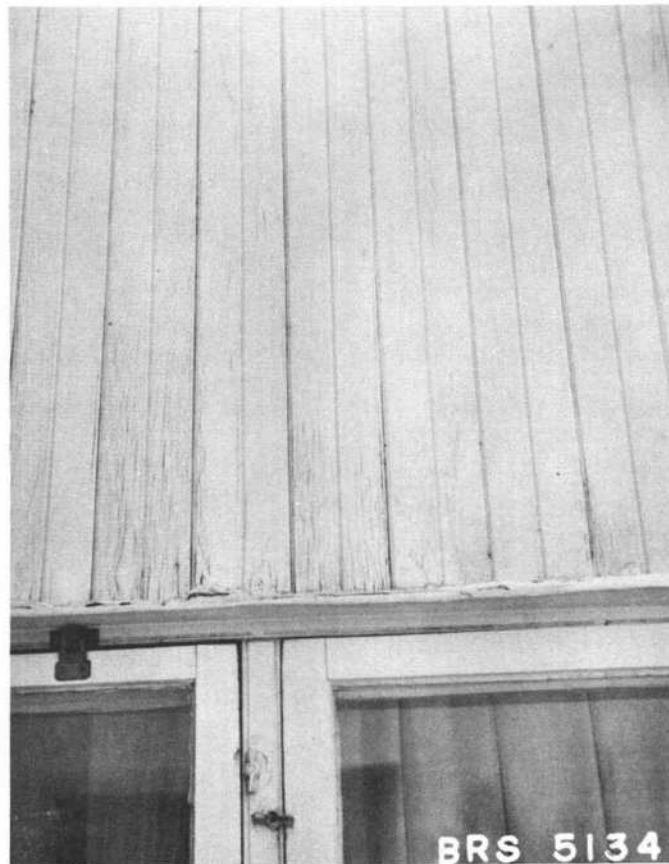
Although the units were painted in 1963, the wood panels needed repainting by 1966. There was severe paint cracking and some checking of the wood near the lower ends (Figure 4). Cracking was less severe over the rest of the panels but nevertheless the paint had failed. There was some peeling from the soffits perhaps because there are fewer ventilators here than at Brookdale Terrace and the slope of the roof is lower. Soffit peeling was as prevalent over the windows as over the brickwork. The plywood ceilings of the door canopies had cracks and peeling at the outer edges (Figure 5) that may have been caused by a constructional defect. The caulking was in better condition here than at Brookdale and there was no peeling on the window sash or storm windows. The accumulation of dirt on the exterior paint seemed excessive.

Figure 4 Wood panels at Cumberland Court, Cornwall, showing cracking and checking of paint and wood

It was suggested that because failure extended into the wood substrate a comparison of methods of surface preparation be made. Methods proposed were disc sanding, burning, and soft sandblasting compared with normal scraping. The use of fillers on badly checked wood was also suggested. For repainting, alkyd and latex finishes would be compared with oil paints.

It was agreed to have the upper wood panels prepared by the contractor in his usual manner and the lower ones treated by three different preparatory methods excluding burning off. The suggestion of two fillers and three topcoats was accepted.

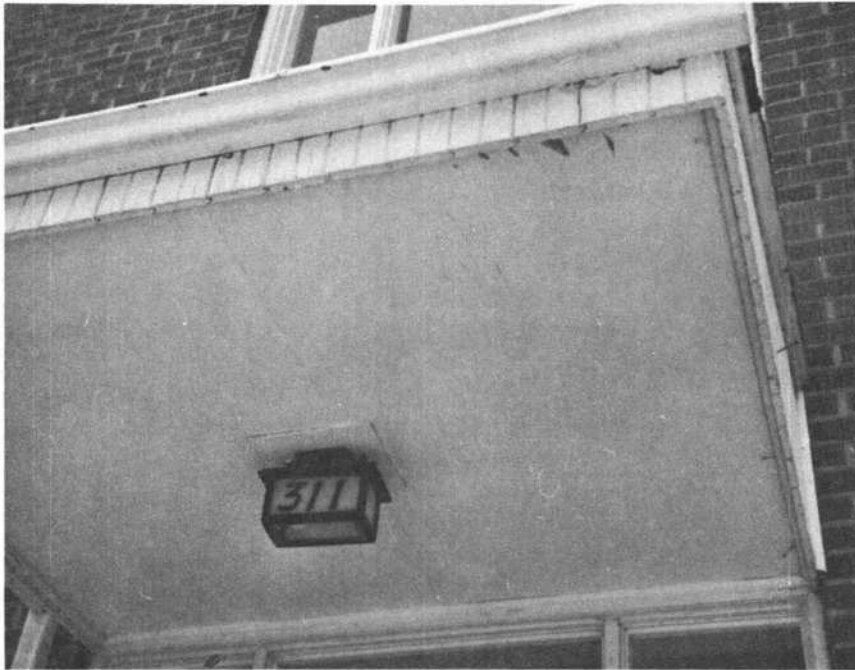
Figure 5 Plywood ceiling of door canopy at Cumberland Court,
Cornwall, showing cracks and peeling at outer
edges

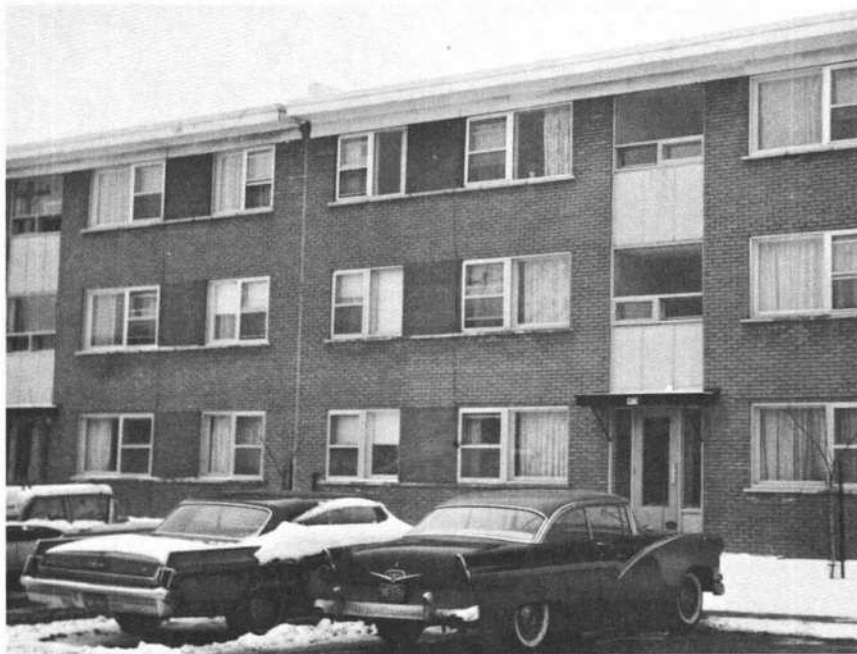
In the first section there was also considerable cracking and flaking on the plywood panels. There was grain raising where water had penetrated the cracks. Panels painted light green showed a two-tone effect from the wet and dry areas (Figure 6). Generally the upper panel failed more than the lower panel.

Figure 6 Exposed plywood panels at Cloverdale Park,
Pierrefonds

It was agreed to reserve 8 plywood panels for tests to compare power wire-brushing with disc sanding for removal of old paint. Latex filler and paste wood filler would be included to determine their effectiveness in filling cracks in the plywood. The finishing systems selected were 1-GP-59 over aluminum primer and two coats of acrylic latex. It was decided, at the request of CMHC representatives, to compare one- and two-coat applications of topcoats on the soffits. Thus on the overlaid plywood, half would have one coat of 1-GP-59 and half two coats applied directly to the overlay. To determine whether improvements in sections 2 and 3 were due to use of alkyd enamel or to better ventilation, it was decided to compare enamel versus paint systems. Again the areas would be divided into one- and two-coat applications of 1-GP-28 and -59 over their respective primers. The treatment studies on the balconies were deleted from the program because it was reported that all wood is pretreated. It was agreed to test 4 different finishes on 8 balconies half of which would face south and half north so that snow accumulation would differ markedly.

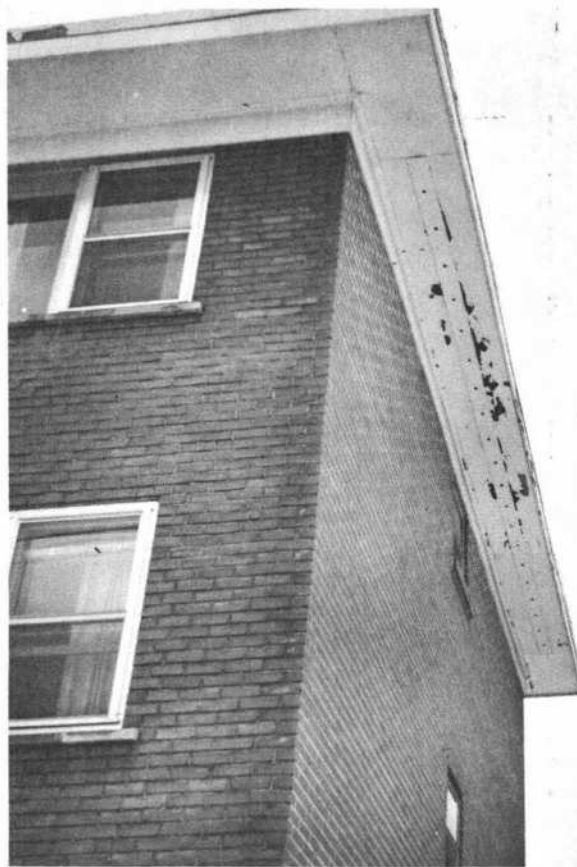
In the first section, which had been repainted in 1962 and was due for repainting in 1966, there was considerable peeling on the fascia and soffits, in some cases right down to bare wood. The failure was less severe along the sides of the building than at both ends which are ventilated (Figure 7). The vents are 1-in. holes drilled in strips of wood placed over slots that were probably the original vents. The peeling did not seem to be as bad on those blocks that were painted grey as on those painted white.

Figure 7 Paint peeling on vented soffits at Cloverdale Park,
Pierrefonds

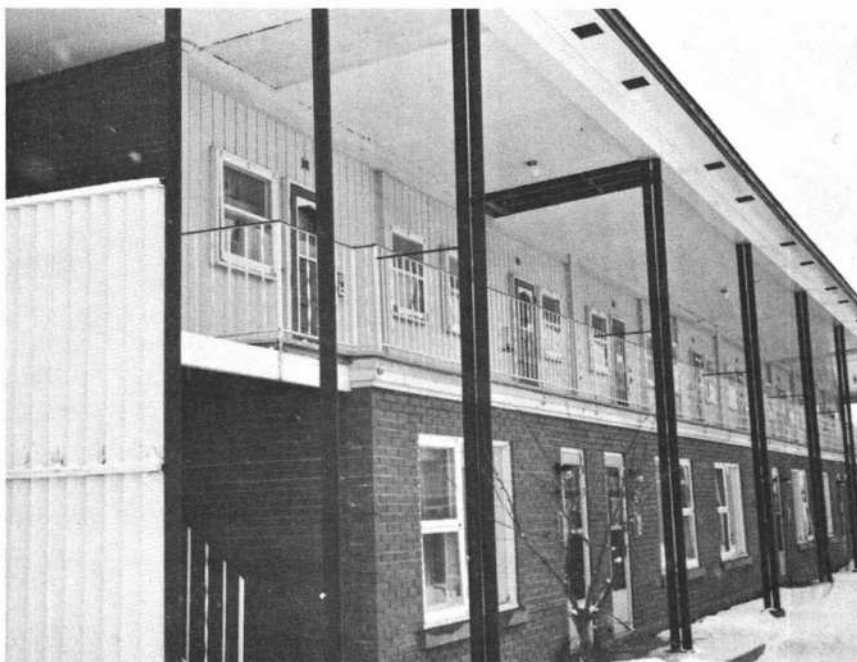
The paint on the fronts of the buildings was in good condition except for slight fading. The porch ceilings were very glossy. The wood in the screens was rotting badly at the bottom of each half where snow accumulates (Figure 8). This wood should be replaced with treated wood.

Figure 8 Protected facing on row housing at Place St. Louis,
Boucherville

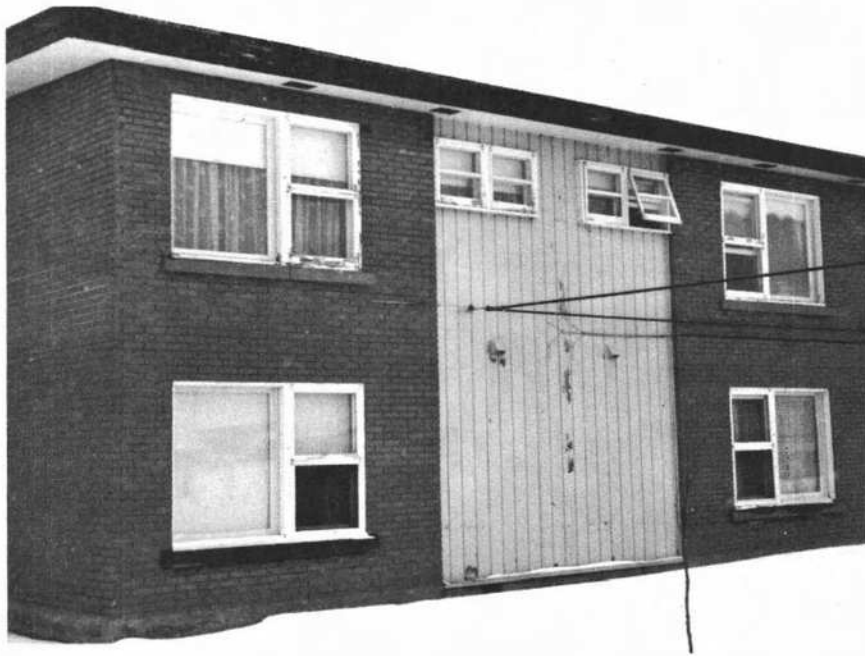
Paint on the large rear panels was generally in good condition except for the bottom 6 inches and on the panels at the ends of the buildings opposite from the furnaces. On these ends peeling started at the fascia and followed the line between apartments across the soffits and down the centre of the panel (Figure 9). As a crawl space is reported to be at this end the peeling is probably caused by moisture migration. There was also some peeling from the soffits at the back over the bathrooms and marked peeling on most of the storm sashes.

Figure 9 Rear of buildings at Place St. Louis, Boucherville,
showing paint peeling at centre of panel and
on sash

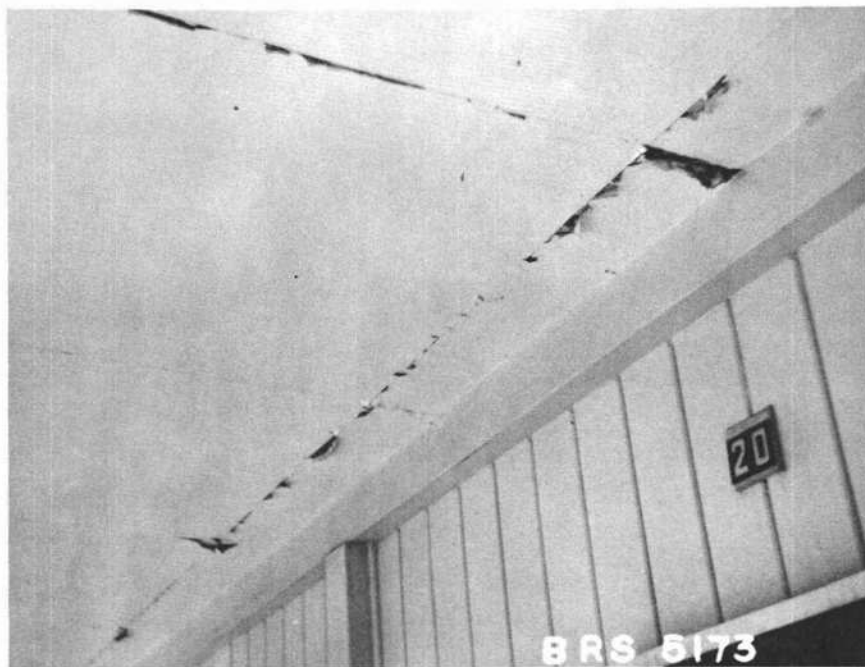
The biggest problem at this project is the ceiling space over the porch. Apparently condensation freezes in this space and when melting occurs the water runs back toward the building because of the slope. The plywood sheets are severely buckled in many places and the paint is peeling back from the panel edges (Figure 10). Some modification of the structure will be required to overcome this defect.

Figure 10 Porch ceiling at Place St. Louis, Boucherville,
showing buckled plywood and peeling paint

It was unanimously agreed that all the problems here were connected with moisture migration and that little would be gained from painting experiments.

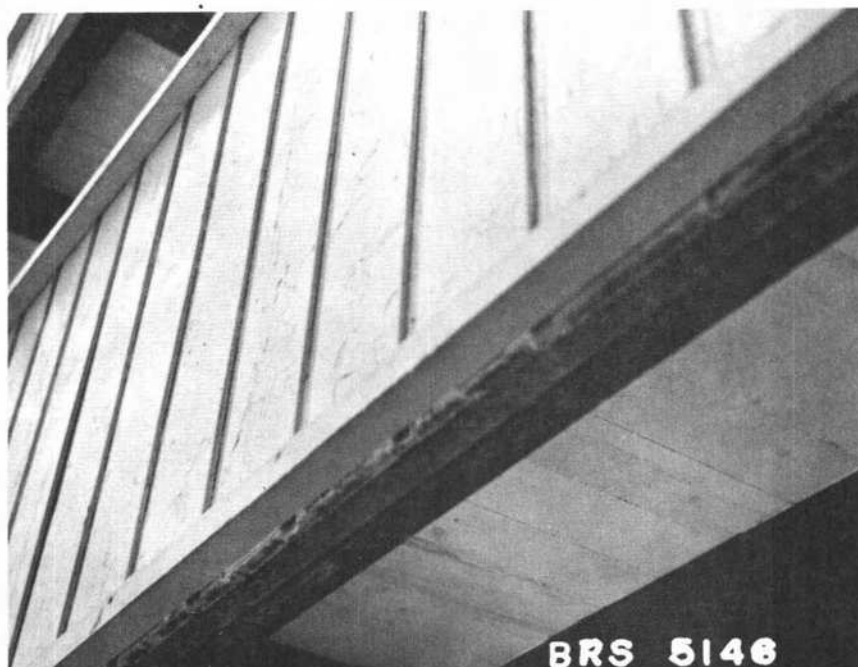
The only parts of the buildings that could be painted are the exterior metal stairways and balconies. The material on the latter appeared to be 1-GP-41 judging by the low gloss. Difficulties that had been experienced on the balcony fronts were probably caused by poor quality wood and poor surface preparation before repainting. In Figure 11 it can be seen that only part of the old paint had been removed and that cracking is starting at the edges of these areas. Two balconies that had recently been repainted after burning off the old paint were in good condition.

Figure 11 Irregular removal of old paint on balcony at
Boulevard Pie IX, Montreal

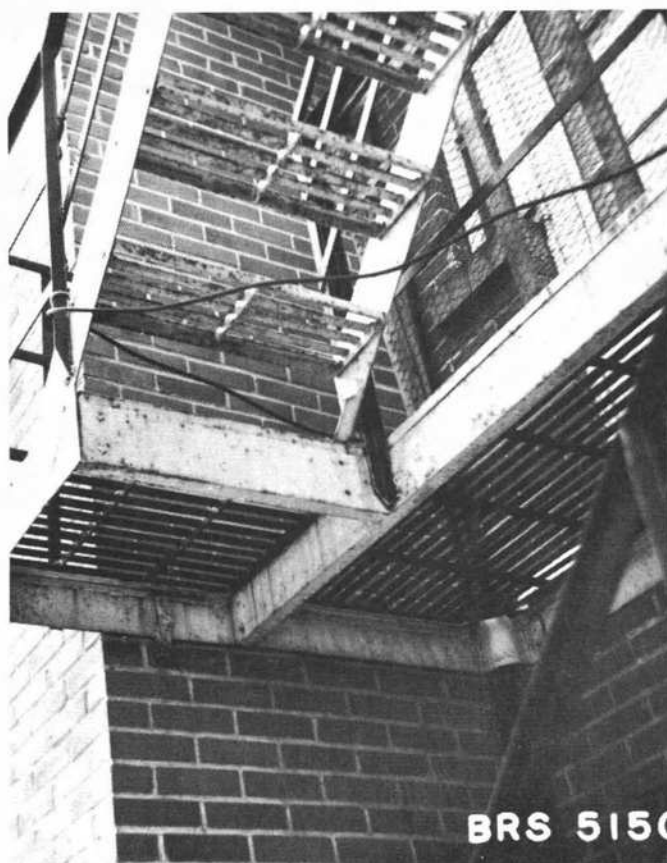
There was some rusting on different parts of the exterior stairways (Figure 12). The stringers, undercarriage and treads which were painted grey appeared to be in worse condition than the guard rails which were red iron oxide in colour. On closer inspection,

however, it was found that all parts were in about the same condition but that the light grey colour made the rust more evident by contrast. The exterior stairs at the north ends of the buildings generally appeared to be a little worse than those at the south ends. The degree of rusting did not appear to be related to the location of the electric clothes-drier vents. The failure was considered to be more severe on the buildings fronting on the boulevard and was thought to be associated with the large amount of salt used on that main thoroughfare during the winter.

Figure 12 Exterior metal stairways at Boulevard Pie IX,
Montreal, showing rusting

good wood. Comparison of 1-GP-59 enamels with 1-GP-41 oil paints in deep colors was also proposed. It was recommended that flame priming, power wire-brushing, and normal preparation be tried on the partially rusted exterior steel stairways. Grit blasting was not included because it would not be practical on the narrow pieces of steel. Three metal primers which differ in their tolerance for poor surface preparation were suggested together with a choice of topcoats. It was also mentioned that zinc-rich coatings that were of special interest to some CMHC personnel could be included but would require removal of all surface contamination.

It was decided that the answer to satisfactory service on the balcony fronts - adequate surface preparation - was already known and the proposed tests were deleted from the 1966 program. It was also thought that flame priming of the steel would be too unfamiliar to contractors to include in the tests. The final program selected for the metal stairways comprised two methods of surface preparation and three primers. A common topcoat to either 1-GP-73 or -61 would then be applied to all six stairways. The decision whether to include zinc-rich coatings was left to CMHC.
