An Attic Condensation Problem Robson, D. R.

441

TECHNICAL NOTE

SUBJECT AN ATTIC CONDENSATION PROBLEM

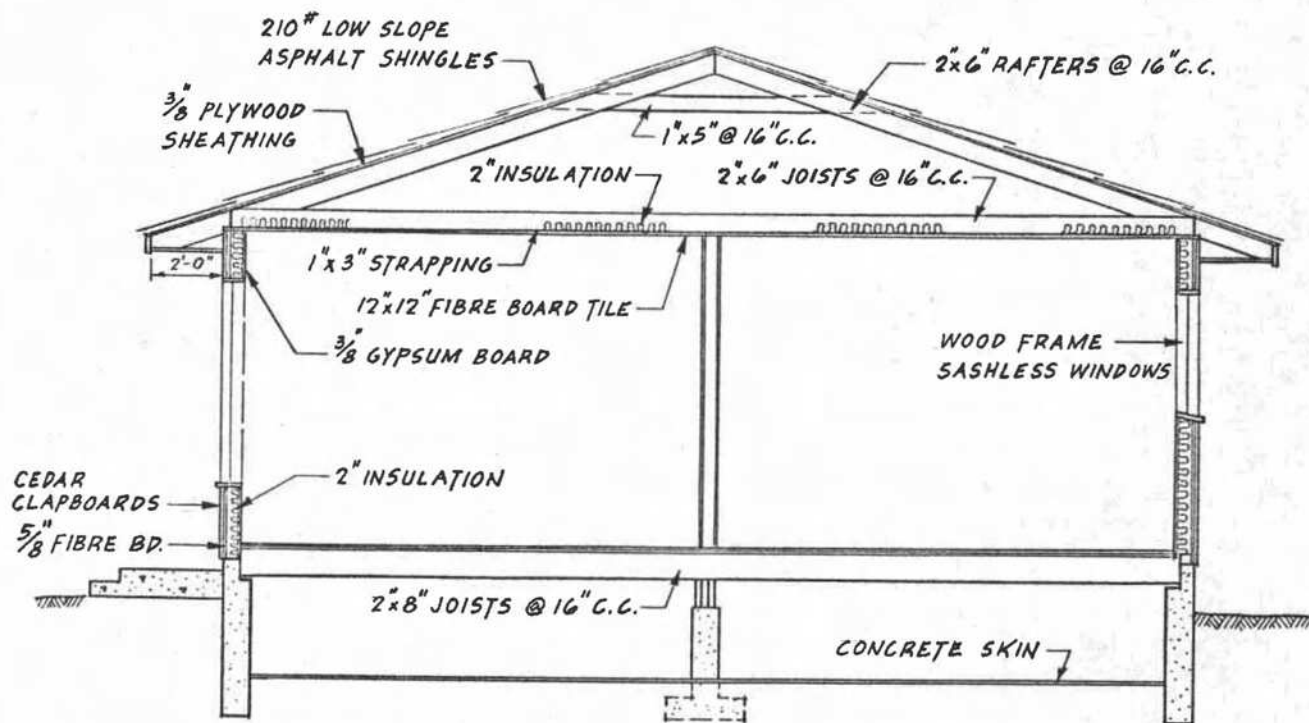
FIGURE 1

The house is of wood-frame construction on a crawl space and heated with a reverse flow furnace with ductwork connecting the perimeter floor registers. The duct for the return air side of the system is run in the attic space from the ceiling grilles to the furnace plenum. The interior finish of the house is dry wall with fibreboard tile ceilings. The exterior of the house is sheathed in 5/8-in. fibreboard covered with building paper and finished with cedar clapboards. Wood frame sashless sliding windows have been used throughout (Figure 1).

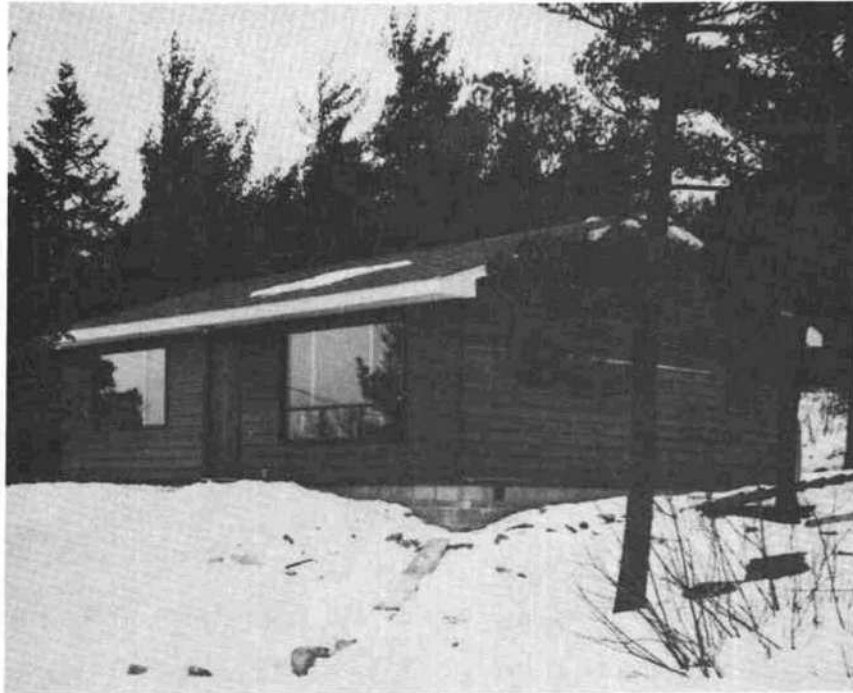
Figure 3. House under observation.

were not such as to make an apparent contribution to the moisture problem under investigation. The block walls of the crawl space were uninsulated, and the ground surface was covered with a thin layer of concrete and no vapour barrier was used under the concrete skin. The addition of a light skin of concrete over the crawl space fill has the advantage of making the crawl space much more usable as storage space (Figure 2). Access to the crawl space is conveniently located in the floor of the closet serving the main entrance. Heat is introduced to the crawl space by outlets taken from the main plenum. Figure 3 (AR-531) illustrates the position of the house relative to the surrounding area.

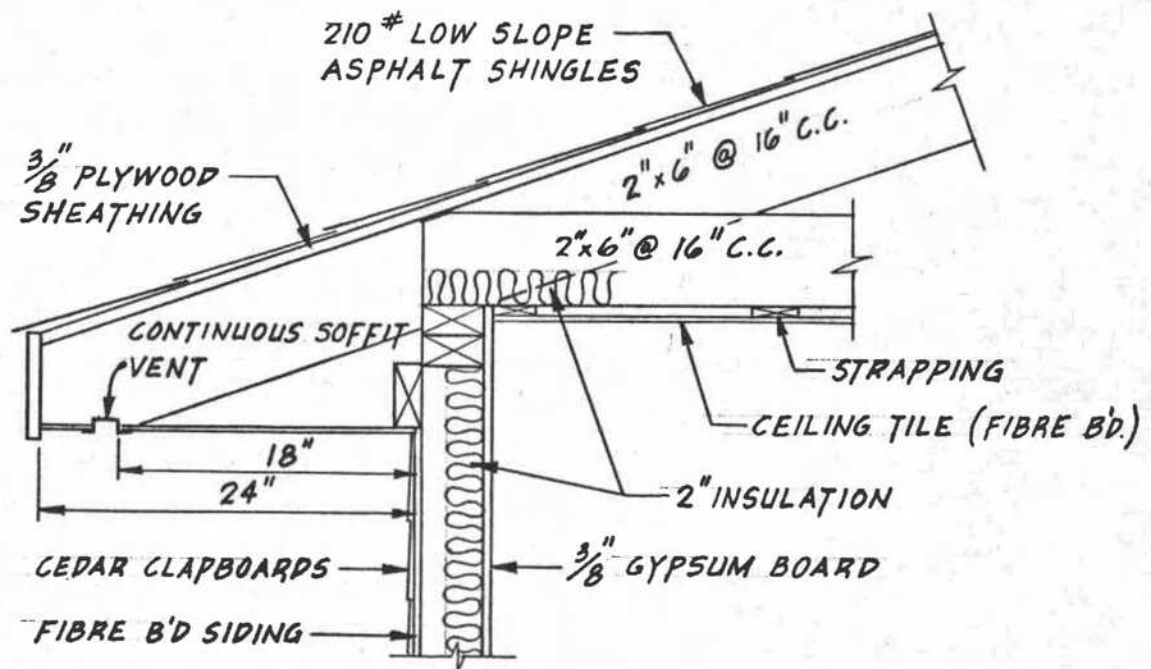
FIGURE 4

The ventilation provided for this attic space originally consisted of two 8- x 12-in. aluminum louvered vents, one at each end of the attic space at the peak. These louvered vents were screened and provided in total a net free area of 80 sq in. The insulated ceiling has a total area of 89,280 sq in. which would require a vent area of 1/300 of 89,280 or 297.6 sq in. The vent area provided, therefore, was only 27 per cent of this requirement.

In December of 1960 soffit vents were added (Figure 4) and this work was completed in the third week of December. This additional venting provided a total area of 390 sq in. which is 30 per

cent more than that suggested by the 1/300 normally required.

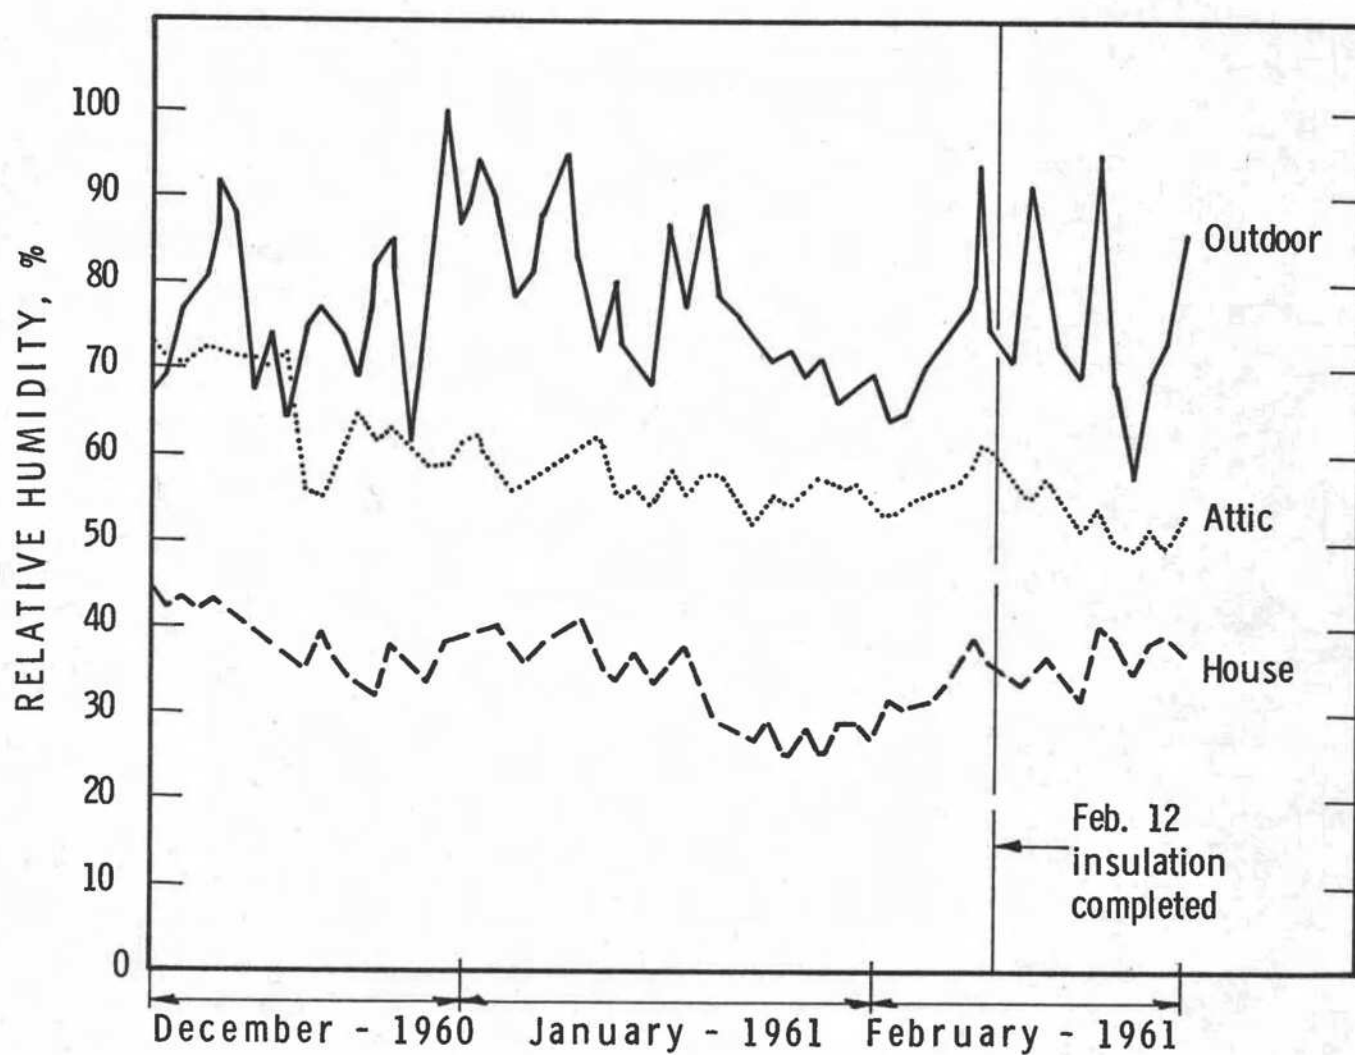
FIGURE 5
RECORD OF RELATIVE HUMIDITY
(DAILY AVERAGES)

The change in wood moisture content in the attic following the increased ventilation is illustrated by the readings recorded in Table I for 27 December 1960 and 3 and 10 January 1961. Table II and Figures 5 and 6 for this period show a gradual fall in the attic humidity and a slight drop in the attic temperature.

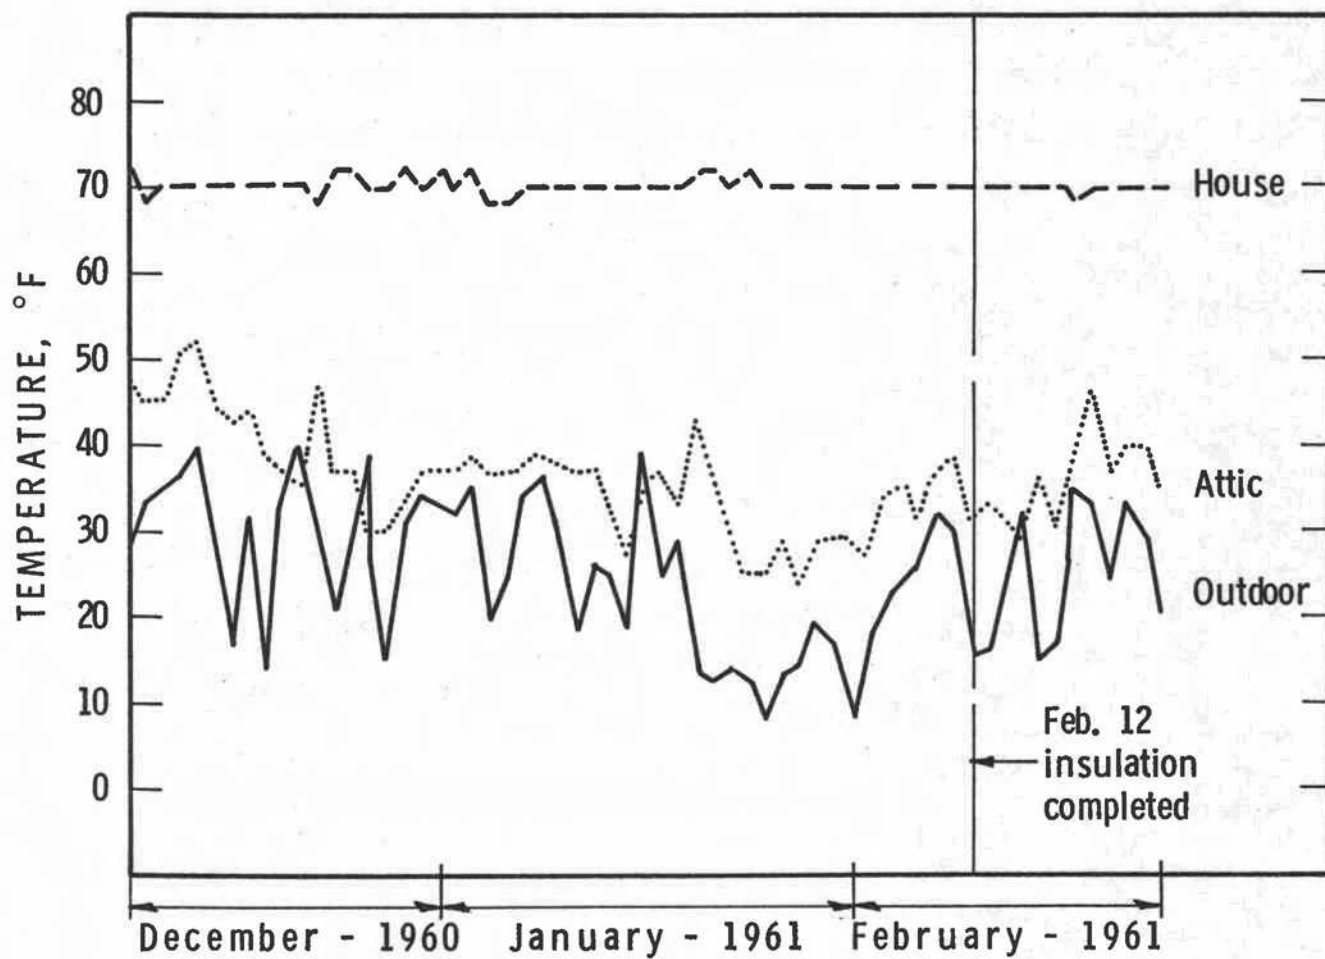
FIGURE 6
RECORD OF TEMPERATURES
(DAILY AVERAGES)

The thermal barrier on the ceiling was discussed following the drying out of the attic space. The addition of a positive vapour barrier under the insulation was difficult without removal of the ceiling tile and the homeowner was not in favour of this if it could be avoided. Because the condensation problem had improved with the increased ventilation in the attic space, it seemed reasonable to suggest the addition of loose fill insulation without a vapour barrier. Loose mineral wool was used because of its non-hygroscopic properties. The addition of ceiling insulation to a uniform depth of 4 in. was not completed until 12 February so that any change before this time is difficult to assess. Figure 6 illustrates the close relationship between the attic and outdoor temperature after 12 February.
