### Structural test of a house under simulated wind and snow loads

Dorey, D. B.; Schriever, W. R.

*Research Paper (National Research Council of Canada. Division of Building Research), 1957-10*

RESEARCH PAPER NO. 43  
OF THE  
DIVISION OF BUILDING RESEARCH

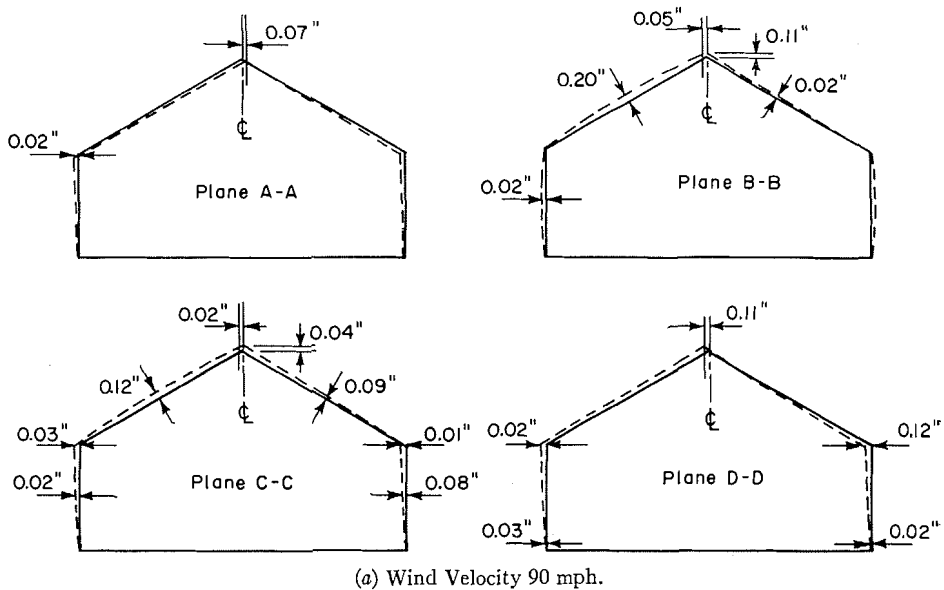
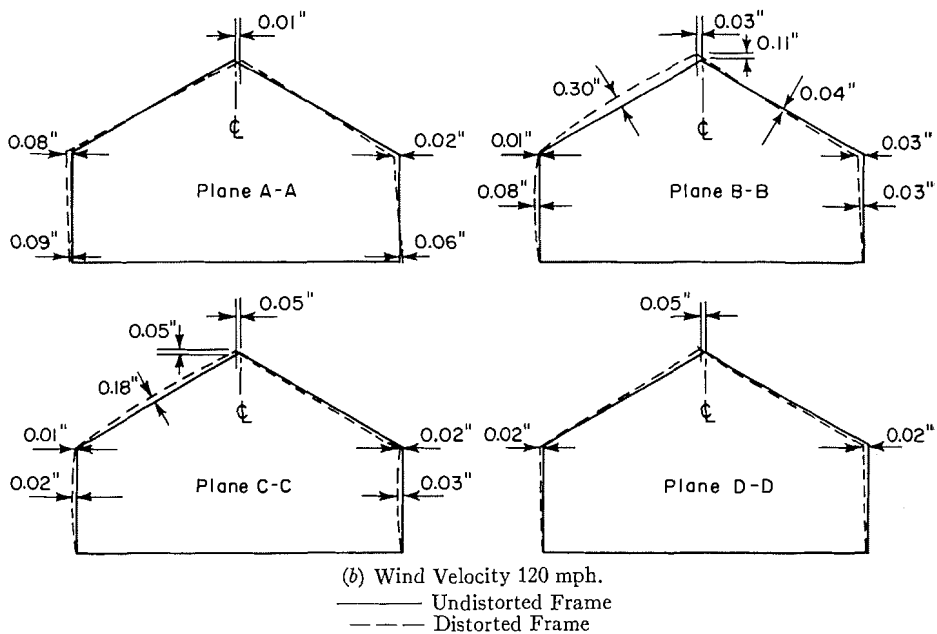
FIG. 10.—Deformations due to Wind Loads (Internal Suction).

Internal suction (windows open on leeward side only) was the first wind loading condition applied. This condition is less severe than that producing internal pressure, as it results in smaller loads except on the windward wall. The loads were applied in increments of pressure corresponding to increases in velocity of 10-mph, beginning at 70 mph and ending at the design velocity of 90 mph. The loads were maintained for  $\frac{1}{2}$  hr, and the loads for a velocity of 90 mph were maintained for 1 hr. Deformations were recorded on the deflection chart in the instrument hut before and after each increment of loading and after complete unloading. A visual inspection was made of each of the 13 plaster telltales before and after each loading increment to see if any cracks had developed. No cracks appeared during this loading phase. Deformations resulting from the first phase of loading are shown in Fig. 10 (a).

After reapplying pressures equivalent to a 90 mph wind velocity a crack in telltale No. 5 was discovered, and toward the end of the 1-hr period of sustained loading, a second crack became visible in telltale No. 9. All loads were then increased to pressures corresponding to 100, 110, and finally 120 mph and maintained for 1 hr in each case. During the 120-mph loading, cracks appeared in two more telltales, Nos. 6 and 10. The deformations resulting from this phase of loading are shown in Fig. 10 (b).

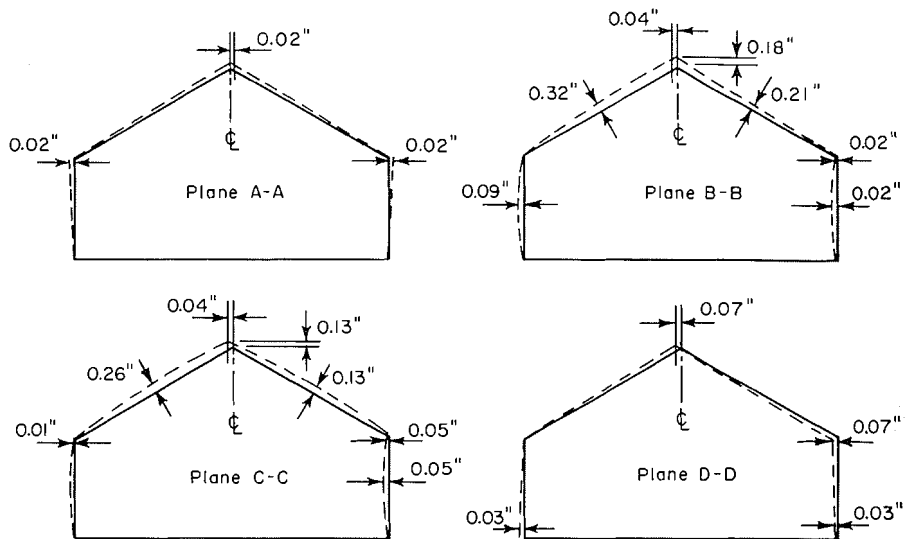
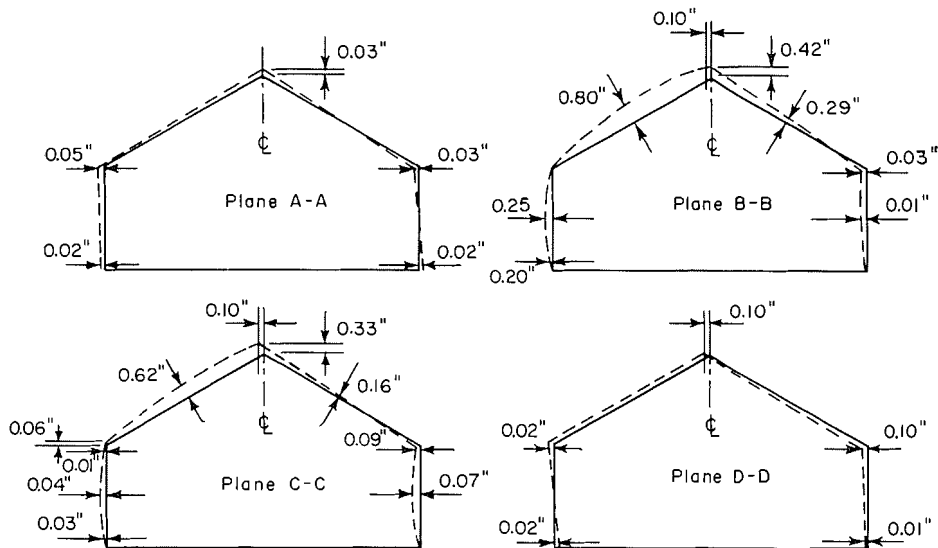
Loadings were again applied in increments of pressure corresponding to increases in velocity of 10 mph starting at a velocity of 70 mph and ending at the design wind velocity of 90 mph. At loads corresponding to a velocity of 80 mph, a new crack became visible in telltale No. 6. The 90-mph load was maintained for 1 hr, but no further cracks appeared in the plaster telltales. Then pressures were released in three steps to zero. The deformations resulting from this loading phase are shown in Fig. 11 (a).

During the process of increasing and maintaining loads to 90, 100, and 110 mph, no further cracks appeared, but during the 1-hr period of sustained loading for a wind velocity of 120 mph, a crack which appeared in telltale No. 5 earlier in the test extended noticeably. At the end of the loading period, all loads were released to zero. The deformations resulting from this phase of loading are shown in Fig. 11 (b).

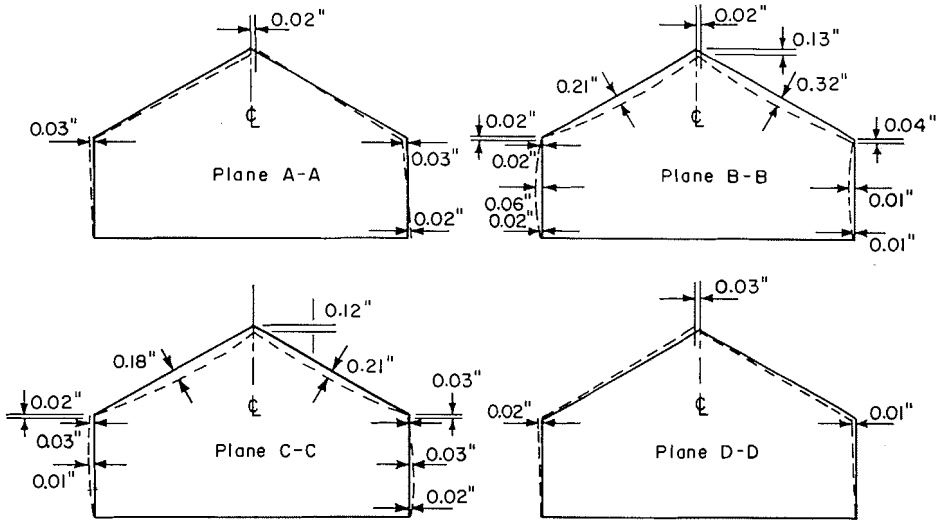
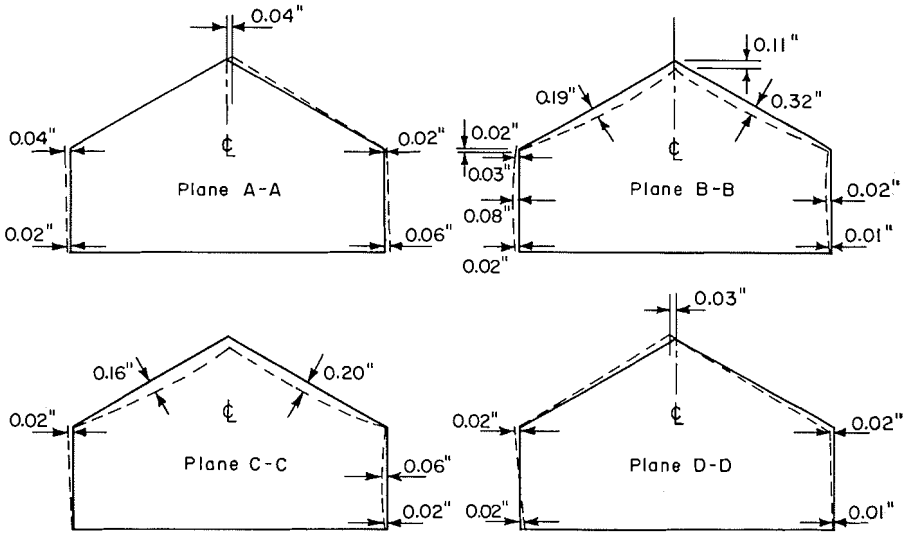
FIG. 12.—Deformations due to  $\frac{1}{2}$  Design Snow Load plus Wind Loads.

The combined loading of  $\frac{1}{2}$  design snow plus wind load was applied for wind velocities varying from 70 to 120 mph. At 70 mph sustained loading, a small new crack appeared on the ceiling side of telltale No. 4. No further cracking took place in the plaster telltales as regular increases of 10-mph wind velocity were applied until an equivalent condition of a 110-mph wind velocity was reached, when a small new crack became visible in telltale No. 8. A final loading of  $\frac{1}{2}$  design snow loading plus a wind velocity of 120 mph was reached without any further apparent cracking in the telltales. After being maintained for a certain period, all loads were reduced to zero in three stages as before. The deformations resulting from this phase of loading for wind velocities of 90 and 120 mph are shown in Figs. 12 (a) and (b).

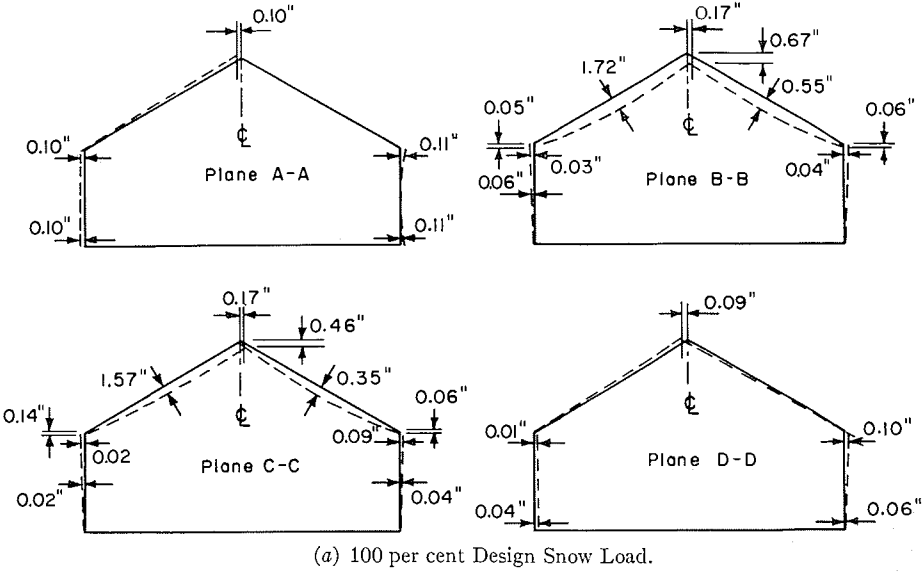
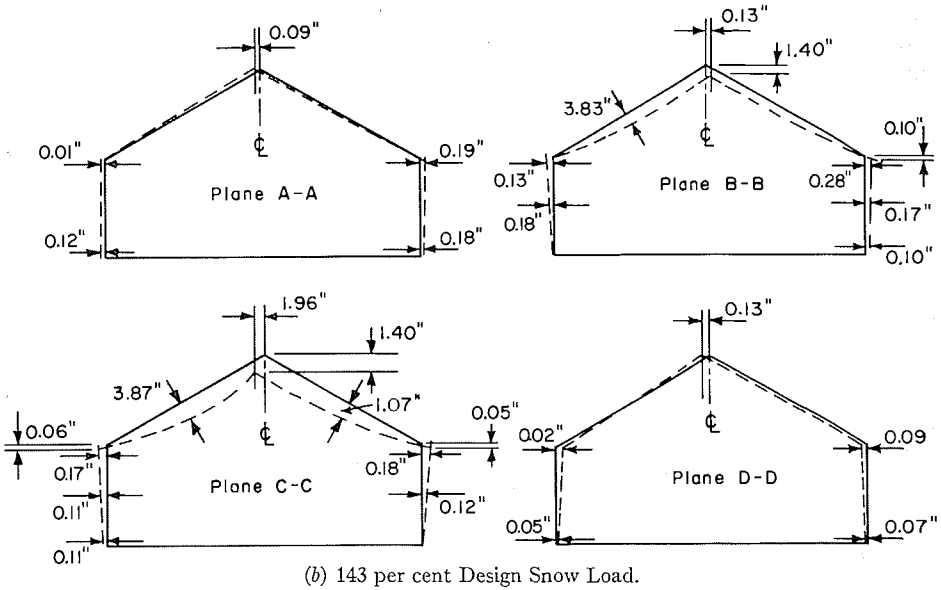
(a) 100 per cent Design Snow Load.

(b) 143 per cent Design Snow Load.

As the snow loads were applied in the final phase of the loading test, the deformations in the test house became more and more pronounced until failure began to occur in some parts of the roof at 143 per cent of the design snow load of approximately 50 lb per sq ft so that

At 100 per cent snow load the largest deflection in the rafters reached 1.72 in. on the front slope and 0.55 in. on the rear slope. The allowable deflection (National Building Code of Canada, 1953) for a rafter having a horizontally projected span of 12 ft 2 in., is  $\frac{1}{240}$  of the horizontal projection of the rafter or 0.61 in., neglecting the support offered by the collar ties. Therefore, in the test, the allowable deflection was exceeded on the front slopes by 182 per cent at design snow loading for this particular roof slope. When failures occurred in the end collar ties and one rafter at 143 per cent of the design snow load, the rafter deflections had reached values of 3.87 in. on the front slope and 1.07 in. on the rear slope in plane C-C and there was a total of 1.96 in. of displacement in the ridge board towards the front slope on this plane of deflections.

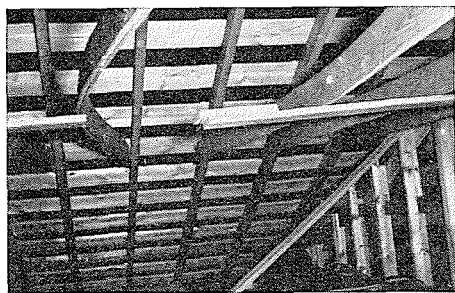
suddenly, one at the end of the house and one over the living room and kitchen. A splice in the longitudinal member attached to the underside of the collar ties had also given way. The break in the splice of the longitudinal member and the buckling of the collar ties is shown in Fig. 14 and the failure of the two end collar ties in Fig. 15. An additional failure occurred in one of the rafters at a knot. Except for a brief period of time during which failures were taking place in the roof assembly, it was possible to maintain stable console pressure for

FIG. 14.—Failure in Splice of 1- by 4-in. Longitudinal Member and Buckling of Collar Ties in Attic under 143 per cent of Design Snow Load.

The longitudinal 1 by 4-in. member which was fastened to the underside of the collar ties was not attached to the gable ends nor, because of the central location of the chimney, was it continuous over the full length of the house. Consequently as the snow load was increased, the collar ties were free to buckle in groups in each end of the house on opposite sides of the chimney, thus affording little support to the rafters after initial buckling had taken place. Figure 14 shows the failure of the splice in the longitudinal 1 by 4-in. runner and the extent of lateral buckling.

ties the runner board of the collar ties was cross-braced in each half of the house on both sides of the chimney. The cross-bracing consisted of 1 by 6-in. members nailed to the underside of the collar ties. Then the simulated snow loading of the roof was repeated and a maximum load of 175 per cent of the design snow load was reached, an increase of 32 per cent. At this point, a failure occurred in two rafters and one collar tie, and the loads on the roof had to be released.

After reviewing the considerable gain in strength obtained from the bracing of the existing collar ties it was decided to go a step further and replace the relatively thin 1 by 4-in. collar ties by 2 by 4-in. members at every second rafter, thus using no more lumber than before. These new collar struts were also cross-braced by a 1 by 4-in. runner and 1 by 6-in. cross-braces. The snow loading on the roof was then repeated again and a load of 206 per cent of the design snow load reached. At this point several rafters broke, two of which had been spliced after the earlier failure. Under this load, considerable further cracking inside the house was observed and photographs of all plaster telltales were taken. The vertical crack between the solid plaster partition and the outside wall was approximately  $\frac{1}{2}$  in. wide, indicating the outward movement of the walls under the thrust developed by the rafters.

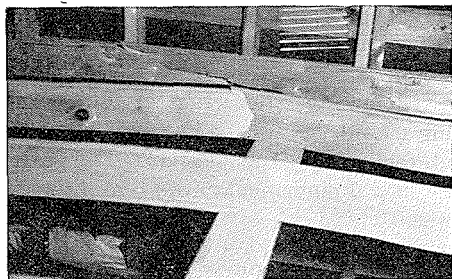
FIG. 15.—Failure of Two Collar Ties in the Attic at one End of Test House under 143 per cent of Design Snow Load.

As the relatively early failure of the roof at 143 per cent of the design snow load (or 72 lb per sq ft) seemed to be mainly the result of the compression in the collar ties, it was decided to alter this part of the roof frame to find if in

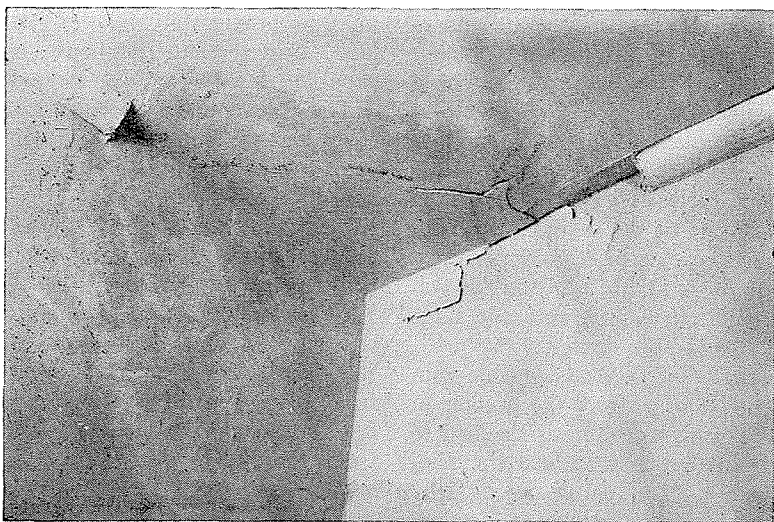
FIG. 16.—Plaster Telltale No. 4 After Completion of Test, Showing Extent of Cracking but no Signs of Separation Between Adjacent Walls.

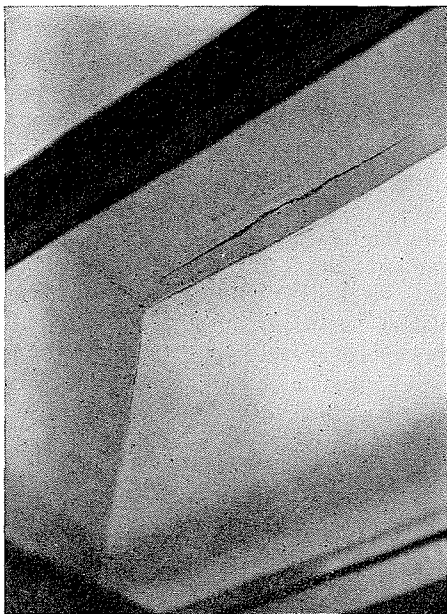
In the interior of the house, damage became progressively larger as the snow load was increased, particularly at the intersection of interior partitions and exterior walls, where the exterior walls moved outward at eave level in most cases. This pattern of deformation was produced largely by the spreading effect of the deflecting rafters and by ineffec-

tive resistance of the ceiling joist to this movement. Already at 75 per cent of design snow loading the exterior wall and the solid plaster partition separated for a considerable distance from the ceiling down. Under further loading this separation grew larger. Although there was extensive cracking in the plaster telltales at other points in the test house, there were no signs of apparent separation at the junctions of the conventional partition walls and exterior walls, as shown in Fig. 16. Further evidence of the spreading of the exterior walls is shown in Fig. 17 where the front wall moved outward between the conventional partition walls of the entrance and produced a fracture in the gypsum board ceiling.

FIG. 17.—Damage Caused to Ceiling Above Entrance by Spreading of Rafters Under Snow Load.
