INVESTIGATION OF SURFACE CONDENSATION IN A CMHC HOUSE IN HULL

(Prepared for Central Mortgage and Housing Corporation)

Ottawa
October, 1950.

DBR Report
R 26

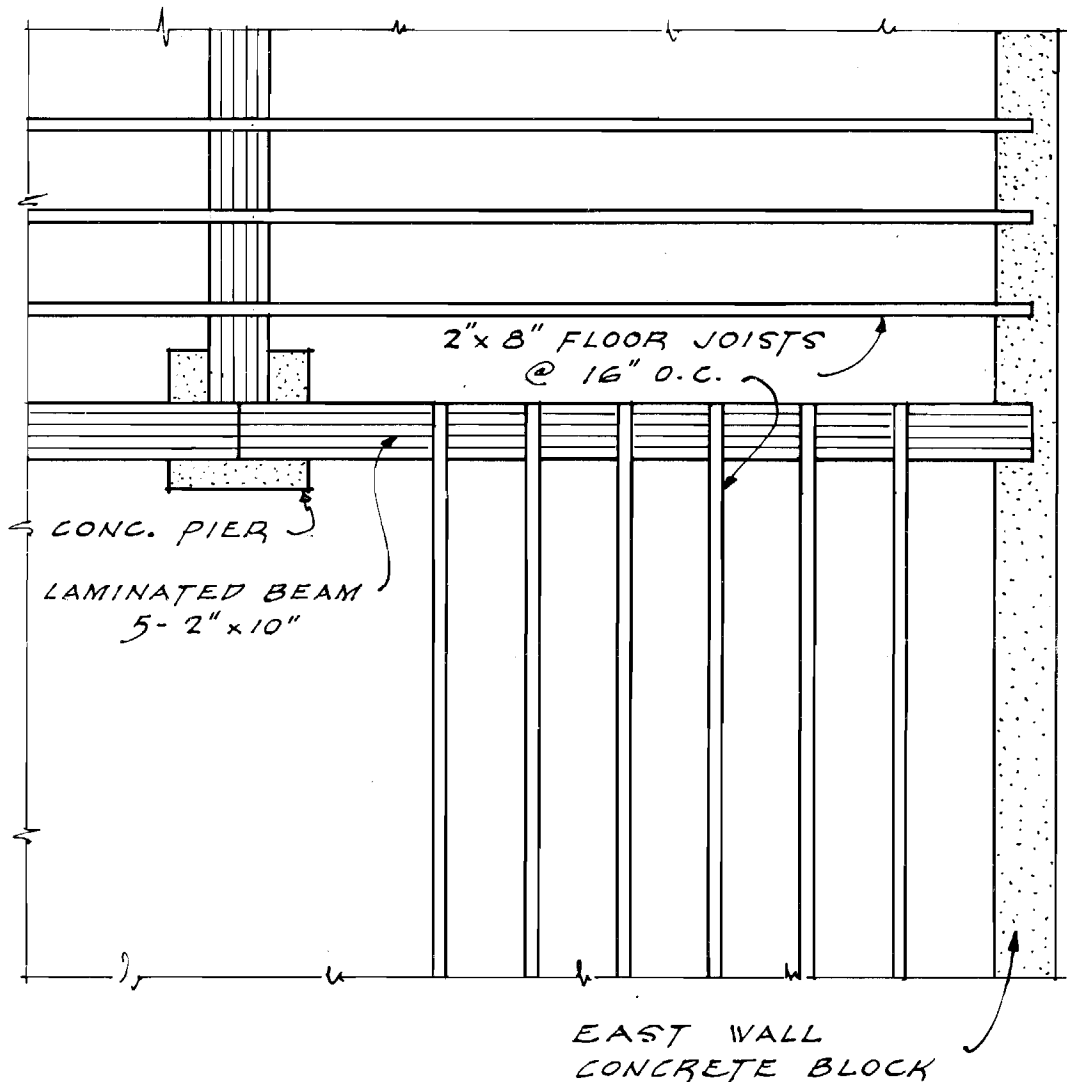
FIGURE 1

The depth of excavation beneath the floor varied from 1 to 3 feet, making it possible to inspect closely only the east wall. The floor framing in the vicinity of the east wall is indicated in Fig. 1. For a distance of about 3 feet south of the beam on the foundation wall, the wall was badly broken with no mortar between blocks. There was evidence of repair work in this section and the CMHC administrator reported the possibility of the wall being broken during sewer repair work. North of the beam the foundation was sound. All blocks on the east wall were damp and filmed with moisture in spots. The sill plate was damp and discoloured, and all joists and beams in contact with the wall were damp. Large patches of mould were seen on the beam and on the first two joists north of the beam (see Fig. 3). The 2 x 8 above the sill, south of the beam was damp and discoloured. All the joists north

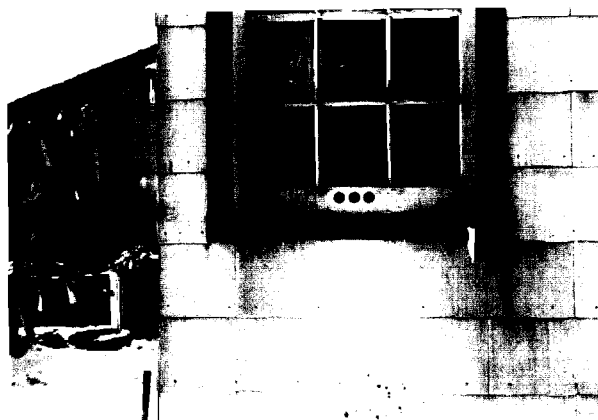
All windows were provided with storm sash and appeared tightly fitted. The windows were filmed with moisture and frosted at the edges of the glass. No windows were open on the first or second floors and it appeared that the windows were rarely opened. Icicles hung from beneath the window sills on the east exposure (see Fig. 2). This condition was not evident in adjacent houses.

Fig. 2
Icicle on S. E. bedroom window

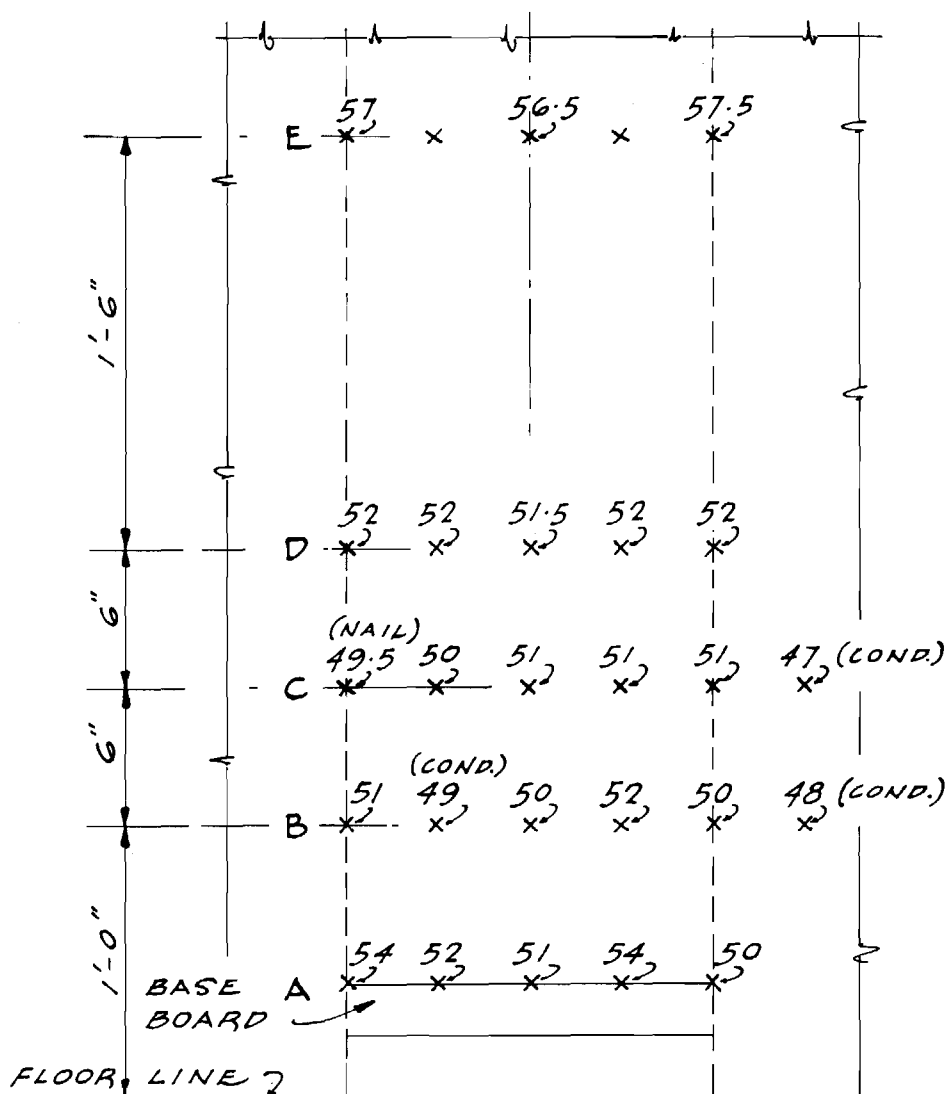
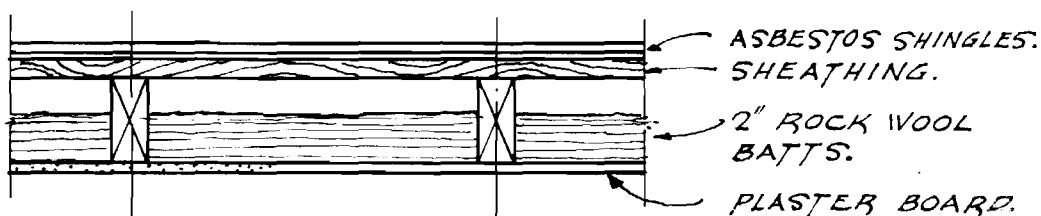
FIGURE 6

On the morning of Feb. 14, wall surface temperature measurements were taken on the inside surface of the exterior wall in the south-east ground floor bedroom. These readings were obtained with an Alnor portable pyrometer having an accuracy, according to the manufacturers, of 3°F . These readings and the locations at which they were taken are shown in Fig. 6. At the time the readings were obtained, only a few spots of moisture were noted on the wall and baseboard. One of the inside windows was open and considerable frost had accumulated on the glass of the storm sash.

The combined effect of the foregoing factors affecting wall surface temperatures was to cause the surface temperatures of the lower portions of the wall to fall, at times, below that of inside window surface temperatures, thus making the wall areas the condensing surfaces.

3) The addition of insulation to the lower portions of the wall would increase the inside surface temperatures and would help to alleviate the inside surface condensation. It would not, however, help the crawl space conditions.
