NATIONAL RESEARCH COUNCIL OF CANADA
DIVISION OF BUILDING RESEARCH

STUDY OF WIND DAMAGE TO RURAL BUILDINGS IN
SOUTHERN SASKATCHEWAN

by
A.G. Davenport and G.O. Handegord

Report No. 142
of the
Division of Building Research

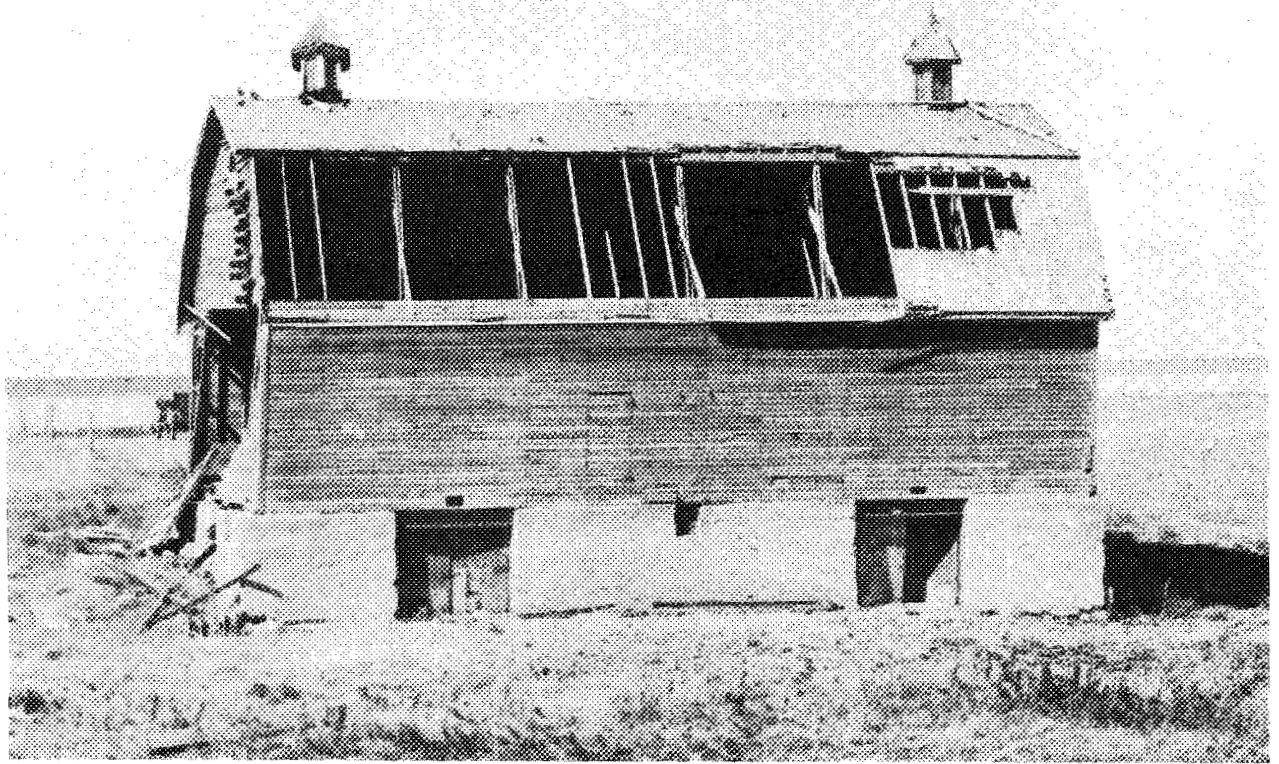
PRL 368

The effect of this initial failure was to increase the opening to the wind with a consequent change in internal pressure from suction to a large positive pressure. Although the external pressure on the roof should not change substantially, this change in the sense and magnitude of the internal pressure will increase the total forces tending to suck the roof off. As before, the suction acting on the east end of the roof will be less than that on the more windward end. Thus, the next portion to fail probably will be the west part of the roof, and this is exactly what happened, a small portion of the roof to the east being left intact (Fig. 2).

Figure 2 Moysey Farm, Tuxford, Sask. Damaged barn.
(July 27, 1957).

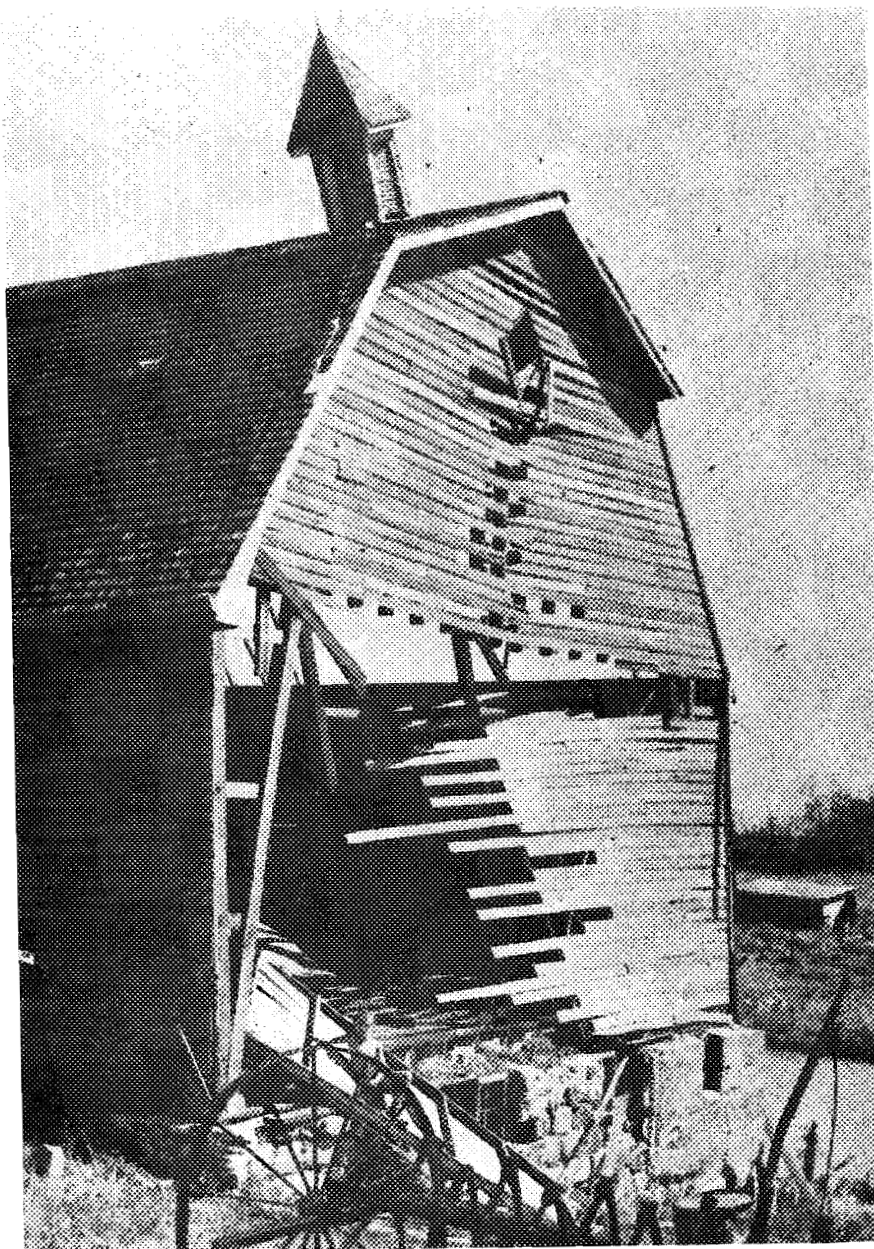
PRL 369

Wind tunnel studies on similarly shaped buildings with approximately the same orientation to the wind, indicate that the pressure distributions on the end walls and roof are approximately those shown in Figs. 7(a) and 7(b) (1). Initially, with the west gable end intact the greatest pressure will be found on this wall; the suction on the roof decreases from the west to the east end, where it changes to slight pressure. With most of the openings on the sides or to leeward a slight suction will be induced internally; this will augment the effective pressure on the windward gable end wall and balance some of the suction on the roof. Initially, therefore, by far the greatest forces will be on the west gable end which, in fact, was the first portion to fail (Figs. 3 and 4).

Figure 3 Moysey Farm, Tuxford, Sask. West wall of damaged barn. (July 27, 1957).

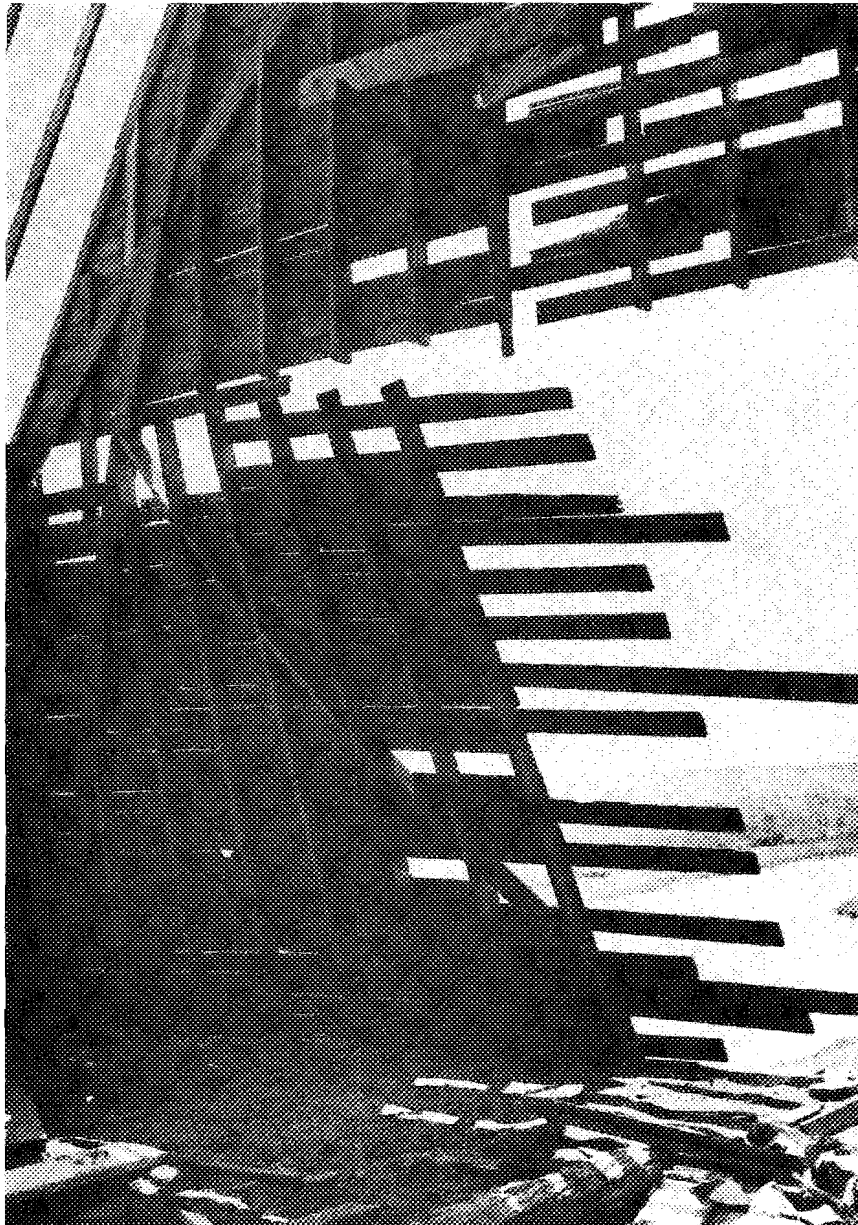
PRL 378

Figure 4 Moysey Farm, Tuxford, Sask. West wall of damaged barn. (July 27, 1957).

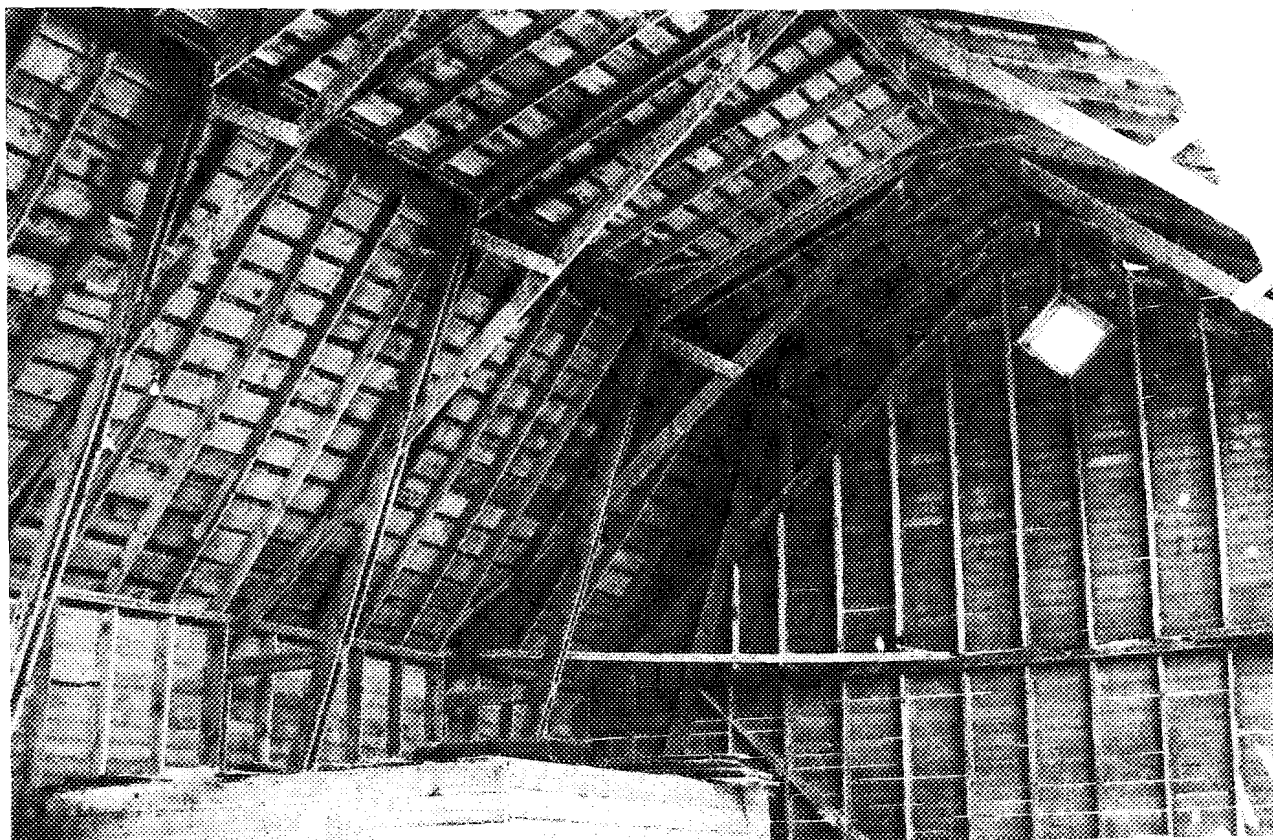
PRL 370

This barn illustrated in Figs. 2 to 6, was built about 1920 or earlier and it is interesting to note that it survived a severe windstorm in 1953. The barn was of reasonably good construction having 2- by 6-in. studs at 24 in. o.c. (Fig. 5). Horizontal cross-bracing is evident at the east end in this figure. There was, however, no evidence of similar bracing on the west wall.

- (d) The pressure regime on the side walls is similar to those on the roof suggesting the inadequacy of the horizontal bracing used in the structure (Fig. 5). This bracing does no more than transfer some of the pressure from the west end wall to the side walls (tending to push them outward) when these are already under high suction outward. Had the west end wall not failed these side walls would have been even more vulnerable.
- (e) There are indications that better spiking might have increased the rigidity of the west end wall. It is notable that all boards in the wall are intact and all rupture has occurred at the spiking. In addition there is very little horizontal support in the wall.

Figure 5 Moysey Farm, Tuxford, Sask. Undamaged portion of barn roof (looking northeast). (July 27, 1957).

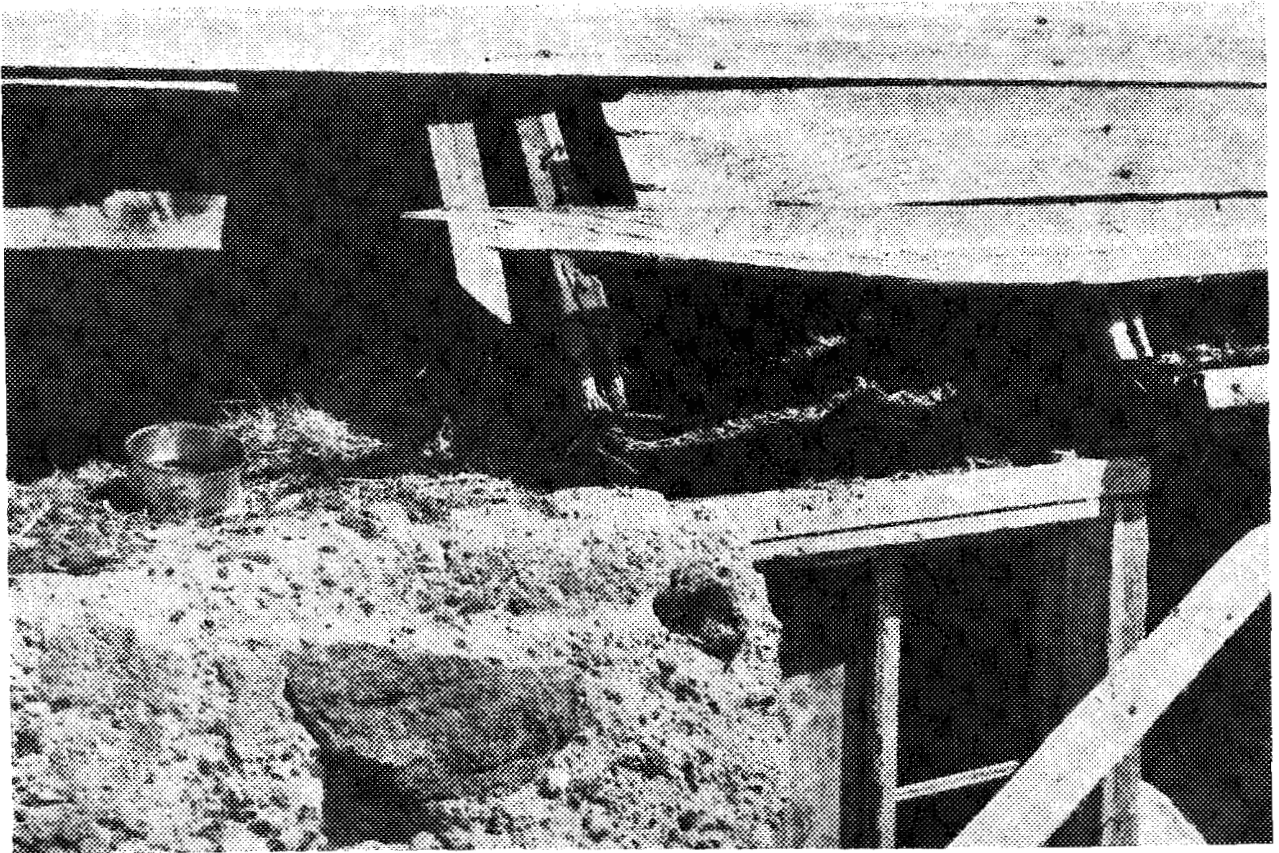
PRL 371

Figure 6 Moysey Farm, Tuxford, Sask. Plate detail at
centre of west end of barn. (July 27, 1957).

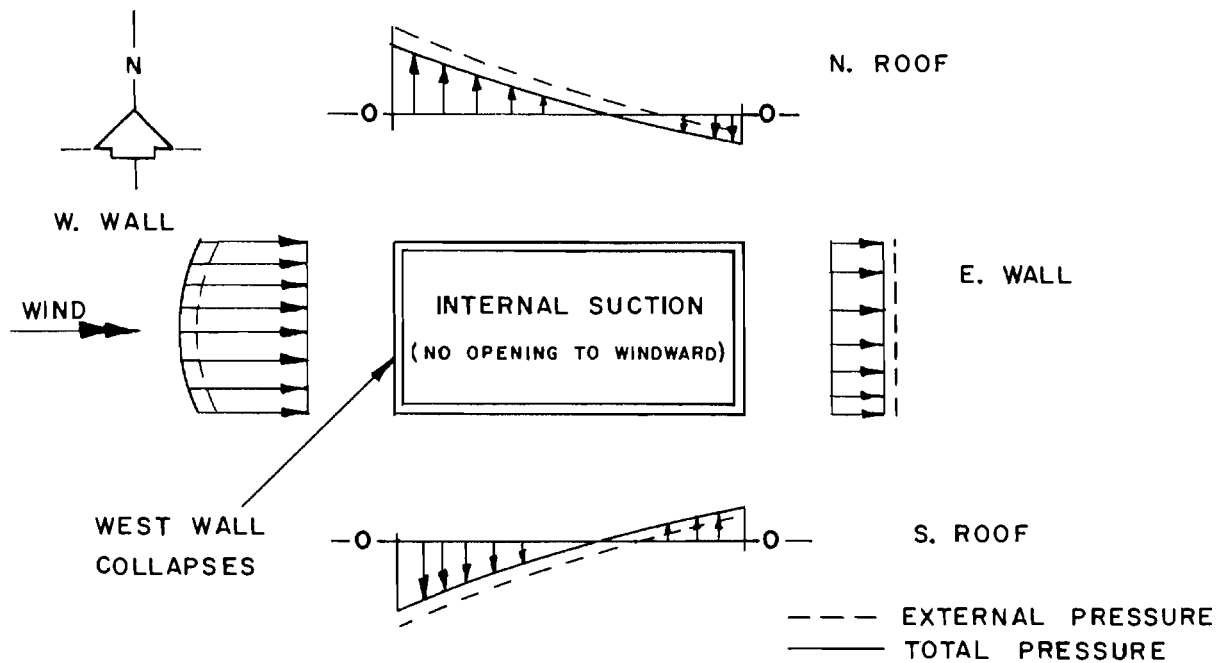
The failure is shown diagrammatically in Figs. 7(a) and (b). The wind, as in all cases discussed, was approximately west to west-northwest and the ridge of the roof ran east-west. The failure took place in the following way: (a) The west gable end of the barn blew in leaving a gaping hole in the face of the wind. (b) The west portion of the south roof blew outwards.

FIGURE 7a
SHOWING RELATIVE PRESSURE DISTRIBUTION ON
MOYSEY BARN BEFORE COLLAPSE OF WEST WALL

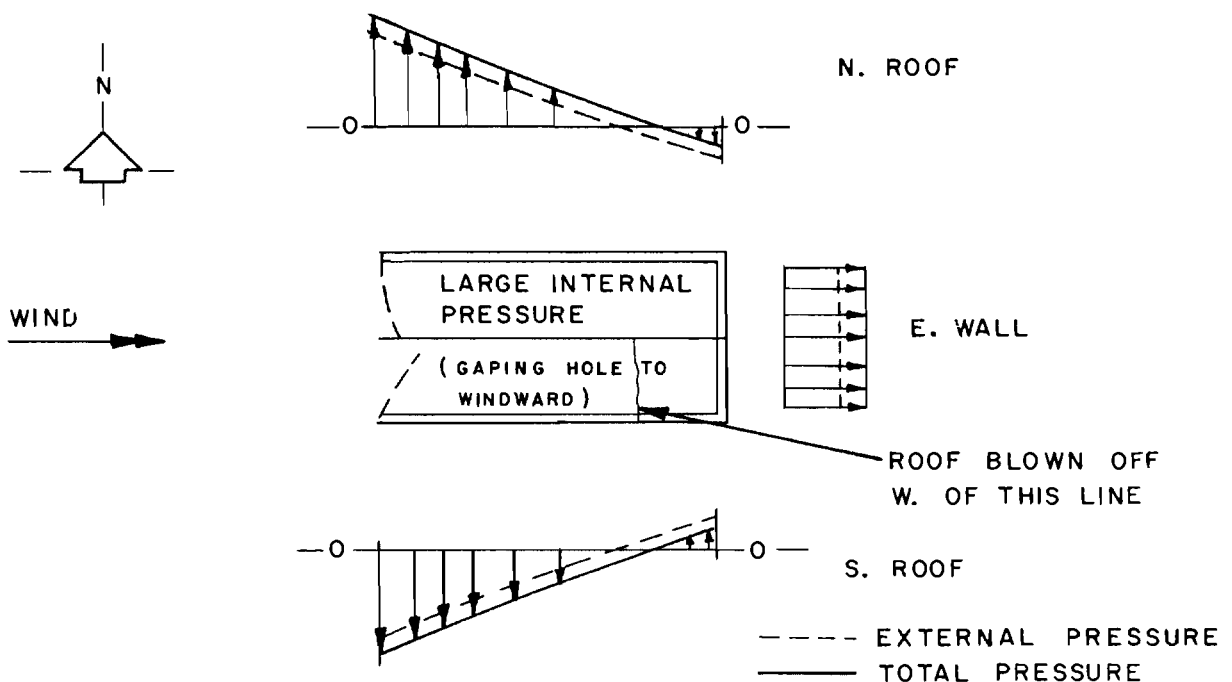
FIGURE 7b
SHOWING THE CHANGE IN THE PRESSURE DISTRIBUTION
DUE TO THE COLLAPSE OF WEST WALL

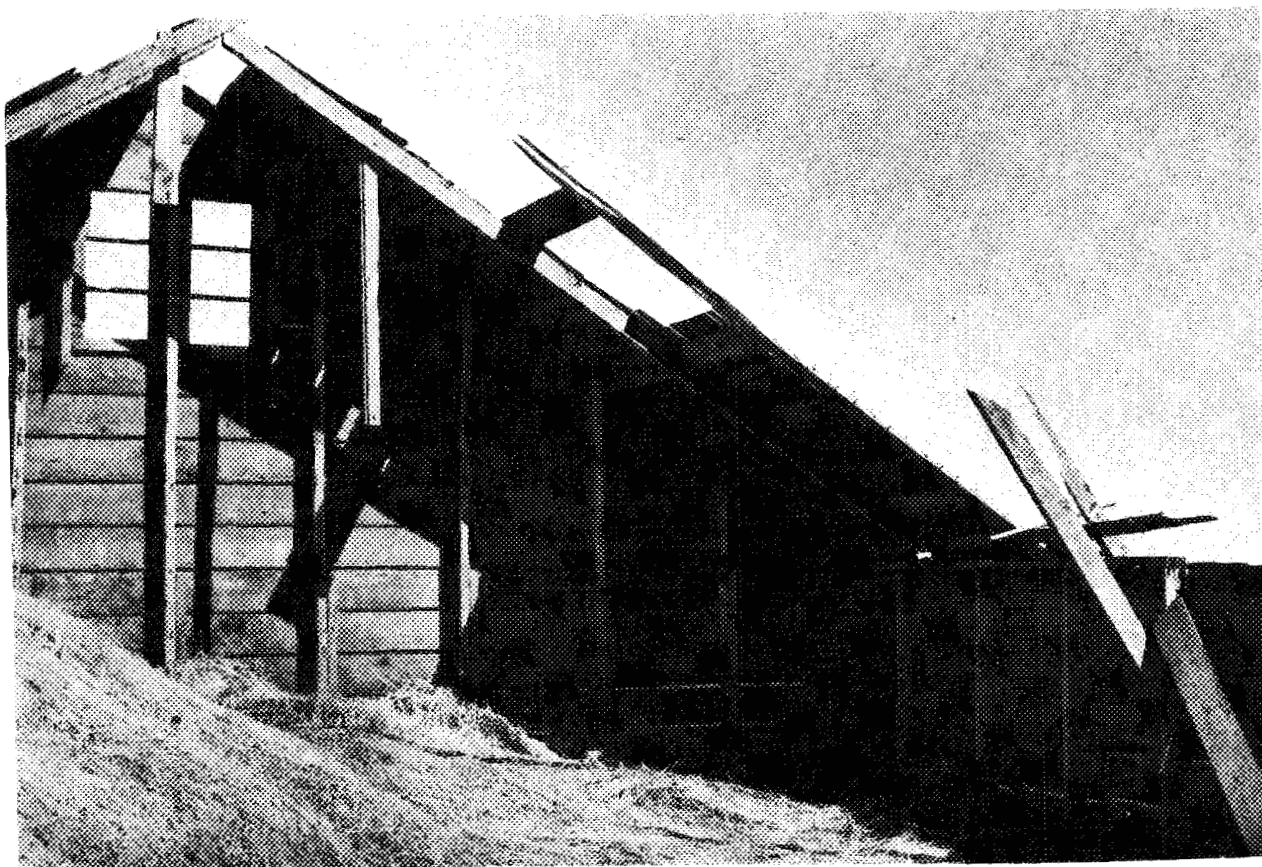
PRL 362

This barn (Figs. 8, 9, 10 and 11) was constructed of 2 x 4's on 24-in. centres sheathed on one side with shiplap. The rafters were spiked to the top plate with four toe nails and the top plate was in turn nailed to the bottom plate with one 3-in. spike at approximately 16 in. o.c. (Fig. 9).

The orientation of the barn to the wind and the manner in which it failed are almost identical to those of the Moysey barn. The wind was from the west, blowing almost parallel to the ridge of the roof. As in previous cases the sequence of failure was: (i) collapse of west wall; (ii) collapse of west portion of south roof, leaving the east portion of the roof intact.

Figure 8 Seiffert Farm, Bethune, Sask. East gable roof blown off barn. (July 26, 1957).

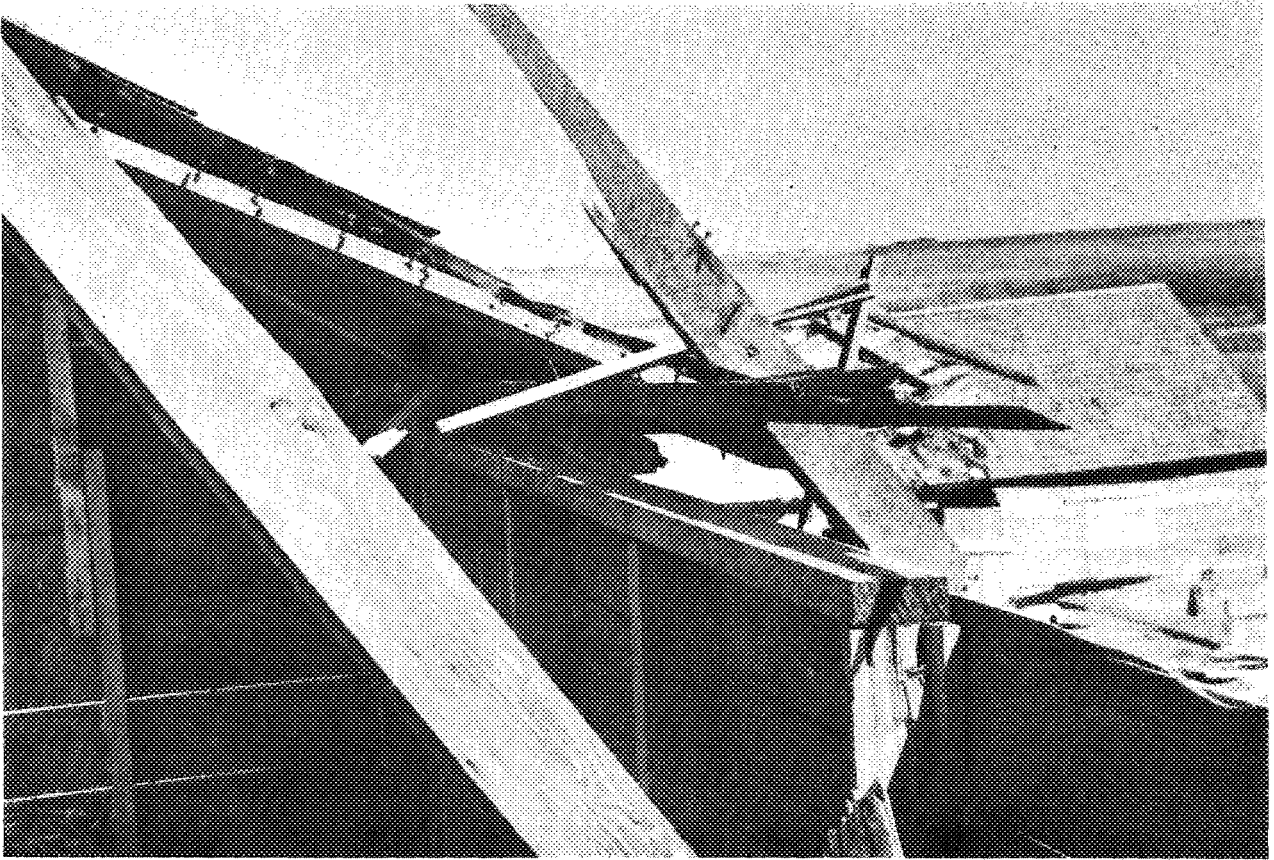
PRL 363

- (a) As in the case of the Moysey barn this failure indicates nothing contrary to wind tunnel results; these explain very adequately the manner in which the barn failed.
- (b) The conclusion drawn previously concerning the inadequacy of the spiking is again underlined in this failure. It is noticed in Fig. 9 that the top plate has come away from the bottom plate. Had more spikes been used to join these members the performance of this structure undoubtedly would have been improved. Also it is noticed in Fig. 10 that the boards on the roof have been so securely spiked to the rafters that the latter have split instead of severing at the spiking. This might also have been due to the toe nailing of the rafters to the top plate, and on these grounds the inadequacy of this type of connection is indicated.

Figure 9 Seiffert Farm, Bethune, Sask. Detail of Fig. 8.
(July 26, 1957).

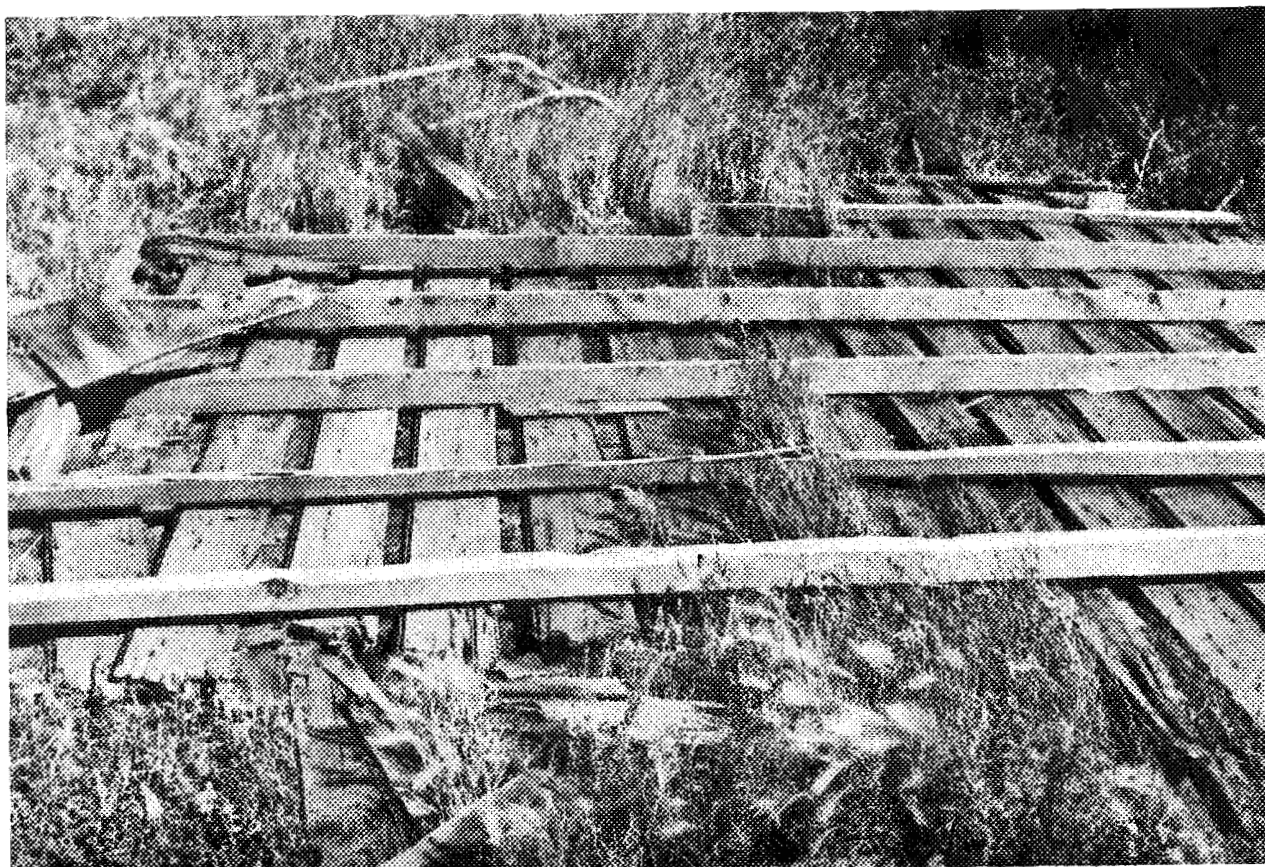
PRL 364

Figure 10 Seiffert Farm, Bethune, Sask. Roof of barn showing split rafters. (July 26, 1957).

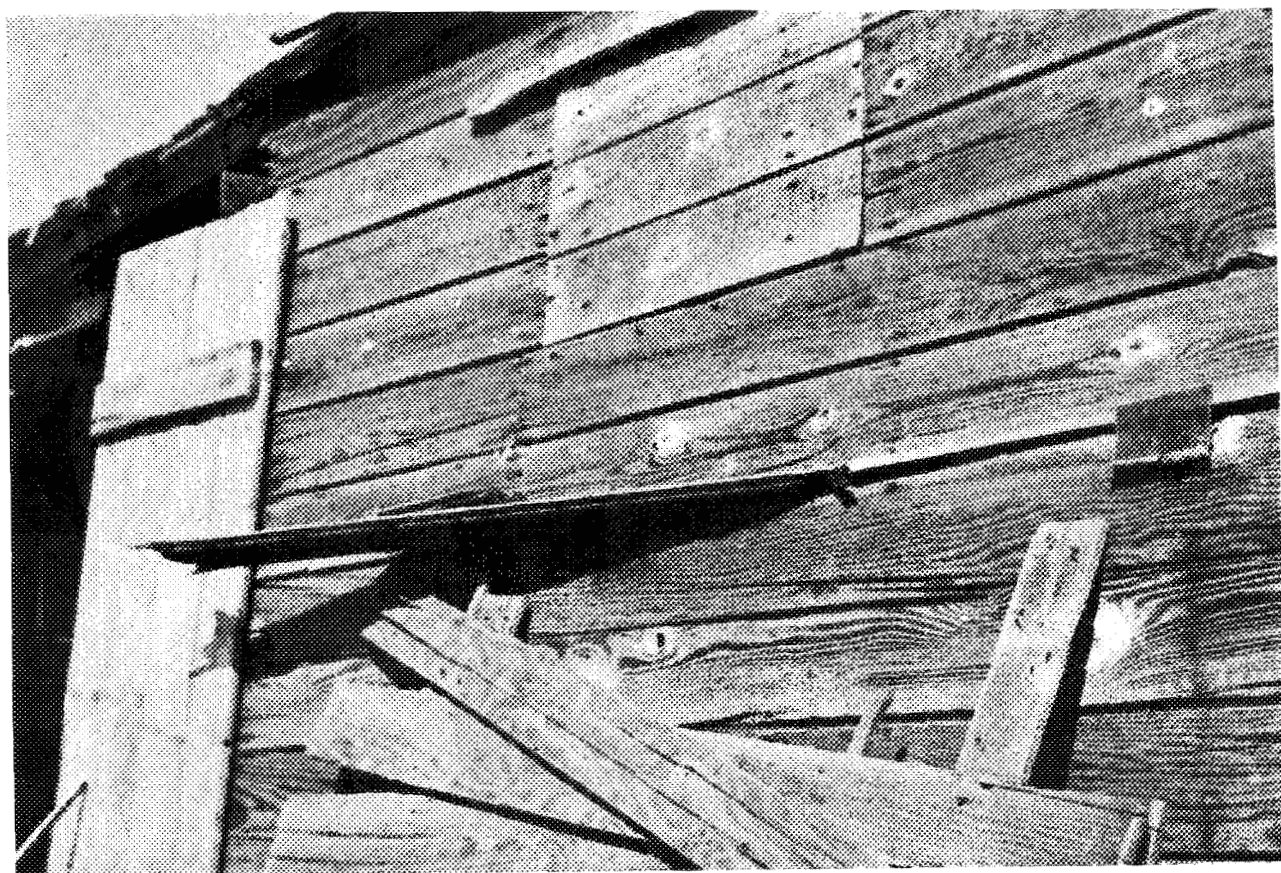
PRL 366

Figure 11 Seiffert Farm, Bethune, Sask. Barn siding board embedded in granary wall. (July 26, 1957).

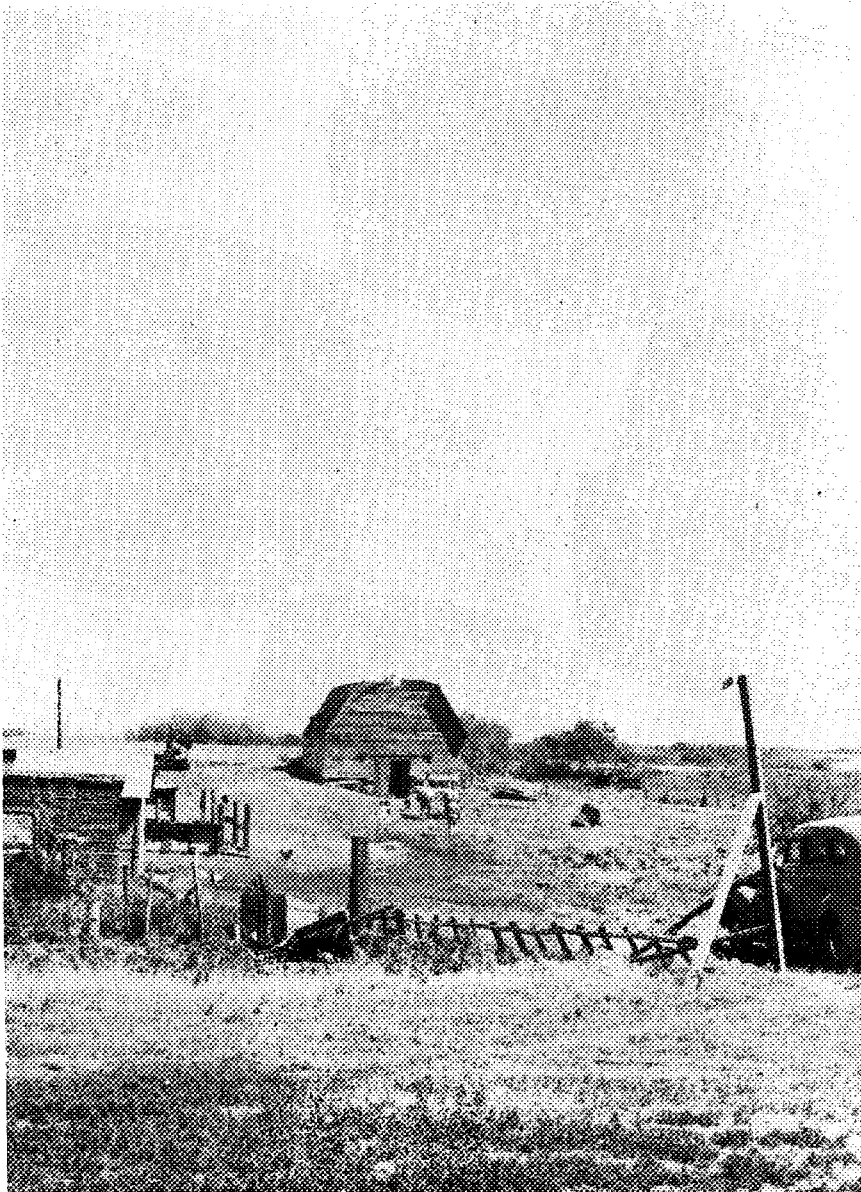
PRL 355

If the large doorway on the west (windward) side (Fig. 12) had been open during the storm, the increased internal pressure would have contributed greatly to the forces tending to blow the roof off.

Figure 12 View from south barn on farm of
Mr. Bundas, 1 mile north of Sifton,
Sask. (July 26, 1957).

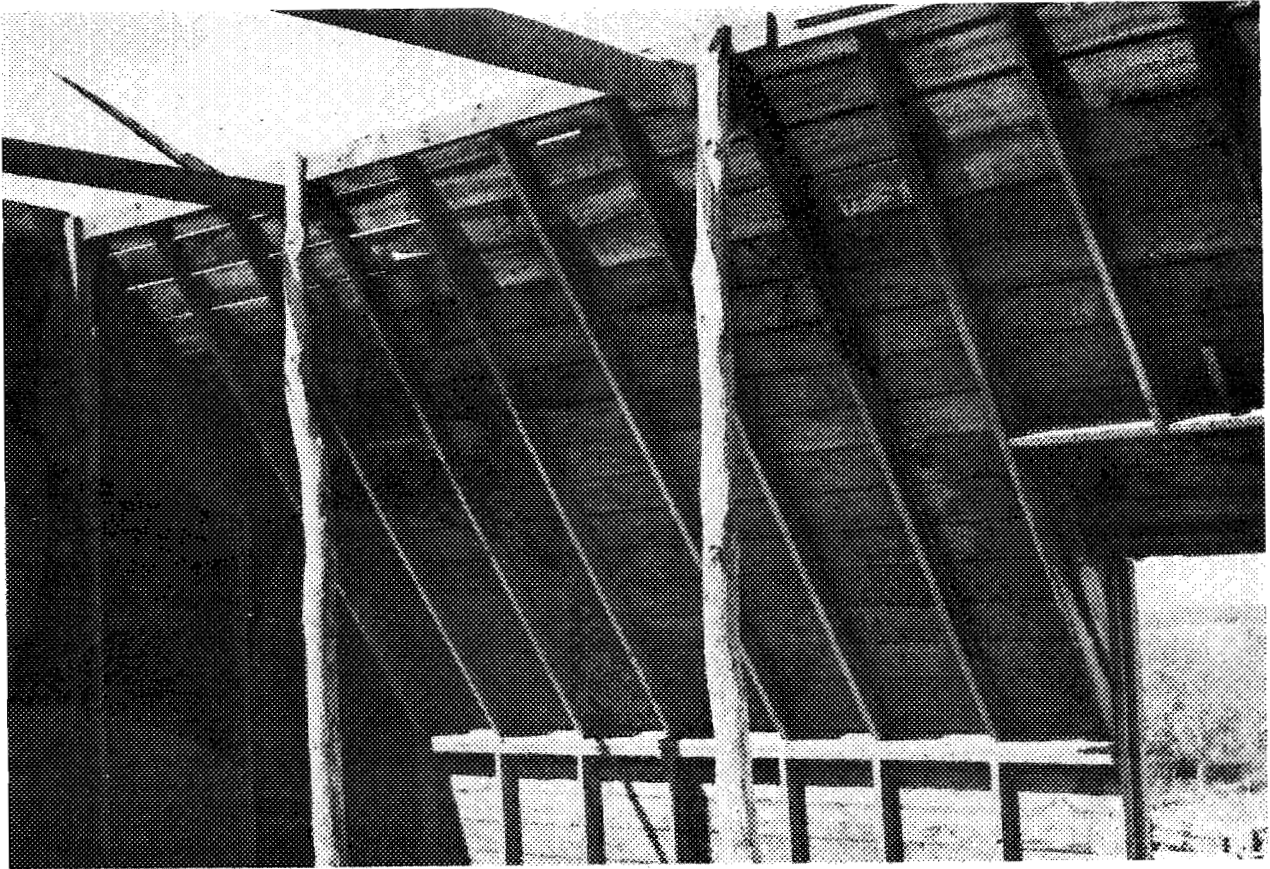
PRL 356

Although this barn (Figs. 12, 13 and 14) had been standing for about 30 years, it appeared to be of substandard construction with 2-by 4-in. studs and rafters on 24-in. centres and one side sheathed with 8-in. shiplap.

Although it was similar in shape to the Moysey barn with the conventional gambrel roof, the orientation of the barn to the wind differed; the ridge of the roof was at right angles to the wind rather than parallel to it. The two upper panels of the gambrel roof were completely removed by suction.

Figure 13 Interior of barn loft on Bundas Farm north of Sifton, Sask. (southwest corner). (July 26, 1957).

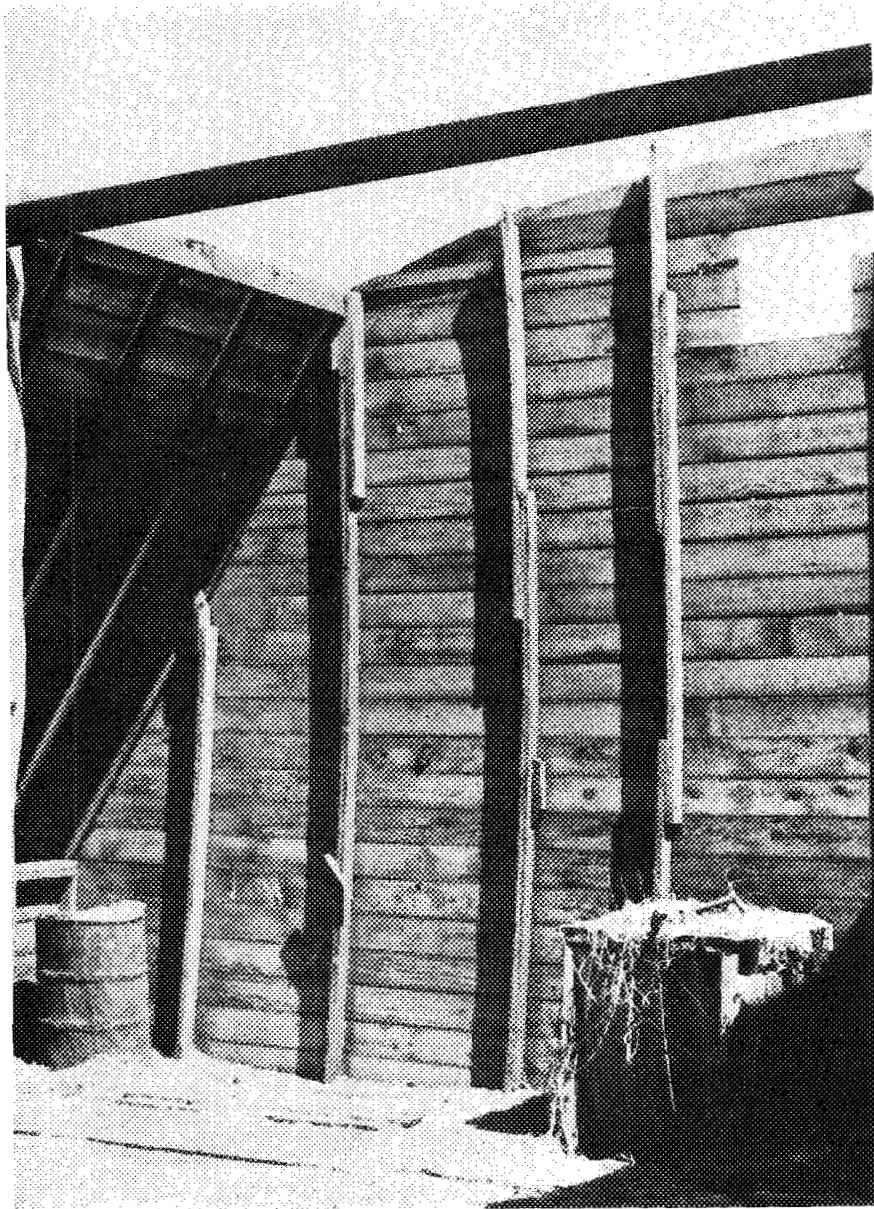
PRL 354

Figure 14 Bundas Farm, Sifton, Sask.
Interior of barn loft (north-
west corner). (July 26, 1957).

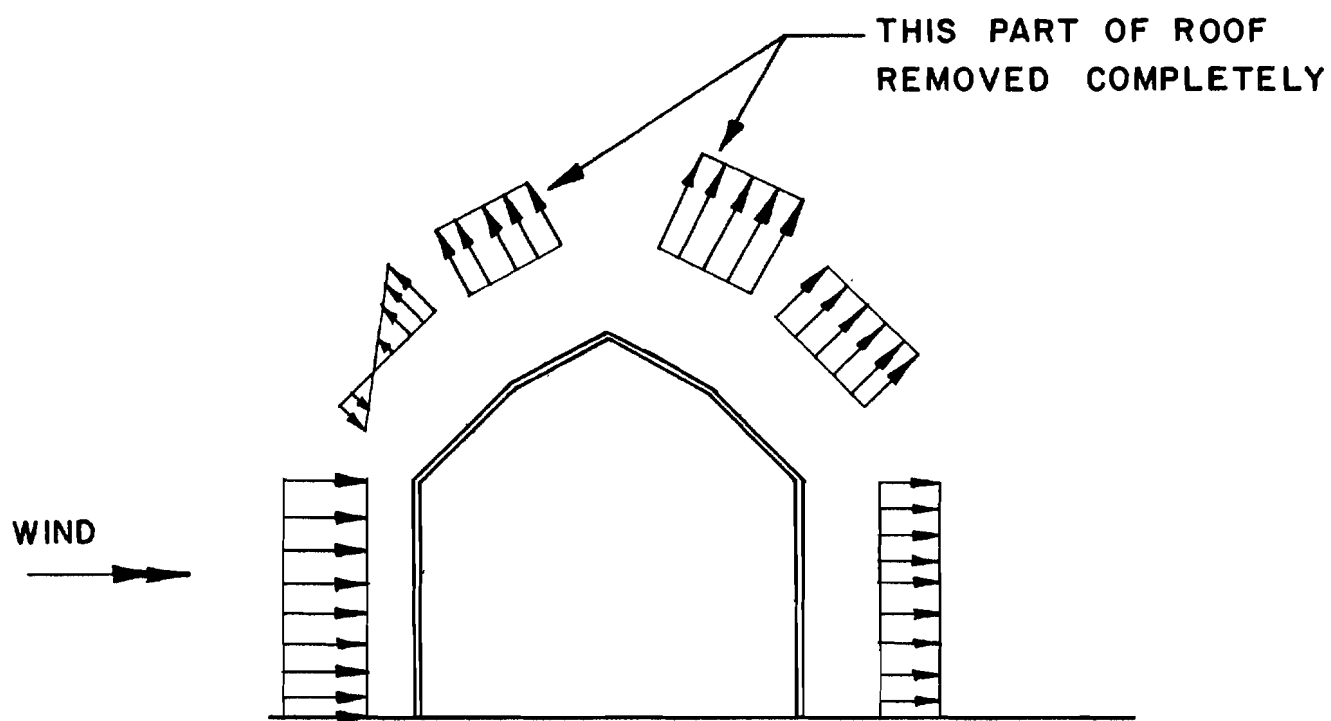
FIGURE 15

Figure 15 shows the external pressures exerted on a roof of this type when the wind is at right angles to the ridge of the roof according to the wind tunnel studies (2). This diagram clearly indicates that failure occurred in the region of highest suction, evident on the uppermost panels of the roof.

PRESSURE DISTRIBUTION FOR DUNDAS BARN ACCORDING
TO WIND TUNNEL RESULTS

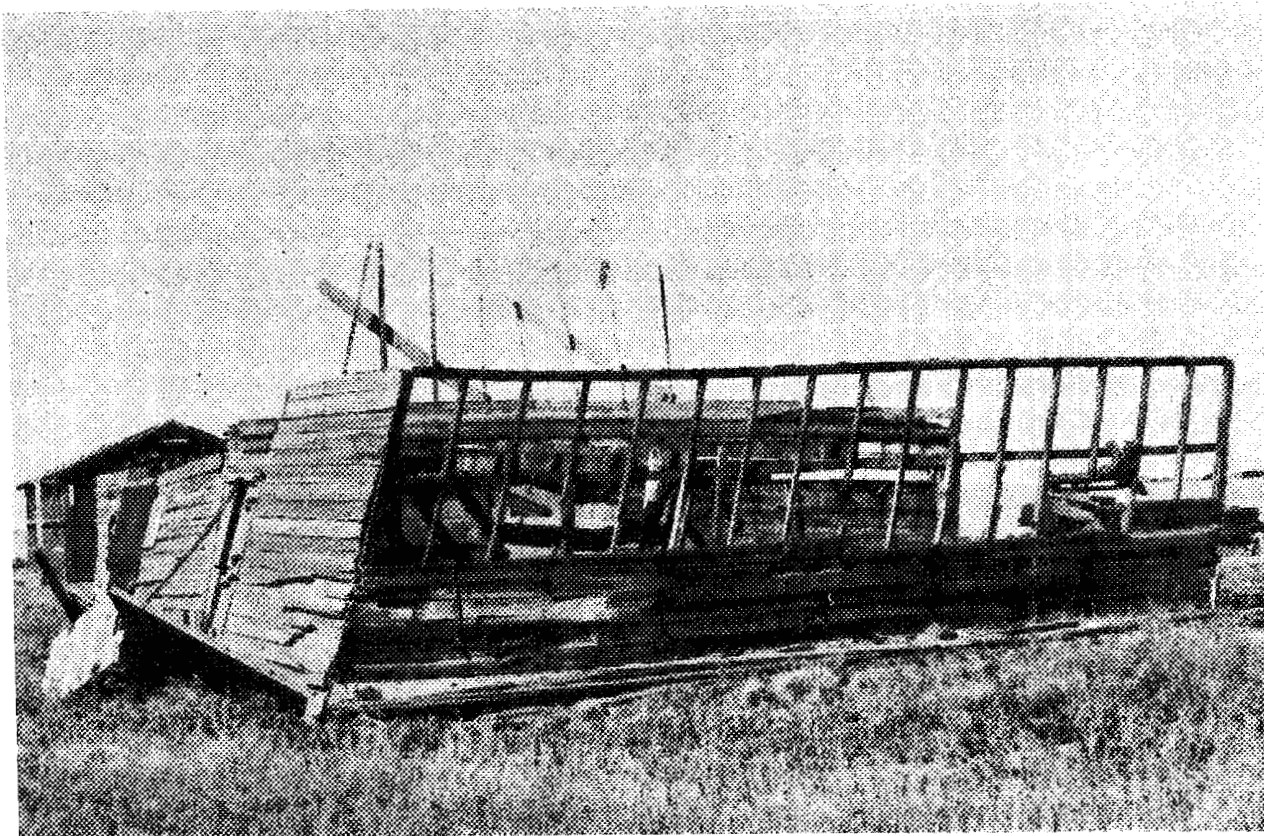
PRL 360

As can be seen from Figs. 16 and 17 very little remains of either of these buildings. Figure 16 shows what was partly a two-story barn. Some observations, however, can be made:

- (a) With the wind coming from the left hand side of Fig. 16, this photograph shows the consequences of inadequate shear bracing to resist racking.
- (b) The pressures which would be exerted on the side walls (facing the camera in Fig. 16) would have been suction which could account for the removal of the boards, (unless the owner had removed them!).
- (c) The roof on the far side was close to horizontal and the high suction on this type of roof is indicated by the angle of the remaining rafters on the far side.

Figure 16 Mutch Farm, Bethune, Sask. Small barn demolished by storm. (July 26, 1957).

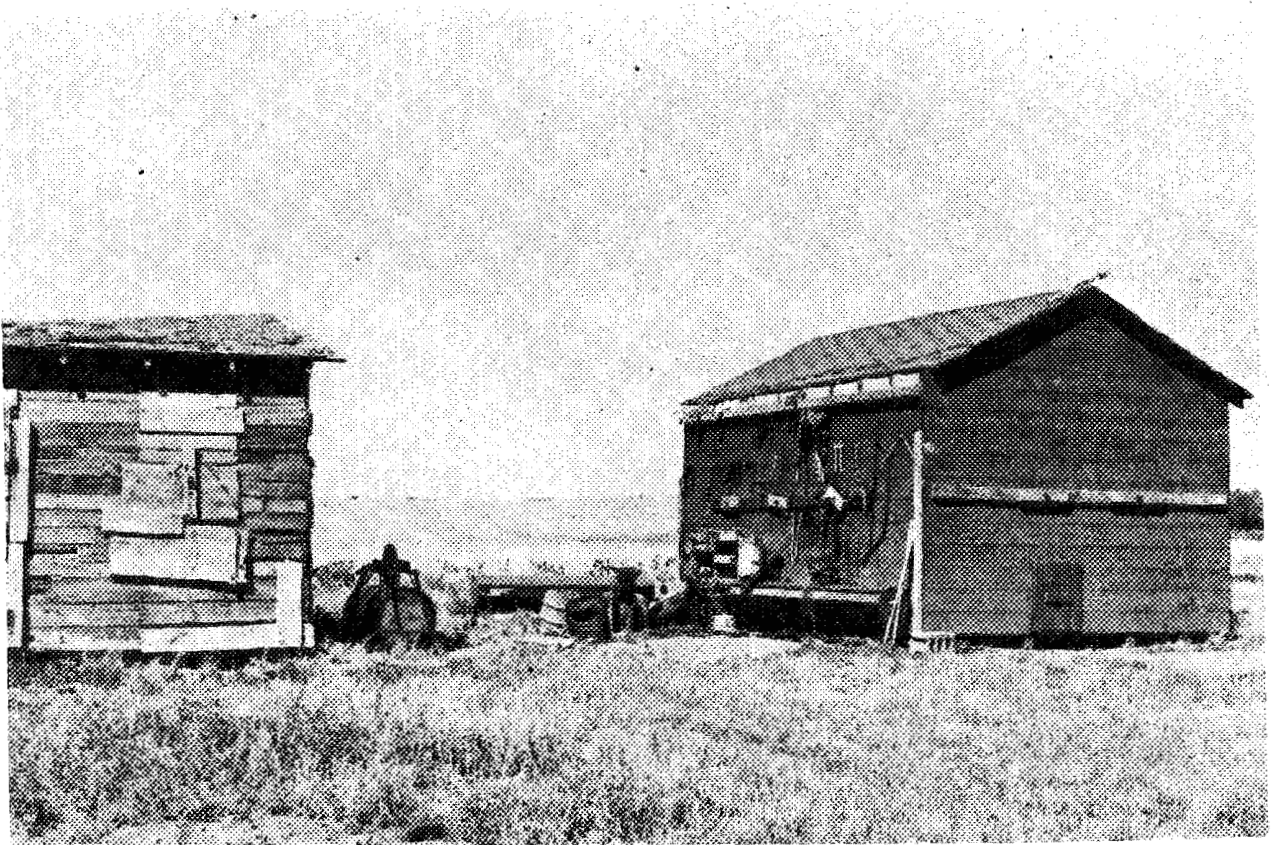
PRL 361

Figure 17 shows the spot where a machine shed once stood. A failure of this nature where the whole building has been toppled over might yield a numerical value for the overturning moment which would be helpful for comparison with wind tunnel results.

Figure 17 Mutchka Farm, Bethune, Sask. Machine shed
which was blown away from side of granary.
(July 26, 1957).

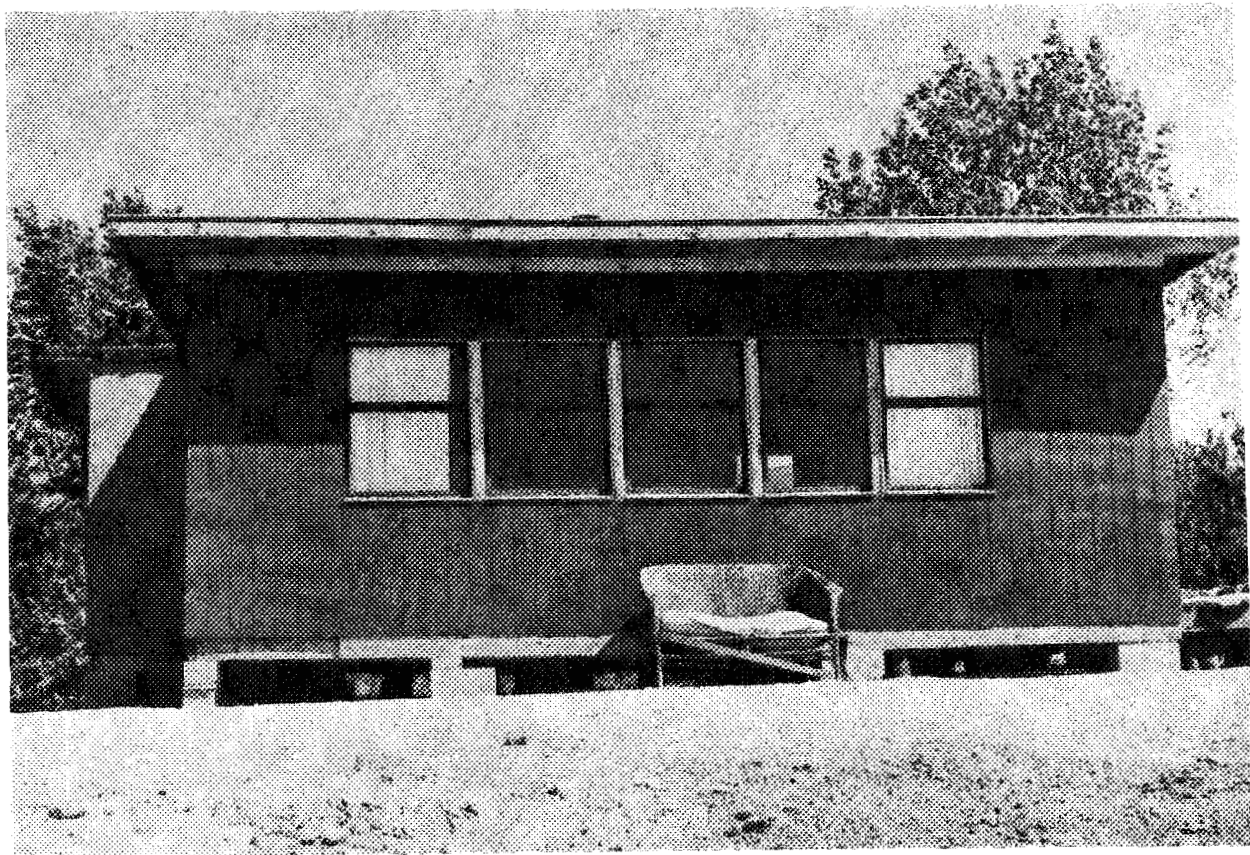
PRL 357

This cottage (Figs. 18 and 19) faces southwest so that the wind was almost at right angles to the front wall. The dimensions were about 21 ft by 24 ft in plan; it was of frame construction with plywood "ranch wall" comb sheathing siding, furnished, but with a minimum of interior partitioning. Judging by the position of the front floor beam (Fig. 19) in relation to the concrete blocks on which the cottage rests, (and also the one at the rear), the wind moved the cottage back about 1 1/2 in. The cottage was not tied down.

Figure 18 Beach cottage, Cook's Beach (near Sask. Beach, Sask.). View from southwest. (July 26, 1957).

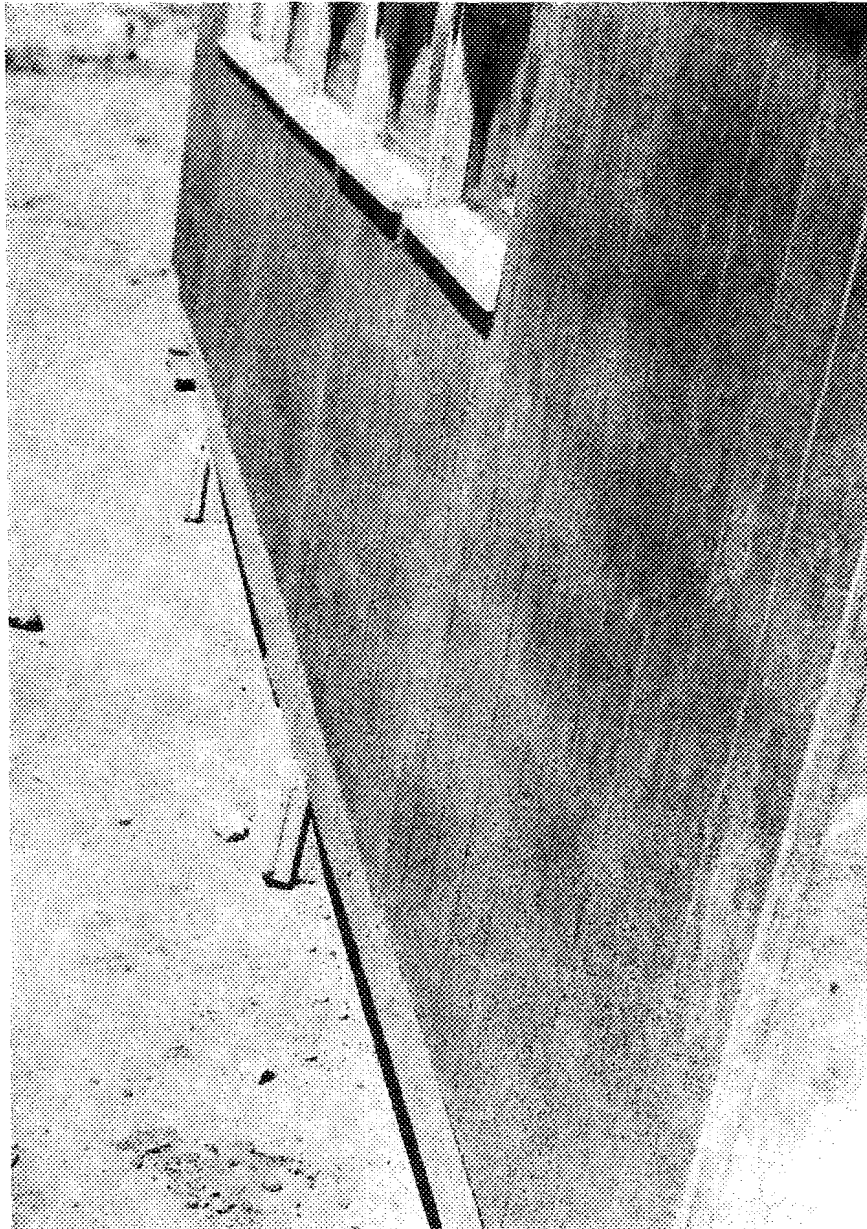
PRL 358

Figure 19 Beach Cottage, Cook's Beach (near Sask. Beach, Sask.). Wall facing southwest shifted back on foundations. (July 26, 1957).

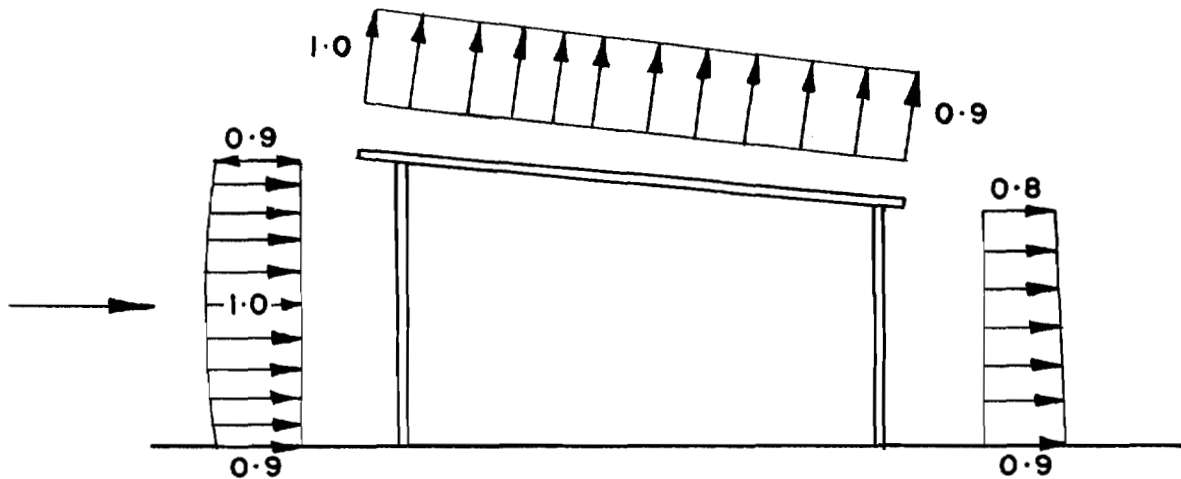
The pressure distribution under these circumstances is similar to that shown in Fig. 20 where the figures indicate the number of velocity pressures in action (2).

FIGURE 20
SIDE ELEVATION OF COOK'S BEACH COTTAGE
SHOWING PRESSURE COEFFICIENTS FOUND FROM
WIND TUNNEL RESULTS FOR A BUILDING OF THIS
SHAPE
