NATIONAL RESEARCH COUNCIL OF CANADA
DIVISION OF BUILDING RESEARCH

STUDY OF WIND DAMAGE TO RURAL BUILDINGS IN
SOUTHERN SASKATCHEWAN

by
A.G. Davenport and G.O. Handegord

Report No. 142
of the
Division of Building Research

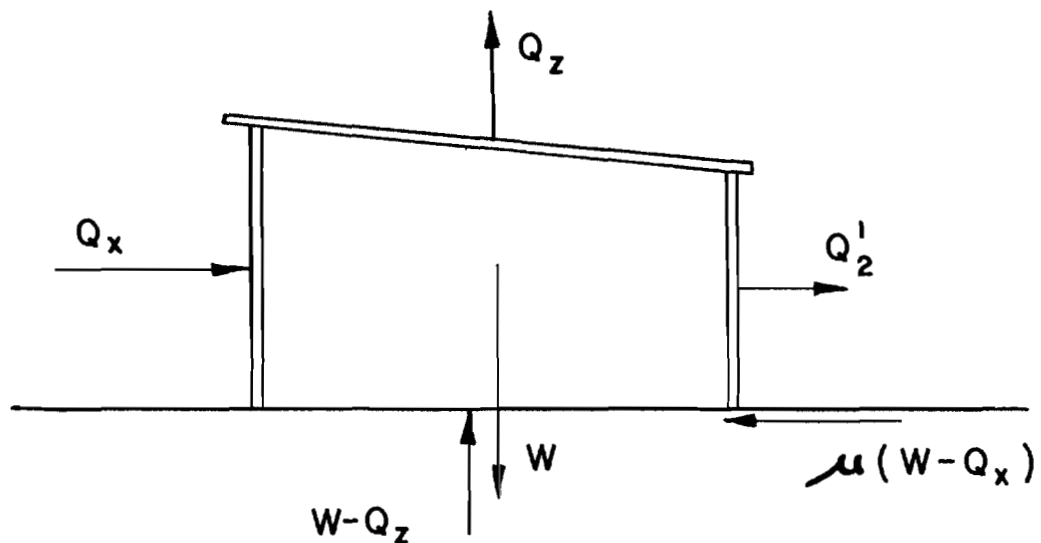
Consider the forces on this structure if it is just about to slide (Fig. 21). Let the resultant vertical uplift force (calculated from the area of the roof with the pressure distribution of Fig. 20) be Q_z ; let the resultant pressure and suction forces on front and rear walls be Q_x and Q'_x respectively; let the total weight of the cottage be W and the coefficient of friction between wood and concrete block be μ .

$$Q_x + Q'_x = \mu (W - Q_z)$$

FIGURE 21
FREE BODY DIAGRAM OF FORCES ACTING ON
COTTAGE AT POINT OF SLIDING
