PAINT PERFORMANCE ON HOUSES IN AMHERST, N.S.

Internal Report No. 327  
of the  
Division of Building Research

Ottawa  
May 1966

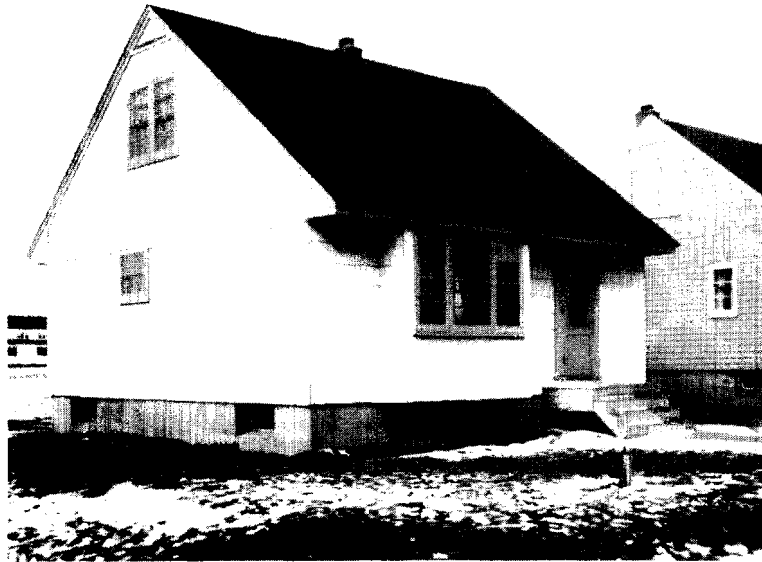
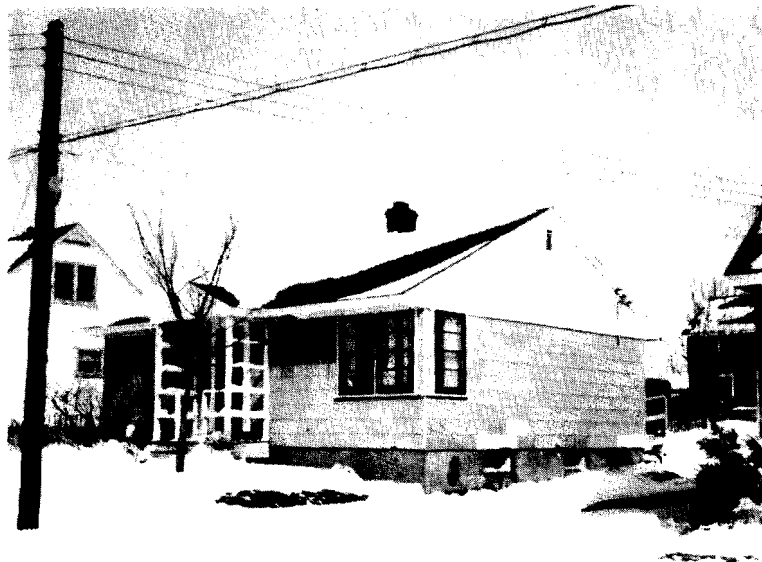
Figure 2 Asbestos Siding to Eave Line with Vertical  
Wood Vee-Joint at Gables  
(Note Peeling Bottom of Vee-Joint)

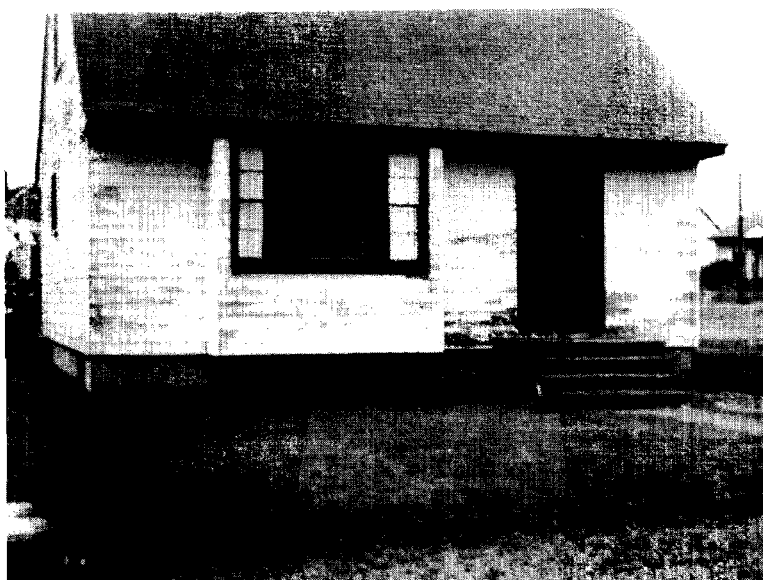
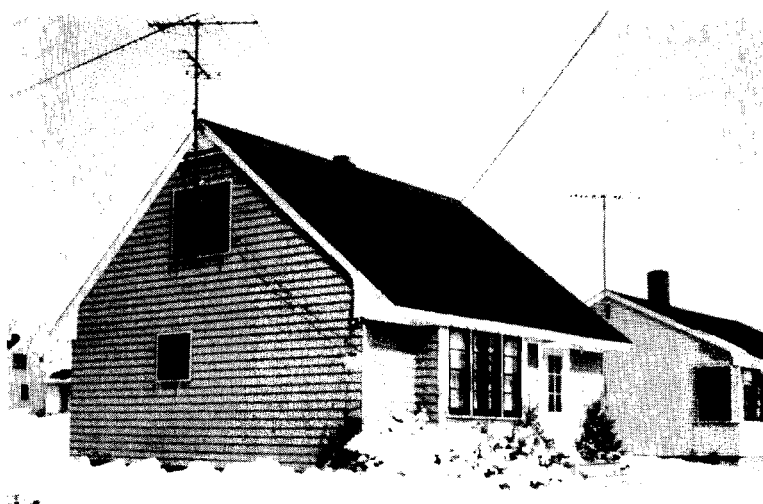
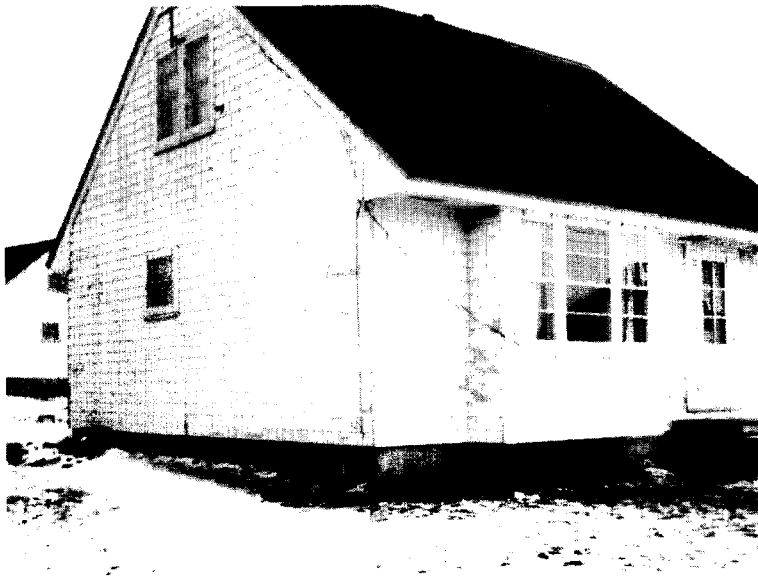
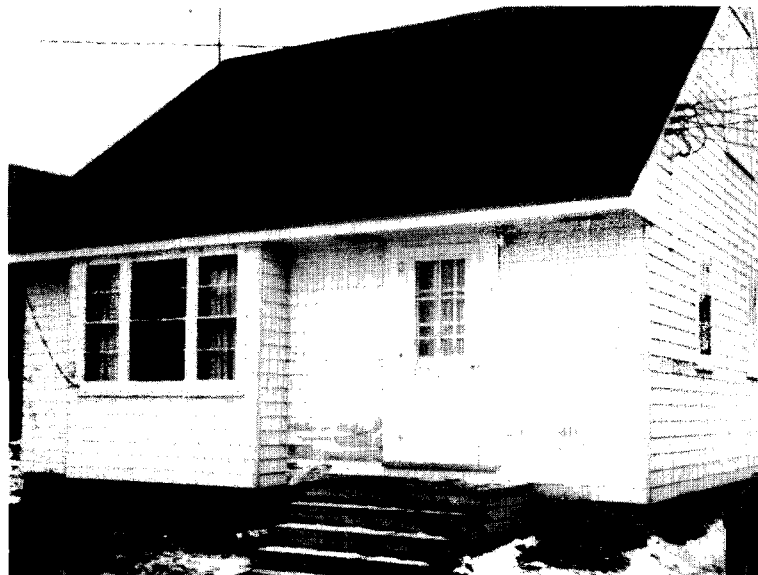
in the group repainted at that time. Of particular interest was the excellent condition of 114 Spring Street (Figure 5) as this house had been cause for chronic complaint regarding its unsightly appearance since it was built.

Figure 5 Various Conditions of Paint on Wood Siding,  
114 Spring St. (South and Southeast Exposure)

Of the 13 houses clad with wood siding 12 have some walls that can be rated poor and should be repainted. Some peeling is limited to areas around openings while, for example, on 114 Spring Street (Figure 4) all walls have severely peeled. Of the 13 houses with combination siding (asbestos side walls to eave line and vertical wood Vee-joint gables), all but two face east or west and wood gables on north and south exposures are involved. Practically all of these exposed to the south are in poor condition. Some have peeled badly all over while others have peeled at the joints, butts, and around windows. There is something to be said for the omission of the flashing and water table at the butts in the future use of Vee-joint siding on gables and for letting these butts be painted and backprimed for a foot or two and installed to lap the siding below for a few inches. This would reduce and might even eliminate wicking at the butts of the siding. Generally the south-exposed walls show the greatest extent of paint failure for all types. Conditions of paint on bungalows and  $1\frac{1}{2}$ -storey houses, based on observations made in 1957, are given in Tables I and II of this Appendix.

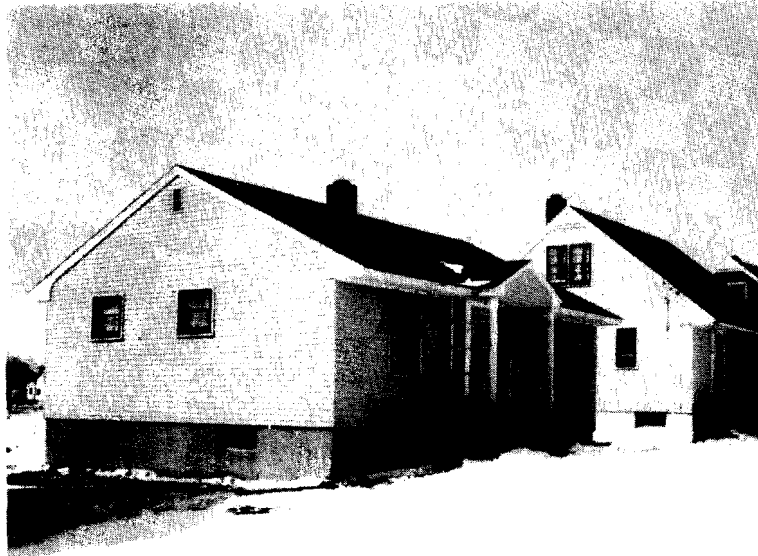
Figure 6 Limited Peeling on South Wall, 23 Westminster Ave.

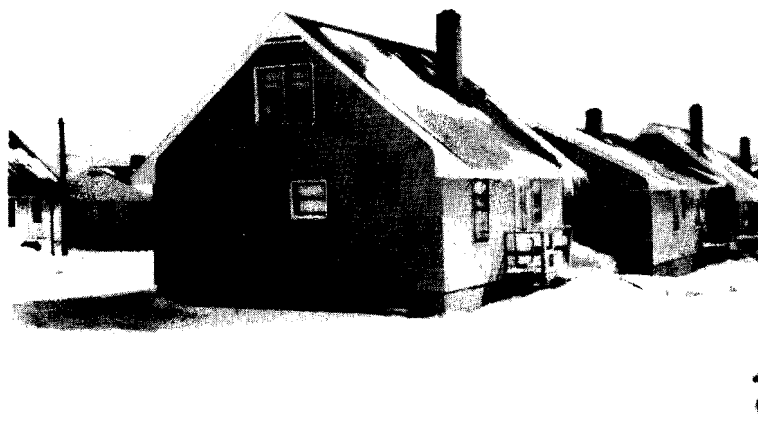
Figure 7 Spot Peeling on North Wall, 15 Westminster Ave.

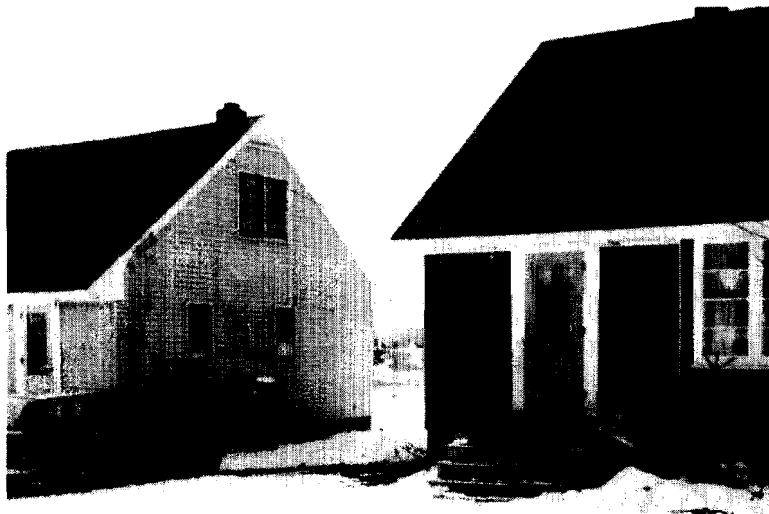
Figure 8 Severe Peeling on West Half of North Wall,  
11 Westminster Ave.

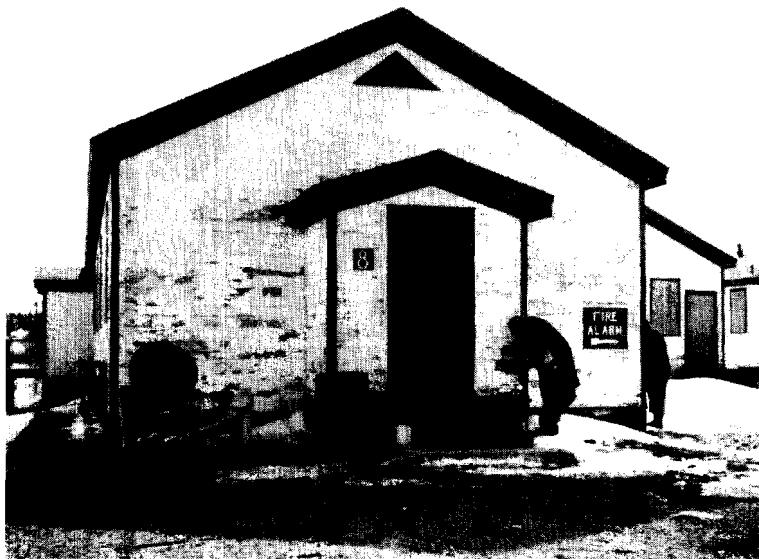
To deviate from this specific study, members of the DBR Atlantic Regional Station had the occasion in March 1961 to examine some Army huts at York Redoubt where conditions were such as to indicate that the paint failure there could not be attributed to the condensation of inside water vapour (Figure 9). These huts were constructed during World War II and were originally clad outside with heavy mineral-surfaced rolled roofing of a type commonly used as ground barrier against rising dampness. They were clad (over the roofing) with wood drop siding in 1954 and painted. Prior to demolition these buildings remained unoccupied and unheated since 1957, when they were repainted. The buildings were uninsulated and were clad on the interior with gypsum wallboard or fibreboard. Condition of framing and wood sheathing when examined on demolition was found to be dry and free from rot.

Figure 9 Paint Peeling on Unoccupied Army Hut -  
York Redoubt

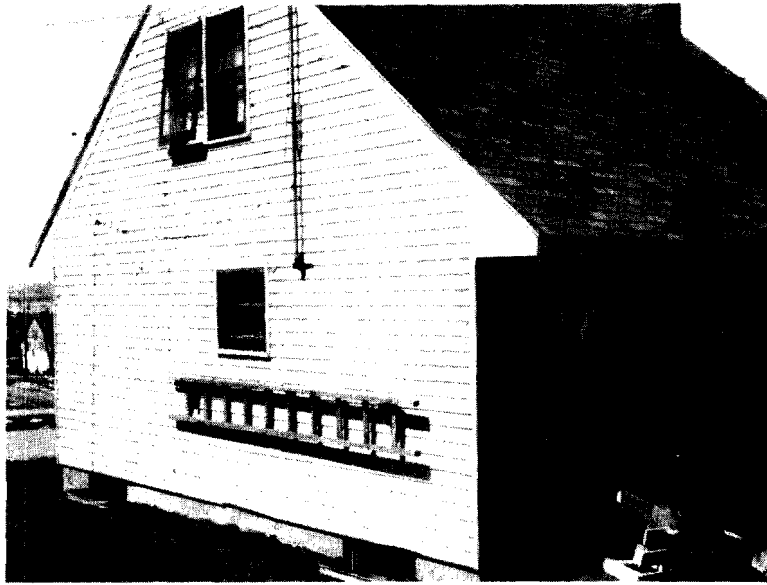
Figure 10 Paint Peeling Starting Near Wood Trim and Window Details

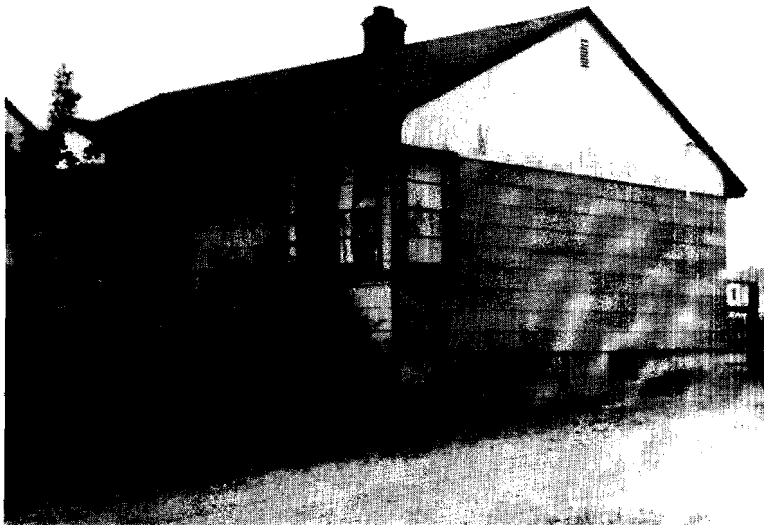
Figure 11 Peeling of Vertical Vee-Joint Butts at Water Table
