EARTHFLAWS AT THE BEATTIE MINE -
A CASE RECORD
by
W. J. Eden

Internal Report No. 221
of the
Division of Building Research

OTTAWA
May 1961

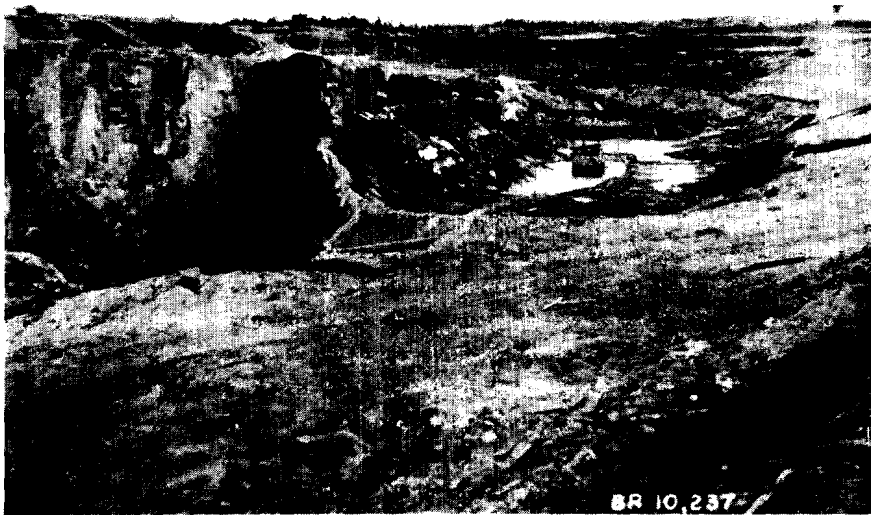
In all cases, the stripped material was deposited near the top of slopes cut in the overburden. The slopes were cut to a slope of 4:1 with a berm bordering the ore body. The maximum depth of overburden was about 100 ft, consisting of 85 ft of clay underlain by 15 ft of sand. Figure 1 is a photograph showing the slopes in 1943. The overburden consisted of varved clay overlying a few feet of sand over the bedrock. The varved clay was deposited in late glacial times in Lake Barlow-Ojibway (Antevs 1925) and was found to be nearly normally consolidated. The mine was located about one mile north of Lake Duparquet and the rim of the pit on the west end was about 60 ft below the lake level. Seismic surveys showed there was no ledge of bedrock between the rim of the pit and the shores of the lake. The tailings disposal site was located in swampy land near the southwest corner of the pit. It was noted that considerable seepage issued from the sand underlying the clay, particularly at the west end of the pit, closest to the lake shore, and the tailings disposal area.

Figure 1: Clay slopes at northwest side of Beattie Mine - June 15, 1943.

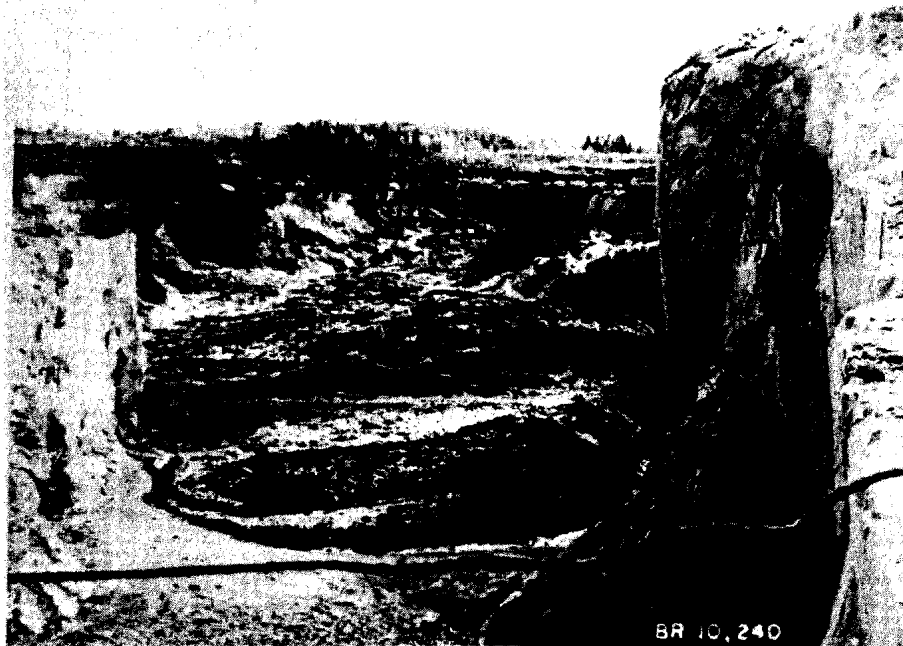
In June, 1943, a tremendous earthflow occurred which involved a million cubic yards of clay. This slide completely filled the glory hole and penetrated the underground workings. Some clay ran nearly half a mile along the sixth level drift towards the Donchester Mine which was connected to the Beattie Mine underground. The main pillar supporting the hanging wall of the pit collapsed, allowing the hanging wall at the east end of the pit to fall into the pit. According to information received from Mr. F.E. Patton in correspondence, the main pillar collapsed during the night of 15-16 June, 1943, prior to the soil movement. The extent of this landslide is shown in Figure 2, along with the smaller failures recorded in 1937 and 1942. Figure 3 is a photograph taken from the west end of the glory hole on 16 June, 1943, showing part of

Figure 3: View from west end of pit after landslide of June 16, 1943.

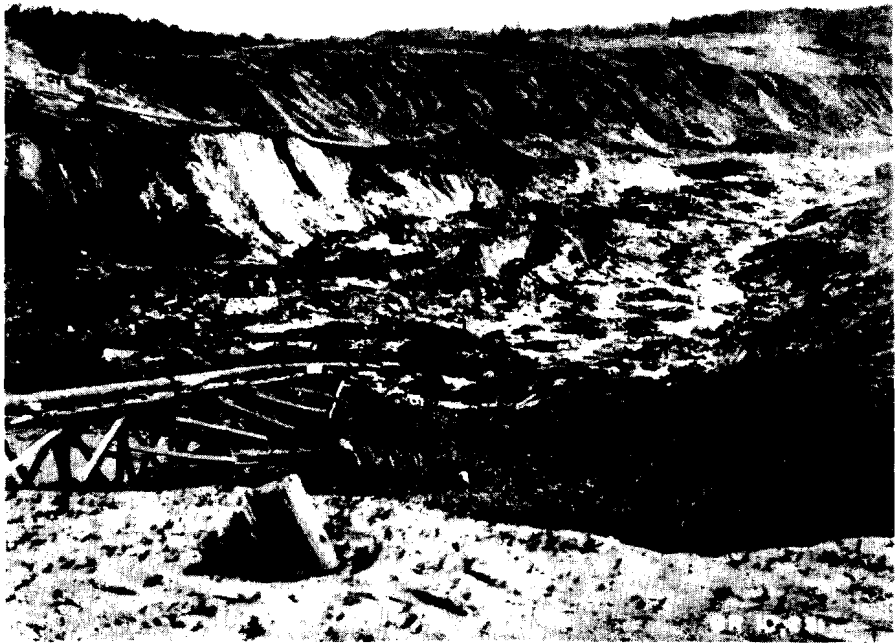
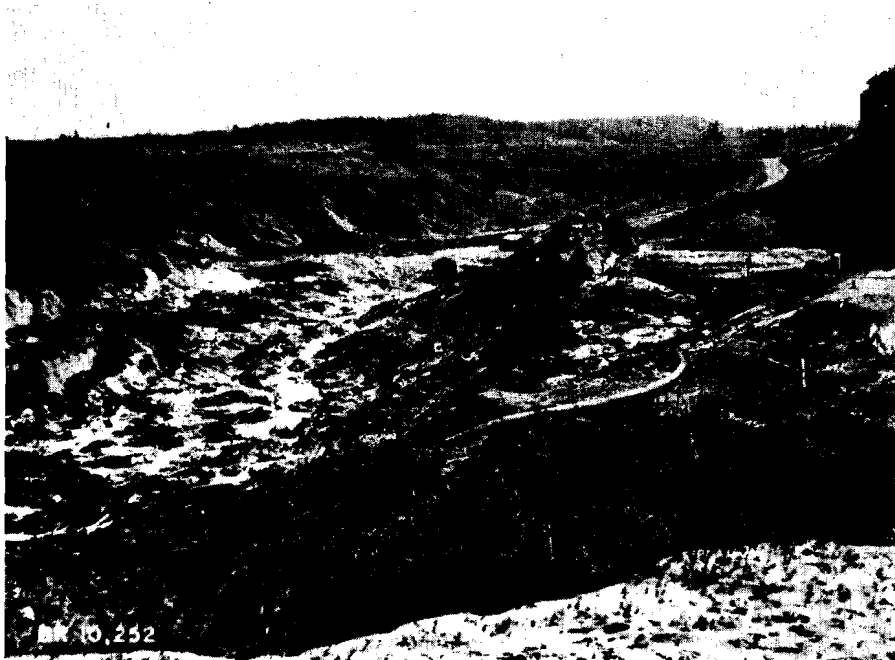
In 1945, a few small slides occurred in the crater, undoing some of the work of the dredges. The slides continued in 1946, the largest one occurring on 25 June, involving about 250,000 cubic yards. Figure 4 is a panorama view from the west end of the mine taken in July 1946. Slides continued throughout the summer, the last ones recorded being on 13 and 28 September. As Figure 2 shows, these slides occurred towards the west end of the pit. In the fall of 1946, gold market prices were falling, and so far as is known, all serious efforts to rehabilitate the mine ceased, except for the sinking of a shallow shaft to reach a lode of rich ore at the west end of the pit.

Figure 4: Panoramic view taken from west end of pit showing earthflows in 1945.

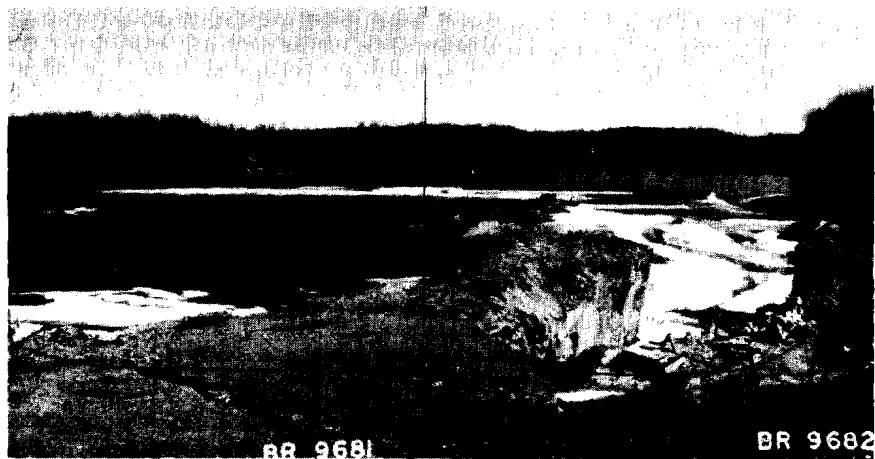
In May 1960, a three-day visit was paid to the Beattie property to obtain more information on the soil properties. Figure 5 shows the site conditions in 1960. The lake shown occupies the crater formed by the earthflows. The footwall of the glory hole appears at the right of the picture. The rock point jutting out at the lake water is the top of the former hanging wall of the pit. The photograph looks in the northeast direction. The site chosen for sampling was along the north shore of the crater slightly left of centre of the photograph.

It was found that the walls of the crater were formed of varved clay. A retrogressive type of failure was indicated by the slump blocks which could be observed around the crater. During the sampling work, layers of sand or silt were encountered in the varved clay. With the hand equipment, it was not possible to penetrate the sandy layers, so that the profile of samples obtained were taken in three borings spaced down the face of the crater. From the three borings, a profile of samples representing 30 ft of varved clay was obtained. The sampler

Figure 5: Panoramic view from west end of pit showing present site conditions - May 1960.

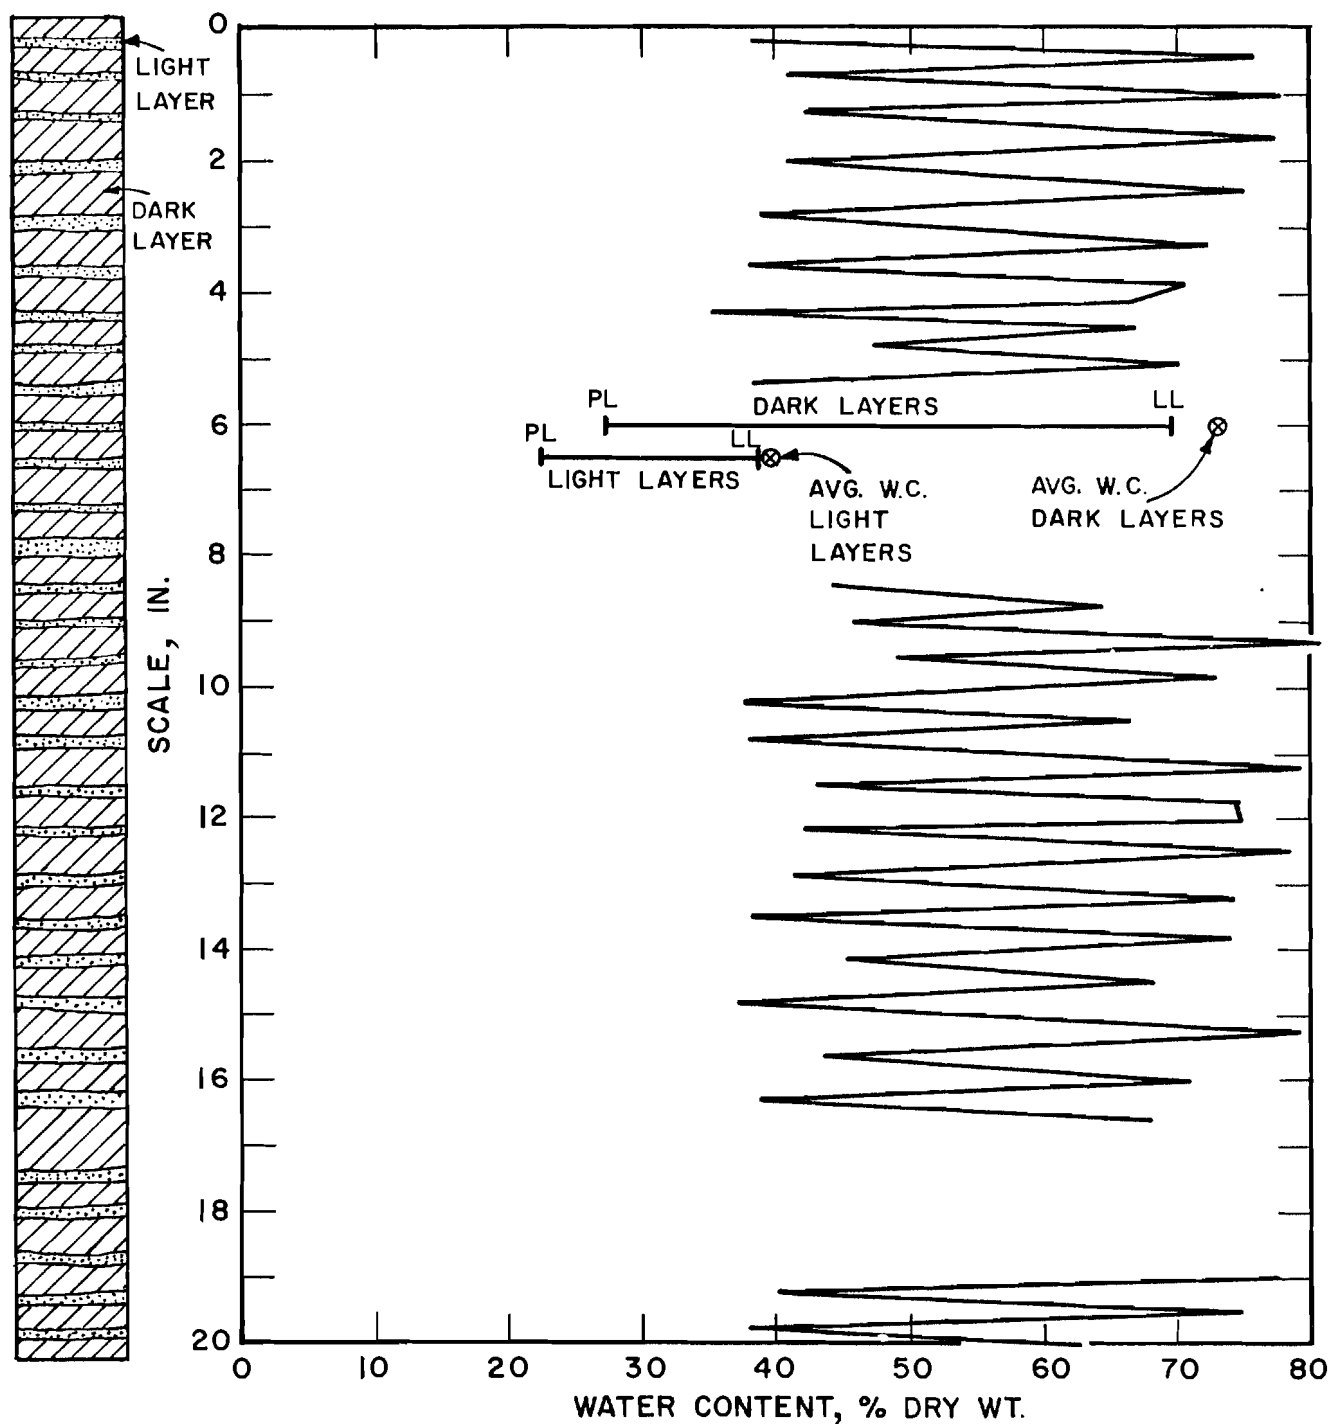
To indicate the variation in properties between the dark and light layers, Figure 7 presents the profile of sample No. 99-5 along with the variation in natural water content. The variation in water content between the dark and light layers is similar to that found for the varved clays at Steep Rock (Eden 1955).

FIGURE 7
VARIATION IN WATER CONTENT FOR SAMPLE 99-5 VARVED CLAY-
BEATTIE MINE

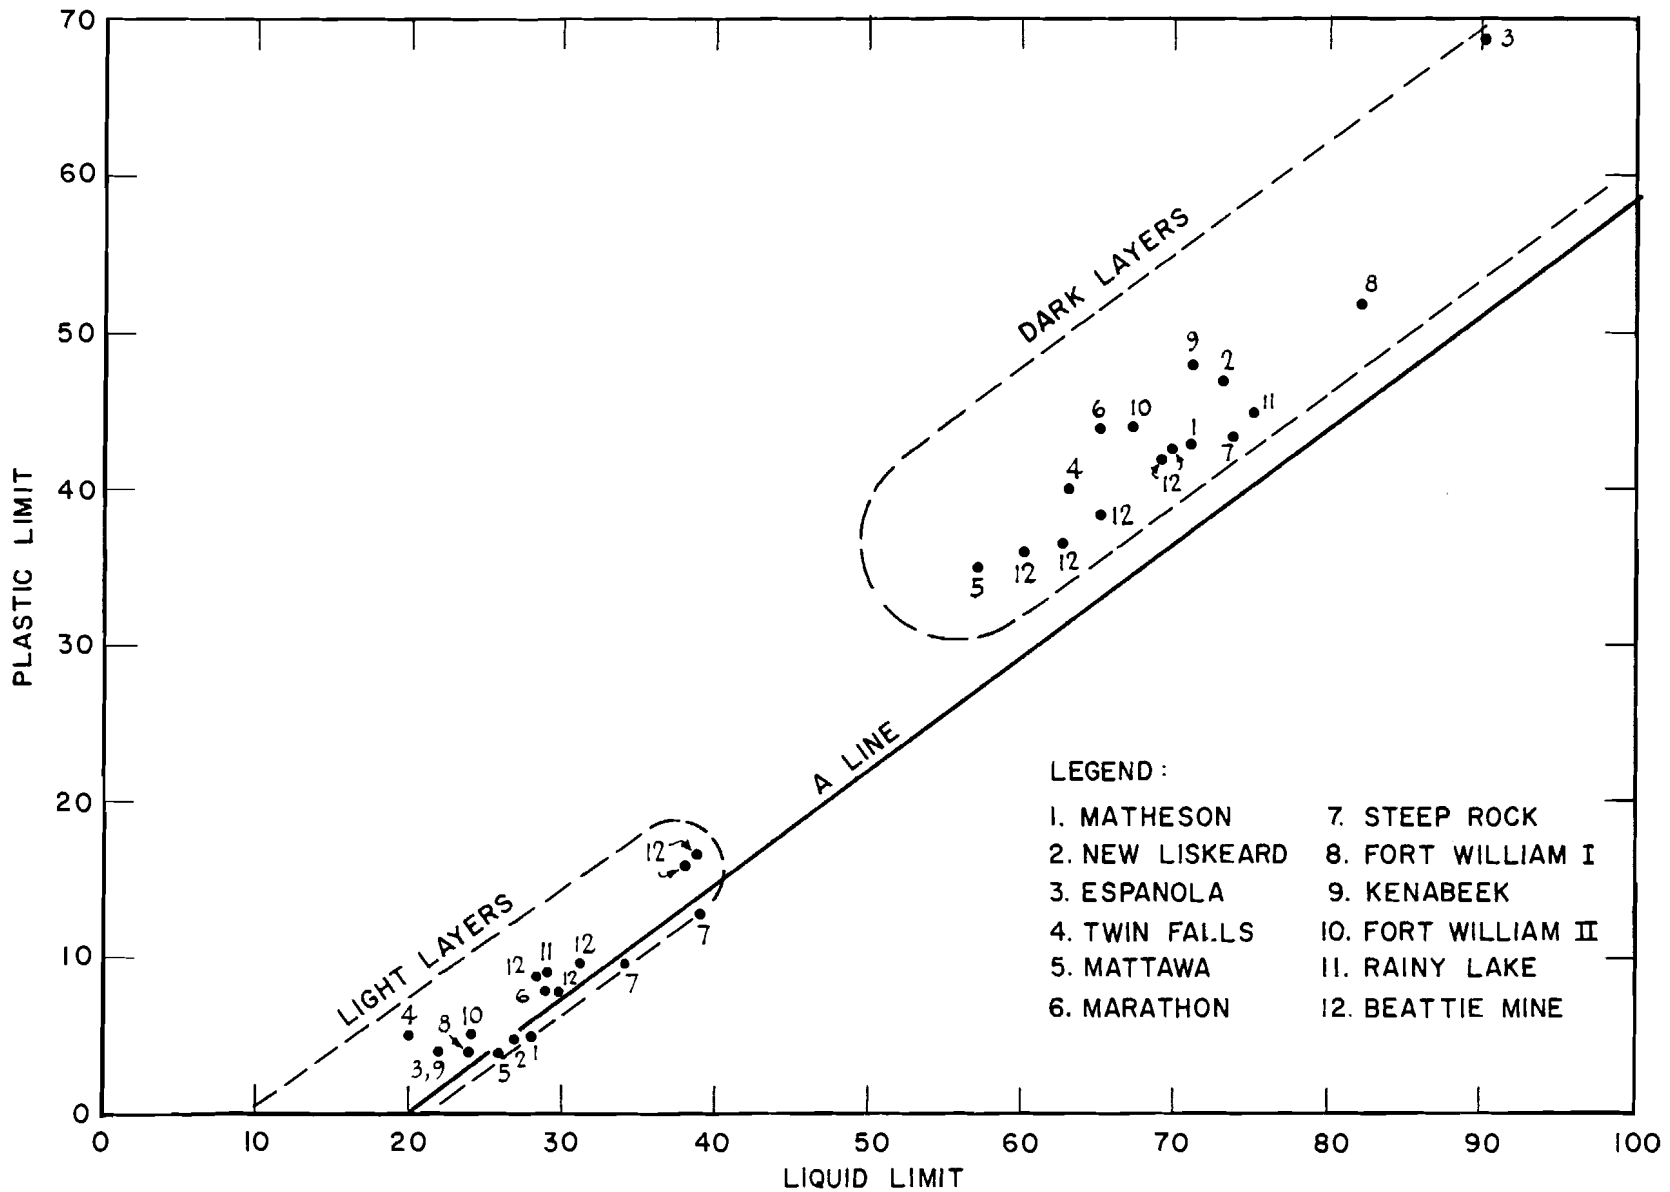
Figure 8 is a Casagrande classification chart showing the Atterberg determinations on the separate laminae of the varved clay from the Beattie Mine, along with results from other sites (Milligan 1960). It can be seen that the Beattie Mine clay is comparable to varved clays from other sites in Northern Ontario.

FIGURE 8
CASAGRANDE CLASSIFICATION CHART FOR VARVED CLAY (AFTER MILLIGAN)
