FIRE FATALITIES IN THE PROVINCE OF ONTARIO
INVESTIGATED BY THE FIRE SECTION
IN 1957 AND 1958

Report No. 176

Division of Building Research

May 1959

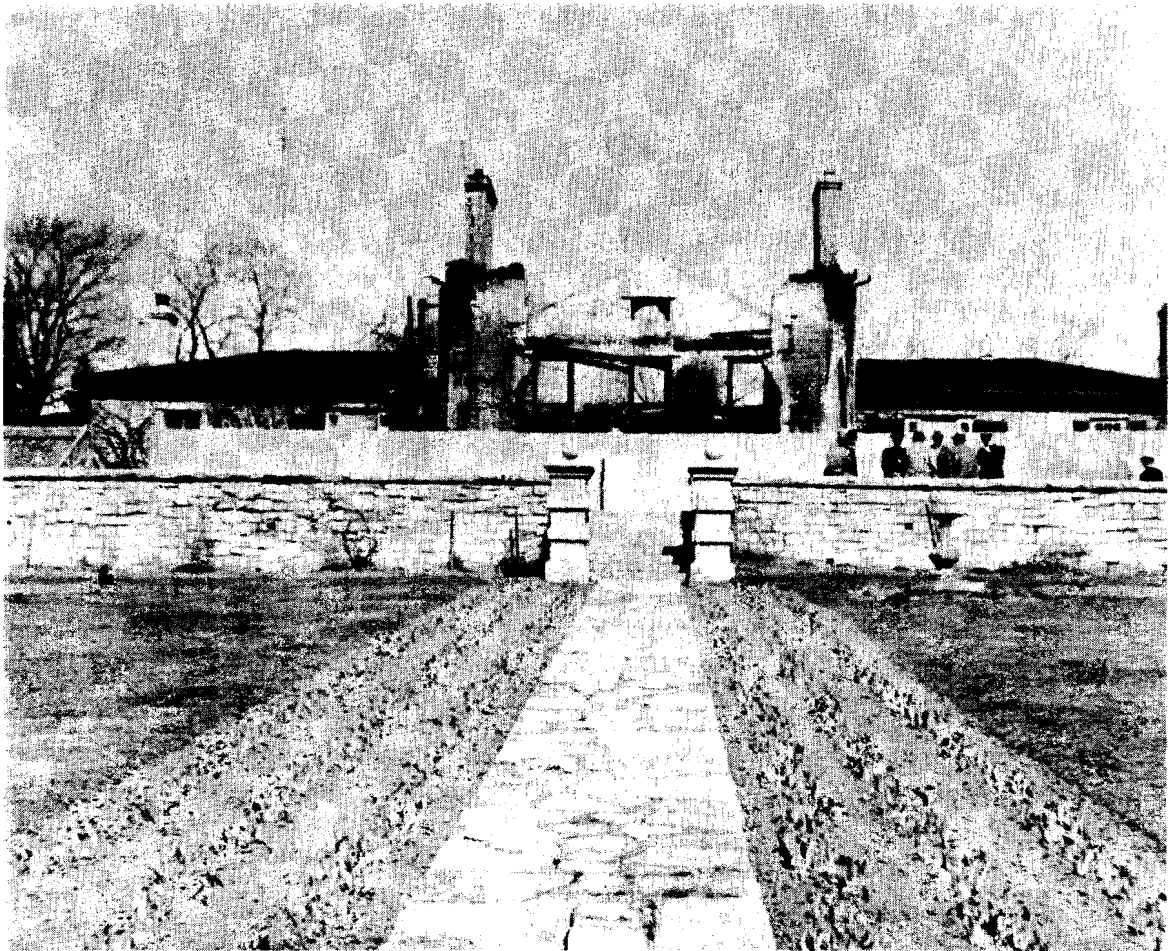
Front view of an historical residence
where two people died from fire.

1. Structure. - The solid masonry building was approximately 110 ft in length, 40 ft in width and two stories in height, with a basement (Frontispiece). The dwelling contained three sections separated by two-foot masonry walls pierced only by doorway openings leading to the east and west wings. The fire was largely confined to the centre section (Fig. 15). The pitched roof was constructed of wood joist sheathed with rough lumber and covered with wood shingles. The interior finish of the masonry walls was lath and plaster over wood furring. Room ceilings and partitions were wood joist sheathed with combustible board. The floors were hardwood on wood joists.

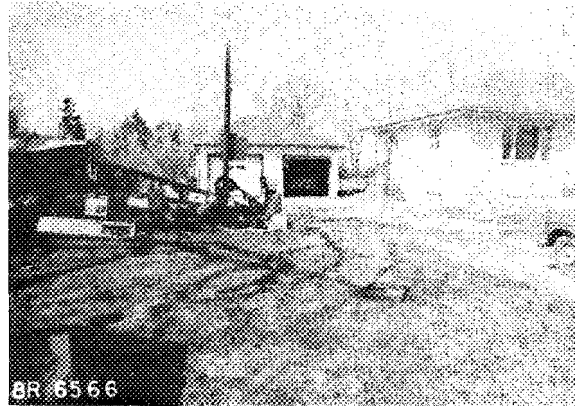
1. Structure. - This fatality occurred in an unoccupied one-room stationary house trailer, approximately 20 ft in length and 8 ft in width, located on the property of the victim adjacent to his dwelling (Fig. 1). The trailer was constructed of aluminum with plywood interior finish that had recently been painted and varnished in preparation for new occupants. The victim entered the trailer to examine the oil heating unit that had been left burning when an explosion occurred blowing off the entrance door and igniting the interior.

Fig. 1 View of remains of trailer adjacent to new residence of victim.

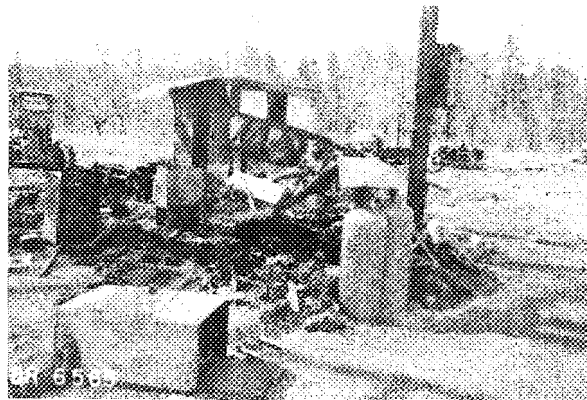
2. Occupancy. - The trailer had previously been occupied by the owner and his wife while awaiting completion of their new dwelling.
3. Heating. - The trailer contained two stoves, an oil-burning space heater providing the heat and a gas propane stove used for cooking. Both stoves were located near the entrance door (Fig. 2).

4. Summary. - The exact source of ignition could not be determined due to complete destruction of the trailer by fire and explosion. However, continued low operation of the oil burner without cleaning and removal of the carbon deposits would inevitably result in clogging the burner orifice and when this happens the flame goes out. The closed room of this trailer could also have contained flammable vapours from the redecorating. It is assumed that this condition existed at the time when the owner attempted to re-light the fire thereby causing the explosion and getting trapped in the interior.

Fig. 2 Showing location of stoves used.

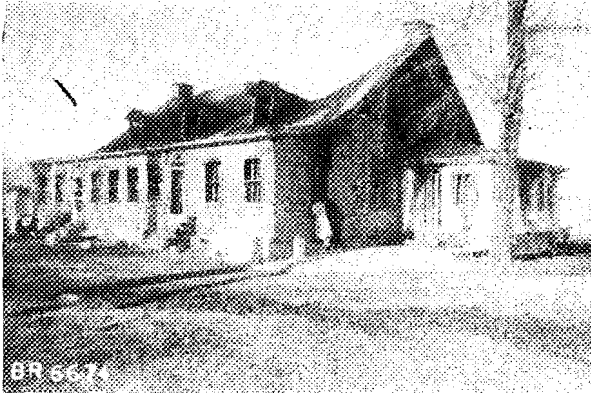
Fig. 3 View of convalescent home.

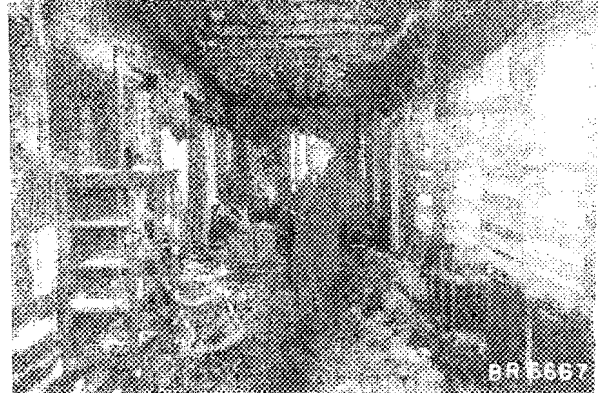
Fig. 4 Showing interior of woodframe additions.

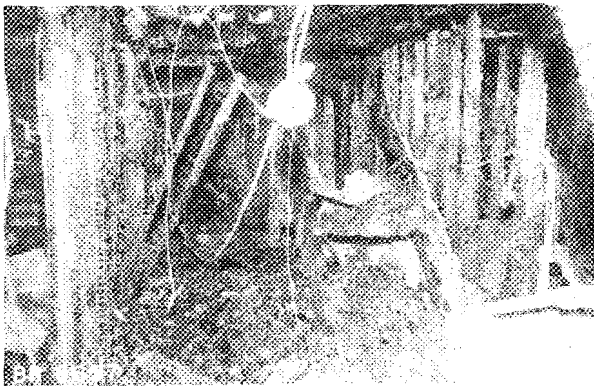
Fig. 5 View of interior showing combustible board partitions.

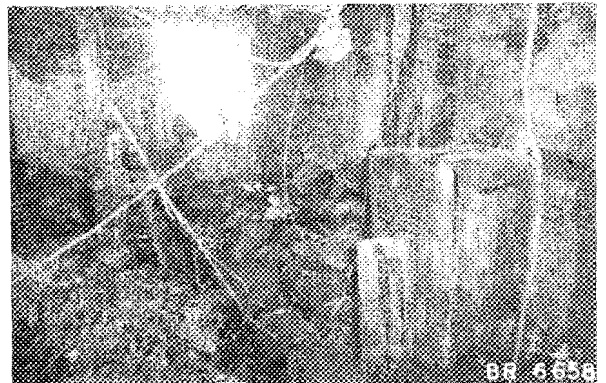
Fig. 6 Showing one of the oil-burning heating units.

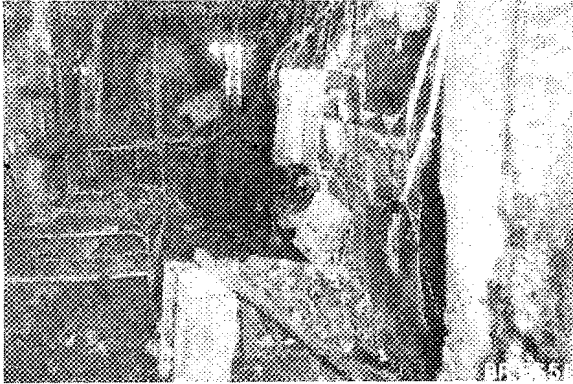
Fig. 7 Room where fire first noticed.

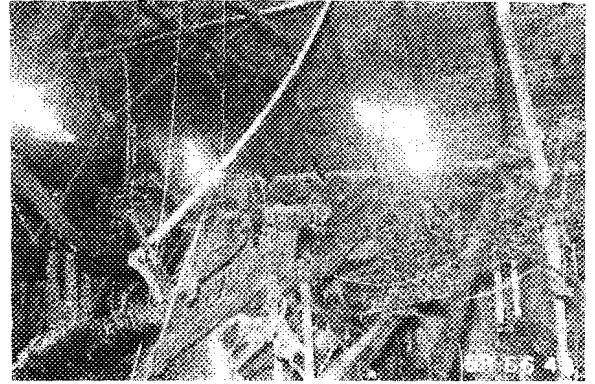
Fig. 8 Interior view of second floor.

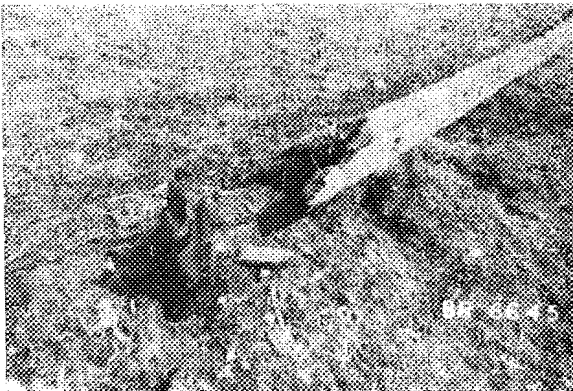
Fig. 9 One of the electric power line poles ignited from overheated wiring.

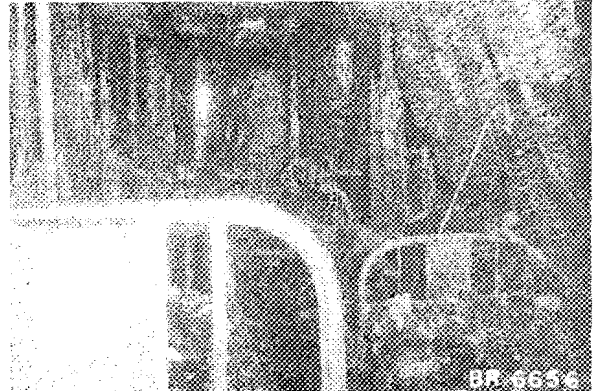
5. Remarks. - Crowded living conditions and poor housekeeping existed in this convalescent home which housed many infirm inmates (Fig. 10). Many homes similar to this one are operated in buildings originally built as private dwellings and the conversion of these older buildings poses many problems with respect to safety to life from fire. The use of highly combustible interior wall and ceiling finishes, open stairways, insufficient exit facilities, the lack of automatic alarm systems and the shortage of trained and experienced staff have been responsible for heavy loss of life in this class of dwelling. The situation might have had a different outcome had a sprinkler system been installed in the building.

Fig. 10 Section of first floor sleeping quarters.

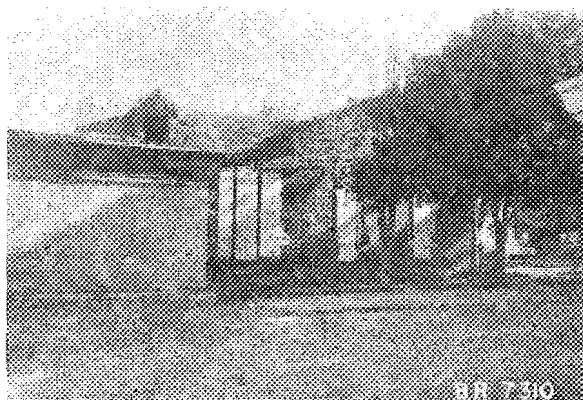
Fig. 11 View of dwelling showing frame addition at the rear.

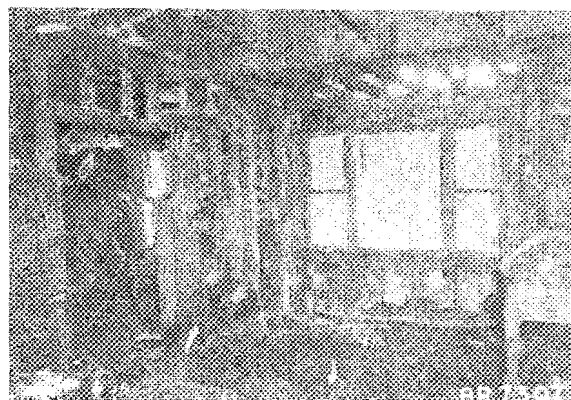
1. Structure. - The wood-frame dwelling in which this fire occurred was approximately 30 ft in width, 50 ft in length and two stories in height, with a basement. The pitched roof was covered with wood shingles. The exterior walls were finished with imitation brick siding. A one-story wood-frame building was attached at the rear of the dwelling to provide additional living quarters (Fig. 11). The interior walls, ceiling and partitions, in the front section of the dwelling were finished with lath and plaster. The interior finish of the rooms in the rear section, where the fire occurred, were combustible board and pressed paper (Fig. 12).

Fig. 12 View of interior showing where fire spread on combustible finish.

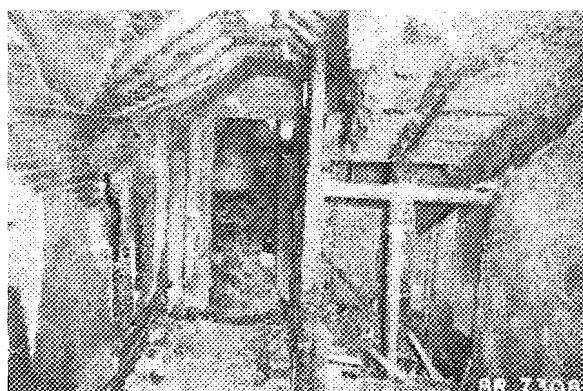
Fig. 13 Showing how fire spread to second floor through concealed space.

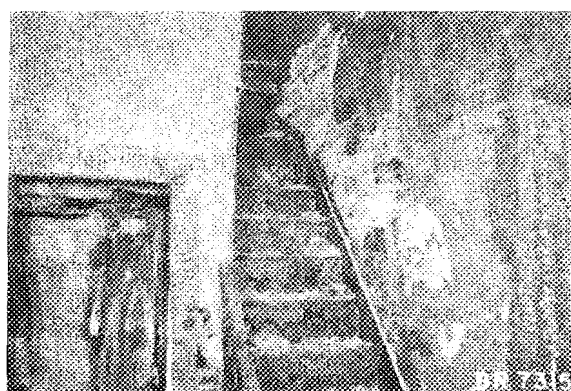
Fig. 14 Open front staircase where heat and gases extended to second floor.

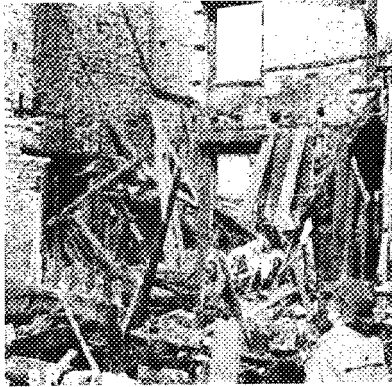
Fig. 15 Interior of centre section where fire occurred.

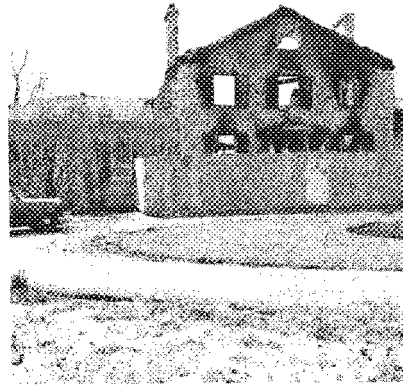
2. Occupancy. - The centre section of the dwelling contained a large living room on the first floor with an open staircase at the rear leading to the second floor bedroom (Fig. 16). The east and west wings of the dwelling contained bedrooms, kitchen, and dining room. At the time of the fire four people were asleep in the centre section and two in the west wing.

Fig. 16 View at rear of dwelling where victims were sleeping on second floor.

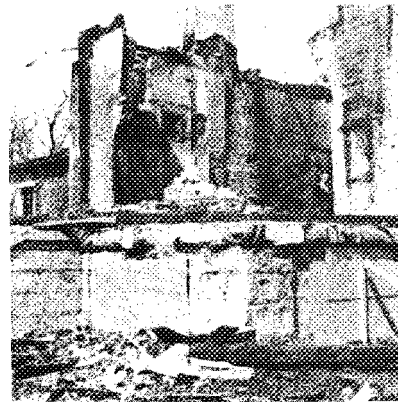
5. Remarks. - The delay in detection of this fire permitted its rapid spread in the combustible interior finish of the dwelling and contents of the living room. The open stairway at the rear of the living room provided an ideal path for the upward travel of smoke, heated gases, and flame and cut off possible escape by this route. Probably the two occupants were asphyxiated in the rear bedroom on the second floor before the fire was discovered. The solid masonry wall extending above the roof prevented the fire from spreading to the east and west sections of the building, but the large french windows provided little support and the front wall and portico were completely destroyed (Fig. 18).

Fig. 18 View of front wall construction.

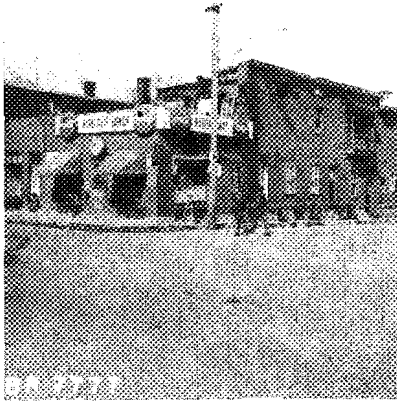
-
1. Structure. - The wood-frame building was constructed on a masonry foundation approximately 90 ft in length, 40 ft in width and two stories in height. The roof was flat, covered with rolled roofing, tar, and gravel (Fig. 19). The interior finish of the walls, ceilings and partitions was mainly of combustible materials (Fig. 20).

Fig. 19 View of stores and apartment.

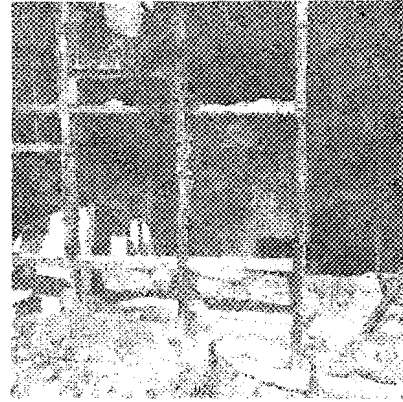
Fig. 20 View showing interior construction.

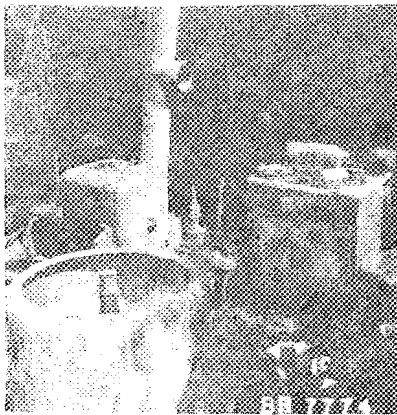
3. Heating. - The apartments were heated separately with oil-burning appliances (Fig. 21).
 4. Summary. - The fire originated in the kitchen of the apartment on the second floor of the building. While an occupant of an adjoining apartment was attempting to extinguish the fire, the mother led her two children to safety and returned to try to rescue the third child but was overcome by toxic gases. The delay in calling the fire department permitted the fire to make rapid progress in the combustible interior finish and partitions and also made rescue operations difficult (Fig. 22). Cause of the fire was attributed to children playing with matches and igniting papers.

Fig. 21 Kitchen where the fire occurred.

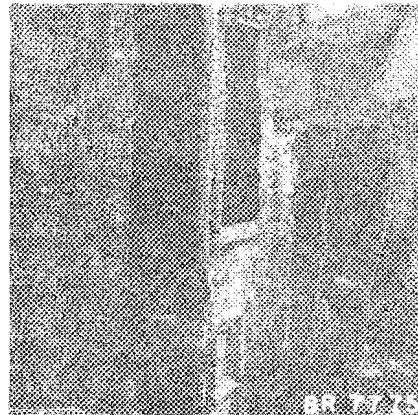
Fig. 22 Entrance to apartment where fire extended.

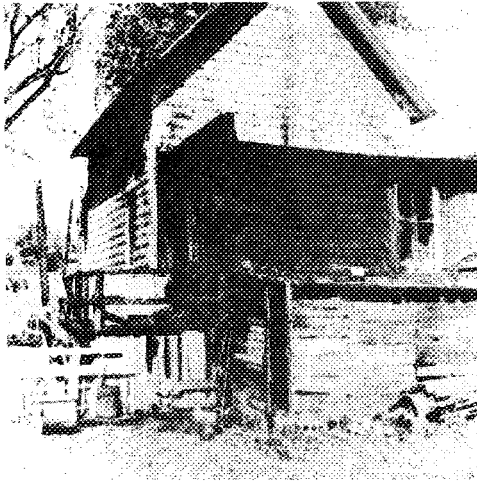
Fig. 23 Wood-frame kitchen at rear of residence where fire occurred.

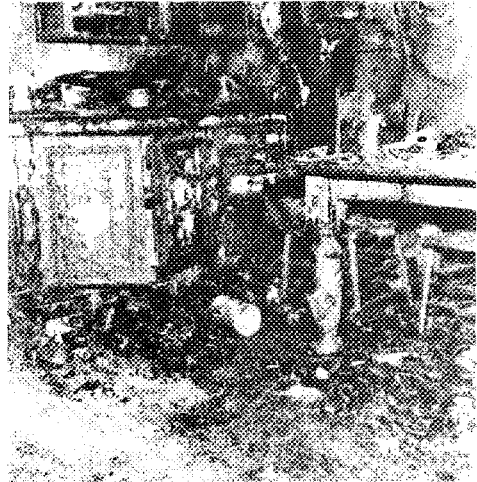
Fig. 24 Interior of kitchen.

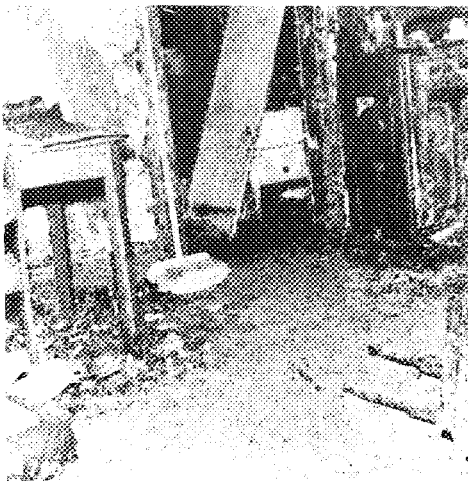
Fig. 25 Showing where fire extended to dining room in masonry section.

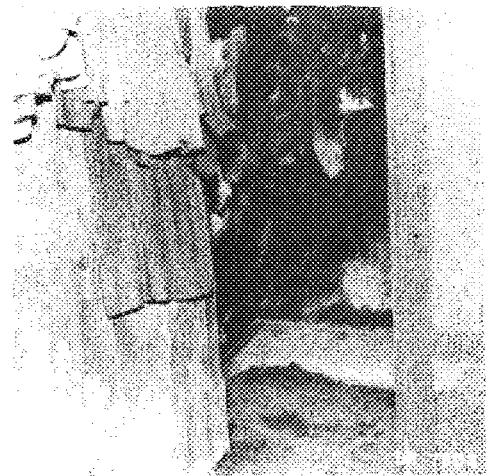
Fig. 26 Door into bedroom where victims found at top of stairs. Clothes on the door which prevented proper closing.

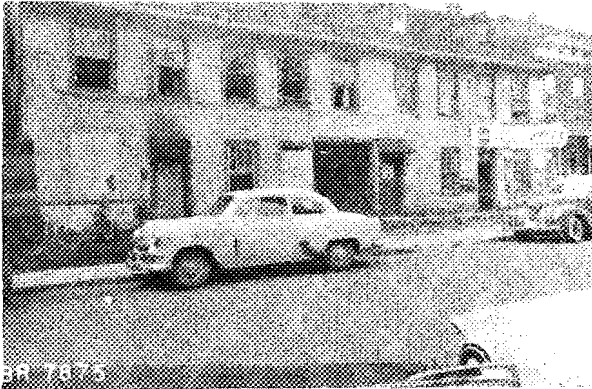
Fig. 27 Front view of tenement.

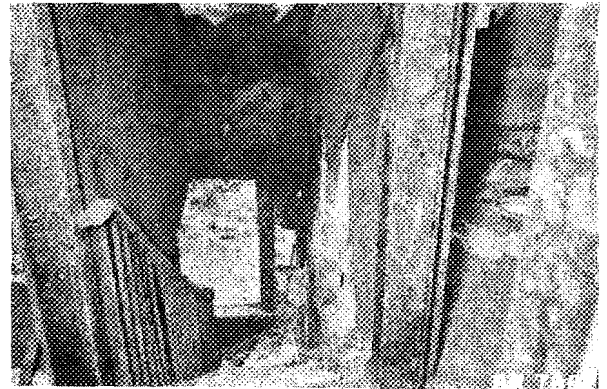
2. Occupancy. - The dwellings were occupied by roomers and contained three rooms on each floor. An open staircase extended from the dining room to the top floor (Fig. 28). An emergency exit was provided from the rear windows on the third floor of the building to an exterior fire escape leading to ground level.

Fig. 28 View showing open staircase leading from first floor.

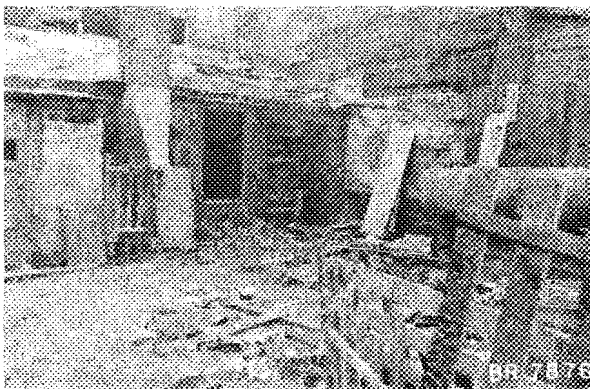
Fig. 29 Rear view of building showing wood shed destroyed and where fire extended to rear kitchen.

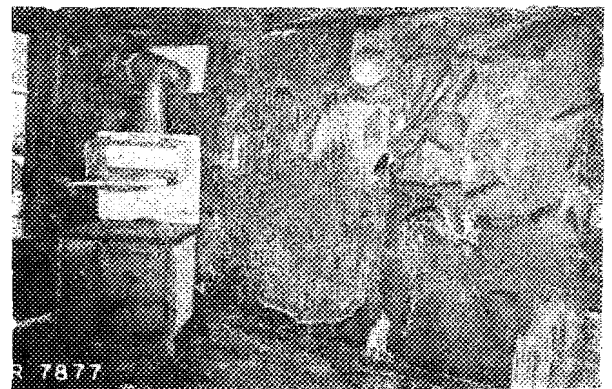
Fig. 30 Interior of kitchen where fire spread; note combustible wall finish.

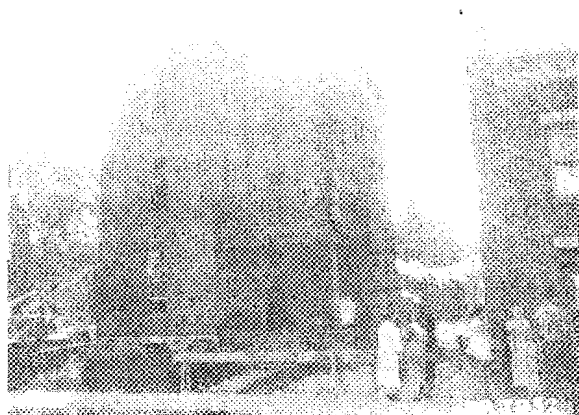
1. Structure. - The brick-veneer building, constructed on a masonry foundation, is three stories in height with a basement. The exterior dimensions were approximately 27 ft by 30 ft. The roof is flat, covered with tar and gravel (Fig. 31). A two-story wood-frame addition with a flat roof and the exterior walls covered with tin sheeting was constructed at the rear and provided additional living quarters (Fig. 32). The interior finish of the walls and ceilings in the front section of the building was lath and plaster with V-joint partitions (Fig. 33), the rooms in the rear section were finished with V-joint and combustible board (Fig. 34).

2. Occupancy. - The building contained small apartments and rented rooms on each floor; five of the seven victims of the fire were children located in an apartment on the third floor at the front of the building, the remaining two victims were severely burnt while trying to escape from the second floor front balcony (Fig. 31).

Fig. 31 Front view of building.

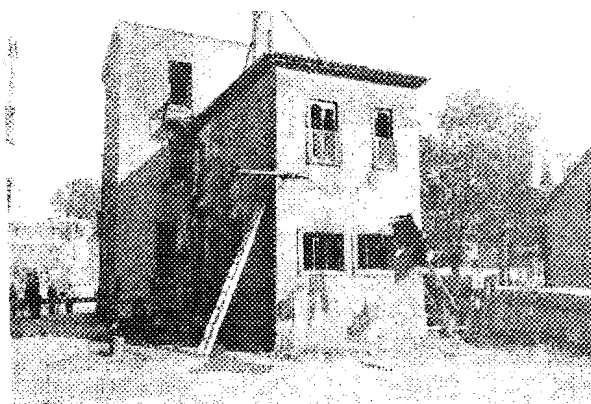
Fig. 32 Rear view of building,
where fire occurred.

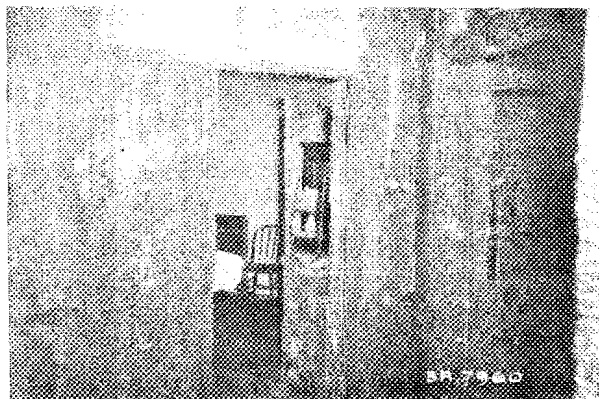
Fig. 33 Interior view of
ground floor where
fire spread.

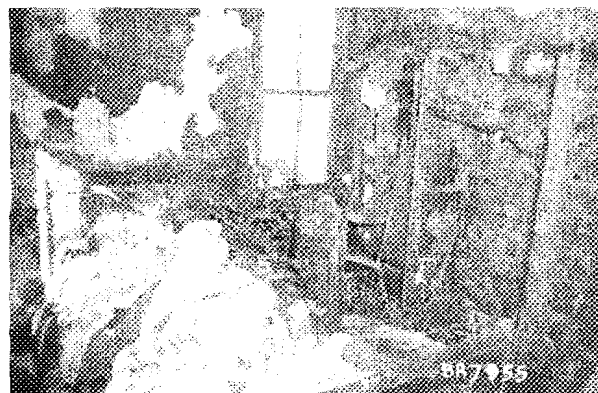
Fig. 34 Room on rear ground
floor where fire
occurred.

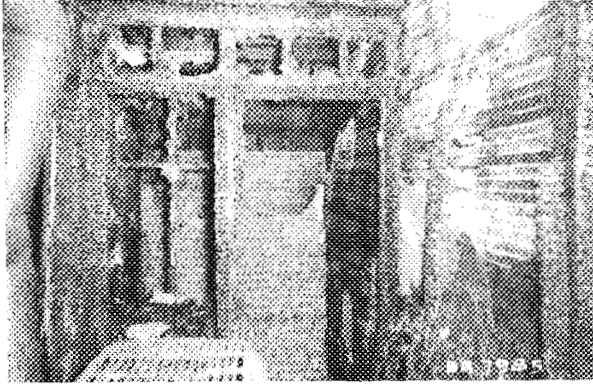
3. Heating. - The building was heated with an oil-burning furnace in the basement and additional oil-heating units on upper floors (Fig. 35).
4. Summary. - The fire originated in the apartment on the first floor occupied by the owner of the building (Fig. 34) and was discovered by a neighbour when smoke and flame were noticed coming from the rear windows. The fire seemed to spread very quickly in the interior of the first floor and staircase which led to the upper floors (Fig. 36) where flame and hot gases cut off the escape of the occupants. Cause of the fire was incendiary.

Fig. 35 View of oil burning unit and entrance to third floor.

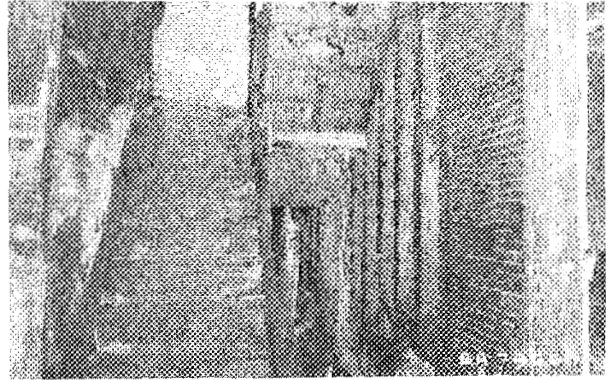
Fig. 36 Open front staircase leading to upper floors.

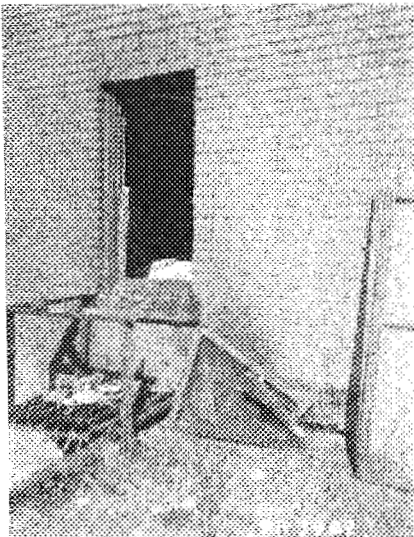
Fig. 37 Exit from third floor window leading to wood staircase. Note the wooden platform at the window and the screen.

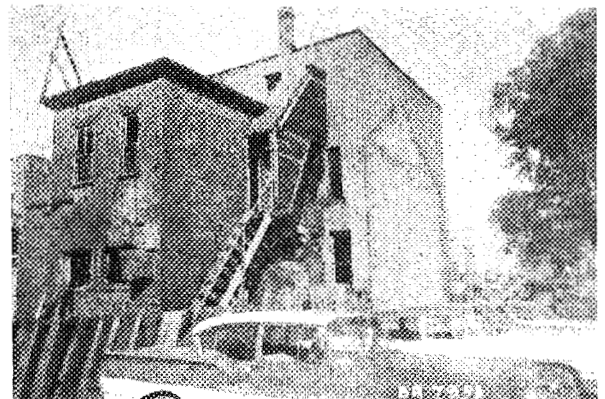
Fig. 38 View showing rear exit from second and third floors.

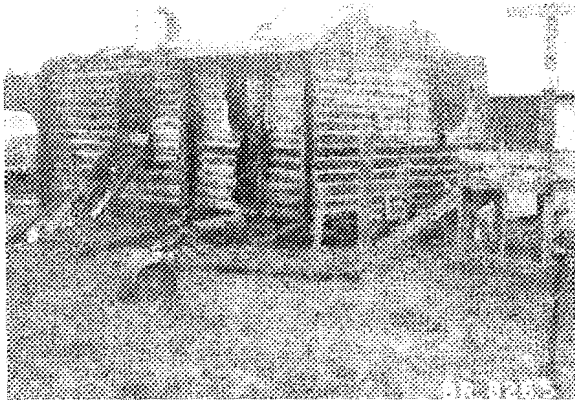
-
1. Structure. - This one-story log cabin was constructed on a wood-plank foundation. The pitched roof was supported with wood joist covered with rough boards and sheathed with rolled roofing. Exterior dimensions of the building were approximately 20 ft by 15 ft. Interior walls and ceiling were finished with combustible board and paper. The cabin was wired for electricity but did not contain plumbing facilities (Fig. 39).

Fig. 39 View of the log cabin.

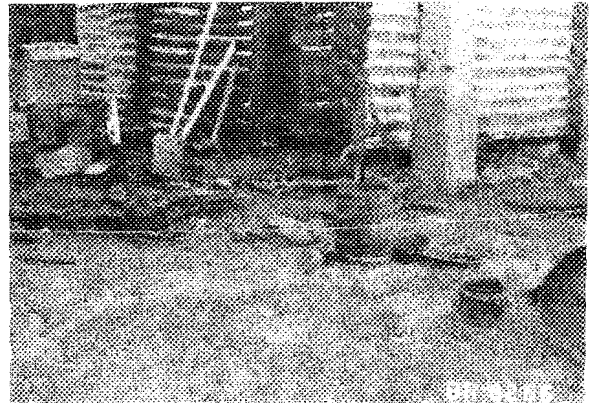
2. Occupancy. - The cabin was occupied by a family of three and one roomer. At the time of the fire all the occupants were sleeping.
 3. Heating. - Heating and cooking facilities were provided by a coal and wood stove located at the south wall of the cabin (Fig. 40).

Fig. 40 View showing stove and entrance.

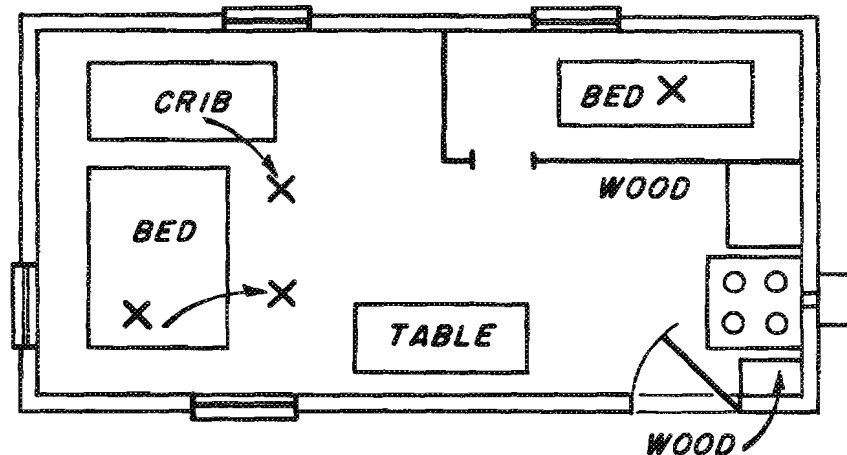
4. Summary. - The fire seemed to have originated around the stove where, it was reported, a large quantity of wood and paper were stored for fuel. The delay in discovering the fire, and the time taken in securing fire fighting equipment from the nearby municipalities, permitted the fire to spread rapidly in the combustible interior finish of the walls and ceiling. The four occupants were asphyxiated. Location of the victims when found indicated that they had attempted to reach the doorway (Fig. 41).

Fig. 41 Floor plan which indicates the location of the four victims when they were found.
