Performance of the Mark IX Steel Basement to 31 January 1975

595

TECHNICAL NOTE

SUBJECTPERFORMANCE OF THE MARK IX STEEL BASEMENT TO 31 JANUARY 1975

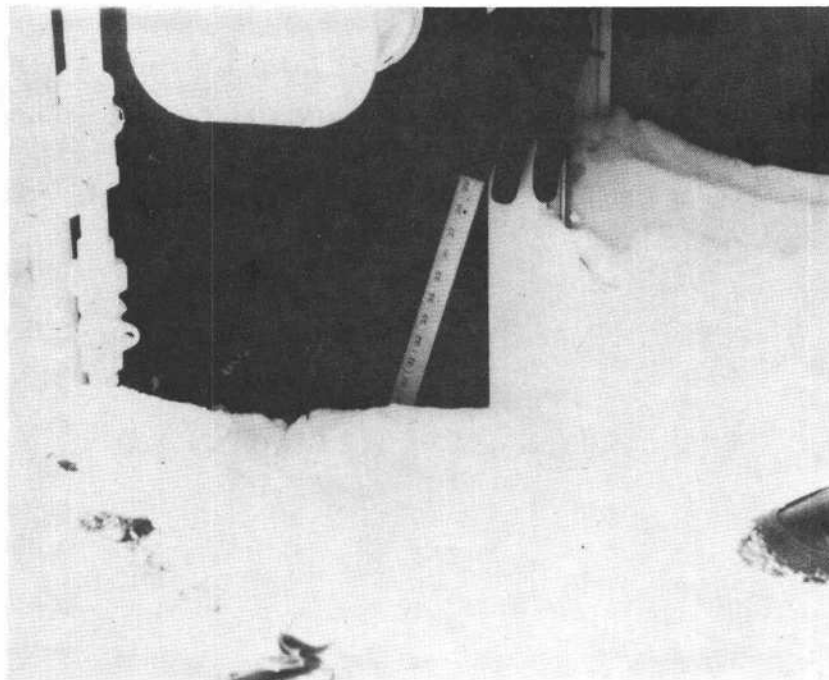
FIGURE 1a

It was noticed early in the winter of 1972-73 that the soil around the basement had shrunk away from the wall, forming a gap 3 in. wide and, at points, more than 3.5 ft deep. There was also a gap at the jointing line where the insulation of the basement met that of the superstructure. The gaps are shown in Figures 1a and 1b. Because of these gaps, cold outside air was able to circulate in the corrugated spaces of the wall, severely undermining the effectiveness of the wall insulation system. As a temporary measure, in January 1973, the

Shrinkage of backfill soil during the fall and early winter of 1972-73 opened a crack between the soil and the basement insulation near the NW corner of the basement.

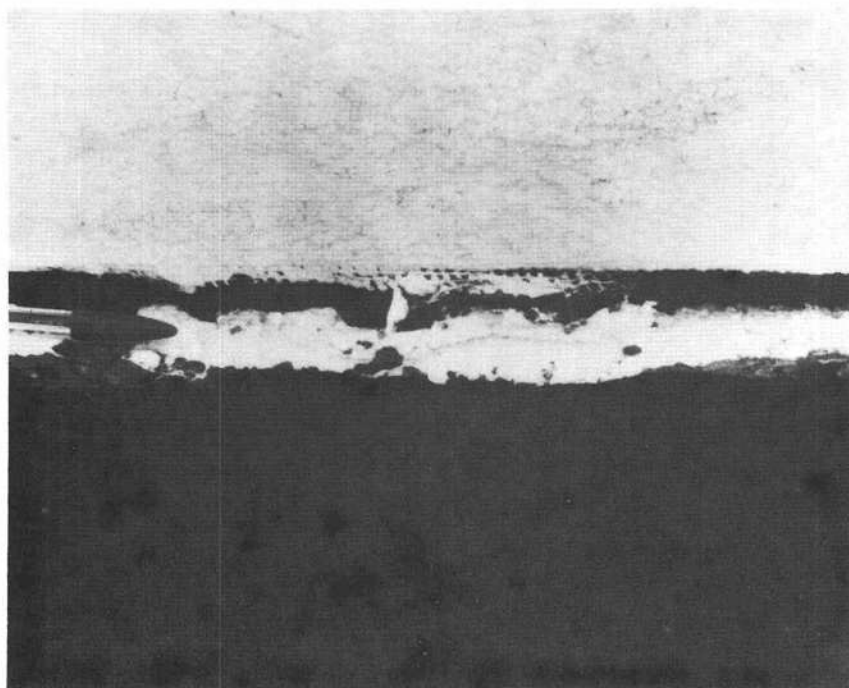
FIGURE 1b

Downdrag and shrinkage of soil away from the basement caused this gap at the jointing line of the basement and superstructure insulation near the centre of the N wall.

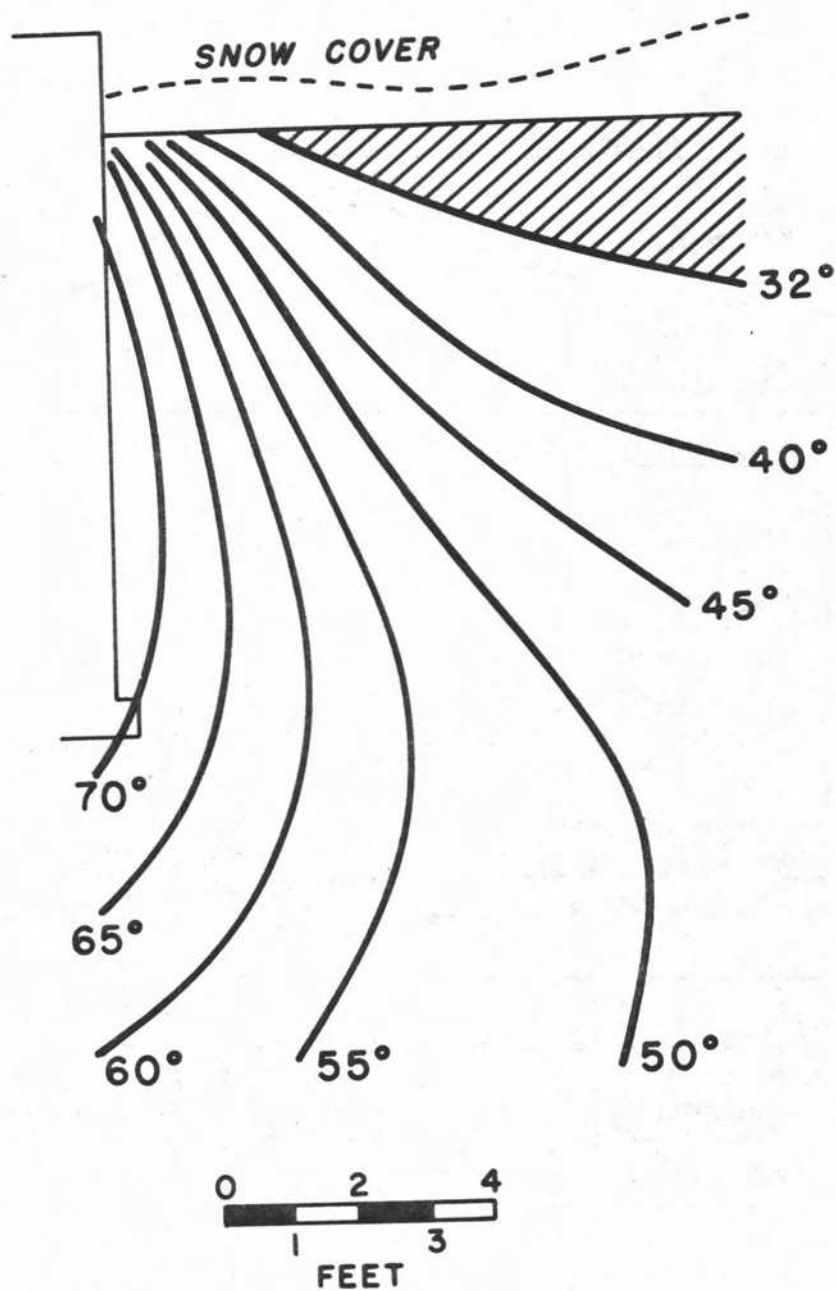
Figure 2a shows that even at the end of a severely cold winter (in which the cumulative freezing index reached 4026 Fahrenheit degree-days), there was no frozen ground in proximity to the basement. The widely spread ground temperature isotherms also indicate that heat loss from the basement was much less than for the uninsulated concrete basement shown in Figure 3 (3). During extremely cold weather, when there was essentially no snow cover, such as experienced on 12 January 1975 (Figure 2b), the freezing front did penetrate into the ground at the basement wall contact. Figures 4, 5 and 6 show a minor trend to reduction in lateral earth pressures during the period. Prairie clay soils typically shrink in the direction parallel to a freezing front, even when frost heaving takes place perpendicular to the front. Provided the freezing front remains essentially horizontal in its advance, basement walls should not be subjected to large additional horizontal forces due to frost action.

FIGURE 3: Ground temperature isotherms for an uninsulated concrete basement on March 13, 1956 (after Solvason and Handegord 1959 (3)).

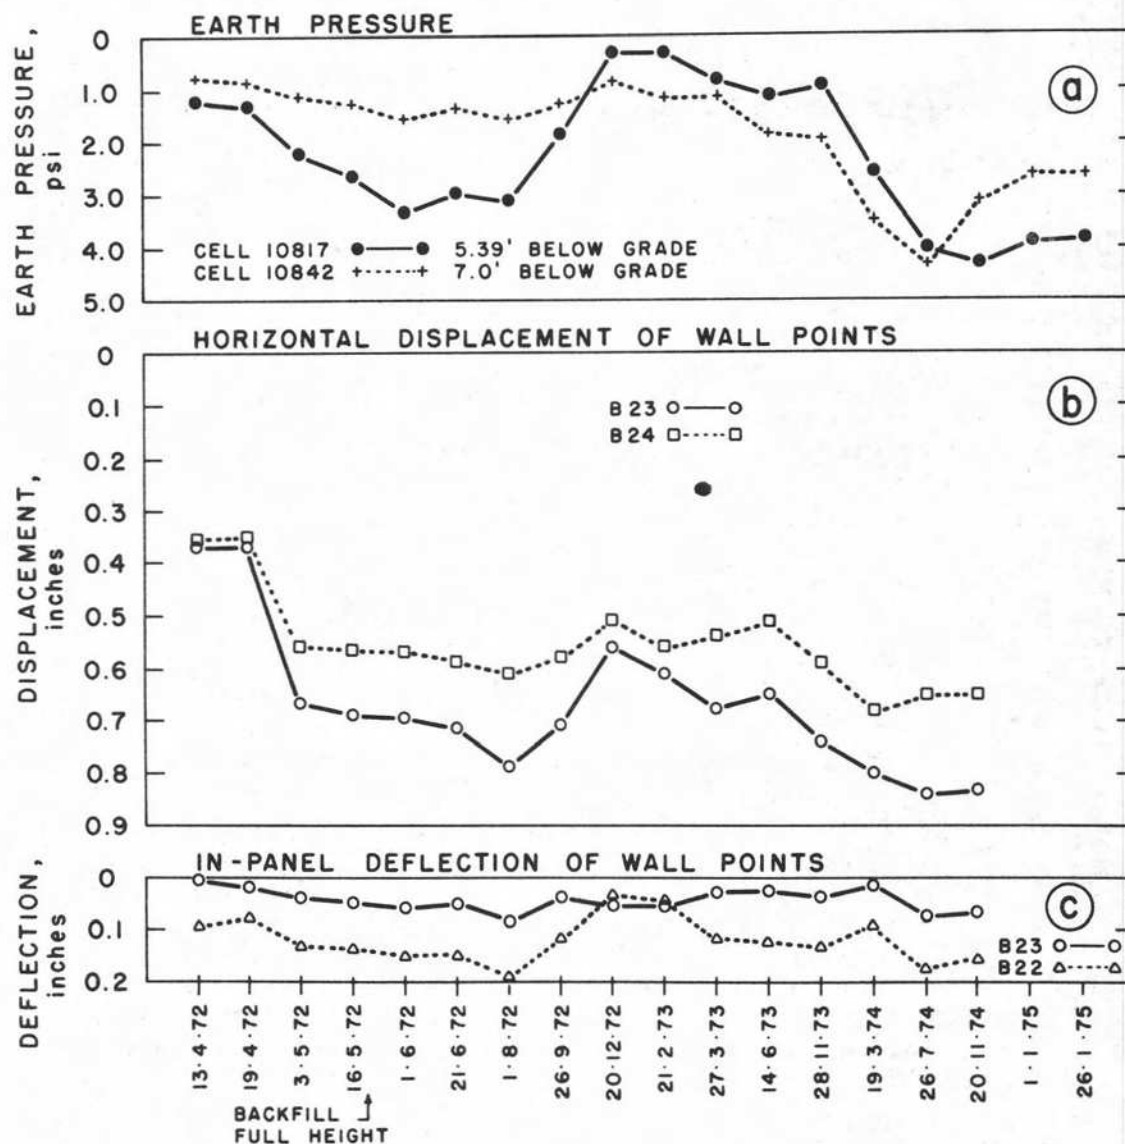
The correlation between the magnitude of measured earth pressures and deflections of the walls was best at section B2, where post-construction disturbances have been minimal. Comparison of the earth pressure results in Figure 5a with in-panel deflections at sections B22 and B23 in Figure 5c shows the best correlations of the three sets of results presented in Figures 4, 5 and 6. This is as expected because section B2 is more uniformly flexible and less well restrained at the bottom than sections B1 and C1. For these two sections, peak earth pressures of 4.5 psi and 5.6 psi were reached at wall displacements of 0.55 in. and 0.39 in.,

FIGURE 5: Earth pressures, horizontal displacements and in-panel deflections at Section B2.

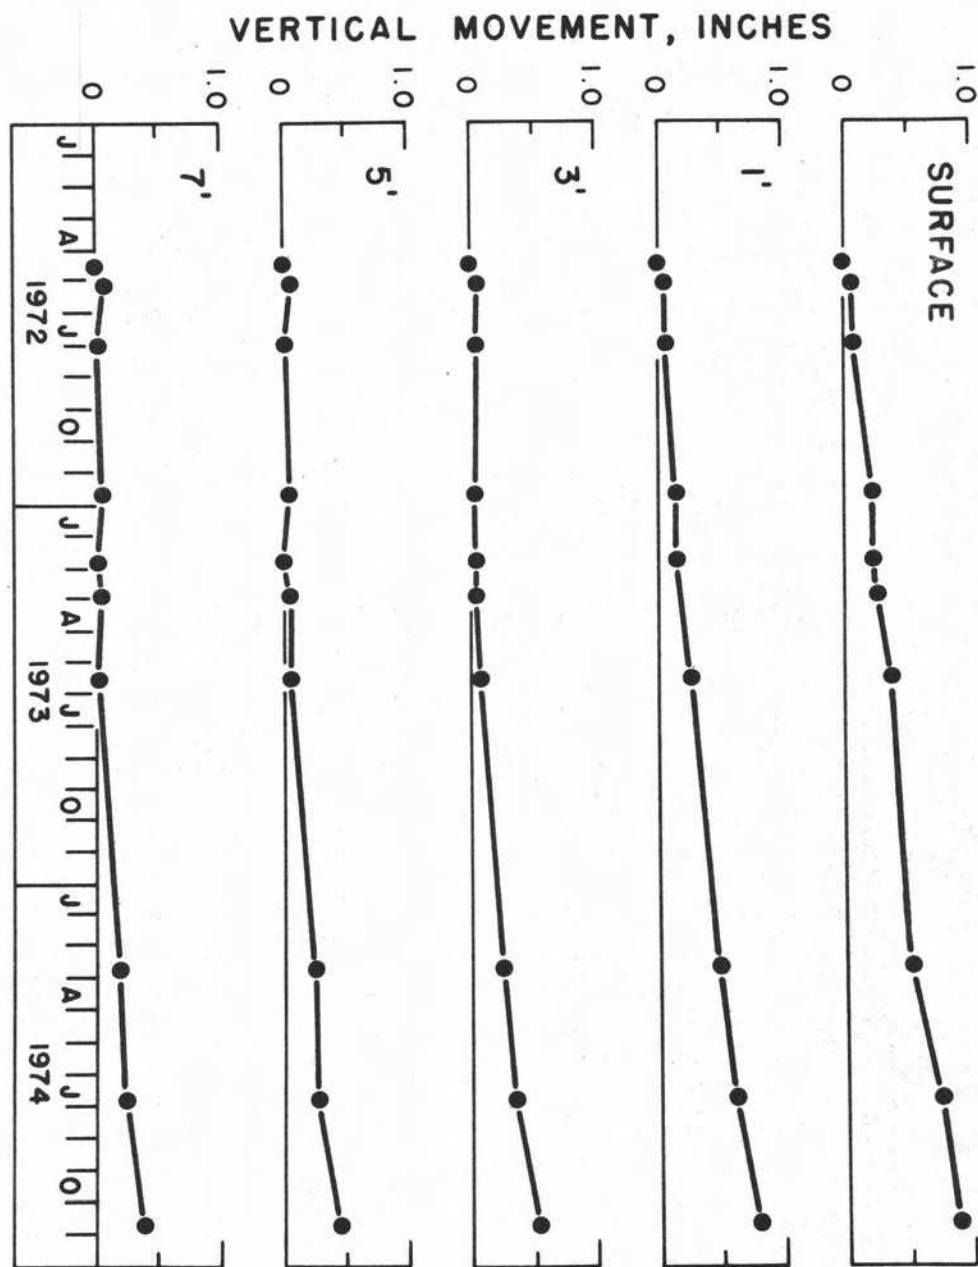
FIGURE 7: Vertical ground movements in crawl space of the Mark IX house.
