PERFORMANCE OF "T. T. W." BRICK BUILDINGS
by

Internal Report No. 380
of the
Division of Building Research

OTTAWA
November 1970

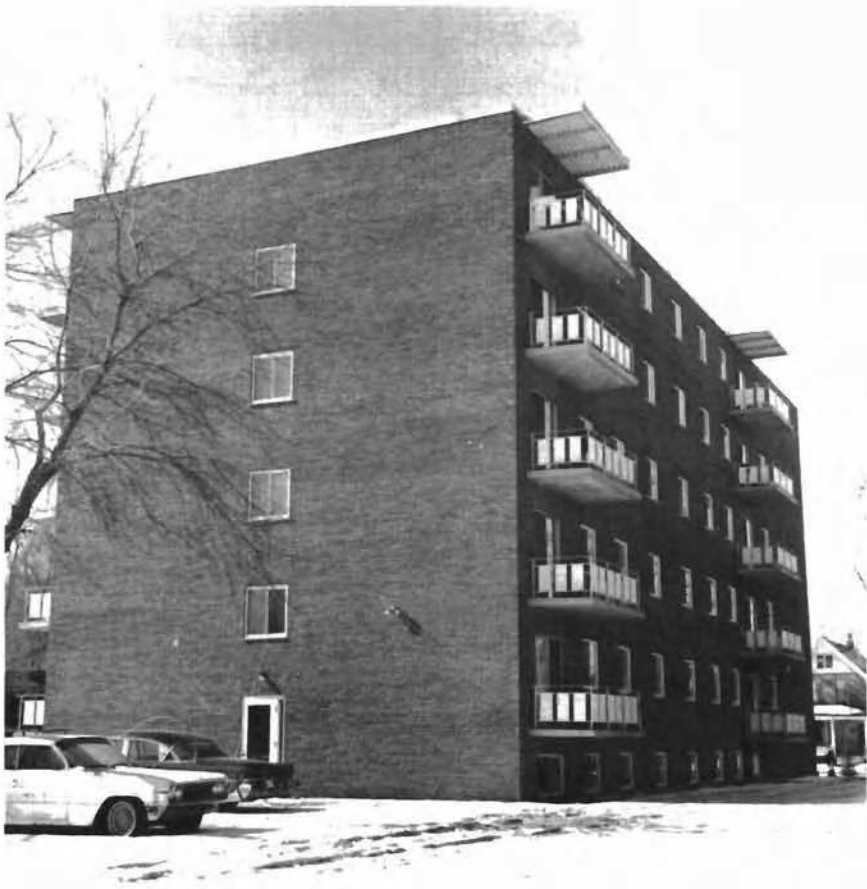
Of the 36 completed buildings examined 22 were reported to have experienced no rain leakage or dampness problems. No information was available on the performance of four buildings, leaving 10 in which rain penetration or dampness had occurred. These 10 buildings included the "Windsor" Apartments, William St., London (Figure 5), a 5-storey structure erected in 1965 in which one apartment on the east-facing wall had some plaster fall only three years after construction. According to the caretaker of the building the plasterer making repairs attributed the failure to dampness in the wall resulting from rain penetration, although no free water or water stains were observed on the wall. The caretaker stated that no further plaster failure has occurred.

Figure 5 - The "Windsor" apartment building, London.

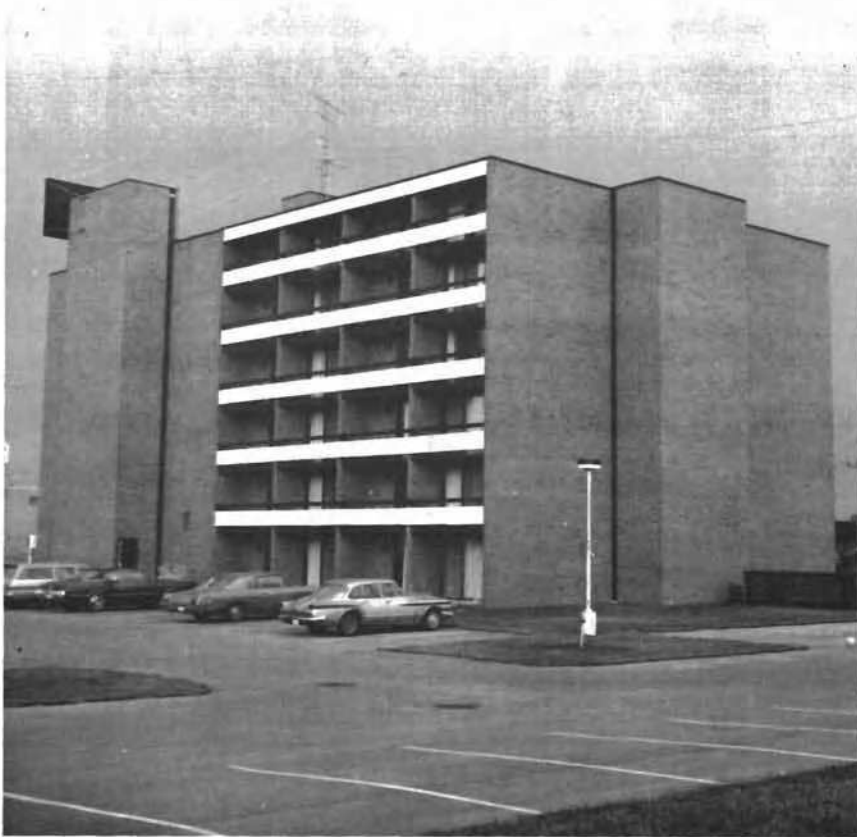
Another example of leakage, involving a 6-storey motel (Figure 7) erected at Niagara Falls in 1968, was reported by the clerk who stated that leakage had occurred during the early life of the building where the

one-storey restaurant wing joins the remainder of the building; leakage had not been a problem elsewhere. At the time of our visit, however, when heavy rain fell several damp spots were observed on the inner wall surface of a stairwell of brickwork without plaster or insulation; seven small areas of dampness had formed on the inner surface of the stairwell through all 6 storeys of the building. There was no indication of rain penetration through the parged and insulated exterior wall of a room adjacent to the stairwell.

Figure 7 - Motel at Niagara Falls; in a heavy rain dampness appeared on the interior surface of the unparged and uninsulated stairwell on the wall on the right.

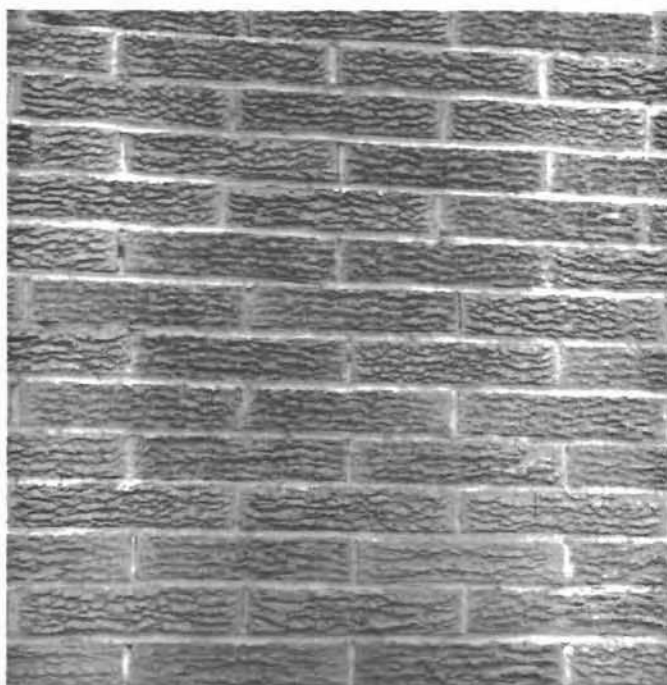
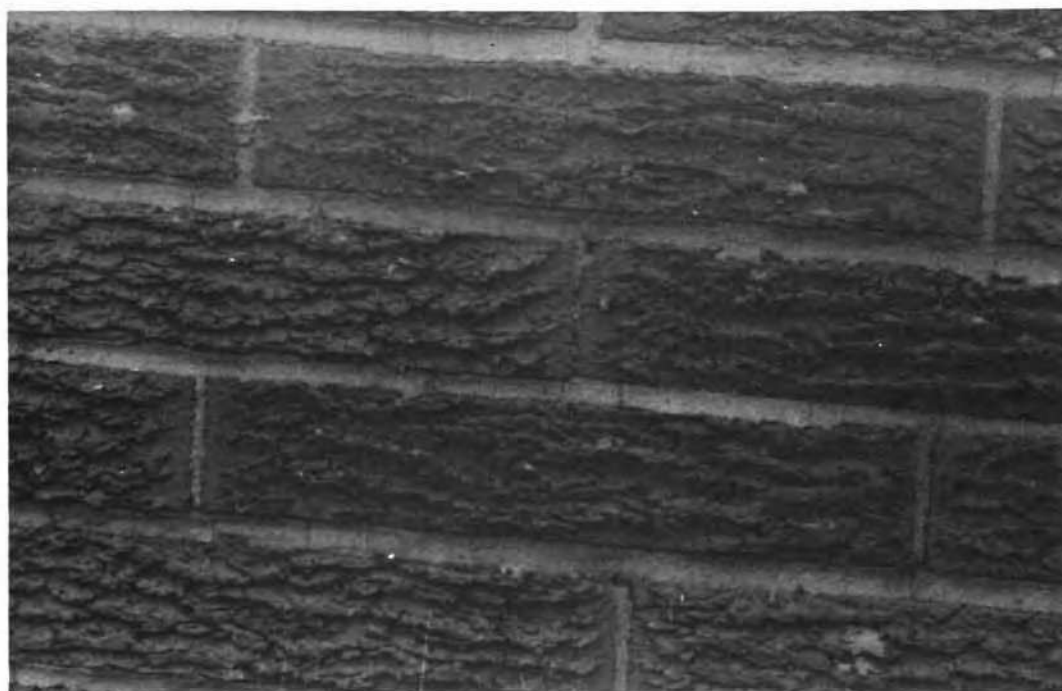
The standard of workmanship in the construction of the buildings examined during the survey varied greatly. Most of the buildings, fortunately, were considered to be examples of careful construction, although the brickwork of a few buildings had obviously been laid carelessly. One fault noted in the latter buildings was the extreme variation in the width of vertical joints which ranged from almost a butt connection of adjoining bricks (Figure 8), to a joint width of about one inch. Incompletely filled joints, both vertical and horizontal, were also noted in the walls of some of the buildings. Both faults undoubtedly adversely influence the weather resistance of the walls and more important, the structural capacity of the walls in load-bearing applications.

Figure 8 - Faulty bricklaying; vertical joints not uniform in width and mortar joints not completely filled.

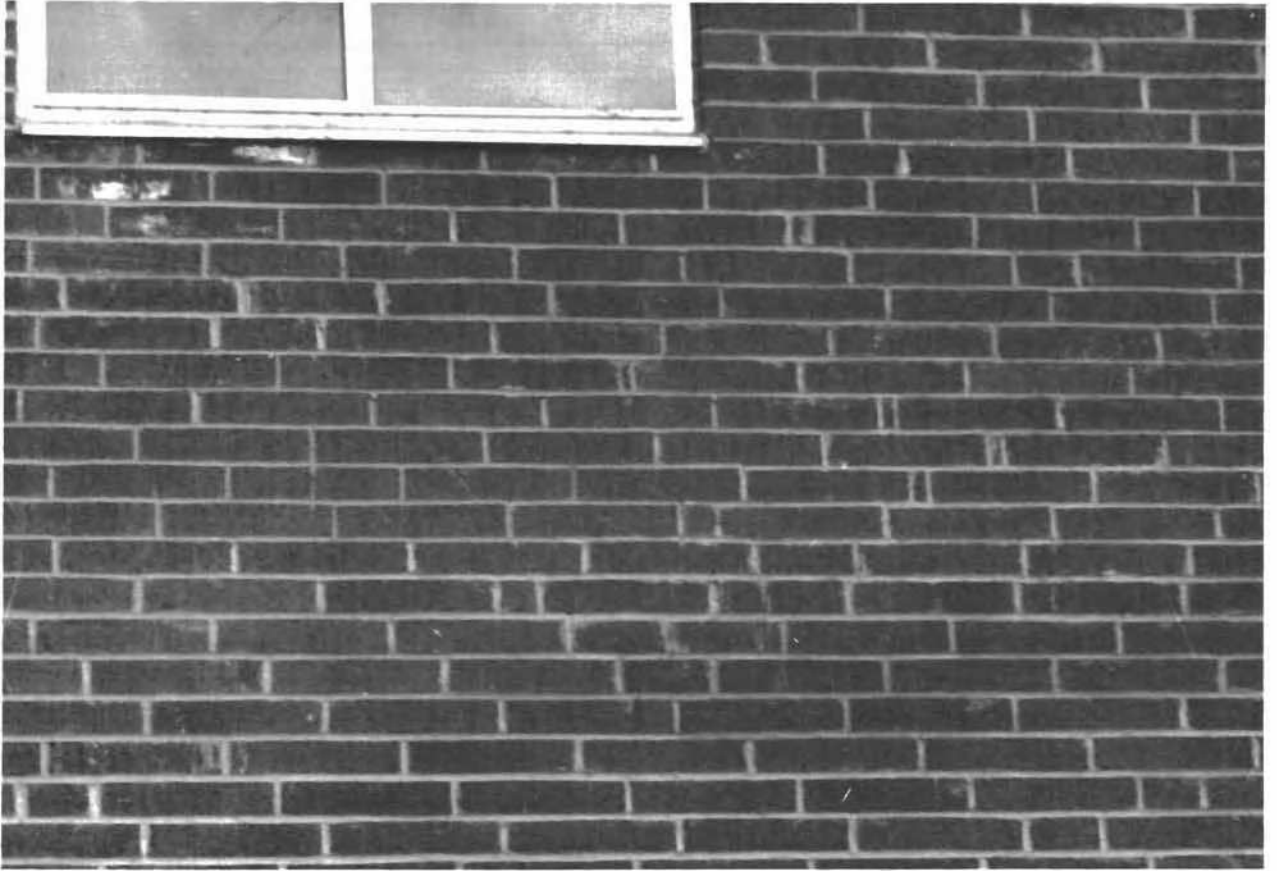
In many buildings, even of brickwork that appeared to have been laid with care, non-alignment of vertical joints was noted. This detracted from the appearance of the walls if not from their technical properties. One reason given for the non-alignment of joints was the relatively high individual cost of a T. T. W. brick, which necessitated the use of any parts broken from a whole brick, these smaller parts being worked into the brickwork wherever convenient thus producing the haphazard appearance illustrated in Figure 9.

Figure 9 - Irregular bonding produced by the use of bricks of non-uniform length.

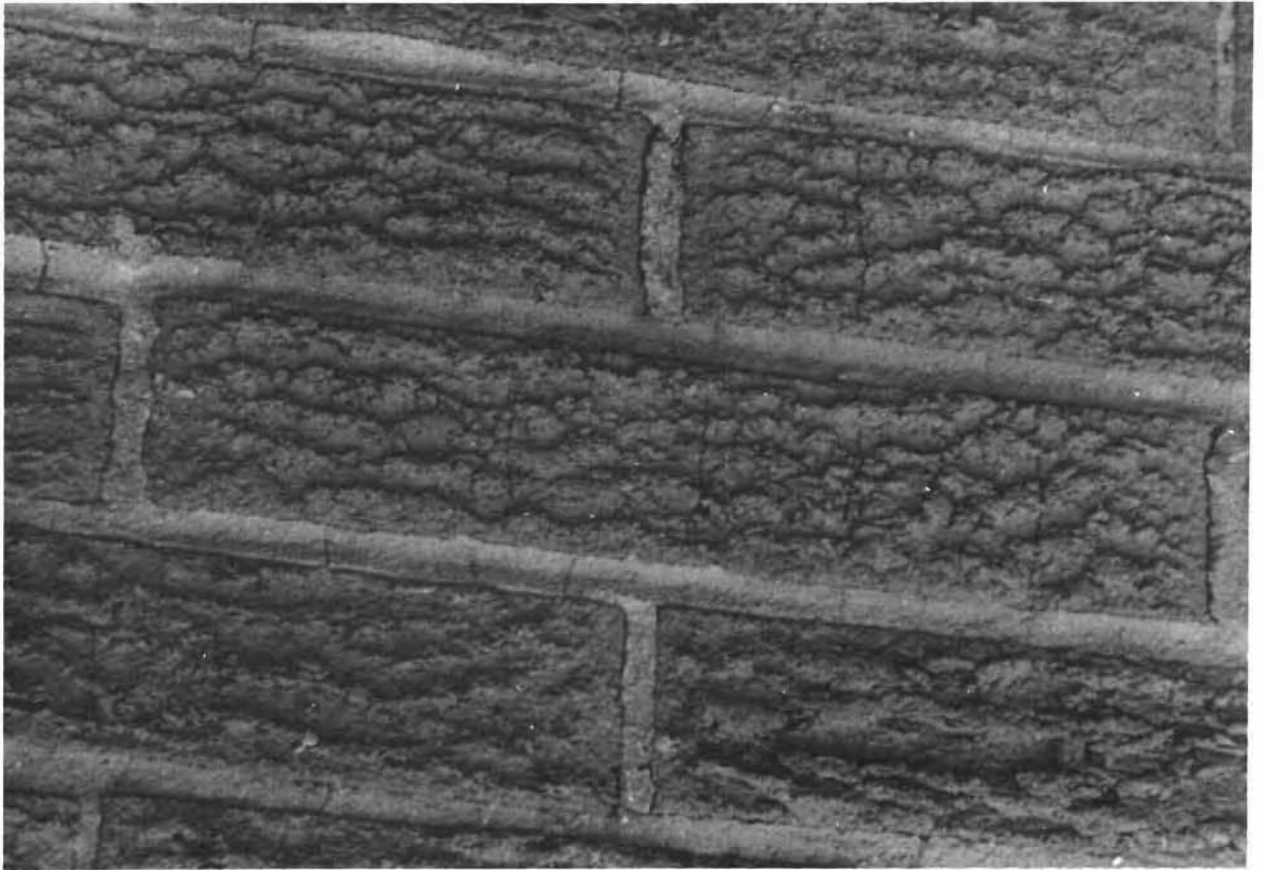
Cracking of individual bricks in one building was particularly extensive (Figure 10), the cracks apparently having been present in the bricks before they were laid. This particular building also had many vertical cracks in the horizontal mortar joints. In a few other buildings some of the bricks were excessively warped imparting an uneven aspect to the wall surface and to the line of the horizontal mortar joints.

Figure 10 - Cracks in bricks and in mortar joints (of the same wall as shown in Figure 8).

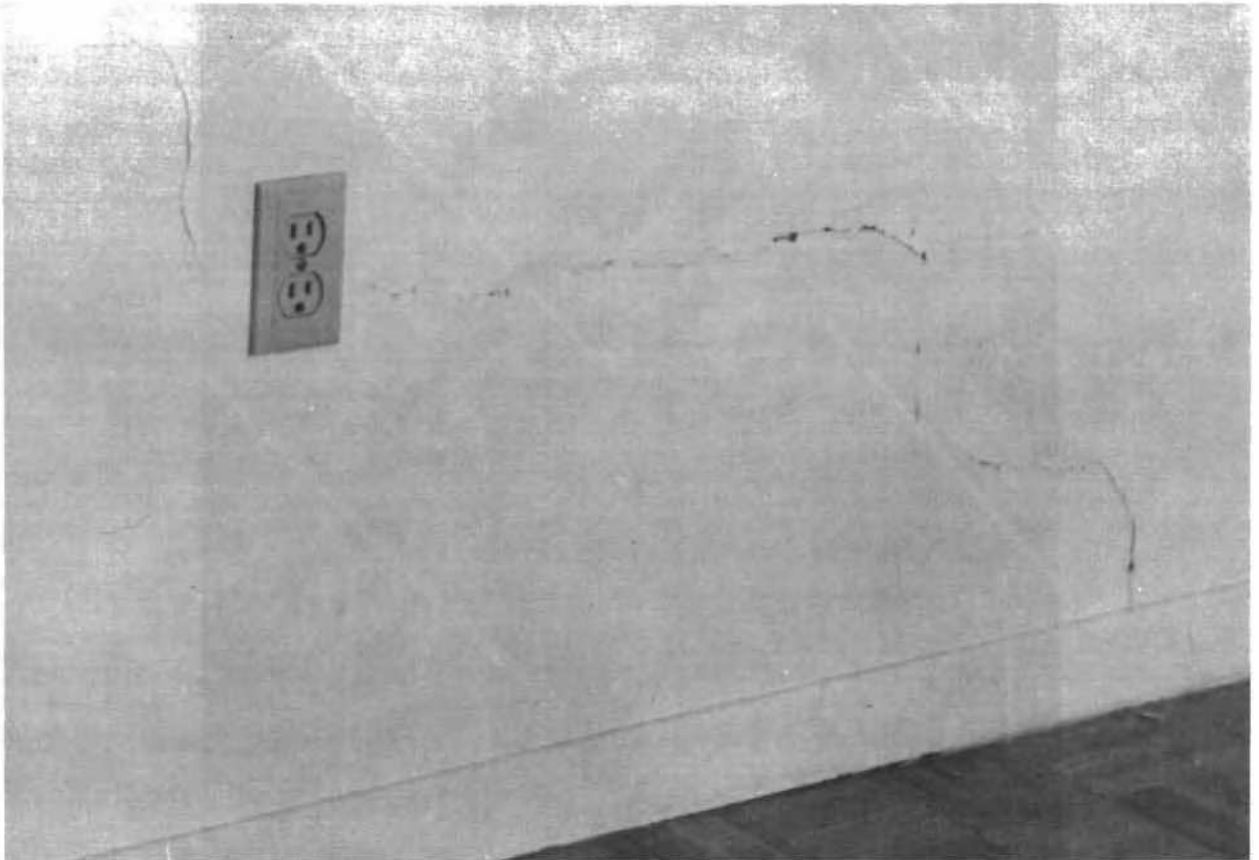
Cracking of interior walls was reported to have occurred in some buildings, particularly where cross-walls of concrete block masonry adjoined the exterior walls. The large apartment building in Sarnia, pictured in Figure 1, showed step-cracking of a concrete wall of the top storey (Figure 11), but the caretaker stated that such cracking was not extensive in the building.

Figure 11 - Cracking of concrete cross-wall (same apartment as shown in Figure 1).

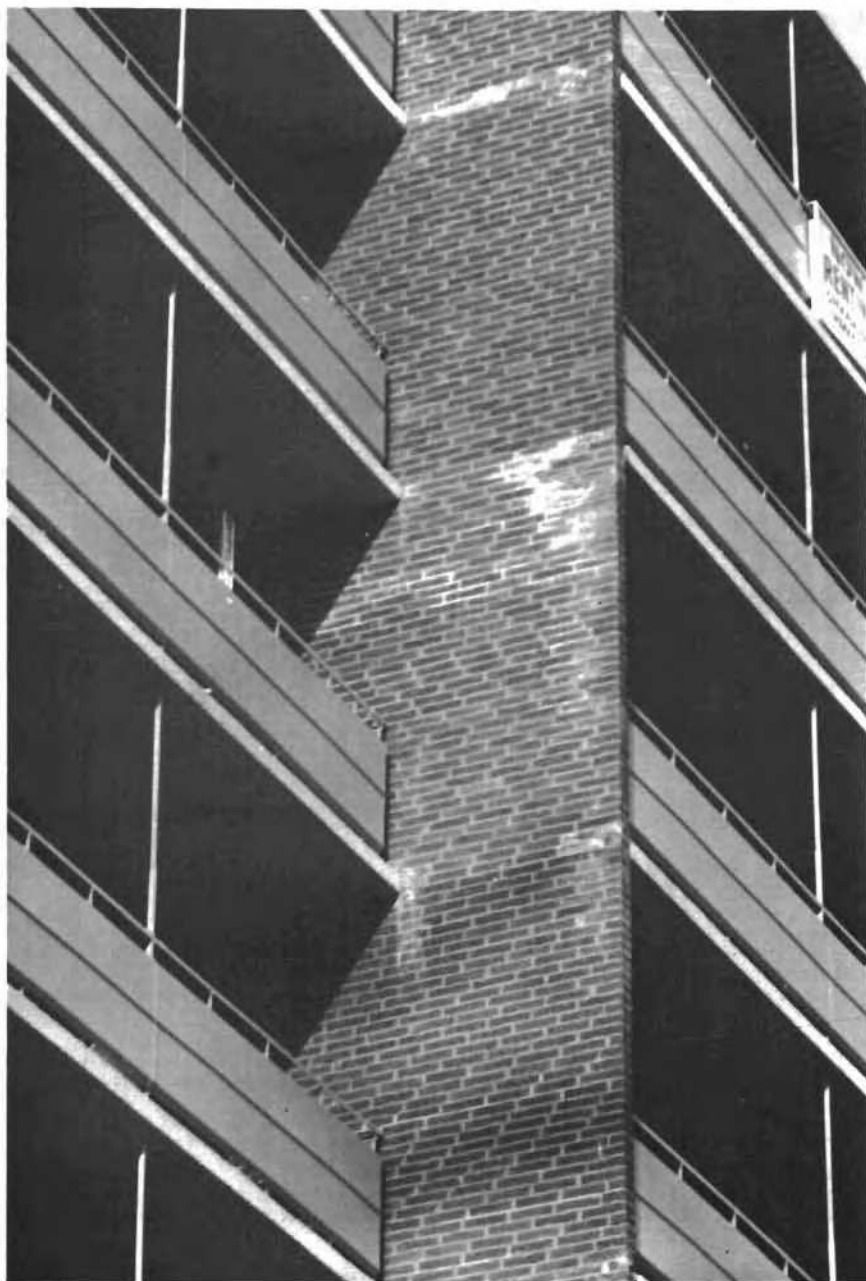
Although his building had not been affected by leakage the caretaker of the Sarnia apartment building complained about the efflorescence problem. Many of the buildings examined showed efflorescence on the brickwork near concrete balcony slabs (Figure 12), the wetting of the brickwork in this area and the contribution of salts to it by the concrete probably accounting for its occurrence.

Figure 12 - Efflorescence and staining at balcony slabs.

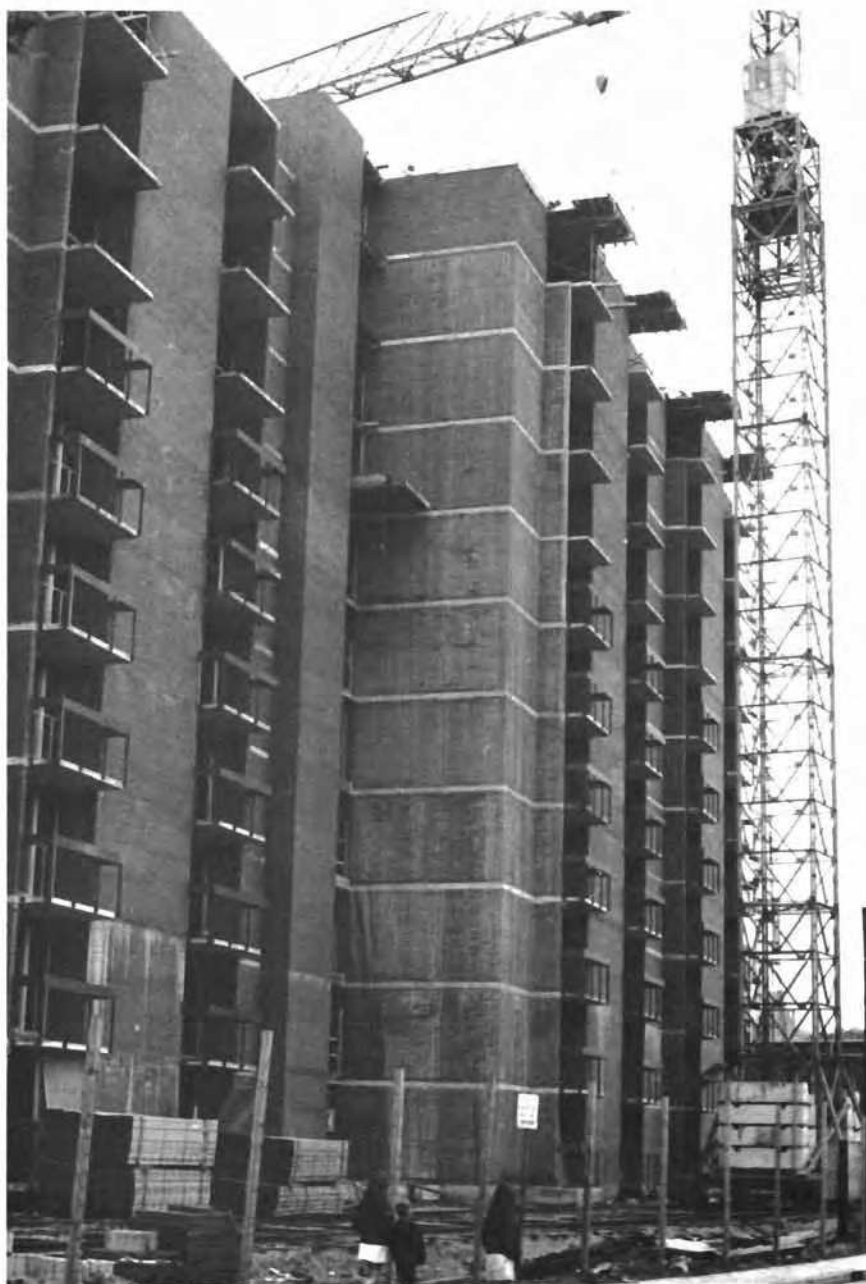
Concrete floor slabs cast on brick walls frequently resulted in staining of the walls due to moisture running down the wall from the concrete. This effect was seen in a 10-storey building in Hamilton (Figure 13) that was affected as soon as the concrete of the top floor slab was placed when a high wind blew fluid from the concrete over the forms to run down the entire height of the walls. The cleaning of walls stained in this way, however, was not considered by the construction superintendent to be a serious problem.

Figure 13 - Staining of brick walls under construction resulting from the run-off of water from concrete (same building as shown in Figure 2).
