A Roof Space Condensation Problem Robson, D. R.

432

TECHNICAL NOTE

SUBJECT A ROOF SPACE CONDENSATION PROBLEM

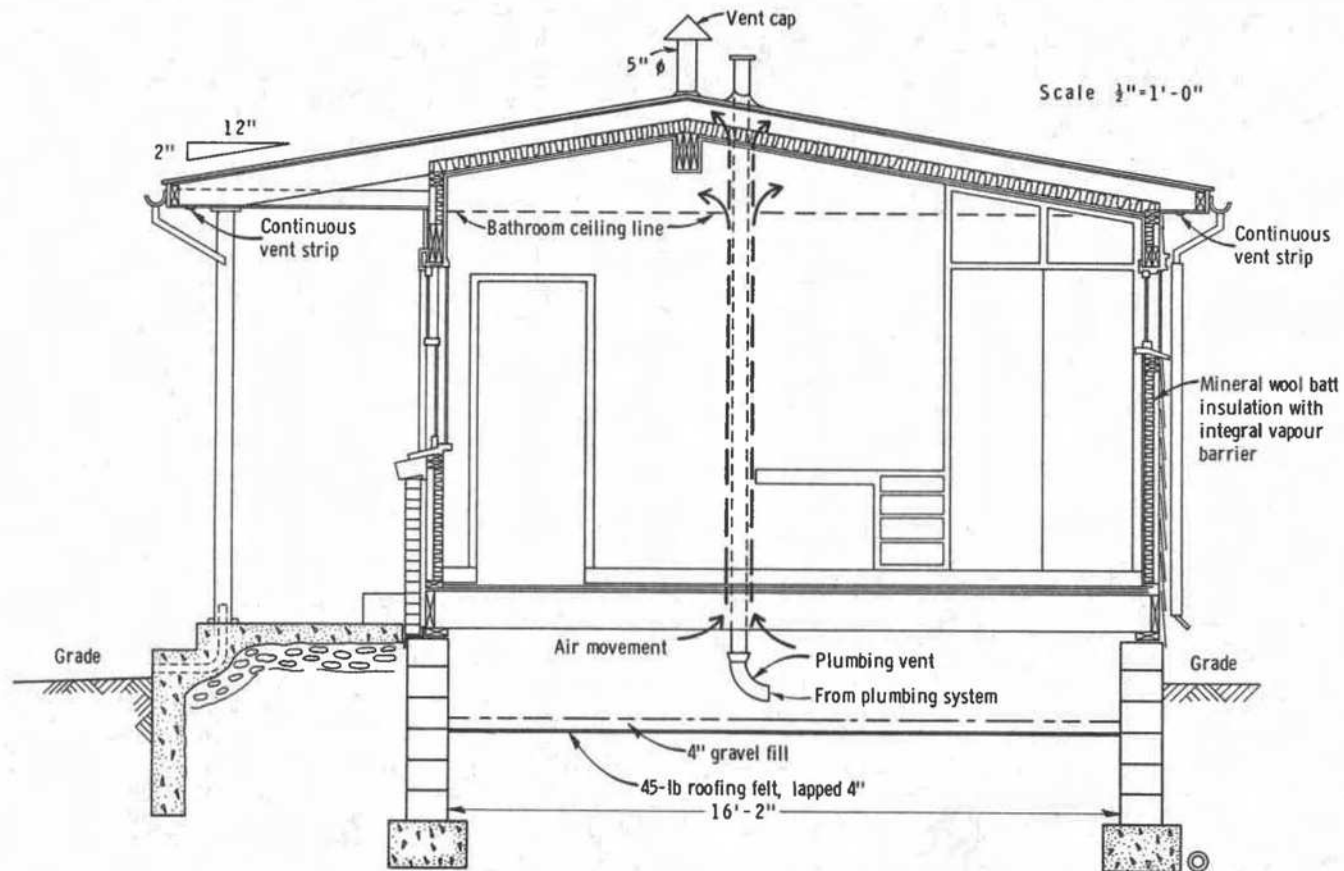
FIGURE 1 SECTION THROUGH MOTEL UNIT

The building is of wood-frame construction built on a crawl space and fully insulated (Figure 1). The first phase of the building, consisting of ten units, was erected about nine years ago. Although original units involved cathedral ceilings, some were later converted to flat ceilings at considerable cost to provide additional ventilation via an attic space.

A careful examination of the building disclosed that the worst problem existed in the old section where the roof sheathing on the south-east exposure had rotted due to condensation. The roof rafters were still fairly sound and the roofing was intact. The owner was reluctant to repair or replace the roof before correcting the condensation problem. During the examination in January, the dew point in the motel rooms was 35° to 39°F and 41° to 55°F in the crawl space. The minimum vent area requirement of

1/300 is met by the continuous strip vents in the soffit (Figure 1). To facilitate air movement a 5-in. vent pipe was installed over each pair of bathroom units to vent the ceiling space above the bathrooms. Severe condensation was evident around these vents and also in motel rooms 7, 8, 9, and 10.

Although the original plans specified 45-lb felt under 4-in. gravel fill in the crawl space (Figure 1), there was some doubt if this was placed over the entire area. On examination of the crawl space it was discovered that the ground was damp and when disturbed, wet. In one place free water was evident.

It was also evident that there were relatively large clearances around the plumbing pipes, and moisture from the crawl space could escape to the ceiling space via the plumbing wall and so bypass the ceiling vapour barrier and insulation.

From the results of this experience it appears that a vent area that is 1/300 of the ceiling area will not prevent condensation if a source of excess moisture that can gain ready access to the roof space is present. When, however, the source of moisture (in this case a damp crawl space) is controlled, the area of the vent is probably large enough. The problem was made more acute by the low slope roof, particularly where the ceiling is directly on the underside of the roof rafters, thereby reducing the volume of air over the ceiling. The absence of a continuous vent at the ridge also made the problem worse.

It was recommended that the crawl space under the entire motel be covered with 4-mil polyethylene and that the areas around the plumbing pipes be caulked to prevent air movement from the crawl space to the roof space.

On 17 January these suggestions were carried out, and a letter from the owner on 22 February 1964 stated that the condensation problem seemed to have been corrected. Satisfactory performance throughout the remaining winter months was confirmed at the time of a visit from the Station on 5 May 1964.
