NATIONAL RESEARCH COUNCIL OF CANADA
DIVISION OF BUILDING RESEARCH

SHEET STEEL AS A PROTECTIVE MEMBRANE
FOR STEEL BEAMS AND COLUMNS

FIRE STUDY NO. 23

Ottawa
November 1969

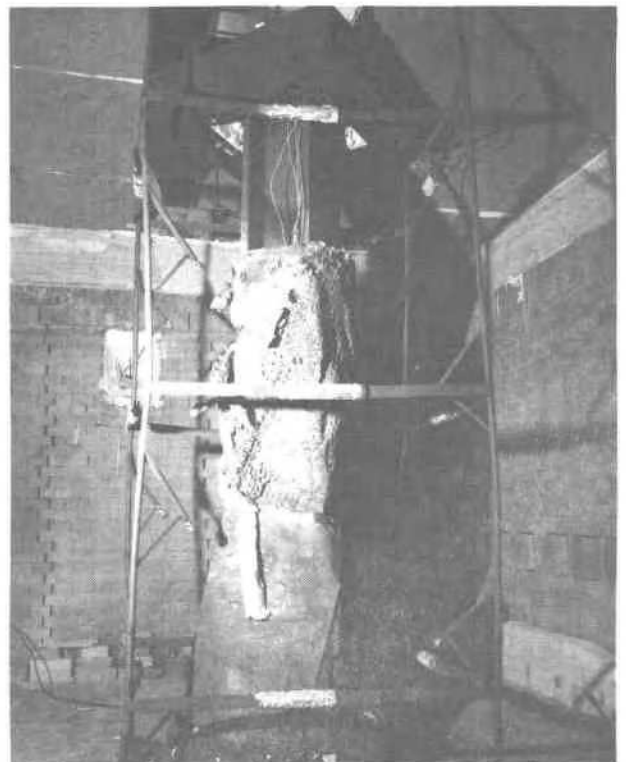
Figure 13. Column No. 1 after test.

During the first ten minutes the furnace was dark, making observations difficult. However, flaming was seen at the joints of the sheet metal at 3 minutes, and the flaming continued until about 30 minutes. By this time the furnace temperature was sufficiently high to permit good observations, and it was noticed that the steel cover was warping somewhat and appeared to be oxidizing on the surface. The warping, never too severe, continued progressively until about 2 hours. At 2 hours the sheet steel cover buckled outward slightly below the centre of the column thus exposing the rock wool insulation near the top directly to the fire.

At 2 hours and 8 minutes the steel had slid well down the column (about 18 in.) and the rock wool insulation had also moved, so that about 6 in. of the steel section at the top was exposed to the fire. By 2 hours and 15 minutes 18 in. of the column were bare, and the sheet steel had warped and collapsed to about 3 ft from the top of the specimen. Only rock wool showed above the steel; not the gypsum wallboard.

The fire test was terminated at 2 hours and 20 minutes. Figure 13 shows the condition of the column still in the furnace after the fire test. Figure 14 was taken after the column had been removed from the furnace and the sheet steel and gypsum wallboard had been discarded.

These tests both had interesting failures. The sliding down of insulation on specimen No. 1 caused the failure to occur at level 1, because only the rock wool remained as insulation at that height. It is also possible, that because about 18 inches of the steel column was exposed directly to the fire, vertical heat conduction along the steel section made a contribution to the higher temperatures at level 1. At the time of failure (135 min) the average temperature at level 1 was 110° F higher than the next highest average temperature at level 2.

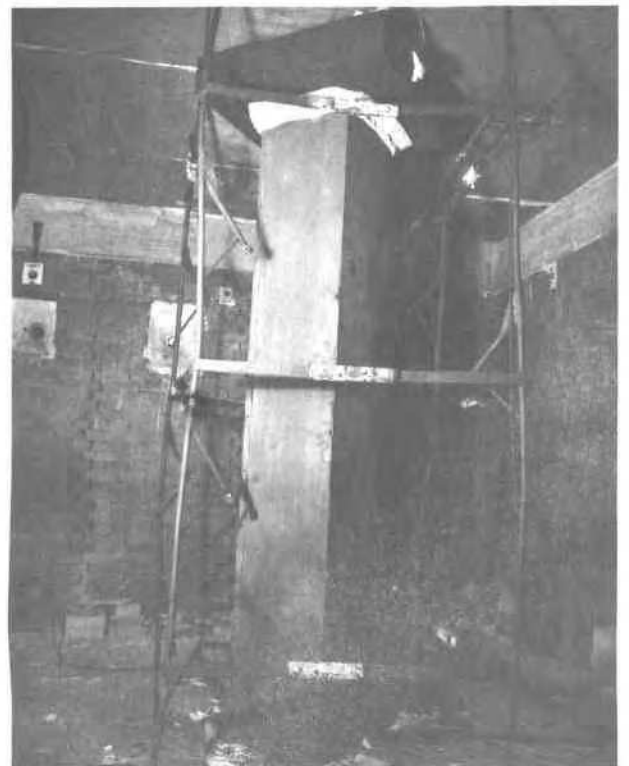
Figure 15. Column No. 2 after fire test.

Nothing visibly significant happened throughout the test. At 50 minutes the steel was still in good condition, although slightly bulged in certain areas. No vertical movement of the protection was observed throughout the test.

The fire test was terminated at 58 minutes. Figure 15 shows the condition of the specimen in the furnace after the test, and Figure 16 is a picture of the column outside the furnace with the insulation removed. The closeup in Figure 17 shows the condition of the rock

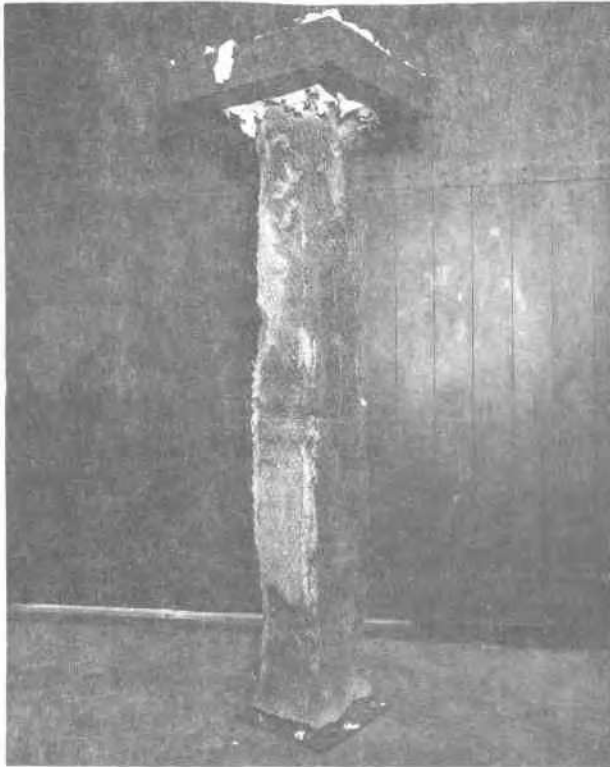
Figure 16. Column No. 2 with steel cover removed after fire test.

The sheet metal was chosen, in addition to its fire resisting abilities, for its attractiveness and durability as a column cover. Its primary function, however, is to act as a radiation shield, and in the case of specimen No. 1, to hold the deteriorating wallboard insulation in place. That it performed the latter function for a long time was shown clearly by the way the steel cover suddenly collapsed due to buildup of the disintegrated wallboard near the bottom. If thicker steel had been used, the collapse would have occurred at a later time. (Measurements on the steel after the test showed that it had oxidized to an average thickness of about 0.012 in. - almost one-half the original thickness).

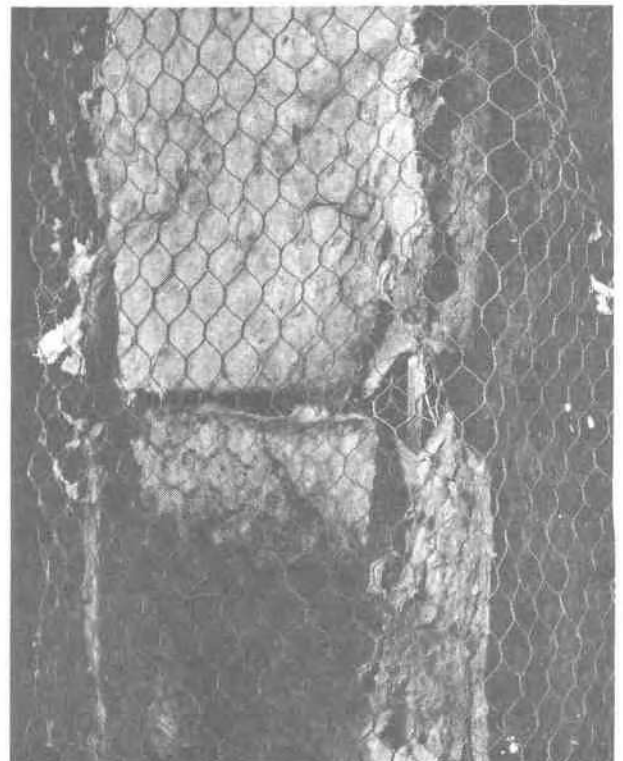
Figure 17. Column No. 2:
insulation joint after test.

wool insulation at the joint. This occurred at the mid height (level 2) of the column.

Specimen No. 2 failed at level 2, which is where the joint in the rock wool insulation occurred (Figure 17). This result emphasizes the importance of placing thermocouples at such locations. At the time of failure (52 min) the average temperature at level 2 was 95 to 100° higher than levels 1 and 3, which were at approximately the same average temperature.
