Temperature induced stresses on modified bituminous low-slope roofing systems

*13th Canadian Conference on Building Science and Technology [Proceedings],
2011-05-09*

NRCC-54459

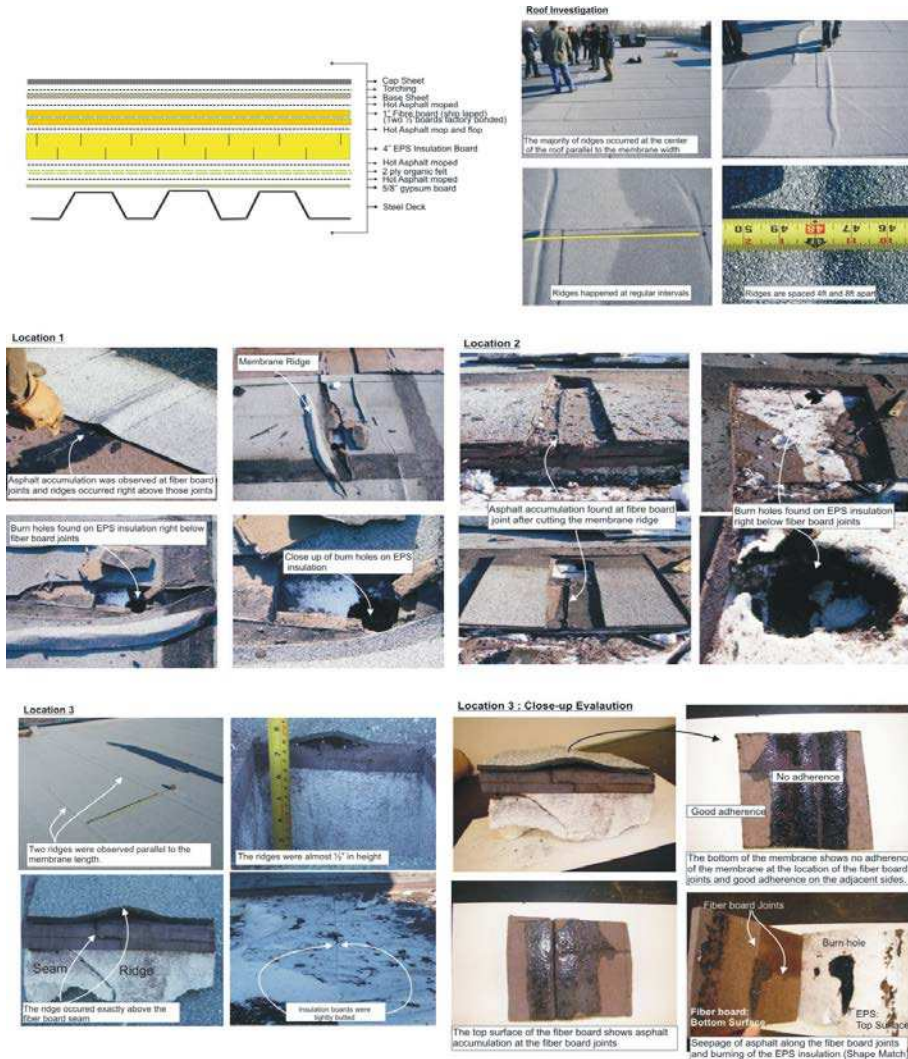
FIGURE 2: INVESTIGATION OF SCHOOL ROOF IN MONTREAL: CASE STUDY 1

The roof was two years old and it underwent four seasonal cycles of hot and cold weathering before sharp membrane ridging appeared as shown in Figure 2. For the roof, majority of the ridging occurred at the center of the roof parallel to the membrane width. The ridges happened at regular intervals of 4 ft (1.2m) and 8 ft (2.4m) apart. Three different locations on the roof were investigated by cutting the roof specimen. On location 1 and 2 when the membrane was cut on one of the ridge, asphalt accumulation was observed at the fiber board joint just below the ridge. Further cutting of the fiber board showed burnt holes on the EPS insulation below the fiber board joints. A test specimen was cut on the location 3 and, the ridges were almost ½ in. (12 mm) in height and once again they occurred exactly above the fiber board seam. On close up evaluation of the test specimen at Location 3, the bottom of the membrane showed no adherence at the location of the fiber board joint and good adherence on the adjacent sides,

which was the same observation on the top surface of the fiber board where actually asphalt accumulation was clearly found on the joint. The bottom surface of the fiber board indicated asphalt seepage through the joint and burning of the EPS insulation.

Summarizing the observations from Figure 2, it is clear that all the ridges occurred on the location of the fiberboard joints. All the locations indicated asphalt accumulation on the joints and poor adherence between the membrane and the fiber board. This phenomenon of membrane ridging can be explained by considering the physical properties of the membrane in relation to the environmental force to which it is exposed.

On a modified bitumen system, the membrane expands on heating developing compressive stresses and contract on cooling developing tensile stresses. During the heating cycle, the plastic or creep flow also begins to occur at the rate that will increase with increasing temperature. At high temperatures, when the membrane develops compressive stresses, the plastic flow could allow the membrane to increase in thickness and shear between the membrane and the substrate below could allow membrane movement .If the membrane is not held down at a particular location, ridging could occur as observed in the Case Study 1. In the present case study, as the roof involved hot asphaltic application, the particle boards are applied using the technique of “Mop and Flop”. During the installation of the particle boards on to the EPS Insulation, the butting of the adjacent boards caused the asphalt to seep and accumulate at the joint and also it caused the excessive hot asphalt to seep into the EPS burning it to form holes. Due to this excessive asphalt accumulation at the fiber board joints, there was a poor adherence between the membrane and fiber board making the joints as the weakest link. With the plastic flow occurring in the membrane as explained above, the ridges appeared on the membrane at the locations of fiber board joints. If sufficient time elapses, the plastic flow or creep could allow the membrane to relax, however as the ridges on the roof did not relax, it can be said that sufficient material has been pushed into the location of the ridge, which might have made the ridges stiff and kept the shape. From Figure 2-Location 3, it is shown that the EPS insulation joints were tightly butted and therefore it can be said that insulation joints or the moisture trapped between the joints had no role to play in the membrane ridging.

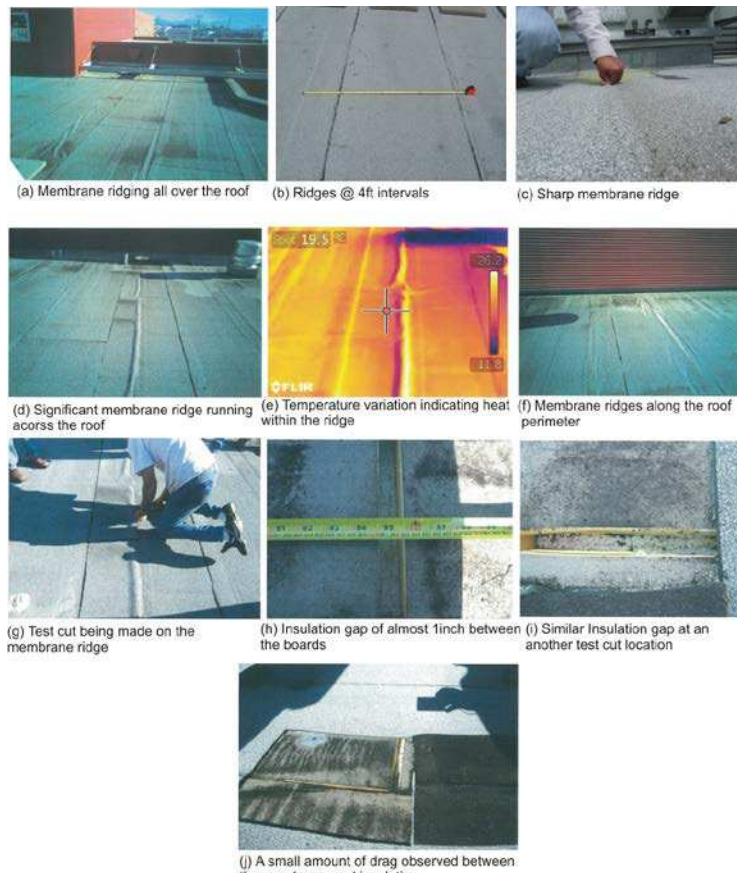
FIGURE 4: INVESTIGATION OF FIRE HALL IN BRITISH COLUMBIA: CASE STUDY 2

As shown in Figure 4a, significant membrane ridging occurred across the roof area. These ridges appeared to occur over insulation joints primarily, but due to being a mechanically attached system, the ridges extend beyond insulation joints in some areas. The membrane ridges were spaced at 4 ft intervals (Figure 4b). The thermographic image of the ridge area (Figure 4d) shows heated air within the ridges (Figure 4e). Different temperature variations can also be observed along the runs of insulation indicating uneven thermal value. At the roof perimeter as shown in Figure 4f, heat loss was observed both at the membrane ridges and at roof perimeter. When the membrane was cut at a large ridges as shown in Figure 4g, gaps were found in the polyisocyanurate insulation right below the ridge. The gaps between the boards were found to be ½ in. (12mm) and in some cases it was found be closer to 1 in. (25mm) as shown in Figure 4h and 4i. A small amount of drag was also observed on the exposed screw and fastener indicating the friction between the insulation shrinkage and membrane Figure 4j.

Similar to the case study 1, the issue of membrane ridging or buckling also appeared in the case study 2. However, in case study 2, as shown in Figure xx, the system configuration was a mechanically attached modified bitumen system, where the membrane was attached to the structural deck only at its seam overlaps. In other word whatever the stresses are developed they are localized within the sheet as the edges of the sheet are fixed to the substrate. In this case, the plastic flow or the creep develops and relaxes within the sheet but it cannot propagate from one sheet to another. So in case study 2, the buckling phenomenon could not attributed to the membrane creep, but it could be said to be a membrane blister occurring at the insulation gaps. It should be noted that gaps around 1 inch were found in case study 2 between the insulation boards indicating that the insulation boards underwent a considerable dimensional change.

configuration comprised of vapor barrier and EPS below the Polyiso boards. The temperature cycle caused the insulation boards to shrink and form a gap or void between the boards. As the boards were not staggered during the layout, the insulation gap was in linear format across the roof. With the vapor barrier below the insulation, the trapped air in the insulation gap expands during the heat of the day inducing pressure on the membrane forming linear blister (crest shape) along the insulation gaps. Had there been no vapor barrier, the membrane would have troughed into the insulation gap like a simply supported beam.
