**MECHANISM OF BREAKDOWN IN THE INTERFACE
REGION OF GLASS REINFORCED POLYESTER BY
ARTIFICIAL WEATHERING**

A. BLAGA AND R. S. YAMASAKI

REPRINTED FROM
JOURNAL OF MATERIALS SCIENCE
VOL. 8, 1973
P. 654 - 666

RESEARCH PAPER NO. 568
OF THE
DIVISION OF BUILDING RESEARCH

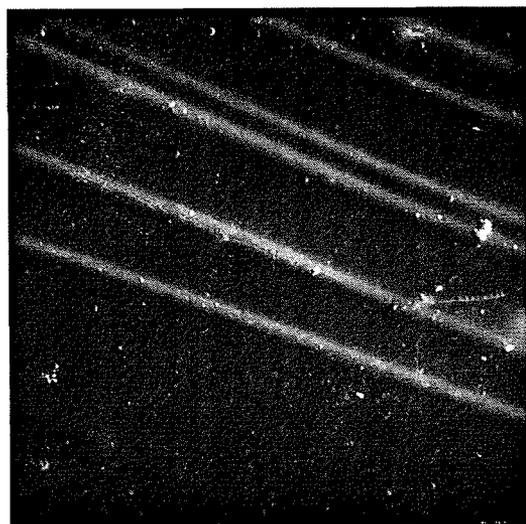
After a few days of ageing the resin layer above the superficial filaments formed ripples or round ridges (Fig. 4) in resin-rich as well as in glass-rich regions. These ripples are indicative of a permanent set resulting from plastic flow under the influence of radial compressive stresses. The ease of formation of these ridges depends upon the proximity of the filament to the surface, since the time of formation ranges from a few days for glass-filaments very near the surface

Figure 4 GRP sheet aged for 12 cycles in the Weather-Ometer ($\times 360$).

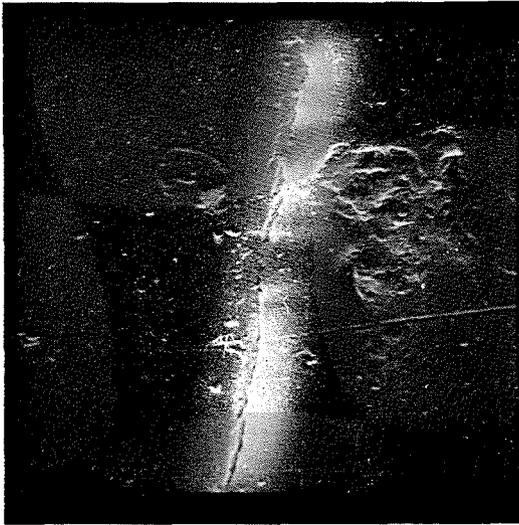
Figure 5 GRP sheet aged for 12 cycles in the Weather-Ometer ($\times 1300$).

The next feature of breakdown is the rupture of the superficial resin layer (Fig. 5) at a ridging filament or above a filament close to the surface. At this point, the resin phase undergoes severe microfragmentation or spalling by a process of brittle fracture as evidenced by the presence of a multitude of irregularly shaped debris (Fig. 6). This suggests that the fracture occurs without prior plastic deformation. Most of the resin debris is then washed away by water during the water-spray period of the cycle, leaving an empty, long cavity (gap) parallel to the adjacent filament (Fig. 7). In most instances, the pattern of the fracture boundaries of the resin indicates that these failures occur under the influence of a definite set of predominating stresses, e.g., the failure shown in Fig. 6 was produced by stresses that were predominantly shear and radial tensile stresses. Fig. 8 shows an outstanding example of a site where the resin ruptured away in a brittle mode under the influence of considerable, predominantly shear stresses operating in the direction parallel to the filament axis (axial shear stresses). This is evidenced by the acute angle between the filament and the fracture boundaries of the resin, resulting in a saw-toothed pattern.

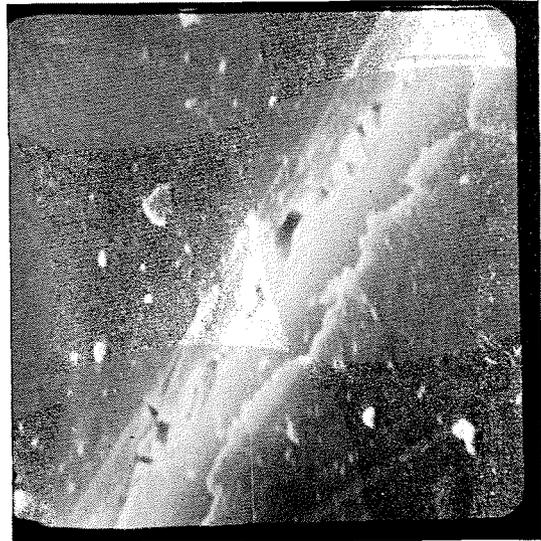
Figure 6 GRP sheet aged for 15 cycles in the Weather-Ometer ($\times 2900$).

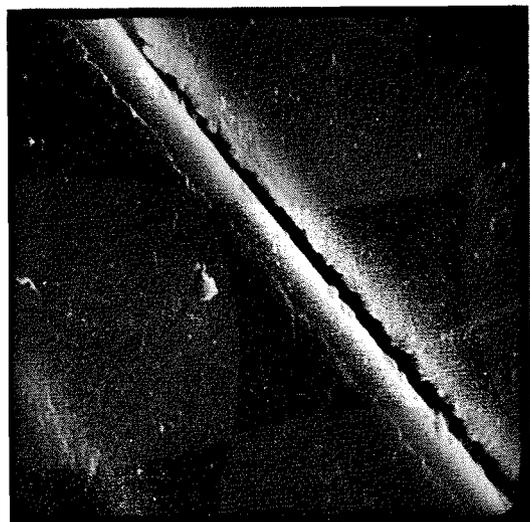
Figure 7 GRP sheet aged for 55 cycles in the Weather-Ometer ($\times 1300$).

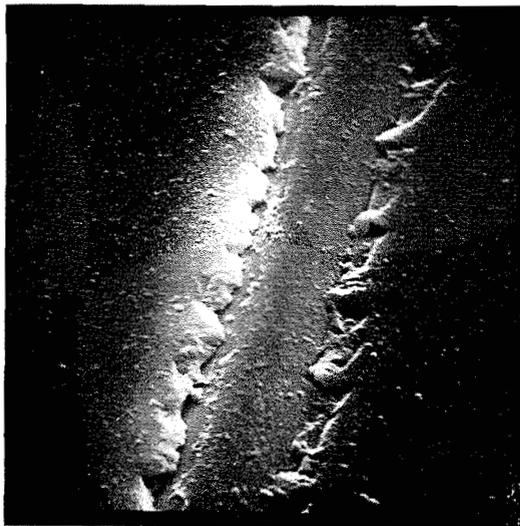
Figure 8 GRP sheet aged for 55 cycles in the Weather-Ometer ($\times 2900$).

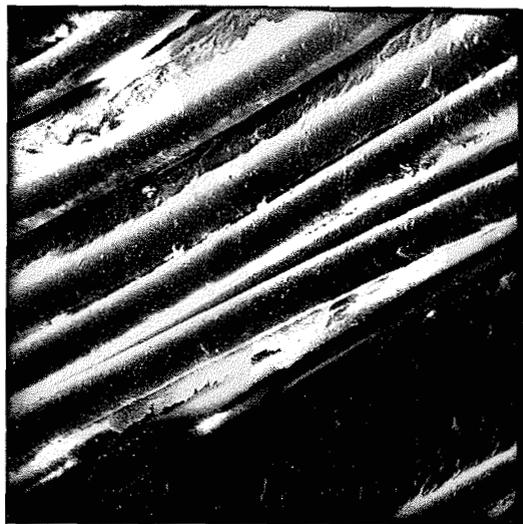
Figure 9 GRP sheet aged for 450 cycles in the Weather-Ometer ($\times 680$).

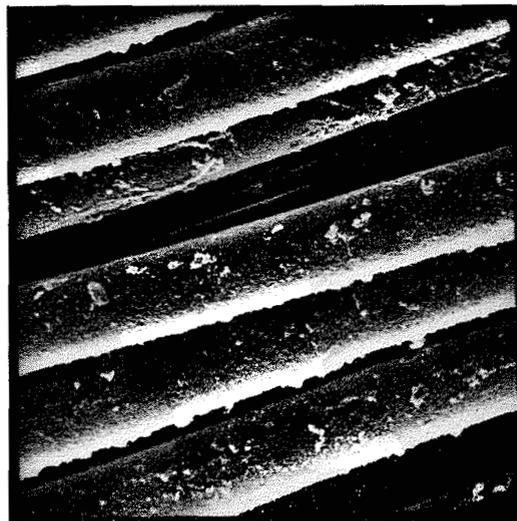
Figure 10 GRP sheet aged for 1200 cycles in the Weather-Ometer ($\times 1300$).

These scattered fibres, the very irregular surface of the fractured resin, and the microcavities diffuse the light instead of transmitting it, and thus render the originally translucent sheets more opaque. This type of failure impairs the appearance of GRP sheet and is commonly called fibre prominence.

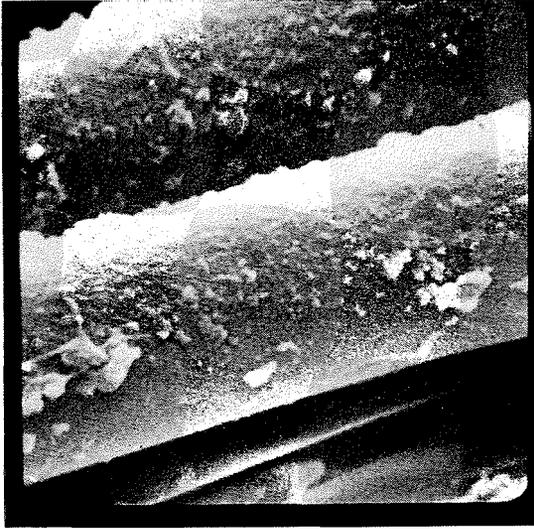
Figure 11 GRP sheet aged for 1200 cycles in the Weather-Ometer ($\times 2900$).

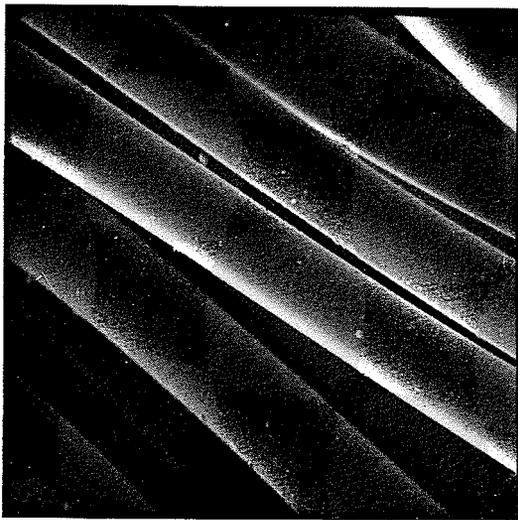
Figure 12 Filaments of chopped strand glass (E-glass) mat heated for 1 h at 650°C ($\times 1300$).

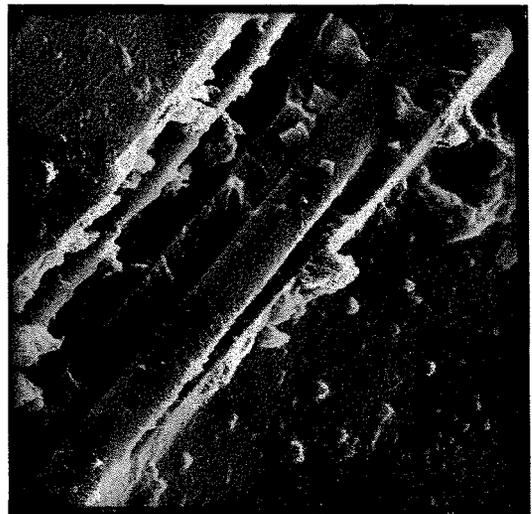
at a much faster rate than on the back side, producing thermally-induced stresses of corresponding magnitude. When the arc is turned on after the spray period the front side is subjected to another but lesser thermal shock. Furthermore, the direct actinic action of the radiation causes cross-linking in the resin of the front side rendering it more brittle than that of the back side, and thus more susceptible to fracture. Fig. 13 shows a failure at a multi-filament region on the surface of the back side of a sheet aged in the Weather-Ometer for 945 cycles (315 days).

Figure 13 Back side of GRP sheet aged for 940 cycles in the Weather-Ometer ($\times 680$).

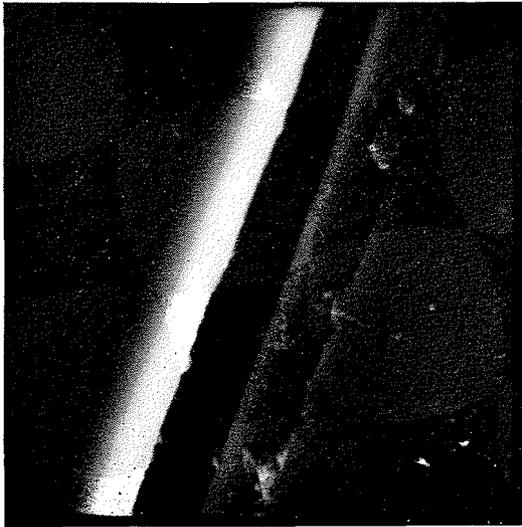
In the Climate Lab, stresses are induced both thermally (11 to 56°C) and by moisture (Table I, treatment 2; Table II). The GRP sheets subjected to this treatment showed breakdown features qualitatively similar to those produced in the Weather-Ometer, but the breakdown proceeded at a slower rate during the later stages of deterioration. In the Climate Lab, as in the Weather-Ometer, the rate of breakdown at single filaments prevailing in the early stages decreases with further ageing. A typical failure at a single filament after 270 cycles (135 days) is illustrated in Fig. 14. Fig. 15 illustrates an intermediate stage of breakdown in a multi-filament region.

Figure 14 GRP sheet aged for 270 cycles in the Climate Lab ($\times 1300$).

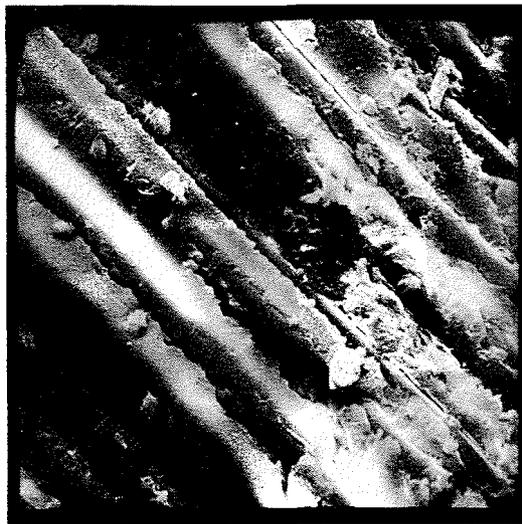
Figure 15 GRP sheet aged for 40 cycles in the Climate Lab ($\times 680$).

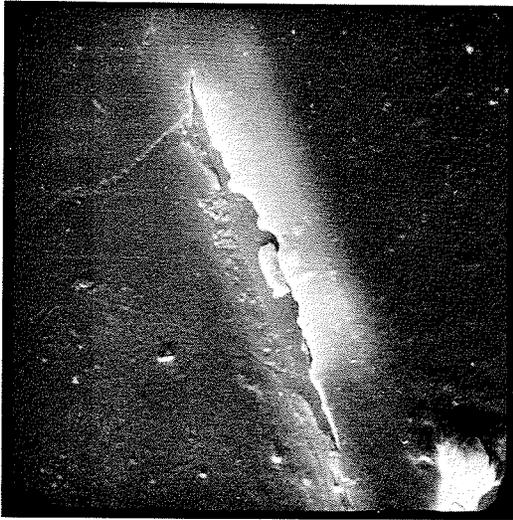
Figure 16 GRP sheet weathered outdoors at Ottawa for 880 days ($\times 1300$).

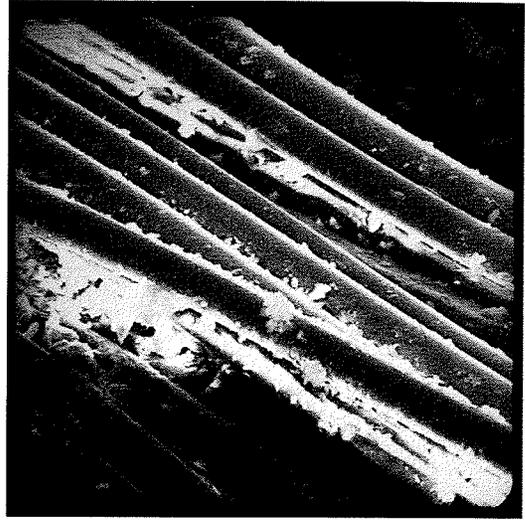
Figure 18 GRP sheet weathered outdoors at Ottawa for 880 days ($\times 680$).

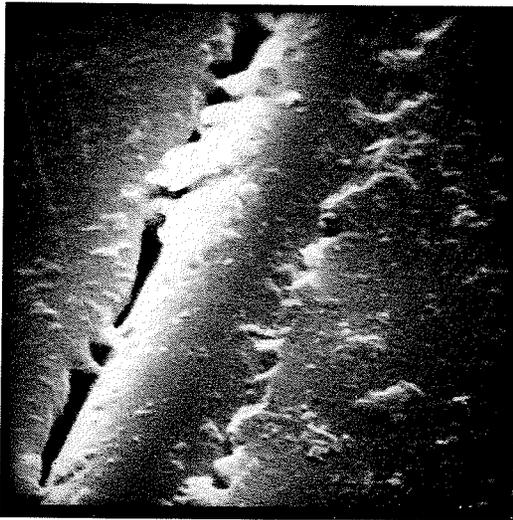
Figure 17 GRP sheet weathered outdoors at Ottawa for 880 days ($\times 2900$).

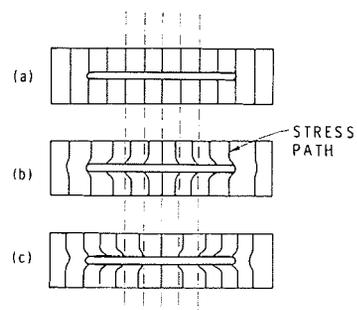
Figure 19 Schematic drawing of deformational stresses in a resin-rich region (single filament): (a) at the curing temperature; (b) after cooling to ambient temperature; (c) at high humidity and/or increased temperature.

contracts more than the glass. In the direction parallel to the filament (Fig. 19b) this differential contraction produces axial compression in the filament and axial tension in the resin [9]. This results in large axial and tangential shear stresses. Similarly, in the direction perpendicular to the filament, cooling results in large radial compressive stresses [9] as illustrated in Fig. 20a.
