## **Protection of foam plastic thermal insulation in low sloped roofing systems**

**Booth, R.J.; DeRushie, C.; Liu, K.K.Y.**

**NRCC-45712**

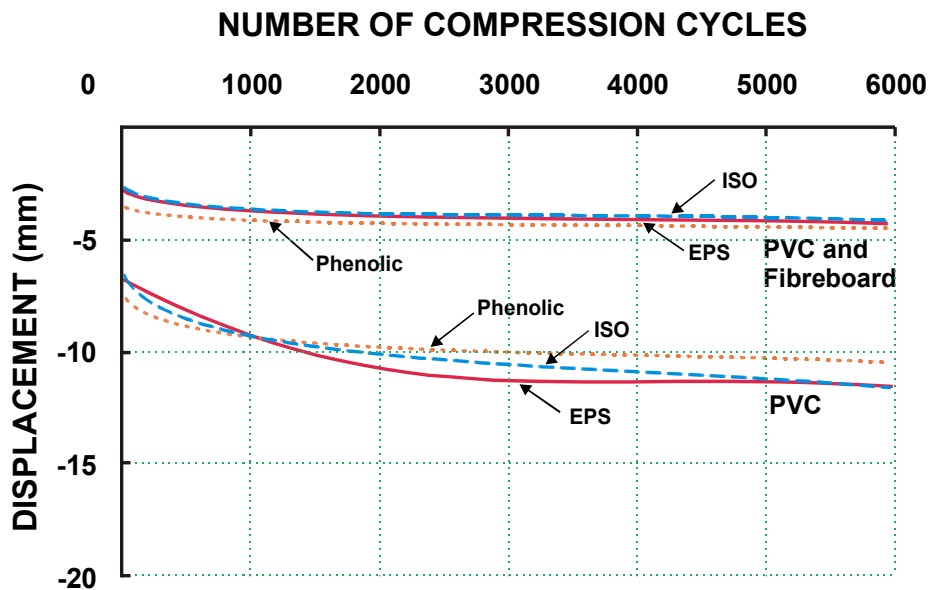
Figure 1 Indentations of polyisocyanurate (ISO), phenolic and expanded polystyrene insulation (EPS) specimens covered with a PVC membrane, with and without a fibreboard, subjected to cyclic compression testing from 0 to 45.4 kg over a work boot heel angled at 30° [6].

Adhering, rather than screw fastening, the protection board removes the potential for membrane puncture by screw fasteners. With single ply membranes the protective layer (eg. paving slabs) is often placed over the finished roof surface to protect both membrane and insulation.

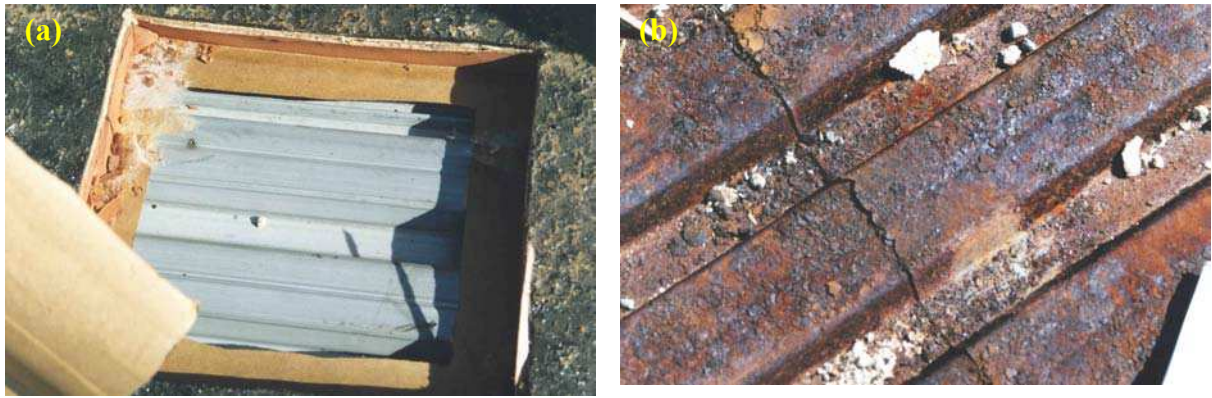
Figure 2 Steel deck over high humidity building (a) section with air/vapour barrier (b) section without air/vapour barrier.

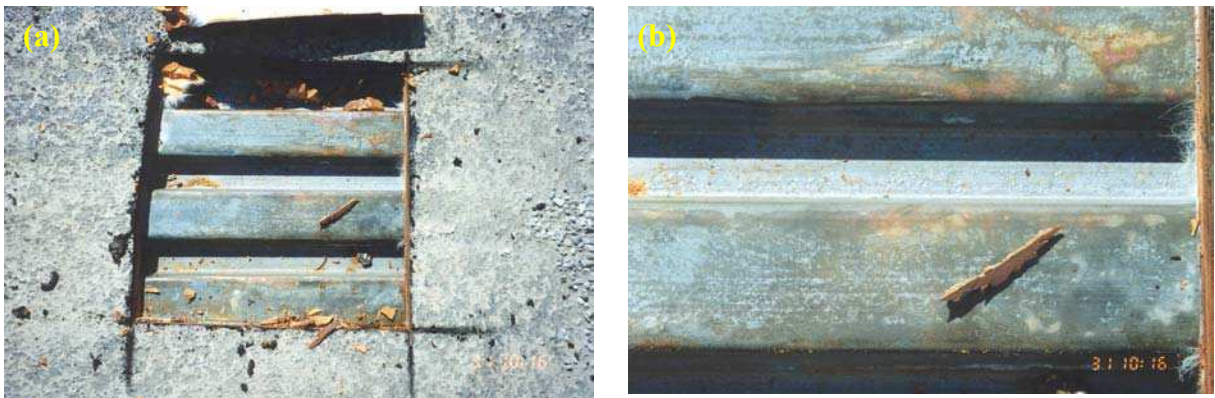
During the roof inspections it was found that phenolic foam exposed to wet and soaking conditions could loose much of its acid content without it causing unusual corrosion. Figures 3a and 3b show the condition of steel deck underneath a leaking roof without an

air-vapour barrier, the phenolic insulation underneath the leak had lost approximately 70% of its acid content at the time of inspection yet the thin galvanizing layer (0.7% of total deck thickness) was still largely intact. Accelerated laboratory experiments showed similar results. [Appendix D].

Figure 3 (a) Steel deck underneath roof leak where approximately 70% of acid content had been leached out of the phenolic insulation (b) close up of steel deck.

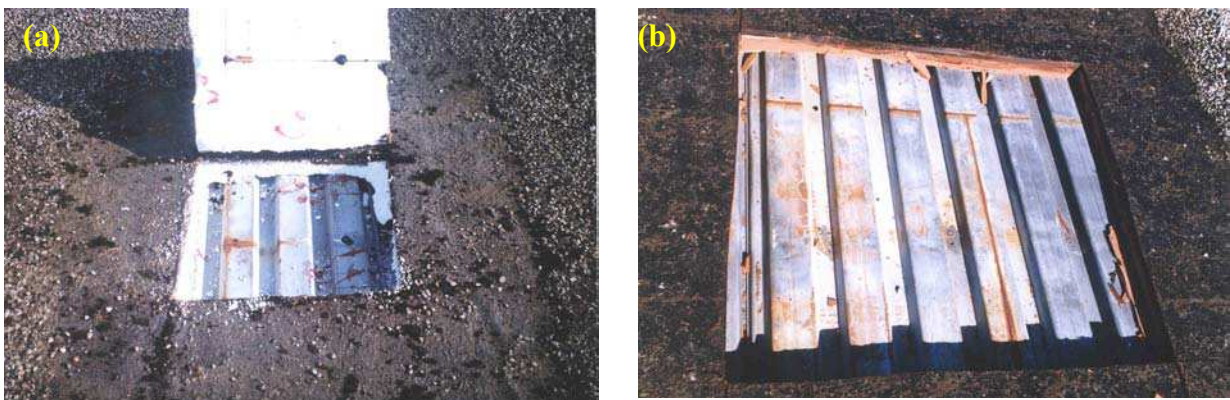
Figures 4a and 4b show "pencil lines" of rust that occurred underneath polystyrene and phenolic insulations in roofs without air-vapour barriers. Such lines are not typically seen in roofs with fibrous insulations because air moves freely into fibrous materials and condensation is stored (within the insulation) over the entire roof area. Air impermeable foams prevent air movement and force (moist) air to the insulation joints where condensation occurs. Joints represent approximately 1% of total roof area and there is a 100 times concentration effect of condensation and corrosion at the joints of plastic foam boards compared to fibrous insulations. The acid content of the phenolic insulation removed from this 9 year old roof indicated that little, if any, acid loss had occurred and the acidity was essentially identical at board edges and board centres. This suggests that "pencil lines" of steel deck corrosion underneath phenolic insulation board joints were related to the insulation's physical properties, rather than to acid loss. [Appendix C]

Figure 4 Pencil line rust under joints of foam insulation (a) polystyrene and (b) phenolic.

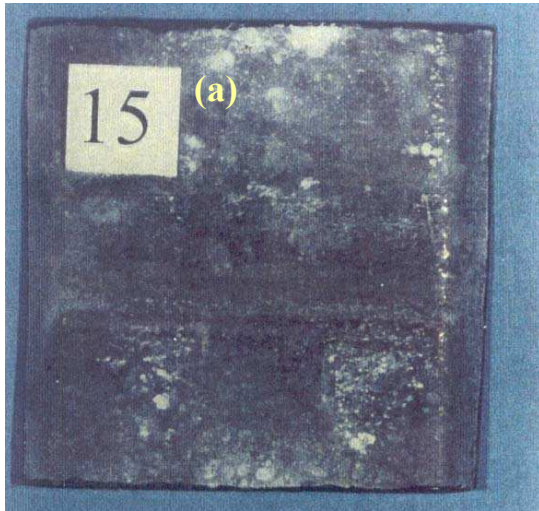
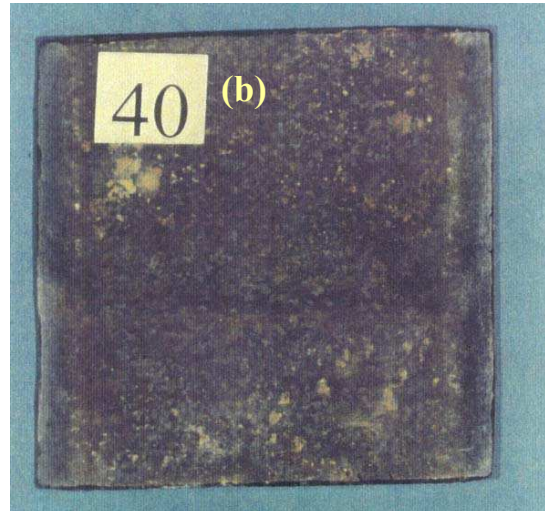
*The amount of steel deck corrosion was inspected visually after 4, 10, 18, 26 and 34 weeks of exposure. After 34 weeks of exposure to these conditions the pH of leachates indicated that 99% of the acid in the phenolic insulation samples had been removed. The amount of corrosion observed on the steel deck under both insulation types was superficial [Figure 6]. The rate and severity of corrosion was slightly worse underneath the polyisocyanurate insulation than underneath the phenolic insulation. Lines of discolouration were visible on the steel deck underneath the joints between insulation samples, this phenomenon has been seen in commercial sized roofs that have inadequate condensation protection.*

Figure 6 Typical condition of the steel deck after 34 weeks of exposure (a) underneath phenolic insulation and (b) underneath polyisocyanurate insulation.
