NHBA EXPERIMENTAL PROJECT MARK II,
FOREST LAWN, ALBERTA

by
G. O. Handegord

Internal Report No. 244
of the
Division of Building Research

OTTAWA
January 1962

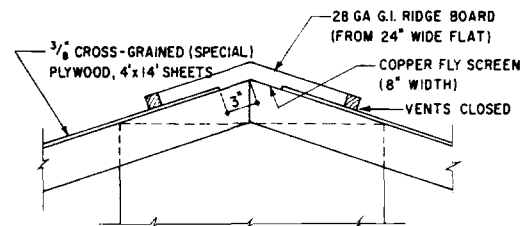
DETAIL A - RIDGE VENT

It was reported in March 1960 that under certain conditions snow tended to enter the attic through the ridge vent and the vent had been blocked off for the most part following this experience (Fig. 2). The attic appeared to be dry and free from condensation in March except for some frost

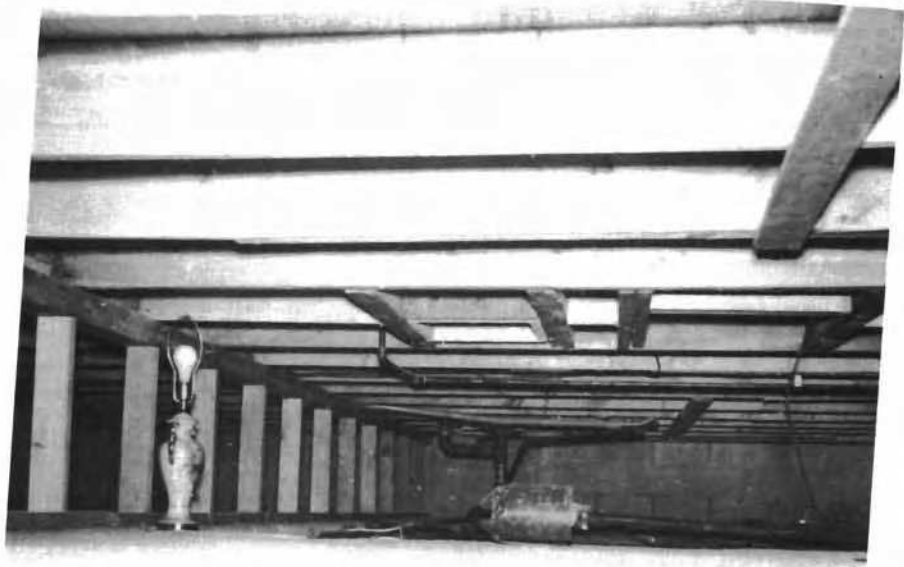
In March 1960, examination of the crawl space revealed a slight displacement of the floor adjacent to the centre footing wall, as shown in Fig. 6. In November there appeared to be no increase in this displacement. During both visits the dark appearance of some mortar joints, as shown in Fig. 6, suggested moisture being present, but no other evidence of water seepage was observed. The crawl space was dry and no cracks were noted in the concrete floor.

Figure 6 Crawl space of Mark II House.

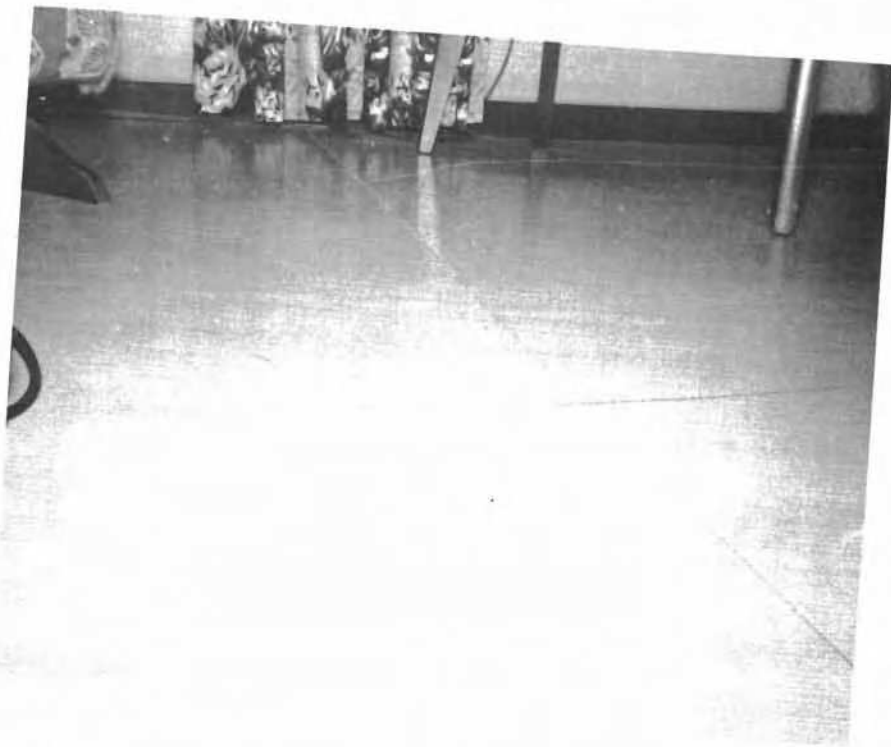
Many of the people attending the official opening criticized the floor system as being too "springy", and this has been the chief complaint of the occupants. Excessive deflection of the subflooring may also have been a contributing factor in producing separation at the joints in the plywood flooring sheets (Fig. 7). The high temperatures in the crawl space would also contribute to this separation, notably due to shrinkage of the plywood subfloor. Shrinkage of the joists was reported by the occupant from measurements taken in the crawl space.

Figure 7 Separation of plywood flooring sheets -- Mark II House.

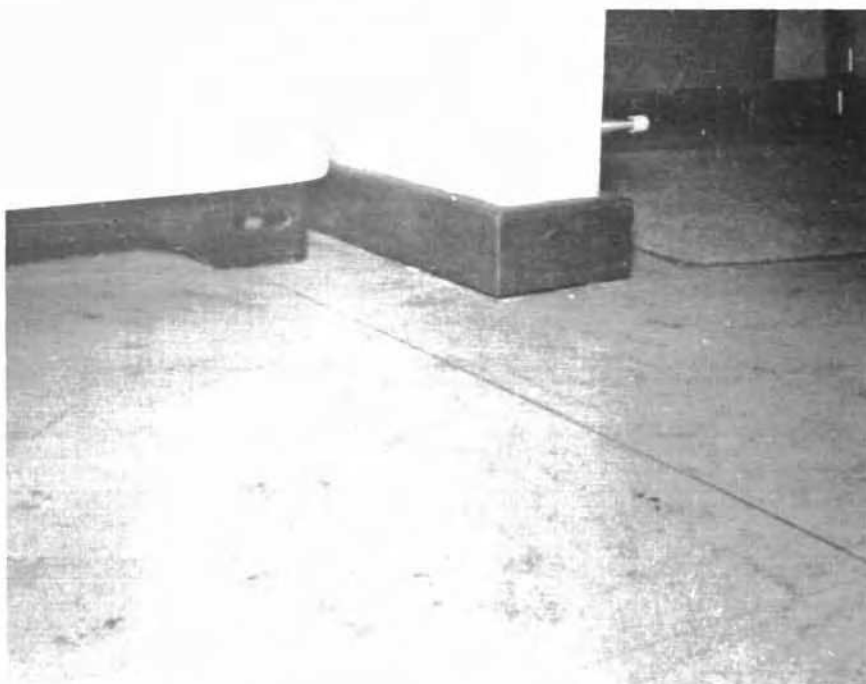
Some separation between the base of the wall and the floor was noticed in March 1960 at the end of the stub wall adjacent to the refrigerator, as shown in Fig. 8. Some shrinkage may have occurred in the baseboard, but examination indicated a gap of some 1/2 inch between plate and subfloor. Evidence of possible floor deflection was also noted at the top of the kitchen storage cupboard in Fig. 9. This is a region of fairly heavy floor loading. No increase in these separations were noted in November 1960.

Figure 8 Separation between base of wall
and floor -- Mark II House.

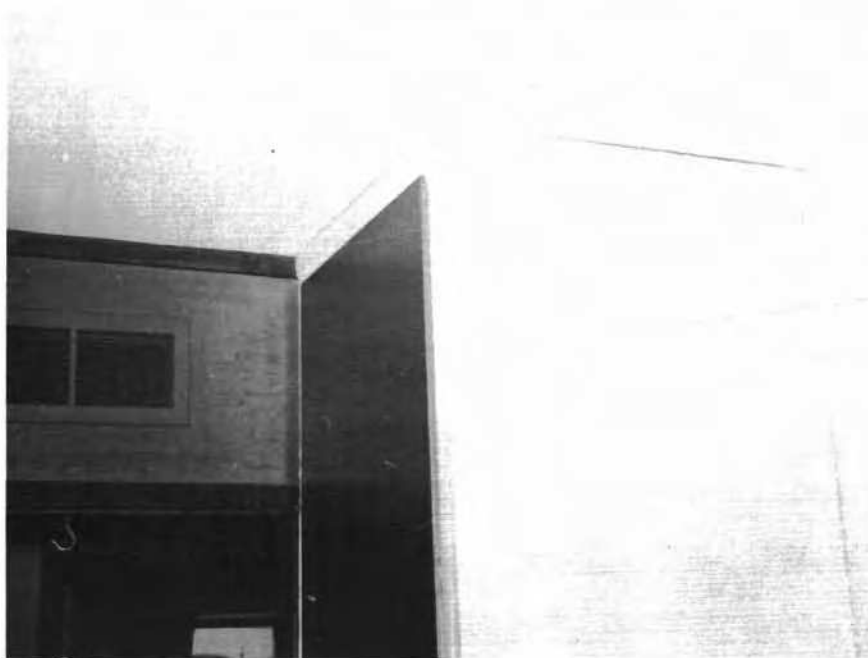
Figure 9 Separation at top of kitchen
cupboard -- Mark II House.

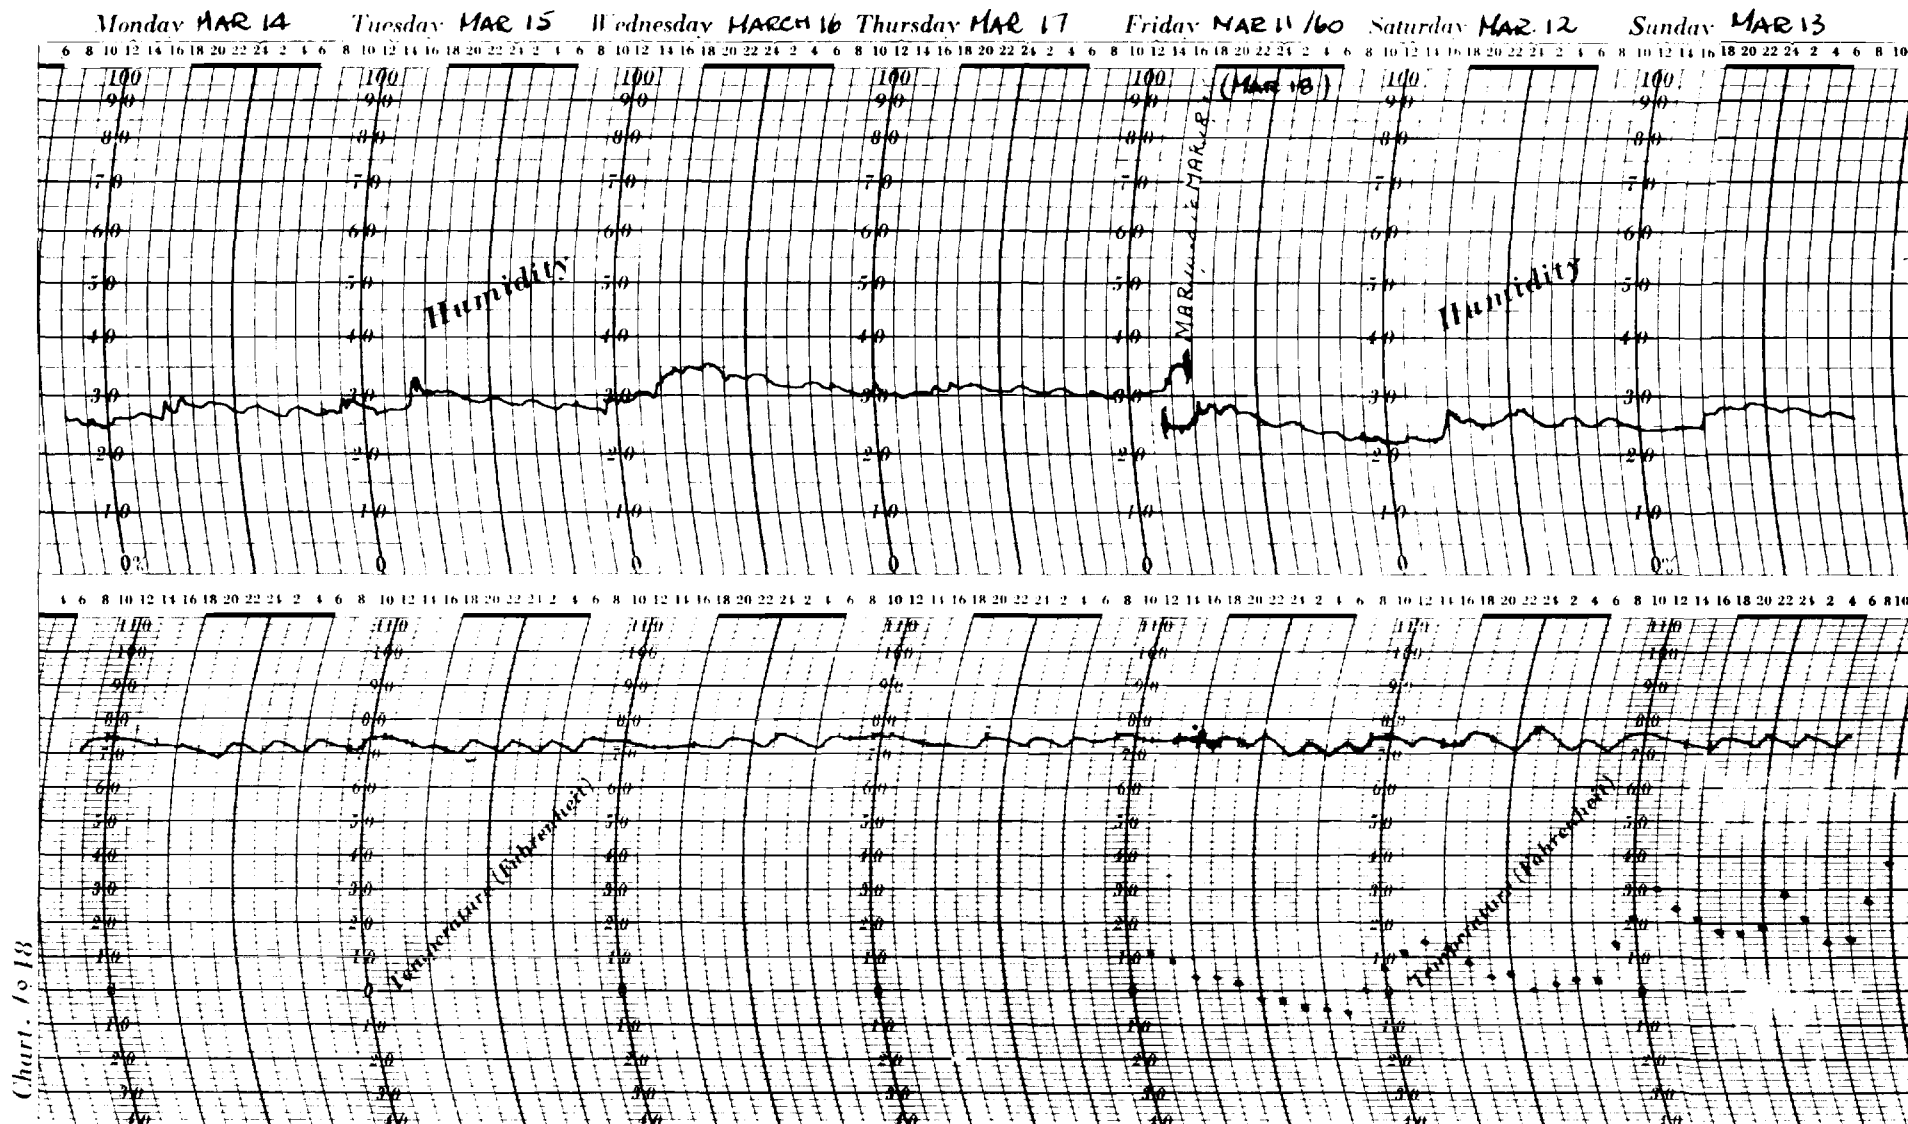
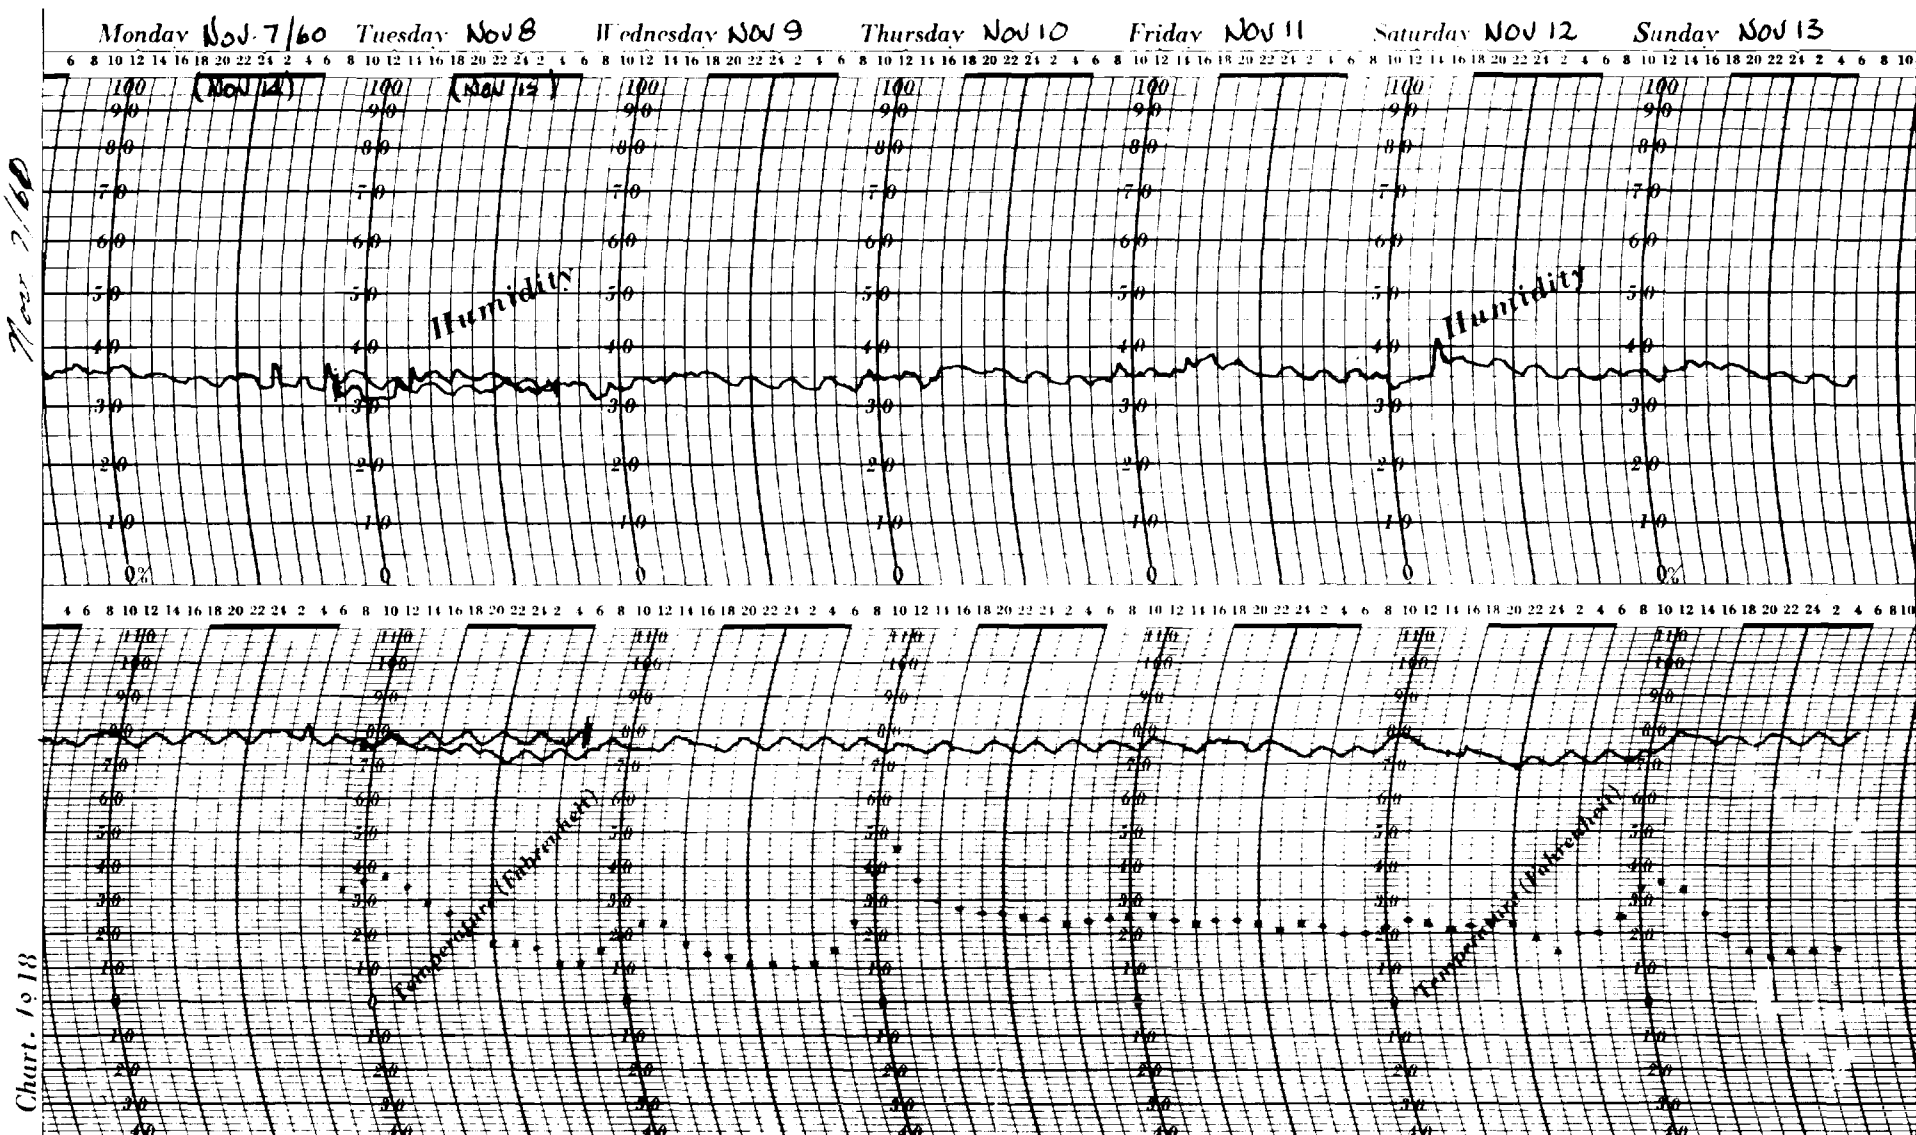
The most significant feature of the records shown in Figs. 11 and 12 is in relation to the frequency of the temperature control cycle. In most houses with basements, with conventional forced warm air, gas fired systems, the "on" and "off" cycle of the furnace, as exemplified by the temperature variation, involves a period of from 20 to 40 minutes, whereas a period of from 3 to 4 hours for each cycle may be noted for the Research House. This is the type of performance that has been noted in a house with a gravity hot water system in Saskatoon and indicates the effect of high heat storage capacity. In the house with hot water heating this is due to the mass of the system and water, whereas in the Mark II House it may be due to the thermal capacity of the concrete slab and floor system. This is not necessarily a disadvantage of the system and it may be observed that the amplitude of temperature variation of approximately $\pm 2^{\circ}\text{F}$ is similar to that obtained in conventional houses even with a shorter cycle.

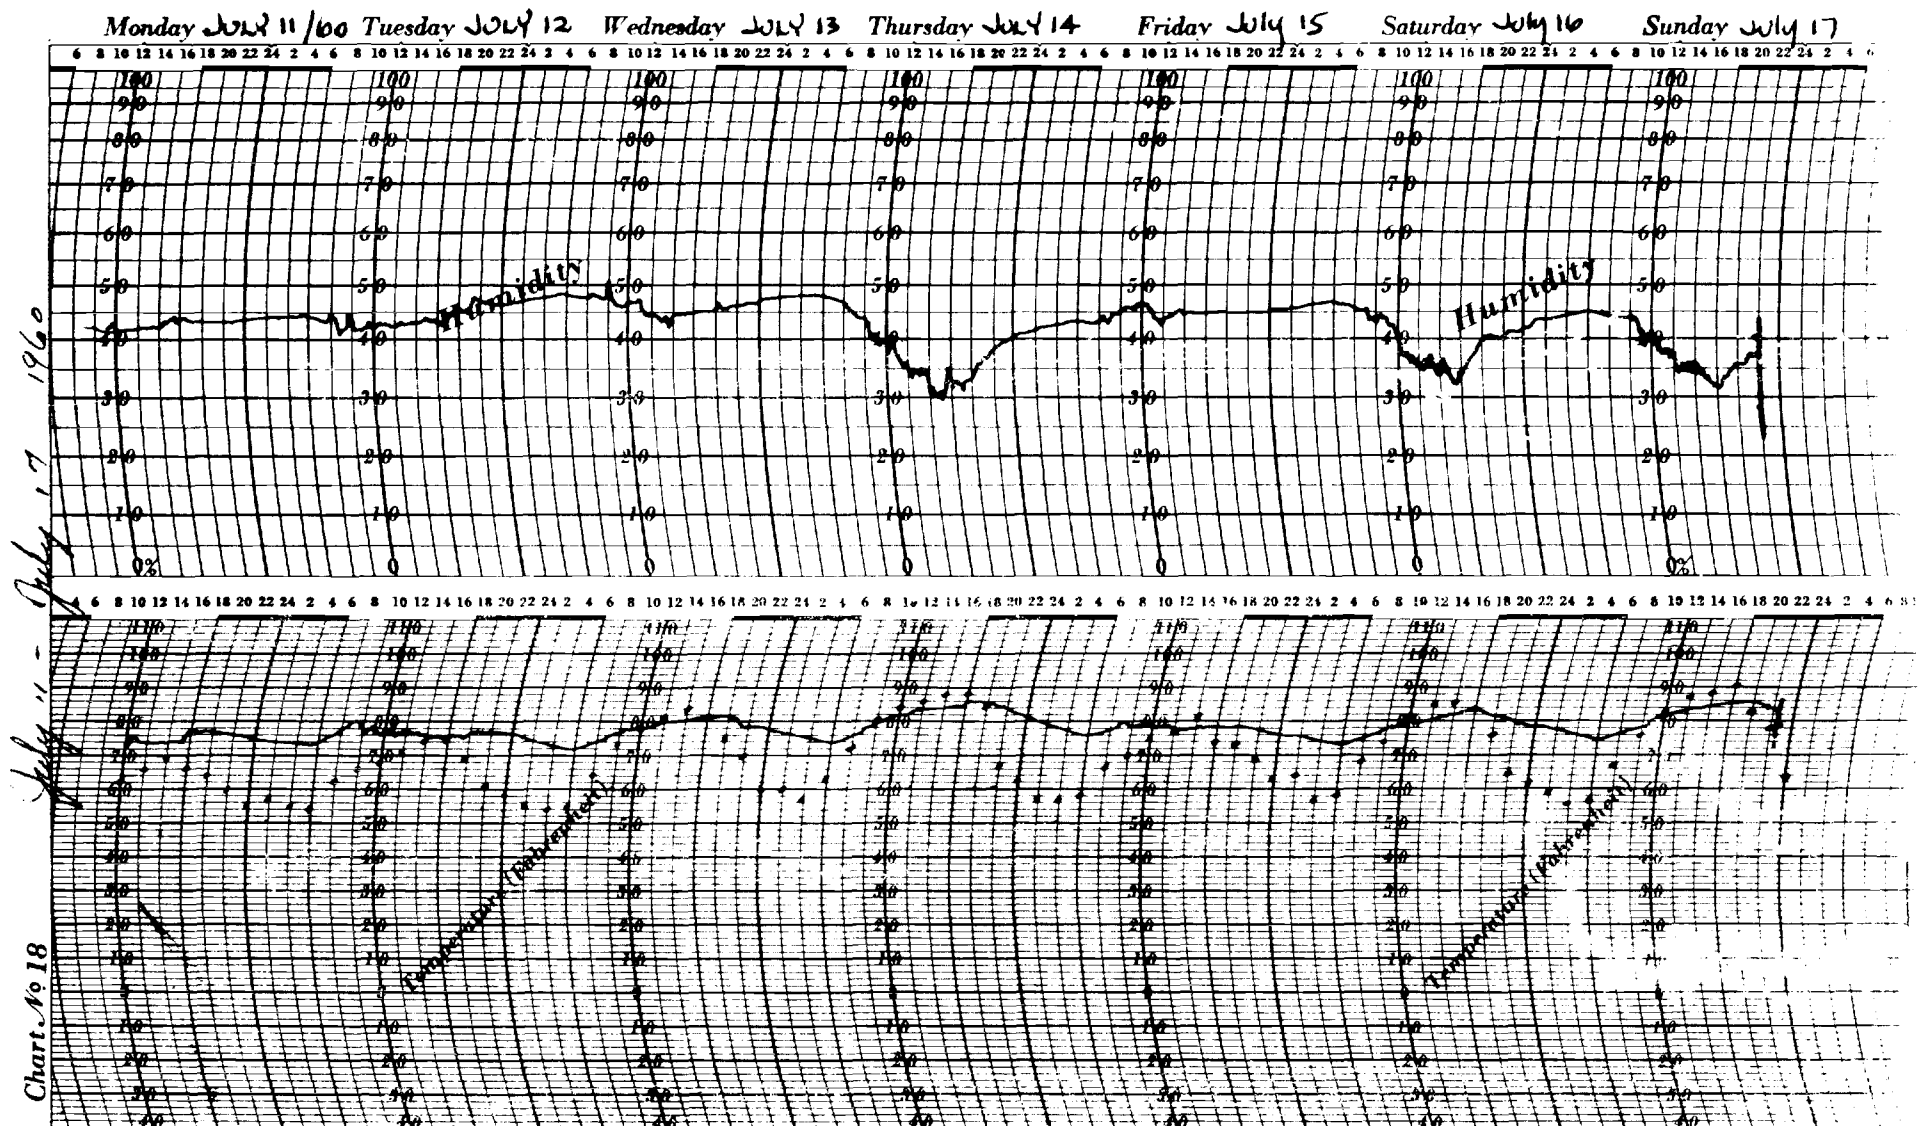
A reproduction of the record of interior temperature and humidity during one of the warmest outside conditions is shown in Fig. 13, together with the average hourly outside temperature. This record suggests that the procedure followed by the occupants resulted in satisfactory conditions being maintained although it is difficult to draw any specific conclusions regarding the inherent merit of the system without comparison with other conventional houses under the same weather conditions. The occupant thought that the conditions were superior to those in other houses of his experience.

Figure 13 Thermohygrograph records, 11 to 17 July 1960 -- Mark II House. Dotted curve in lower chart indicates outdoor temperature.
