TESTS FOR DURABILITY OF TERRAZZO FLOORING

P.J. Seređa and H.F. Slade

Report No. 87
of the
Division of Building Research

Ottawa
June 1956

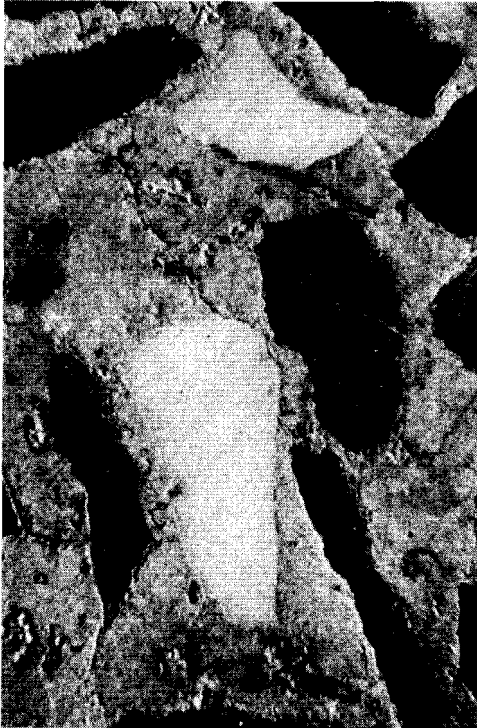
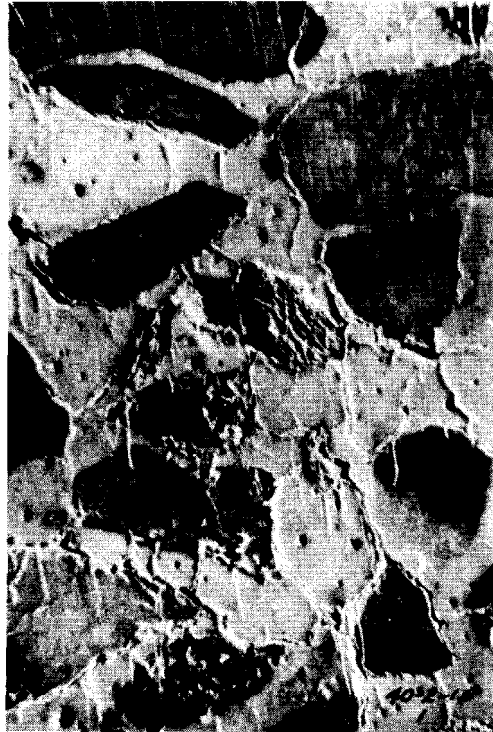
Fig. 3 Portland cement terrazzo (sample No. 1)

Figures 3 to 20 reveal various stages of deterioration of surfaces with repeated cycling in the machine described. It may be noted that those samples having a coarse matrix structure showed much more deterioration than those having a dense, well polished surface.

Before test
(mag. x 6)

After 4500 cycles
(mag. x 4)

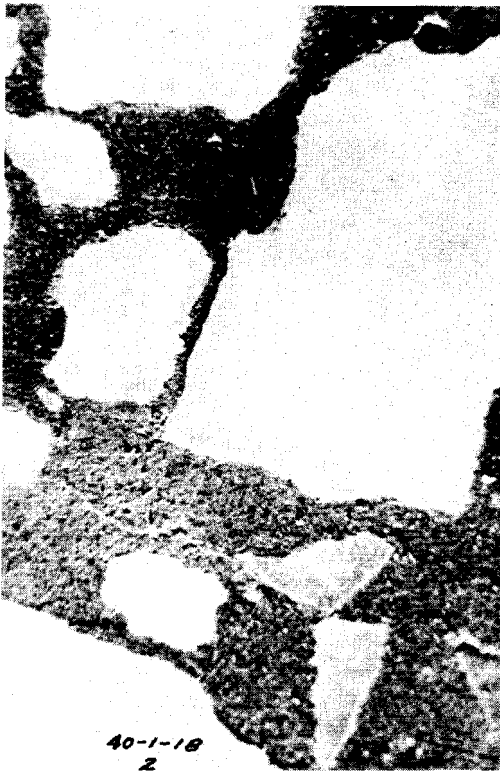
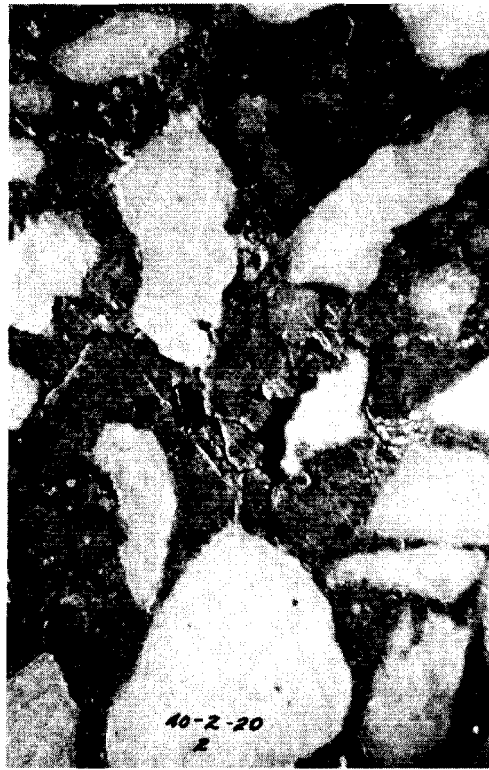
Fig. 4 Terrazzo with 20% copper
concentrate from Noranda (sample No. 2)

Before test
(mag. x 6)

After 4500 cycles
(mag. x 4)

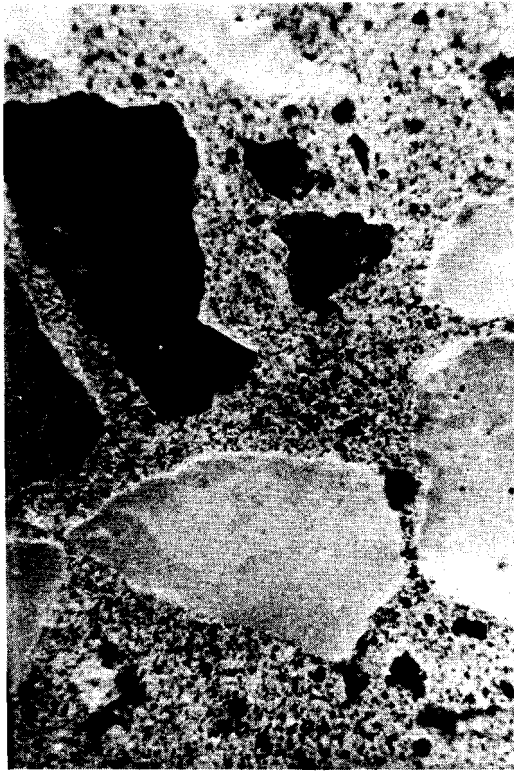
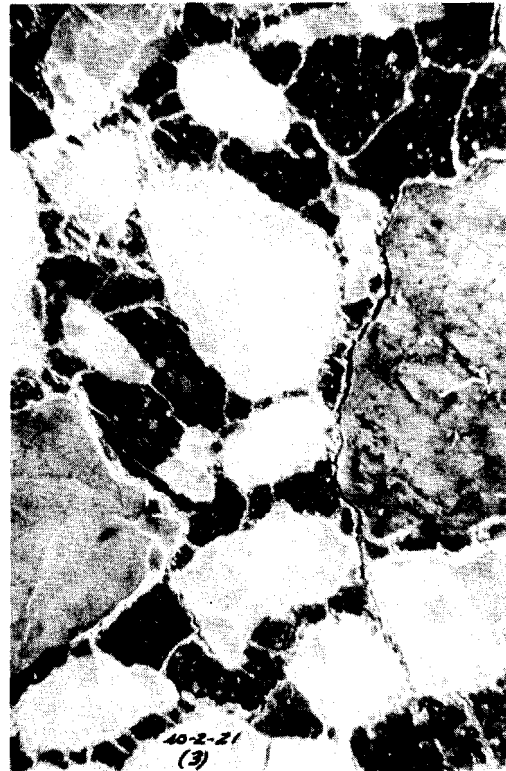
Fig. 5 Terrazzo with 20%
Noranda pyrite (sample No. 3)

Before test
(mag. x 6)

After 4500 cycles
(mag. x 4)

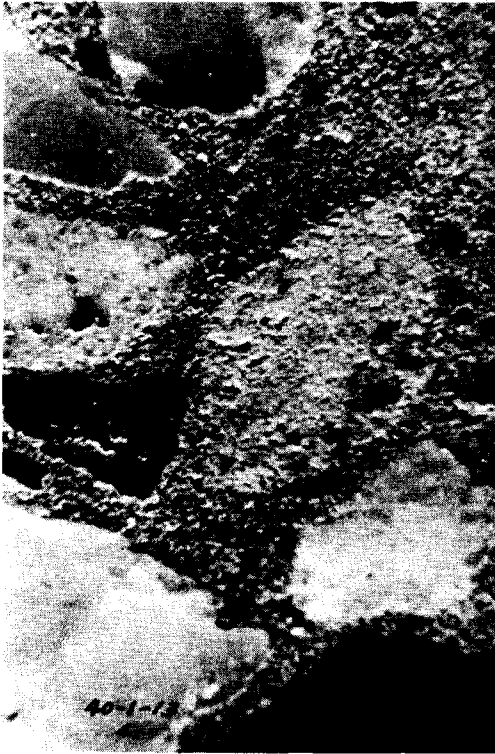
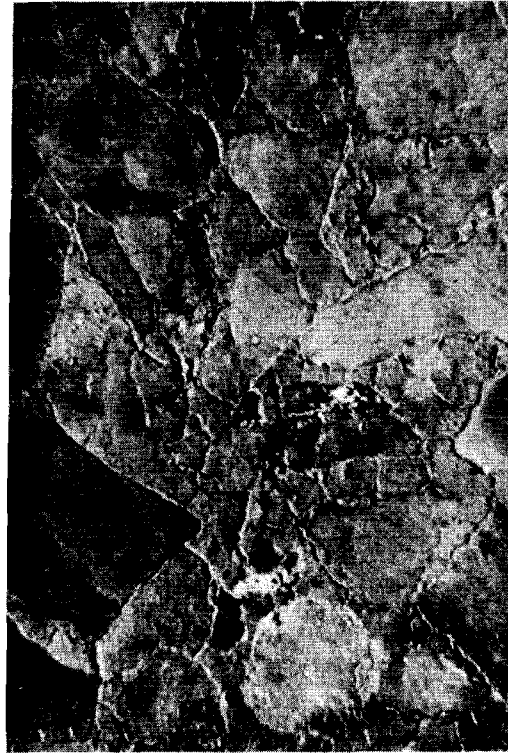
Fig. 6 Terrazzo with white cement
and 2.5% copper powder (V54345) and 2.5%
bronze filings (sample No. 4)

Before test
(mag. x 6)

After 4500 cycles
(mag. x 4)

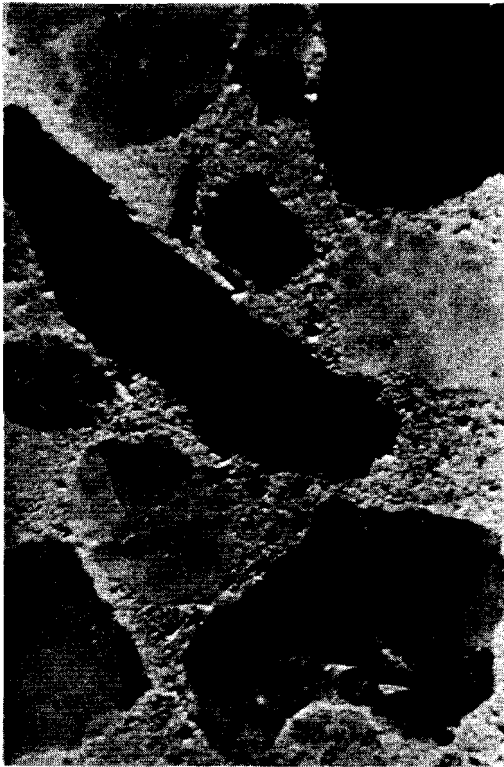
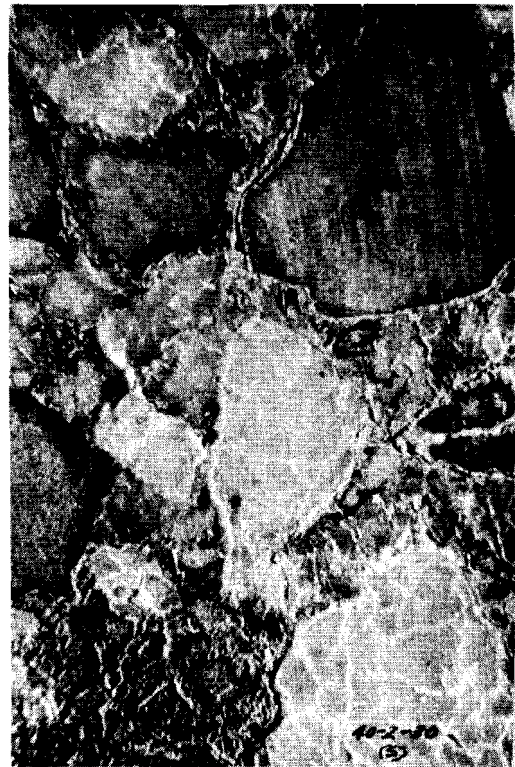
Fig. 7 Terrazzo with white cement
and 10% bronze filings (sample No. 5)

Before test
(mag. x 6)

After 4500 cycles
(mag. x 4)

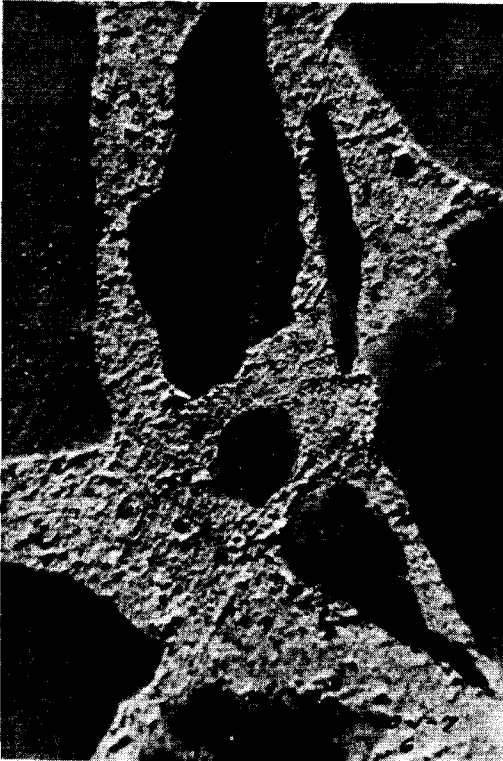
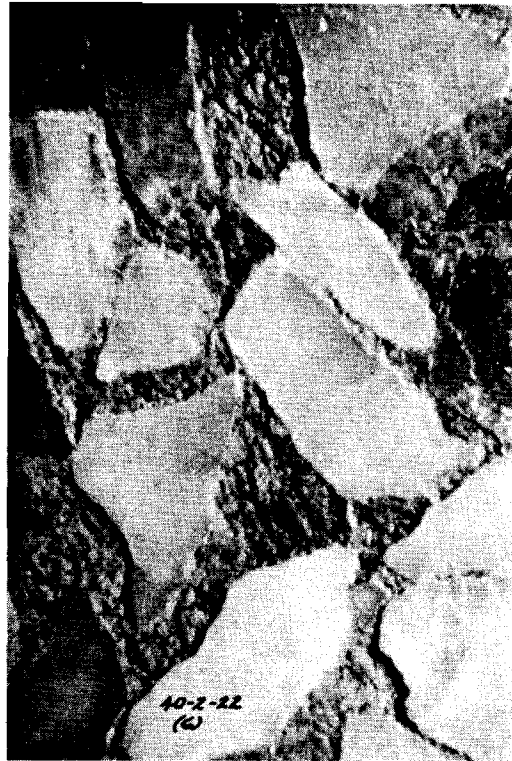
Fig. 8 Terrazzo with white cement and
20% copper powder (V54345) (sample No. 6)

Before test
(mag. x 6)

After 4500 cycles
(mag. x 4)

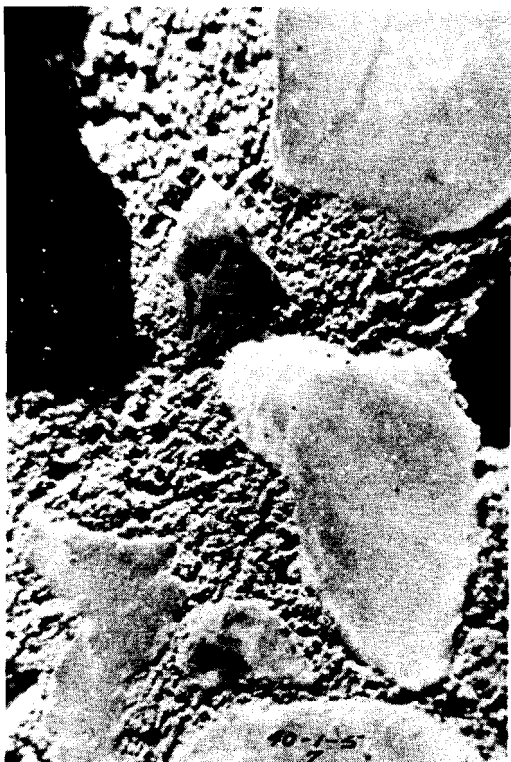
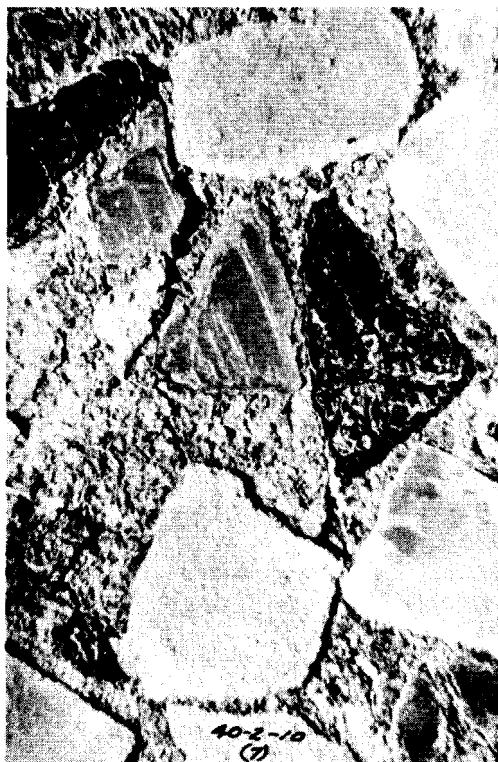
Fig. 9 Terrazzo with 2%
acetylene black (sample No. 7)

There appears to be some correlation between the moisture content change between wet and dry cycles and rate of deterioration. This is what would be expected. Samples with 2 per cent acetylene black appeared to undergo the highest moisture content change per cycle and they deteriorated the most.

Before test
(mag. x 6)

After 4500 cycles
(mag. x 4)

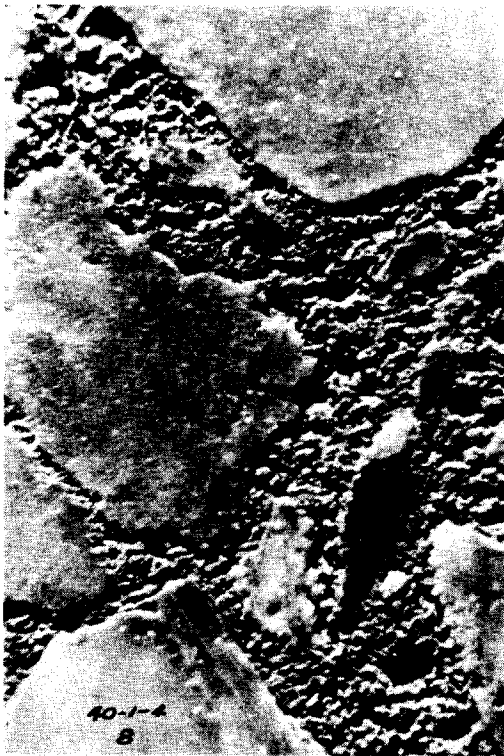
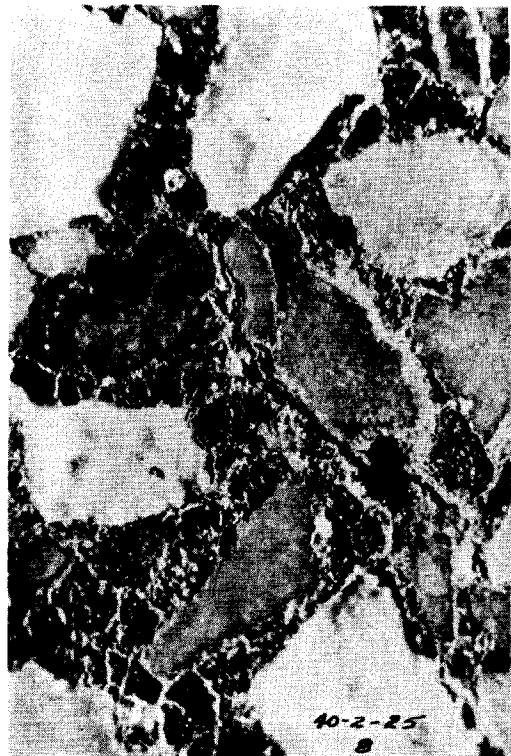
Fig. 10 Terrazzo with white cement, green pigment, and 2% acetylene black (sample No. 8)

Before test
(mag. x 6)

After 4500 cycles
(mag. x 4)

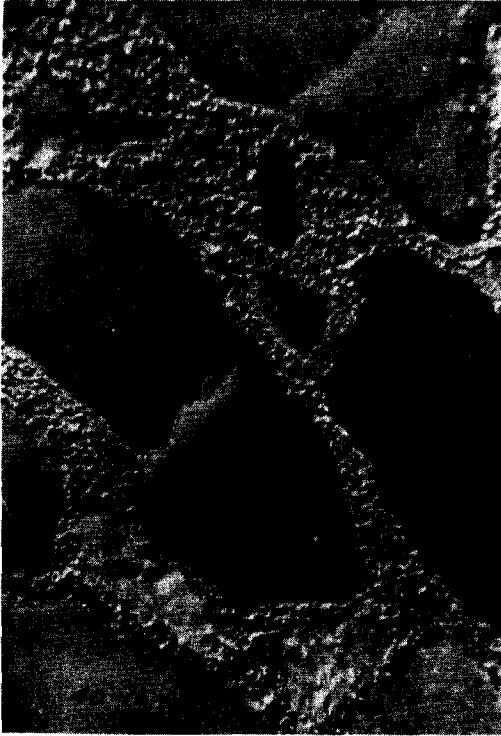
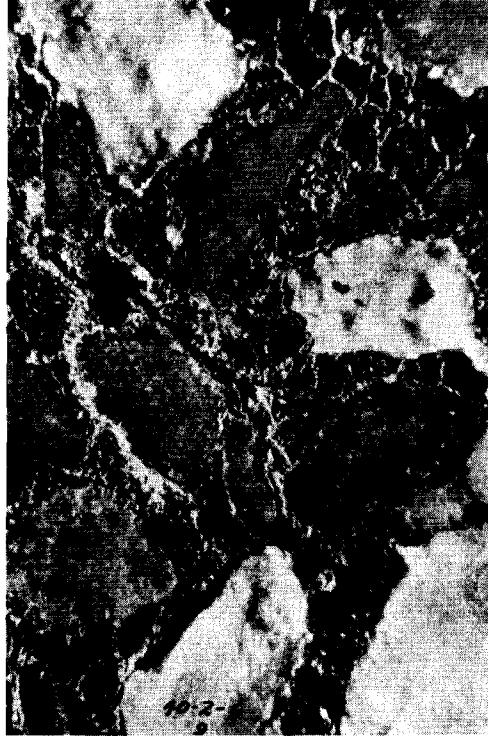
Fig. 11 Terrazzo with white cement
and 2% acetylene black (sample No. 9)

Before test
(mag. x 6)

After 4500 cycles
(mag. x 4)

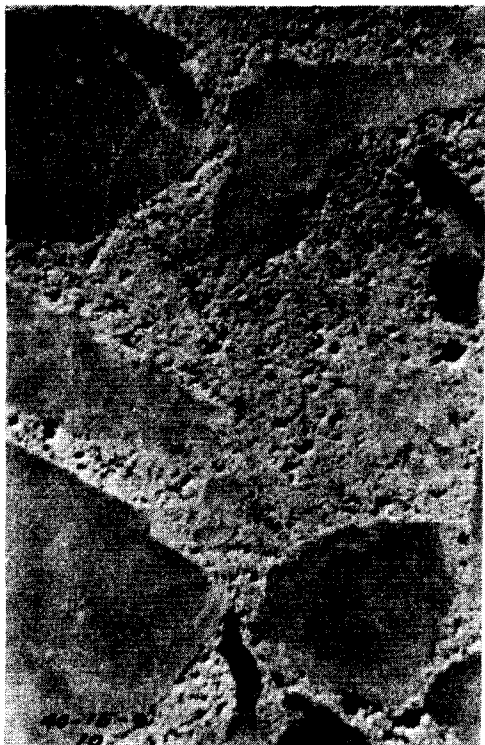
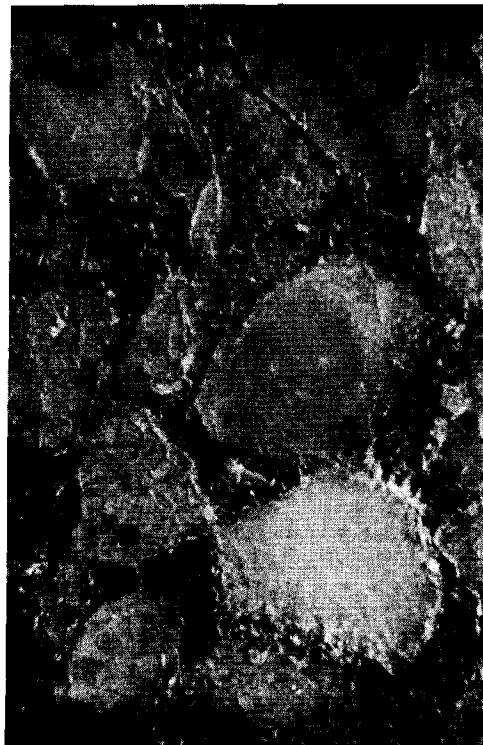
Fig. 12 Terrazzo with white cement and
10% copper powder (V54345) (sample No. 10)

Before test
(mag. x 6)

After 4500 cycles
(mag. x 4)

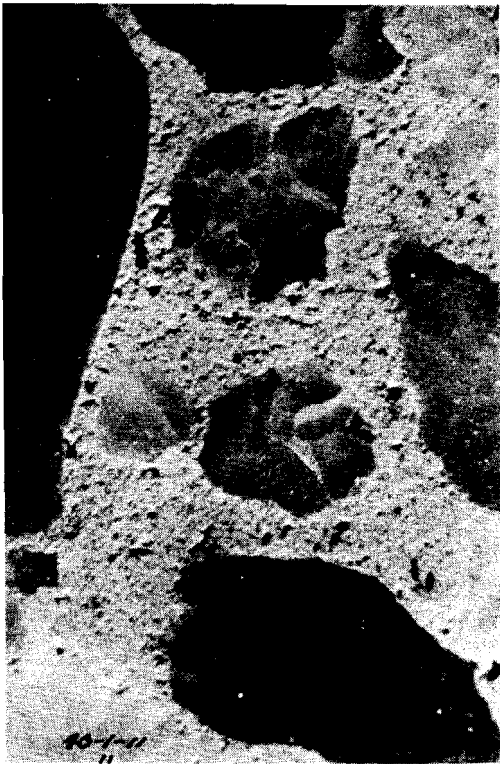
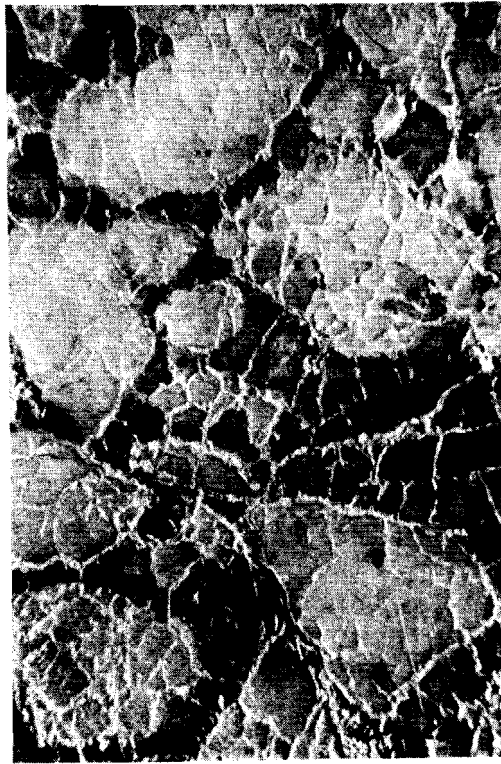
Fig. 13 Terrazzo with white cement
and 5% copper powder (V54345) and 5% bronze
fillings (sample No. 11)

Before test
(mag. x 6)

After 4500 cycles
(mag. x 4)

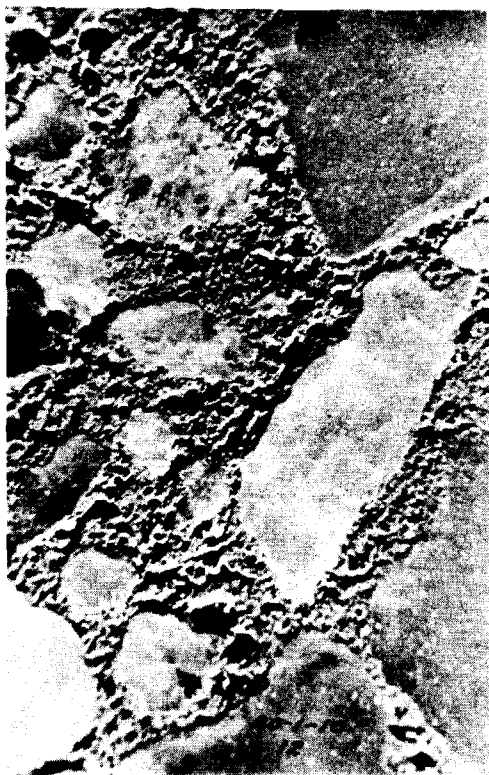
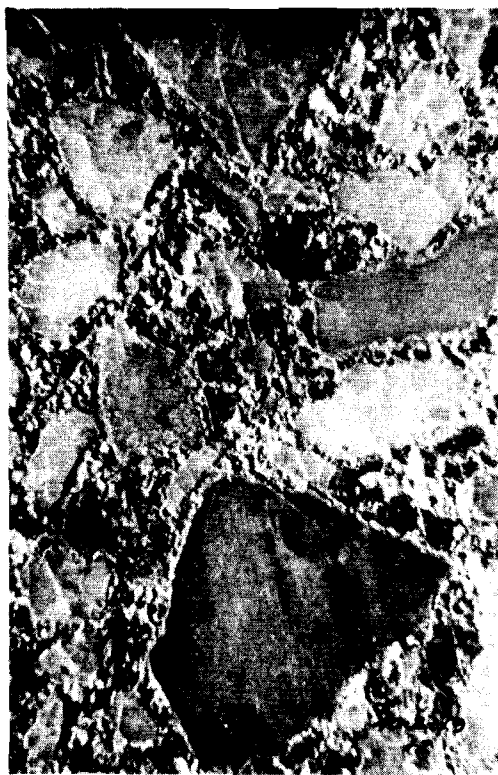
Fig. 14 Terrazzo with white cement
and yellow pigment and 2% acetylene
black (sample No. 12)

Before test
(mag. x 6)

After 4500 cycles
(mag. x 4)

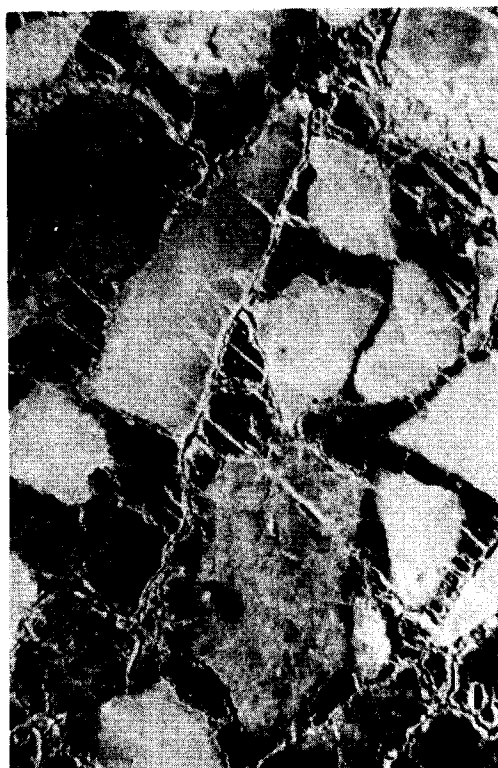
Fig. 15 Terrazzo with 20% Noranda
smelter calcine (sample No. 13)

Before test
(mag. x 6)

After 4500 cycles
(mag. x 4)

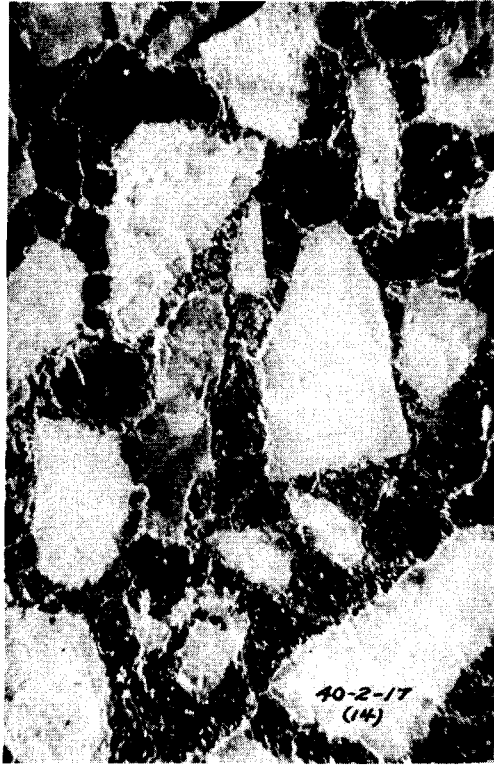
Fig. 16 Terrazzo with 2% acetylene black
(after 4500 cycles, mag. x 4) (sample No. 14)

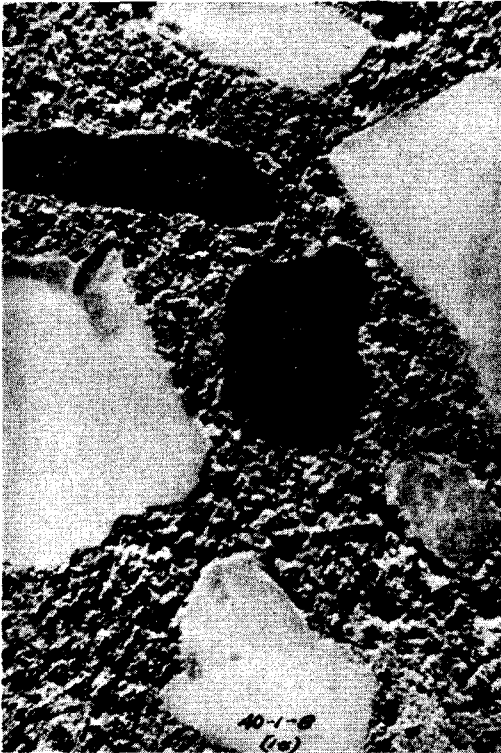
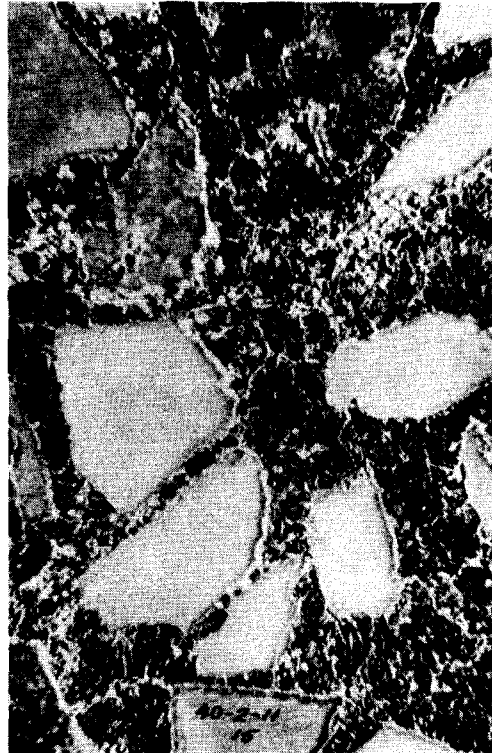
Fig. 17 Terrazzo with 25%
steel filings (sample No. 15)

Before test
(mag. x 6)

After 4500 cycles
(mag. x 4)

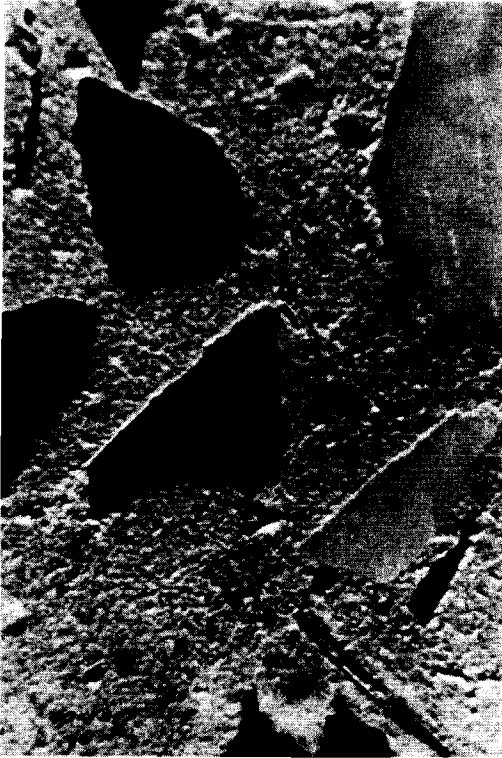
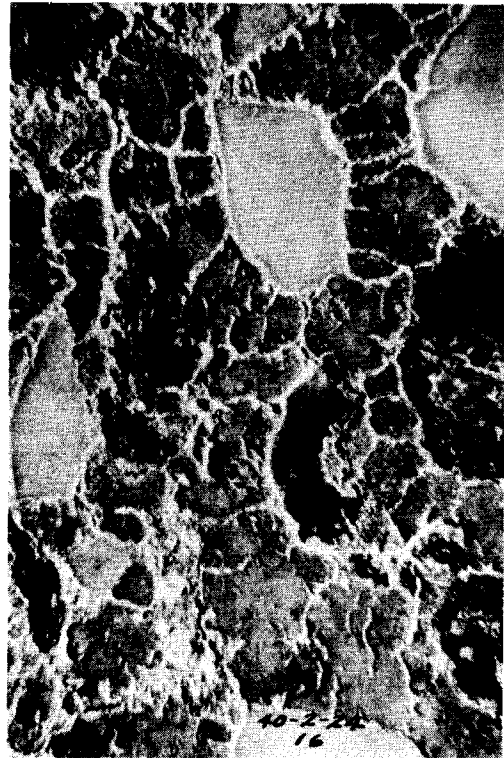
Fig. 18 Terrazzo with 10%
bronze filings (sample No. 16)

Before test
(mag. x 6)

After 4500 cycles
(mag. x 4)

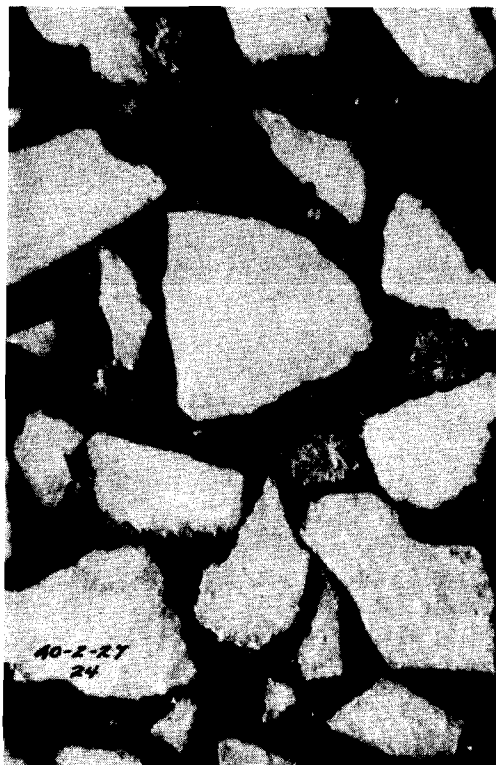
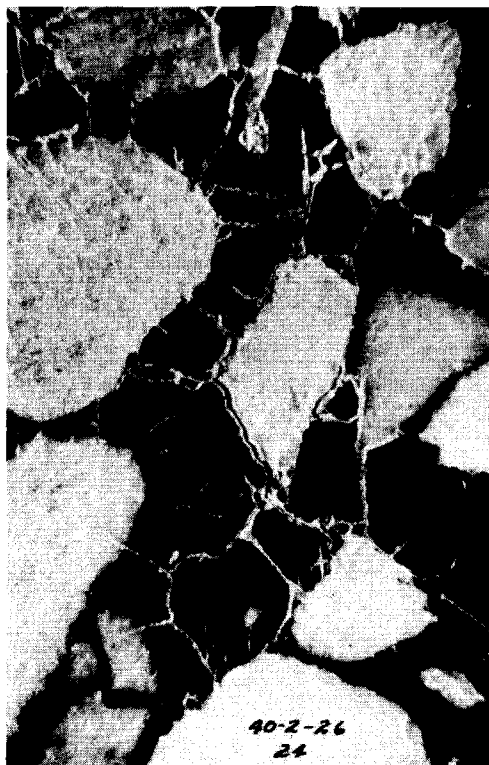
Fig. 19 Terrazzo with 2% acetylene black
removed from a sample floor at Neurological
Institute, Montreal (sample No. 24)

Before test
(mag. x 4)

After 2950 cycles
(mag. x 4)

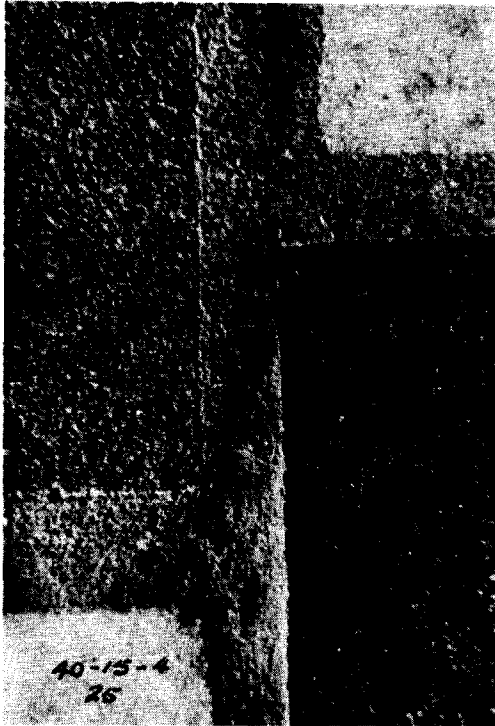
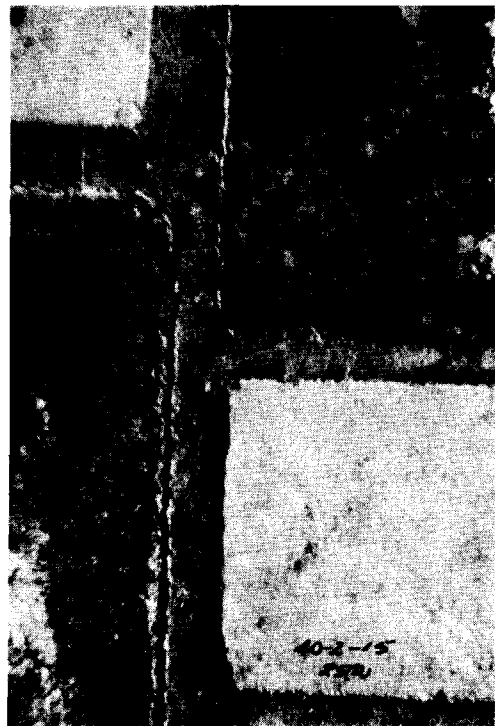
Fig. 20 Ceramic conductive tile (sample No. 25)

Before test
(mag. x 6)

After 4500 cycles
(mag. x 4)
