Penetration of fire separations by plastic pipe: 2nd progress report Attwood, P. C.

PENETRATION OF FIRE SEPARATIONS BY PLASTIC PIPE

(2nd Progress Report)

DBR INTERNAL REPORT NO. 452

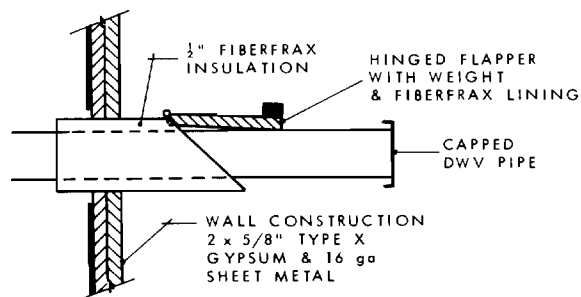
Figure 2
Hinged Flapper Assembly
Series No. 4, Test No. 4

The flapper device used in test No. 4 (see Figure 2) failed in 30 minutes with ABS pipe. The sleeved part of the device had been insulated, as had the flapper itself to reduce heat conduction and radiation. An imperfect seal between the flapper and the sleeve allowed hot gases to eventually leak through the device, however.

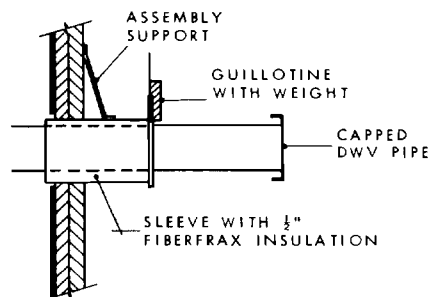
Figure 3
Simple Guillotine Assembly
Series No. 4, Test No. 5

A similar situation existed with the simple guillotine device used in test No. 5 (see Figure 3). In this test, the assembly seemed stable until failure occurred abruptly at 1 hr 55 min. The considerably longer resistance of this assembly was attributed to two characteristics of PVC, those being the formation of a carboniferous char and the blistering of the metal components caused by the acidic products of combustion from PVC. The intumescent nature of PVC along with the formation of an ash plug protected the unexposed side of the assembly from any hot gas leaks. Continued exposure of the ash to heat causes the plug to become brittle and porous; by this time, however, the metal surfaces had blistered and sealed all openings. A leak eventually caused the pipe to ignite on the unexposed side of the structure. Examination of the assembly after the tests showed that the guillotine blade had warped because of the weight attached to it, causing an opening to develop at the top. In constructing this assembly care had been taken to ensure that while the blade channels allowed free movement of the guillotine, it was not loose. This construction constraint was applied to all mechanical devices used in this program.

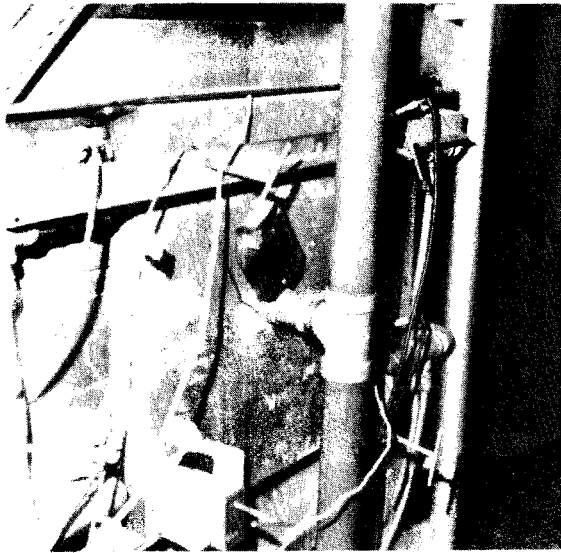
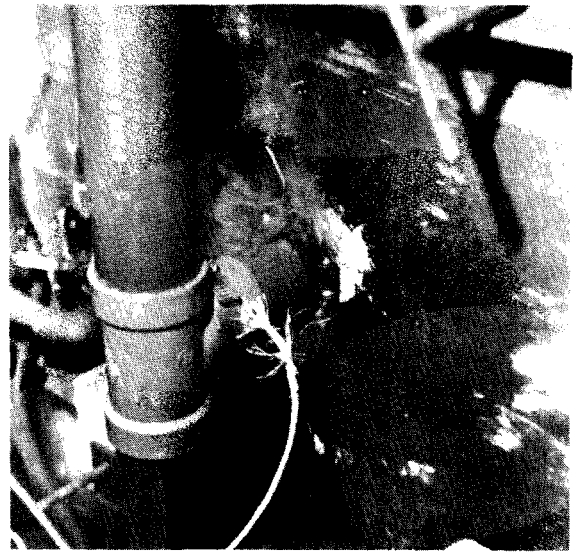
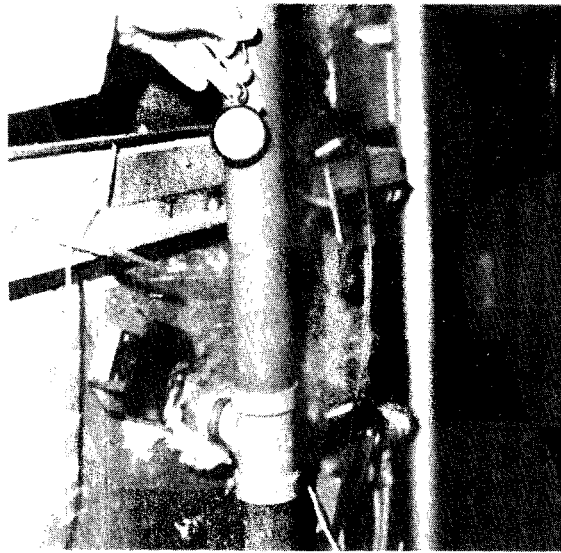
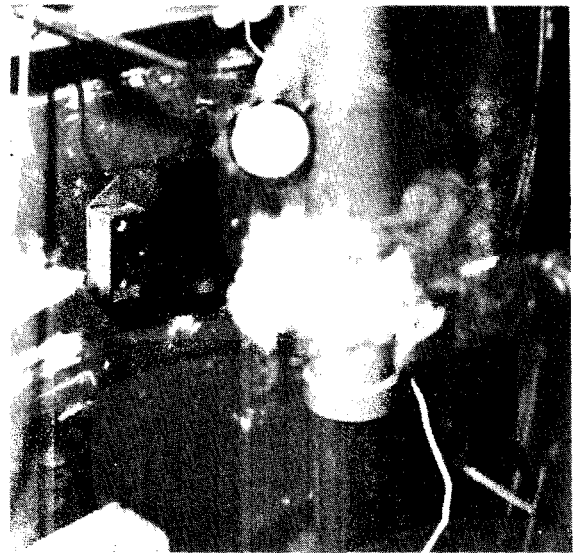
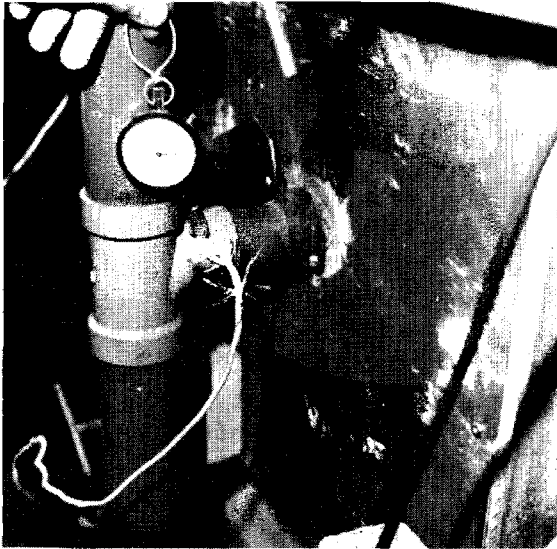
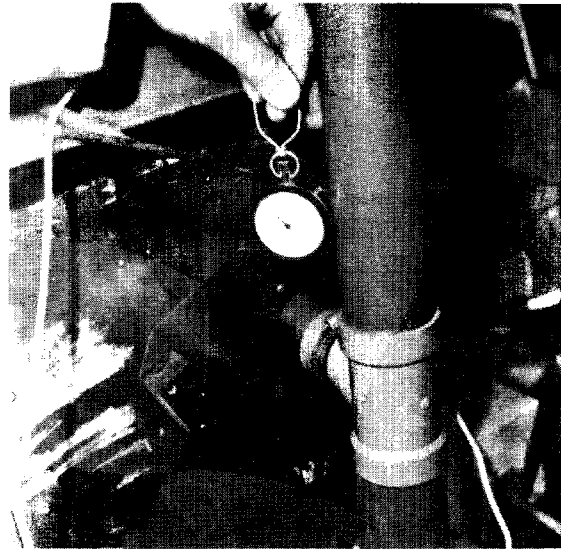
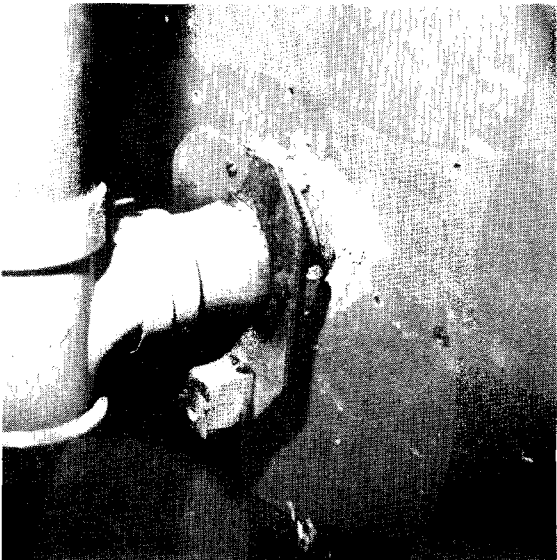
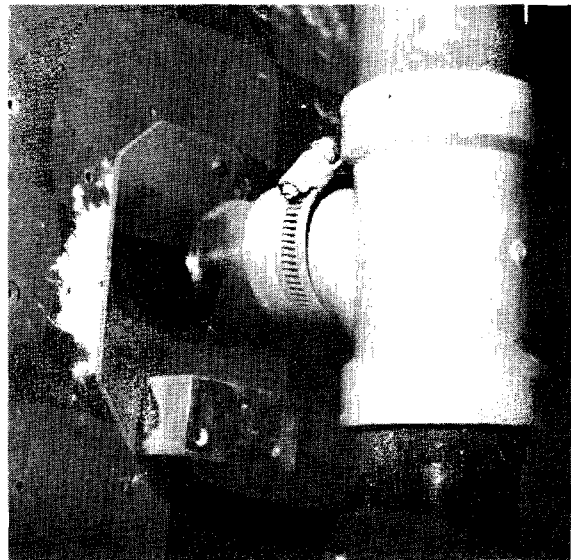
Figure 6
Time Progression of Swivel Flapper. Unexposed Side.

1. The increasing furnace temperature on the exposed side caused the pipe on the exposed side of the wall to soften, thus allowing the first swivel flapper to close and form an initial seal.
2. The temperature within the sleeve increased due to heat conduction and radiation. At the elevated temperature, the plastic pipe within the sleeve softened and allowed the flapper on the unexposed end to start to close.
3. Smoke and fumes from the disintegration of pipe within the sleeve vented through the attached plumbing stack.
4. Eventually, the plastic at the unexposed end of the sleeve softened sufficiently to allow the flapper at that end to close.

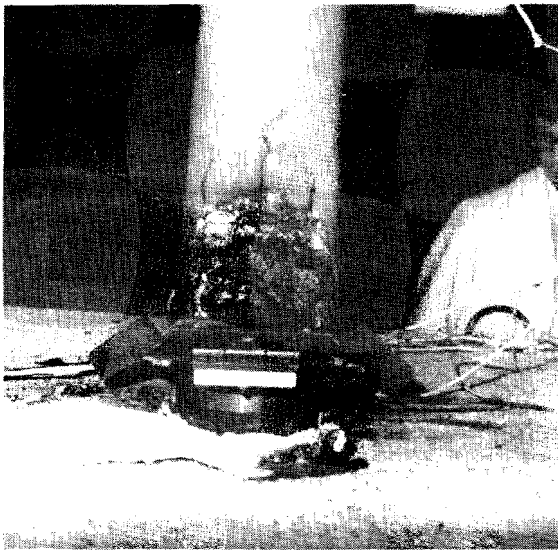
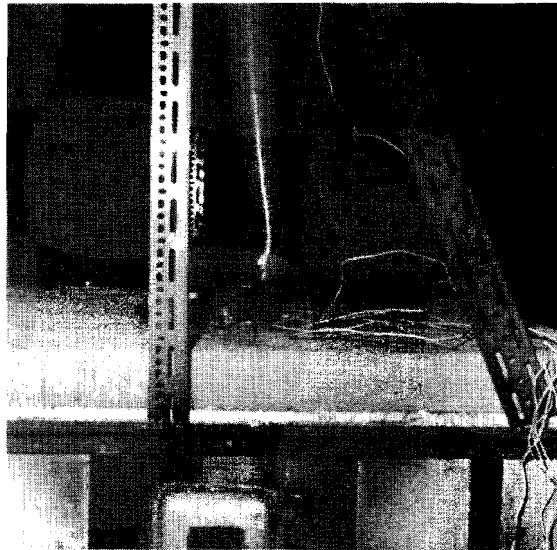
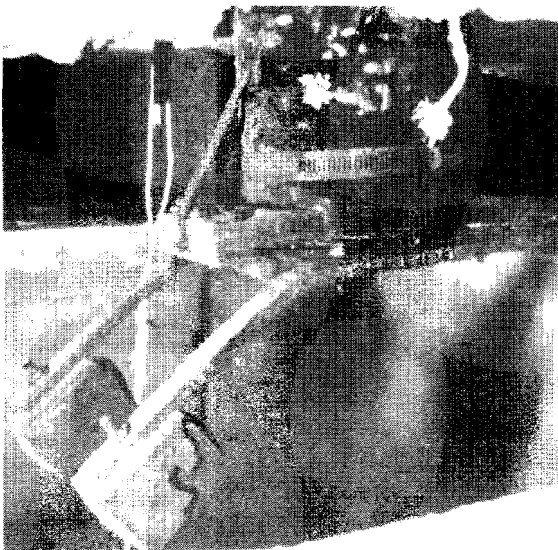
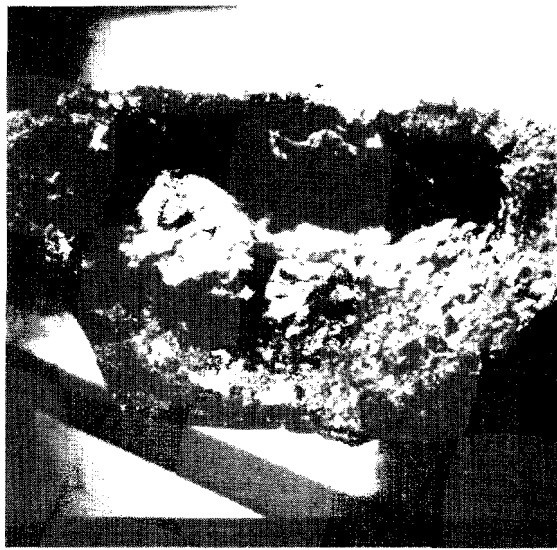
Apparatus and Pipe After Test

This test was repeated in test No. 5 using 4-in. PVC pipe but with two modifications: 1) the assembly was properly anchored to the concrete slab, and 2) the 1/8-in. carbon steel flapper on the exposed side was replaced with 1/8-in. inconel plate. In this test, the bottom flapper completely closed within approximately 21 minutes. Heat transfer caused the pipe in the sleeve and just above to disintegrate first to the typical carboniferous ash, and finally to disappear completely. This took approximately 62 minutes, at which time the top flapper closed completely. The test was terminated after 2 hours. Post test inspection showed that again warpage had occurred in the exposed flapper - this time in the hinge - causing a slight opening to form in the seal. The photographs in Figure 10 show the apparatus and pipe after the test.

Back View - Top of Flapper Assembly
After Test B-5

Side View - Test B-5

View of Exposed Portion -
After Test B-5

Carboniferous PVC Ash Formed Above
Top Flapper

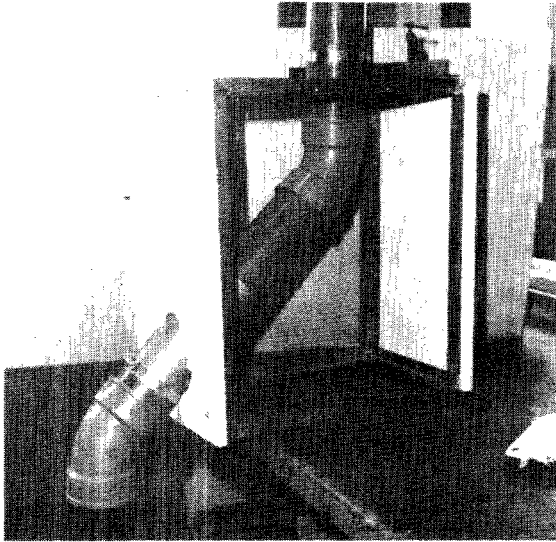
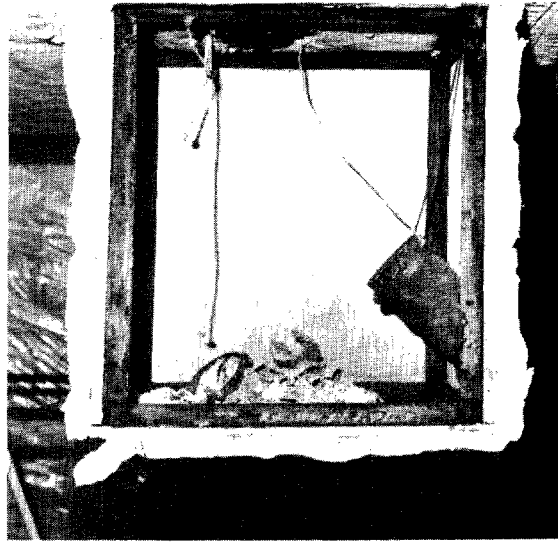
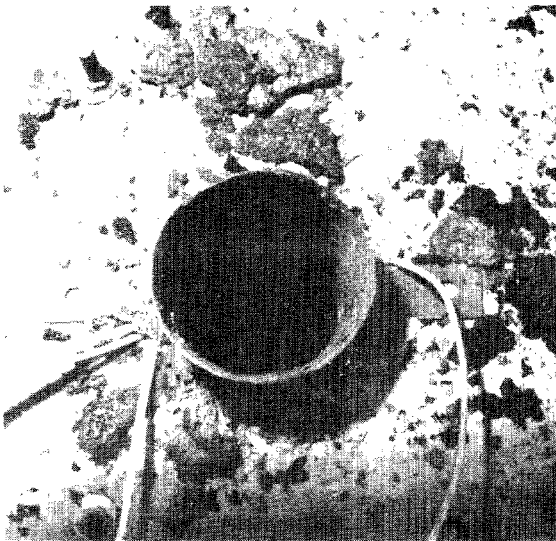
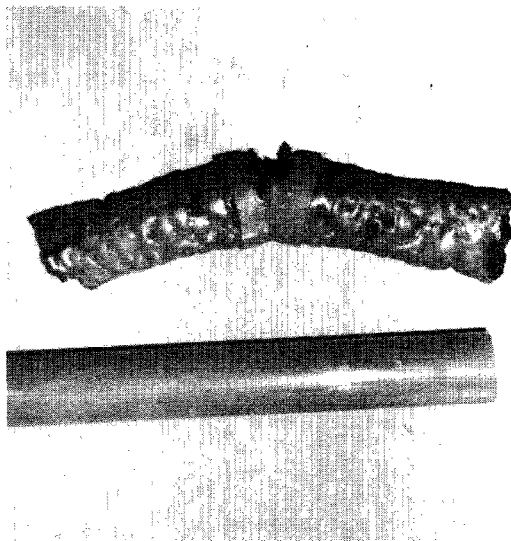
Vertical Test B-6

Figure 12, photographs (b) through (d) show the condition of the sleeves, the compartment, and the collapsed pipe after the test. It is noted that only a small amount of ash remained in the compartment.

Compartment After Test -
Front Panel Removed

Sleeve Through Concrete Floor
Viewed From Above After Test

Section of Collapsed Pipe After Test
Compared to Original Pipe (3" PVC)

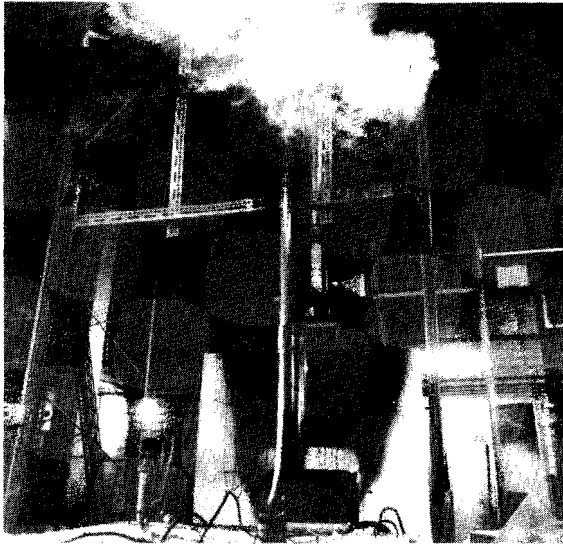
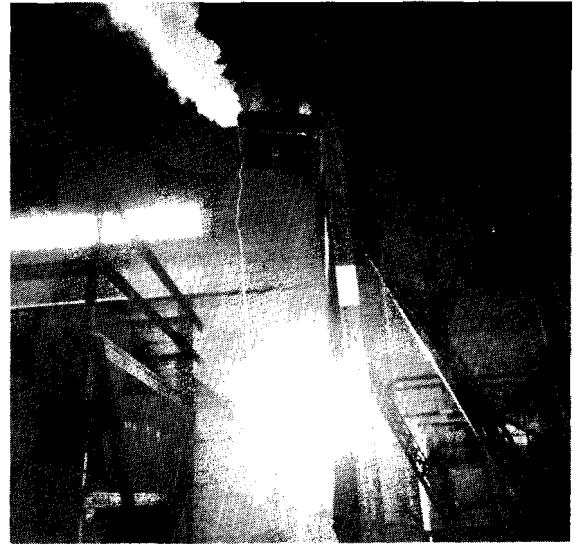
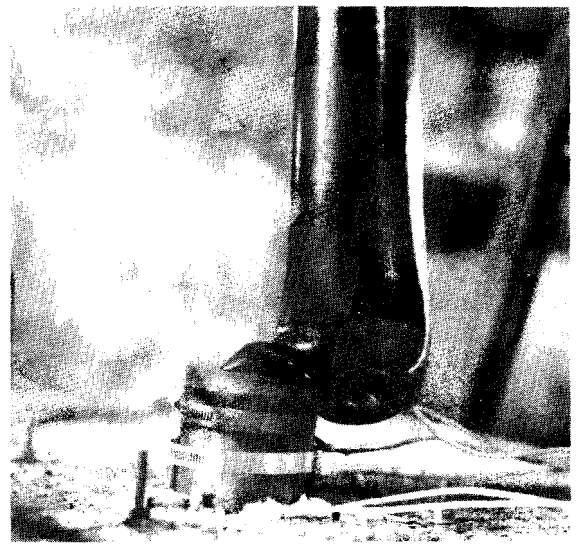
Vertical Test B-7

Test No. 7 utilized the same assembly with 3-in. ABS pipe. However, in the test assembly, the stack extended approximately 18-in. above the uppermost clamp. When the exposed end of the pipe burned and hot gases started to flow through the stack, the ABS softened. The pipe started to sag around the top of the sleeve, but the 18-in. section above the clamp folded over, creating a seal and shutting off the flow of gases. This is unrealistic, as one would not expect this to happen in a proper installation. With this seal formed, however, a hole did not appear in the pipe at the edge of the sleeve until approximately 55 to 60 minutes. Photographs in Figure 14 illustrate this test.

Smoke From Stack Early in Test
Pipe is Starting to Sag

Pipe Folding Over Creating a Seal

Hole Forming at Top of Sleeve
After Approximately 1 hr

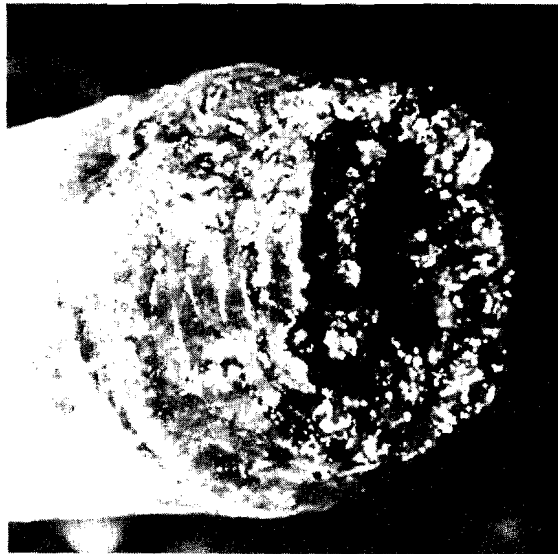
Figure 18
Residual Ash - 2" PVC
Non-Vented

Examination of the samples after the test revealed that in test No. 1 a carboniferous ash had formed a seal across the diameter of the pipe approximately 1 in. above the concrete. The ash was quite brittle and very thin in the middle. No signs of degradation were evident more than 3 in. above the concrete. Figure 18 shows the ash after the sleeve had been removed.
