**NRCC-54572**

A version of this document is published in 5th International Conference on Structural Health Monitoring of Intelligent Infrastructure (SHMII-5), Cancun, Mexico, December 11-15, 2011

# **Field monitoring of reinforced concrete bridge barriers reinforced with GFRP and steel bars**

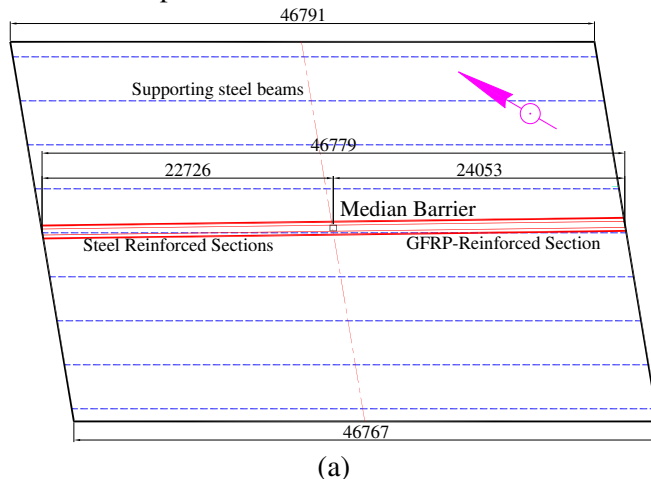
Figure 1. Layout of the project: (a) Hwy 410 overpass bridge; (b) Median barrier cross-section (Dimensions in mm)

The median barrier considered in this investigation was part of the Hwy 410 overpass bridge going over Boulevard de l'Université in the municipality of Sherbrooke (Canada), and was built in June 2010. The six-lane bridge was built as part of the extension of Highway 410 in Sherbrooke. It was constructed using typical slab-on-girder structural system with a total length of about 47.0 m. The median barrier was of Type MTQ 202ME and was cast using a ready-mix high-performance concrete of Type MTQ XIII (50 MPa). Figure 1 shows the general layout of the bridge (plan view), and the cross-section geometry of the median barrier. In order to study the behaviour of different reinforcement type and rate the barrier has been divided into two principal sections. The first section (S1 to S10 in Figure 2) was reinforced with 14 longitudinal GFRP bars No. 15 designated according to CAN/CSA S807-10 (2010). The second section itself is divided into two sub-sections reinforced with 15M galvanized steel bars. The first sub-section (S10 to S15 in Figure 2) was reinforced with a total of 8 steel bars 15M while the second one (S16 to S20 in Figure 2) was reinforced with a total of 12 steel bars 15M. Figure 2 shows the cross-sections of the median barrier as well as the locations of the longitudinal instrumented bars.

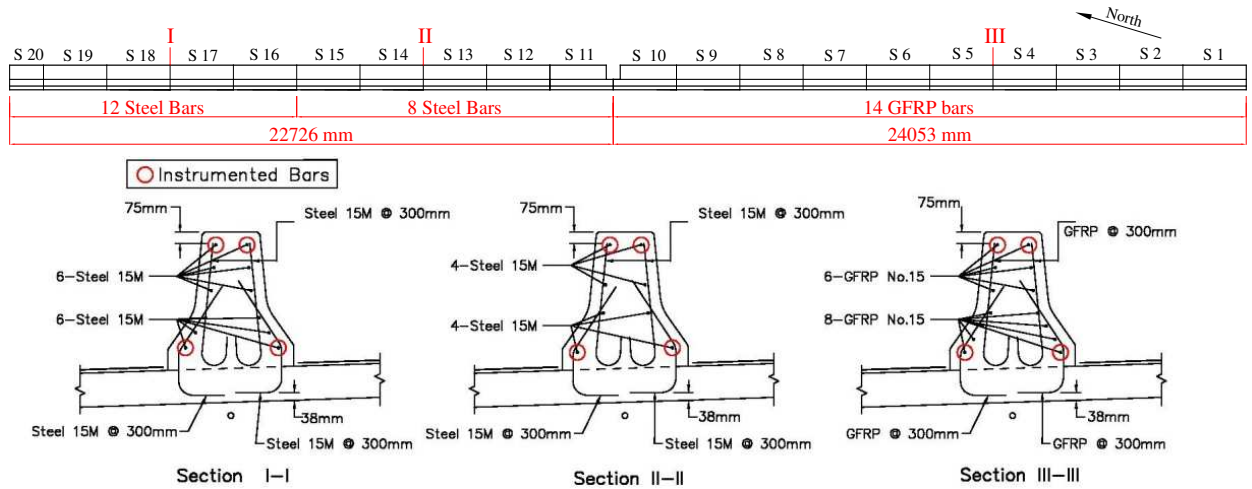
Figure 2. Reinforcement details of the median barrier

The MTQ is currently using two standard designs for the GFRP and steel-reinforced barriers of Type MTQ 202ME. Both of them have the same transverse reinforcement amount of GFRP or steel bars (15M@300 mm). However, the steel-reinforced barrier contains 8 steel bars (15M) as longitudinal reinforcement and the GFRP-reinforced barrier contains 14 GFRP bars (No. 15) as longitudinal reinforcement. As the longitudinal reinforcement plays the main role in controlling restrained shrinkage and consequently transverse cracking in the barrier walls, the MTQ aims at investigating the optimum design of the barrier wall and determining the horizontal

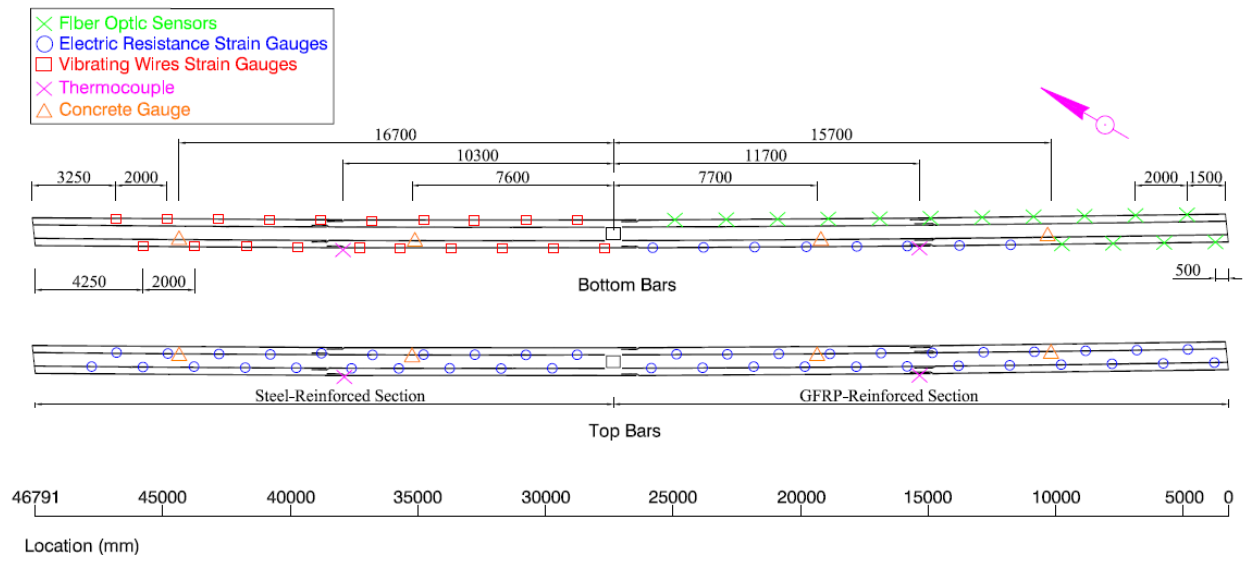
Figure 3. Instrumentation layout of the median barrier (plan view)

Since the main objective was to investigate and monitor the shrinkage and cracking behavior of the median barrier of Type MTQ 202ME, A set of sensors as well as appropriate readout units were selected to monitor the performance of the barrier (GFRP- and steel-reinforced sections). The instrumentations included a total of 15 fibre optic sensors (FOS) attached to the GFRP reinforcing bars; 20 vibrating wire strain gauges of type SM2 (VWSG) attached to the steel bars; 8 vibrating wire strain gauges of type EM5 (VWSG) embedded in the concrete; 4 thermometers (TH-T); and 51 electrical resistance strain gauges (ESG) attached to both GFRP and steel bars. Figure 2 shows the location of the instrumented bars while the locations of the different sensors that were attached to the top and the bottom reinforcing bars (steel and GFRP) are shown in Figure 3. Figures 4 and 5 show the different sensors after being installed. The FOS, VWSG, and ESG were attached to four longitudinal bars (2 bottom bars and 2 top bars) to capture the strain variation along the depth of the barrier. The vibrating wire strain gauges for concrete were installed in the concrete at the level of the instrumented longitudinal bars. The thermometers were installed close to these reinforcing bars to determine the actual temperature surrounding the bars for temperature corrections of the strain data.

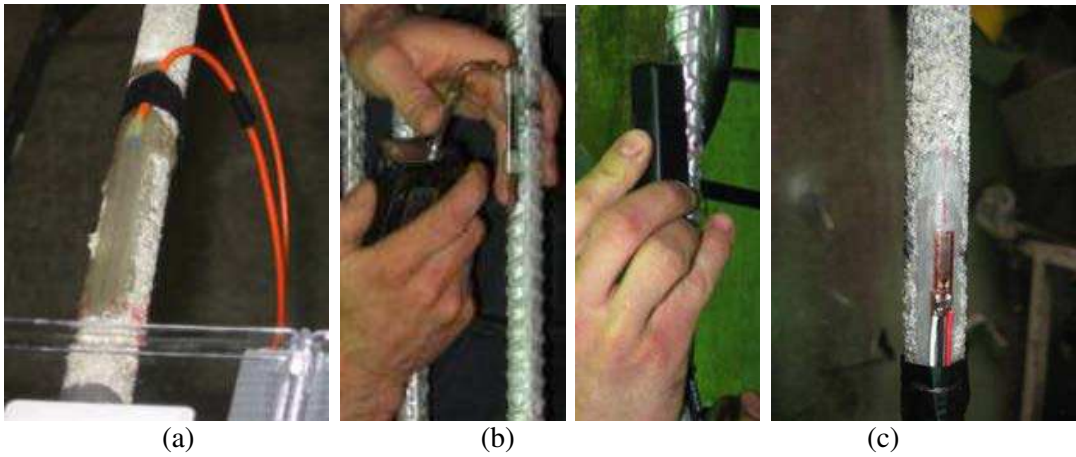
Figure 4. Instrumentation of the reinforcing bars: (a) Fiber optic sensors glued on GFRP bars; (b) VWWSG (SM2) welded on steel bars; (c) ESG glued on steel and GFRP bars

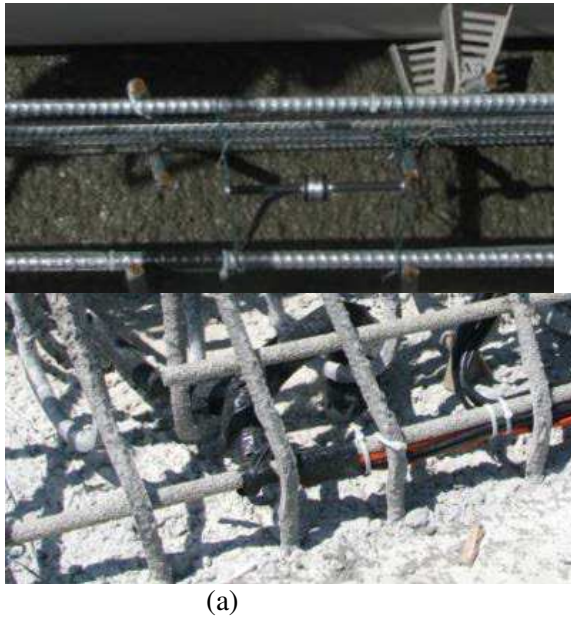
Figure 5. Instrumentation of the barrier: (a) VWSG (EM5) embedded in concrete; (b) Thermometers (TH-T) attached to the reinforcing bars

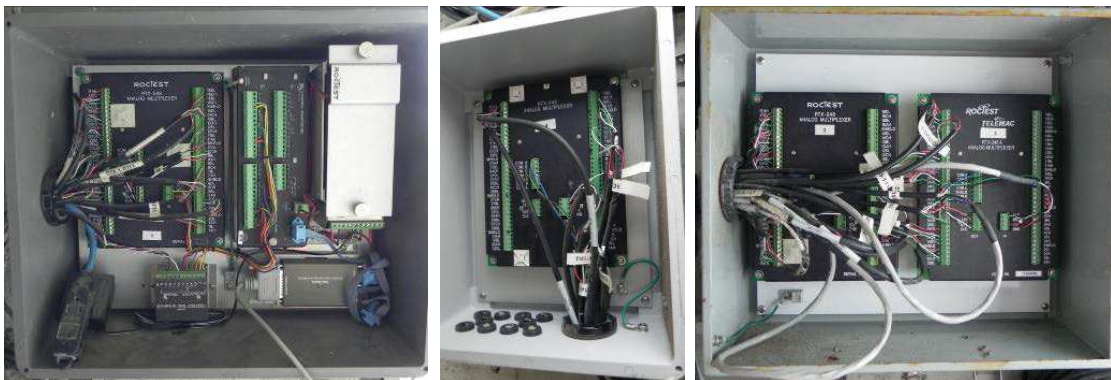
Figure 6. Readout units and multiplexers: (a) Datalogger CR10X; (b) Multiplexer-1; (c) Multiplexer -2; (d) DMI for FOS; (e) P-3500

Three readout units were needed to collect the strain and temperature readings from the VWSG, FOS, TH-T and ESG. These units were Datalogger CR10X for the vibrating wire sensors as well as the TH-T sensors, DMI unit for the fiber optic sensors, and P-3500 readout unit for the electrical resistance strain gauges. The TH-T and VWSG sensors were connected and controlled by a Datalogger unit type CR10X (Figure 6a) while the FOS were connected through a 16-channel DMI unit (Figure 6d). To accommodate the number sensors that were installed, two multiplexers (Figure 6b; 6c) were installed and the VWSG and TH-T sensors were connected to it which, in turn, were connected to the Datalogger CR10X (Figure 6a). These units are installed at the North-West side of the bridge abutment. Thus, the reading from TH-T, VWSG and FOS were respectively store in the Datalogger and DMI units. For the moment, no phone line is installed in the units so the results must be taken periodically with portable PC. On the other hand, the ESG data are being collected manually by a P-3500 unit (Figure 6e). In addition to that, a crack mapping is done periodically through visual observation and measurement where the crack widths were measured using a hand-held microscope of 50X magnifying power.

After connecting the FOS sensors to the DMI unit, the pre-prepared program was uploaded to the Datalogger CR10X by connecting it to a computer and using the PC200W software (Campbell 2010). On the other hand, FISO Commander 2 Standard software (FISO 2010) was used to program the DMI unit. The readings of the Datalogger CR10X are being acquired using the PC200W software (Campbell 2010) while the readings of the DMI unit are being collected using FISO Commander 2 Standard software (FISO 2010).

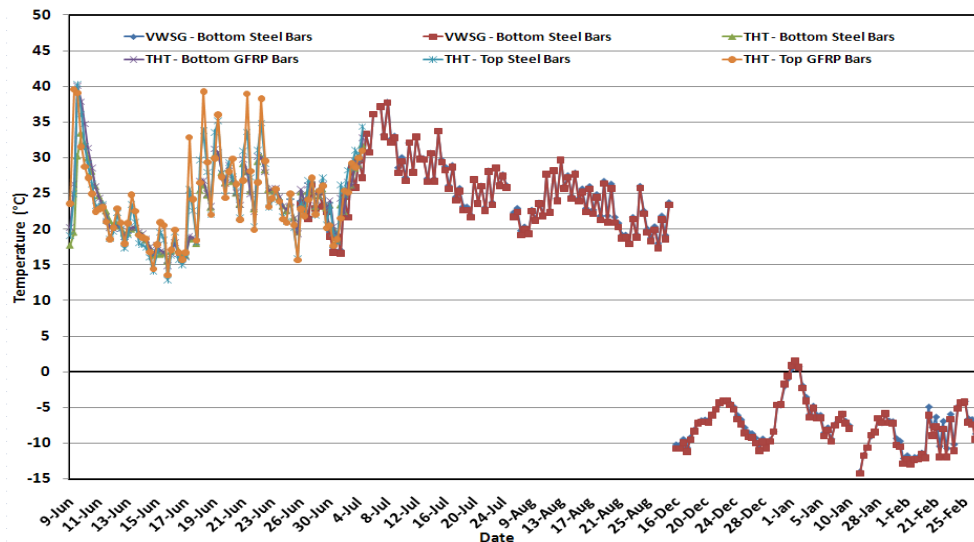
Figure 7. Temperature variation in the median barrier

The variation of the temperature inside the median barrier in the GFRP- and steel-reinforced section was captured using the four TH-T and two VWSG sensors starting from June 9, 2010. The measured temperature variation inside the barrier wall is presented in Figure 7. It can be noticed that the temperature range from  $-12^{\circ}\text{C}$  to  $41^{\circ}\text{C}$  during the period of data taking. Also, in this figure, the effect of cement hydration heat can be clearly observed during the first day after casting (June 9, 2010), after that time the concrete temperature followed the ambient air temperature. Thus, the temperature variation is expected to follow the seasonal temperature changes.

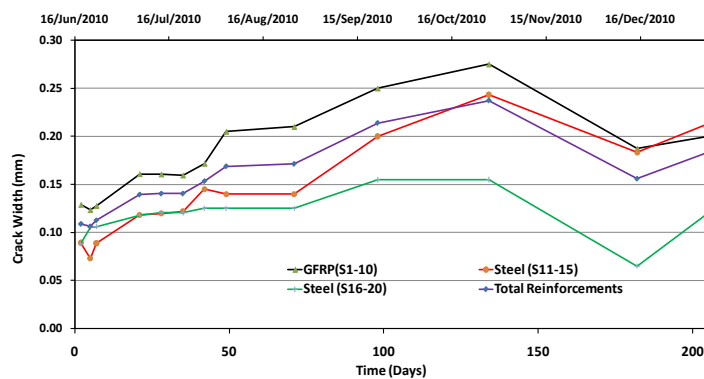
Figure 9. Evolution of average crack width

The time evolution of crack width is presented in Figure 9. The cracks in both of the GFRP- and steel-reinforced sections developed in the first month after removing the formwork. Since then, only one crack appeared in each of the two sections on October 28, 2010. However, the crack width in both reinforced sections has increased from June 16 to October 28, as clearly shown in Figure 9. Thereafter, the crack widths followed the seasonal temperature variation and have decreased with decreasing ambient temperature in the winter season.
